**Class I and II Well Inspection Form**  
**US Environmental Protection Agency – Region 4**  
**Underground Injection Control Program**  
**61 Forsyth Street SW, MC 9T25, Atlanta, Georgia, 30303**  
**Phone: (404)562-9424**

Facility Name: *Blackjack Plant* \_\_\_\_\_  
 Street Address: *4940 Blackjack Plant Road* \_\_\_\_\_  
 City: *Jay* \_\_\_\_\_ County: *Santa Rosa* \_\_\_\_\_ State: *FL* \_\_\_\_\_ Zip: *32535* \_\_\_\_\_  
 Nature of Business: *Oil and gas production* \_\_\_\_\_  
 Facility Owner/Operator: *Black Creek Energy, LLC* \_\_\_\_\_ Phone: *(601) 431-5386* \_\_\_\_\_  
 Email: *harris.butler@butlerroyals.com* \_\_\_\_\_  
 Facility Contact (if different): *Michael Wetzel* \_\_\_\_\_ Phone: *(850) 324-6271* \_\_\_\_\_  
 O/O Mailing Address: *140 Virginia Street, Suite 402* \_\_\_\_\_  
 City: *Richmond* \_\_\_\_\_ County: *NA* \_\_\_\_\_ State: *VA* \_\_\_\_\_ Zip: *23209* \_\_\_\_\_

Well Name & #: *D.M. Kirkland #11W* \_\_\_\_\_  
 Well Type (see table): *Enhanced Recovery (EOR)* \_\_\_\_\_ State Permit: API # *0911320135* \_\_\_\_\_  
 Latitude (°N): *30.871768°N* \_\_\_\_\_ Longitude (°W): *-87.119786°W* \_\_\_\_\_ Elevation (ft): *NA* \_\_\_\_\_  
 Injection M

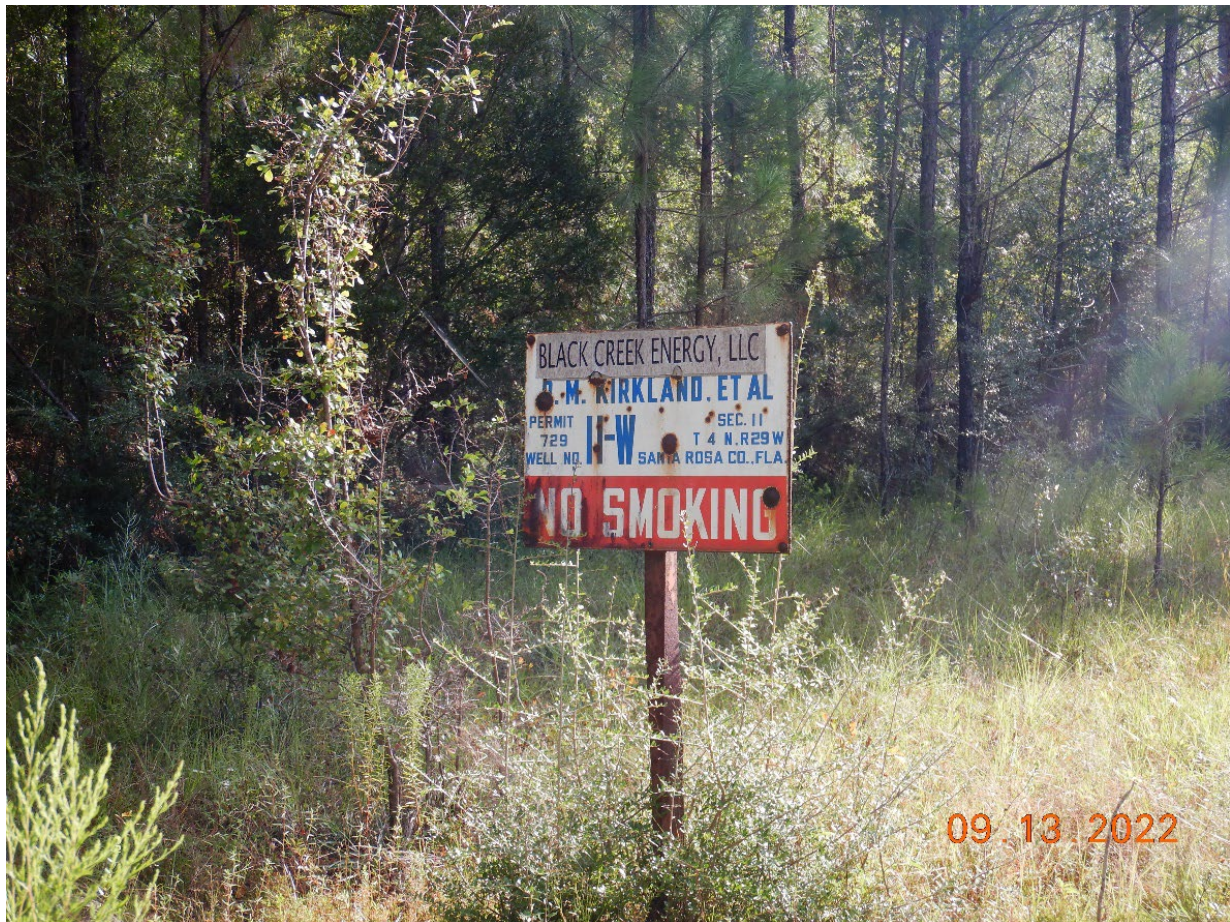
Description: *Looking east, D.M. Kirkland #11-W sign alongside access road.* \_\_\_\_\_

**Photograph 1:** Looking east, D.M. Kirkland #11-W sign alongside access road.

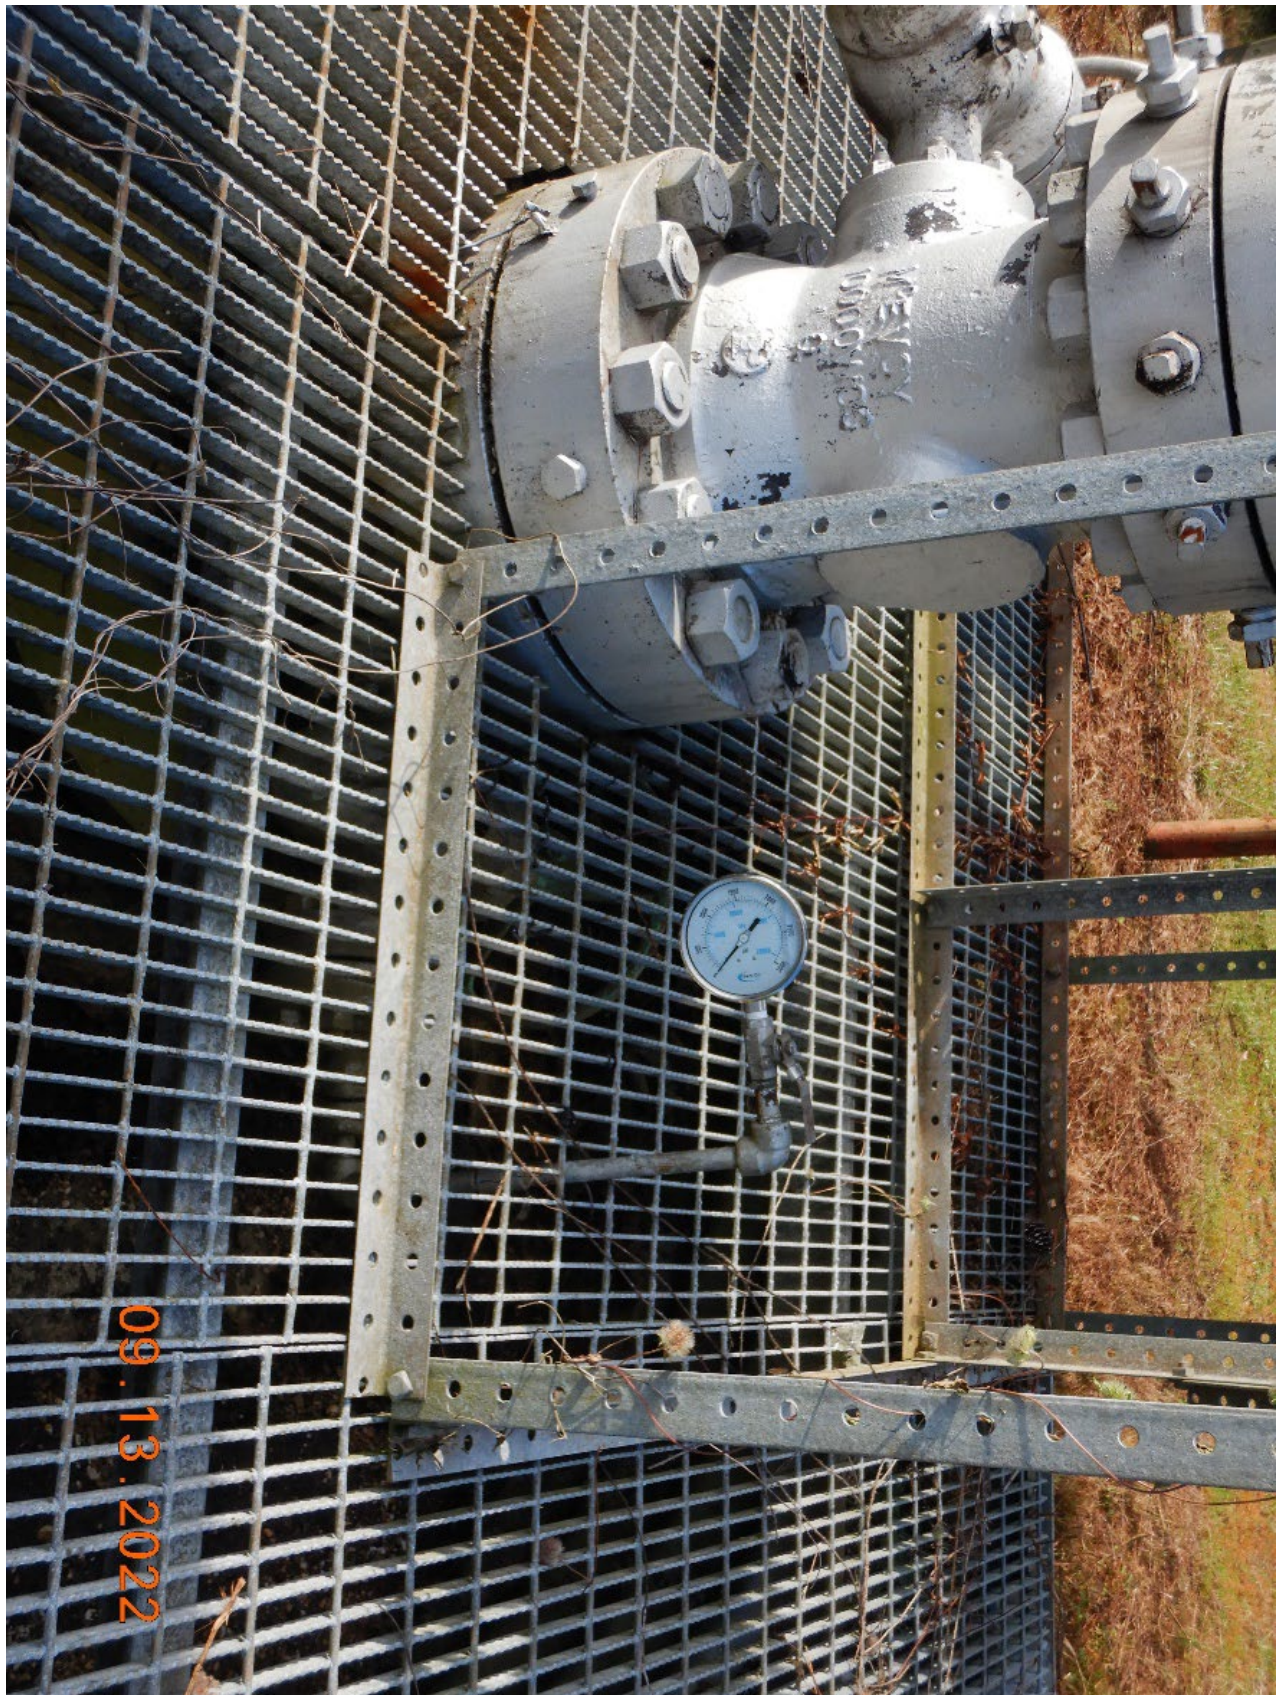
Description: *Looking south, closeup view of surface casing pressure gauge reading 0 psi.* \_\_\_\_\_

**Photograph 2:** Looking south, closeup view of surface casing pressure gauge reading 0 psi.

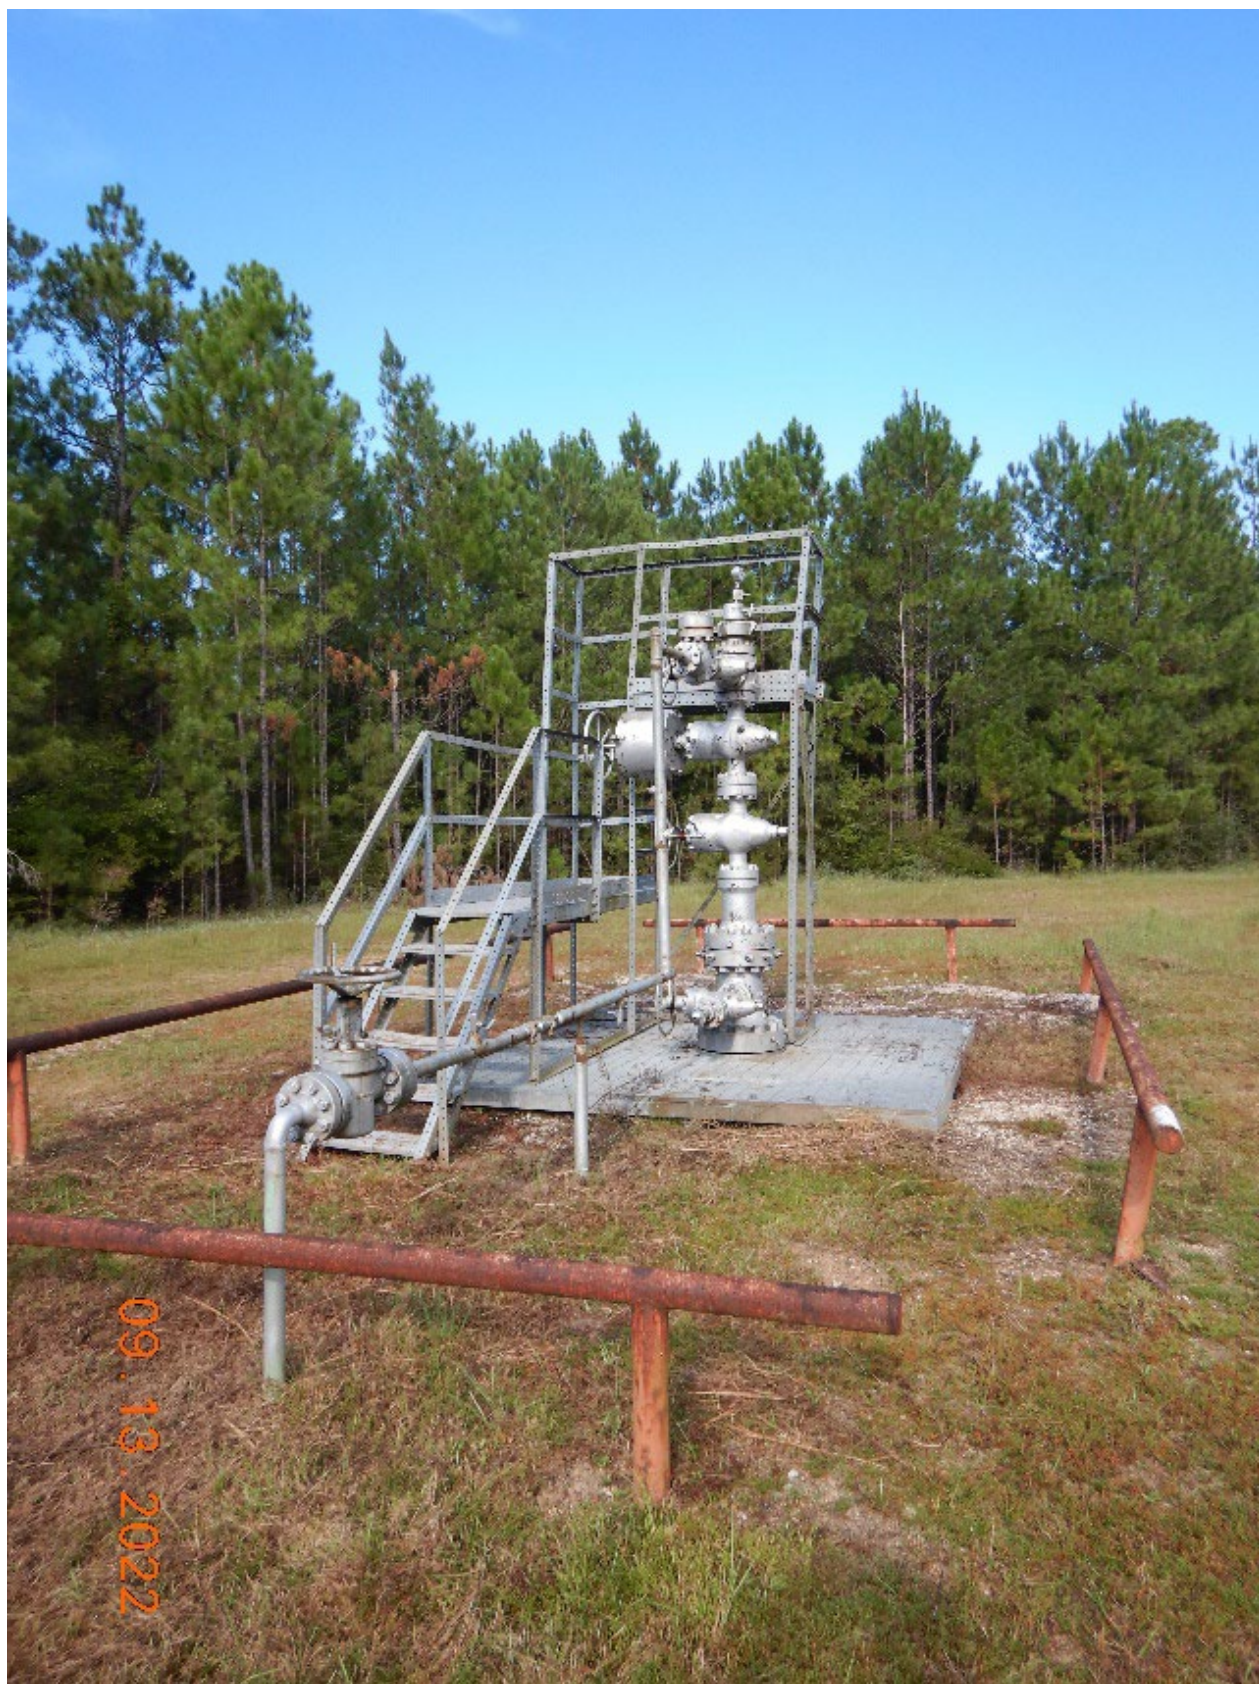
Description: *Looking east, site overview, including well head, pressure gauges, valves, and access stairs.* \_\_\_\_\_

**Photograph 5:** Looking east, site overview, including well head, pressure gauges, valves, and access stairs.
