## **RCRA Inspection Report**

University of Louisville - EPSC  
1810 Arthur St Louisville, KY 40208

August 22, 2023 9:05am

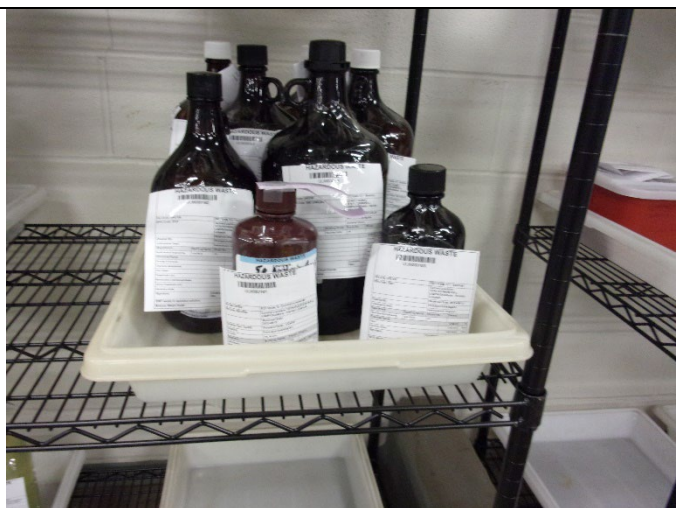
Figure 2: 9:40 AM Oxidizers/Peroxides Section  
Example photo of located containers properly closed,  
labeled, and placed in bins.

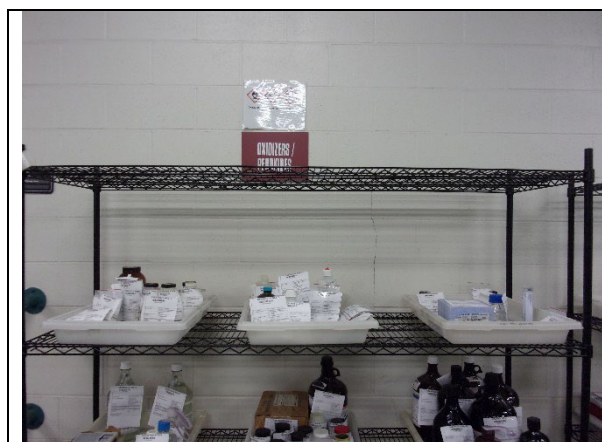
Figure 3: 9:40 AM Oxidizers/Peroxides Section  
Example photo of located containers properly closed,  
labeled, and placed in bins.

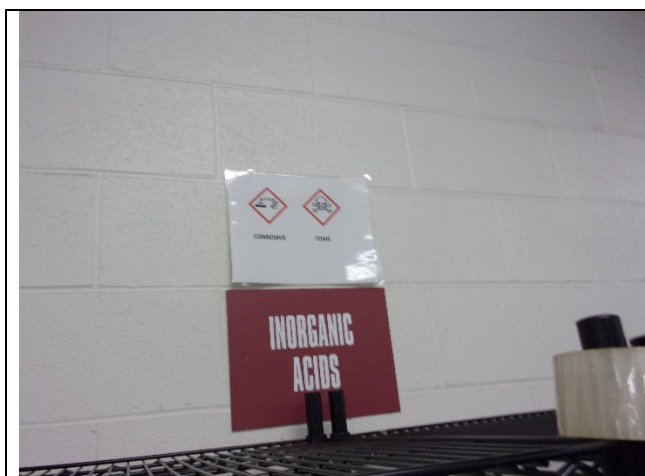
EPSC manages inorganic acids in the Inorganic Acids Section that is generated by research labs, teaching labs, and art studios within the university (Figure 5). The inspectors observed one 55-gallon container in this area (Figure 6). The container was located adjacent to the section's metal shelving rack, and it was equipped with a drum cover lid, which was closed. The container was labeled D002 hazardous waste Ryd lyme (<10% HCL) and identified with an indication of the hazards of the contents (Figures 7-8).

Figure 5: 9:41 AM Inorganic Acids Section Section overhead display.

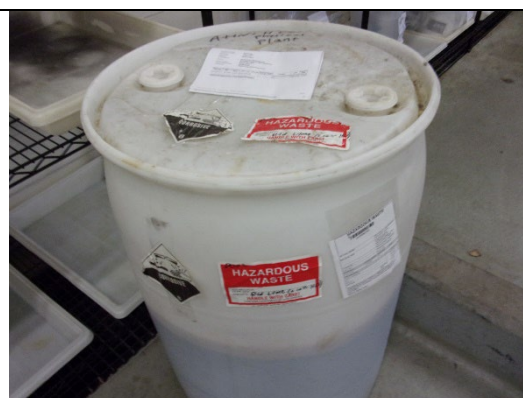
Figure 6: 9:43 AM Inorganic Acids Section (Photo 1 of 3) One 55-gallon container with hazardous waste label, accumulation start date, and indication of the hazards of the contents.

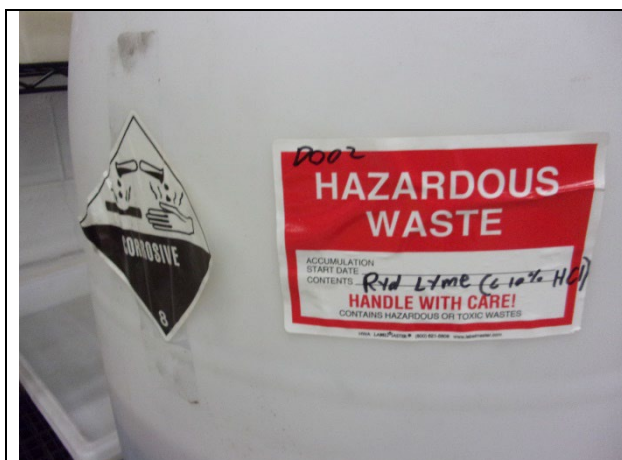
Figure 7: 9:43 AM Inorganic Acids Section (Photo 2 of 3) One 55-gallon container with hazardous waste label, accumulation start date, and indication of the hazards of the contents.

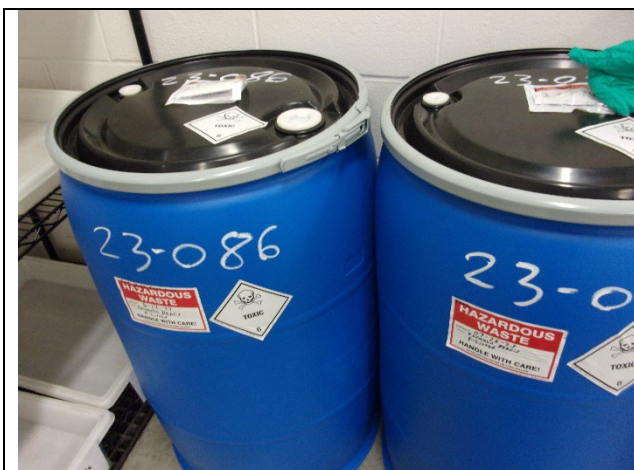
Figure 11: 9:50 AM Non-Flammable Organics Section  
(Photo 2 of 2) Two (2) 55-gallon containers with  
hazardous waste labels, accumulation start dates, and  
indication of the hazards of the contents.

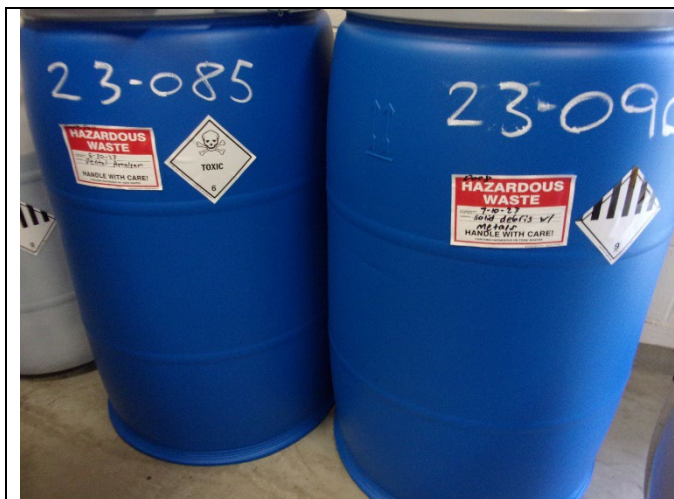
EPSC manages heavy metals in the Heavy Metal Section that are generated by research labs, teaching labs, and art studios within the university (Figure 12). The inspectors observed two (2) 55-gallon containers and one 35-gallon container in this area (Figures 13 and 14). The containers were located adjacent to the section's metal shelving rack, and were equipped with drum cover lids, which were closed. One 55-gallon container was labeled D011 hazardous waste Dental Amalgam and identified with an indication of the hazards of the contents. The other 55-gallon container was labeled D008 hazardous waste solid debris with metals and not properly identified with an indication of the hazards of the contents.

**Pursuant to 401 KAR 39:080, Section 1(1) [40 C.F.R. § 262.17(a)(5)(i)], which is a condition of the LQG Permit Exemption, a generator must mark or label its containers with the following: the words "Hazardous Waste"; an indication of the hazards of the contents; and the date upon which each period of accumulation begins clearly visible for inspection on each container.**

Figure 13: 9:52 AM Heavy Metal Section  
(Photo 1 of 2) Two (2) 55-gallon containers with hazardous waste label, accumulation start date, and indication of the hazards of the contents. One of the 55-gallon containers were not properly identified with an indication of the hazards of the contents.

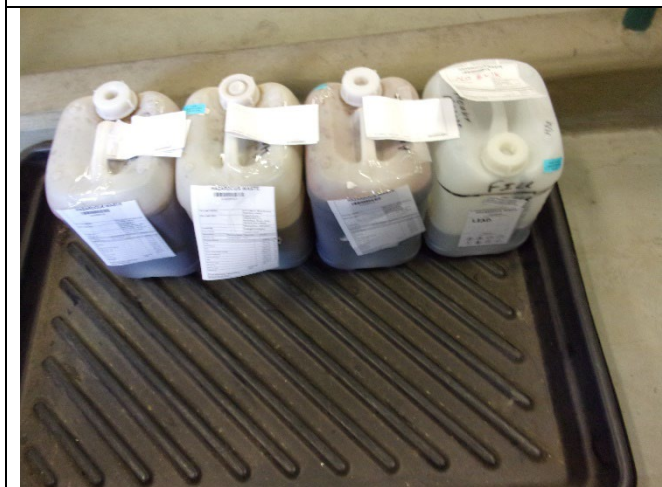
Inspectors observed four (4) 3-gallon containers in this area also (Figures 15-17). The containers were properly labeled and identified with an indication of the hazards of the contents.

Figure 15: 9:57 AM Heavy Metal Section  
Four (4) 3-gallon containers with hazardous waste label, accumulation start date, and an indication of the hazards of the contents

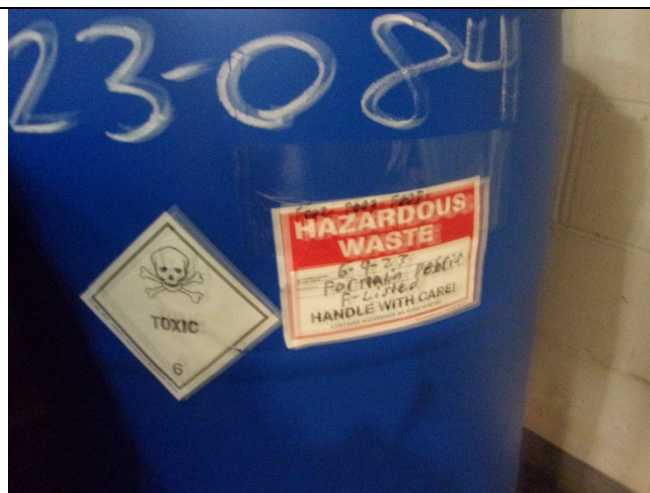
EPSC manages wastes in the Bulking/Blending Room that are generated by research labs, teaching labs, and art studios within the university (Figure 21). The inspectors observed one 55-gallon container in this area (Figures 22 and 23). The container was located underneath a ventilation area within the room, and was equipped with a drum cover lid, which was closed. The container was labeled F002, F003, F005 hazardous waste Formalin Debris, F-listed, and identified with an indication of the hazards of the contents.

Figure 22: 10:08 AM Bulking/Blending Room  
(Photo 1 of 2) One 55-gallon container with hazardous waste label, accumulation start date, and indication of the hazards of the contents.

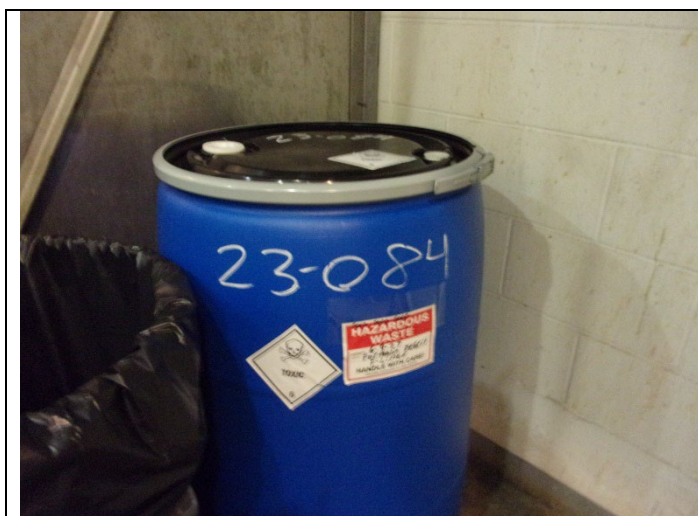
Figure 23: 10:09 AM Bulking/Blending Room  
(Photo 2 of 2) One 55-gallon container with hazardous waste label, accumulation start date, and indication of the hazards of the contents.

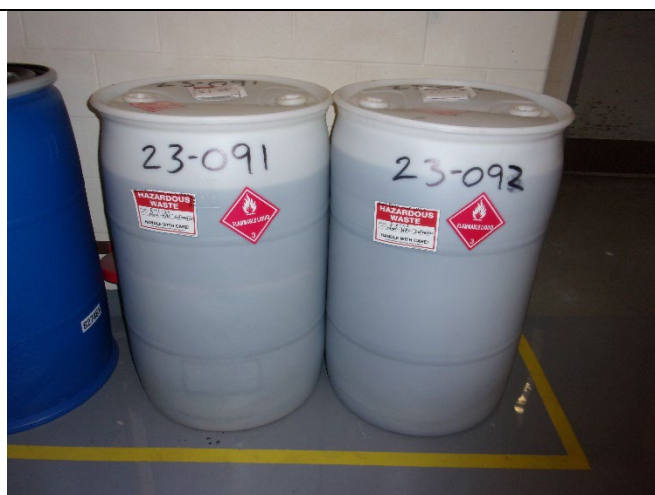
EPSC manages flammable waste in the Flammables Room that is generated by research labs, teaching labs, and art studios within the university. The inspectors observed six (6) 55-gallon containers in this area (Figures 24-28). The containers were equipped with drum cover lids, which were closed. The first 55-gallon container was labeled D001, F003, F005, U002, U003, U080, U112, and U122 hazardous waste non hal solvents, and identified with an indication of the hazards of the contents. The second 55-gallon container was labeled D001, F003, F005, and U122 hazardous waste non hal solvents, and identified with an indication of the hazards of the contents. The third 55-gallon container was labeled D001, D007, F003, F005, U002, and U154 hazardous waste non hal solvents, and identified with an indication of the hazards of the contents. The fourth and fifth 55-gallon containers was labeled D001 hazardous waste aerosol cans and identified with an indication of the hazards of the contents. The sixth 55-gallon container was labeled D001, D007 hazardous waste 3-D printing with debris sand/oil and identified with an indication of the hazards of the contents.

Figure 24: 10:11 AM Flammables Room  
Two of six 55-gallon containers with hazardous waste label, accumulation start date, and indication of the hazards of the contents.

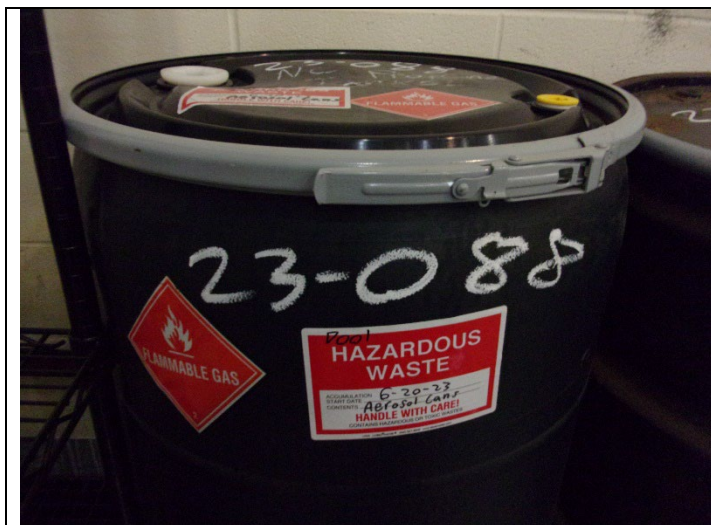
Figure 25: 10:12 AM Flammables Room  
Three of six 55-gallon containers with hazardous waste label, accumulation start date, and indication of the hazards of the contents.

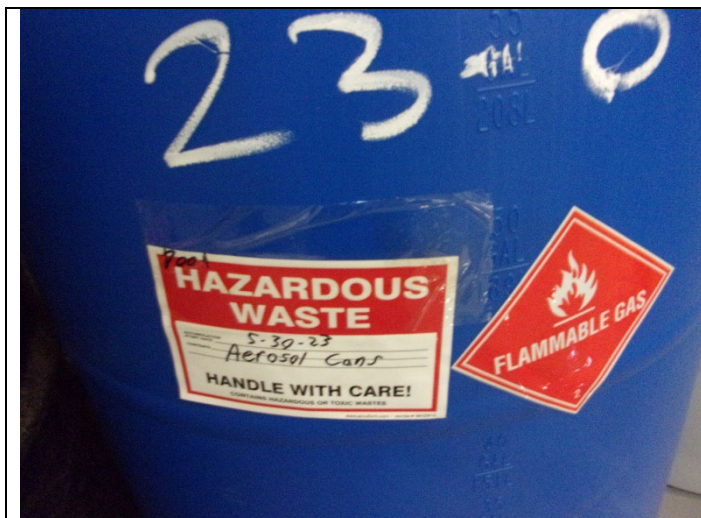
Figure 27: 10:12 AM Flammables Room  
Five of six 55-gallon containers with hazardous waste label, accumulation start date, and indication of the hazards of the contents.

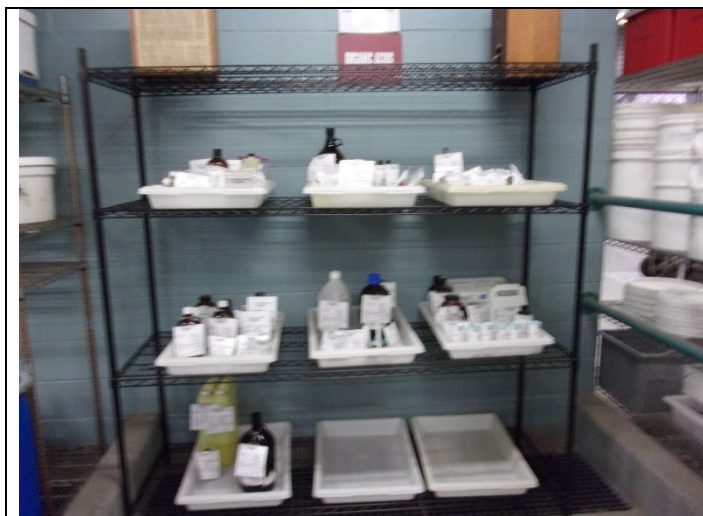
EPSC manages organic acid wastes in the Organic Acids Room that are generated by research labs, teaching labs, and art studios within the university (Figure 29). The inspectors observed seven (7) plastic bins with containers in this area. The containers were equipped with bottle caps, which were closed. The containers were properly labeled and identified with an indication of the hazards of the contents.

Figure 29: 10:17 AM Organic Acids Section  
Fume hood with designated unwanted materials area.

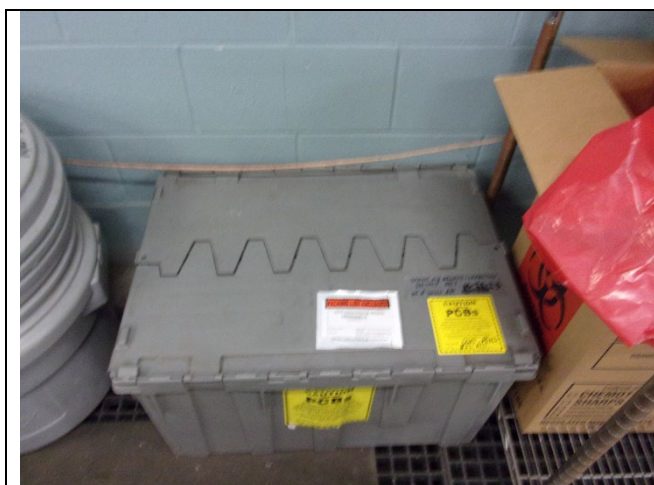
EPSC manages polychlorinated biphenyls (PCBs) in the PCB's Section (Figure 30). Inspectors observed one 2-foot by 1-foot box container of PCBs (Figure 31).

Figure 31: 10:18 AM Universal Waste Section  
One 35-gallon container of PCBs observed.

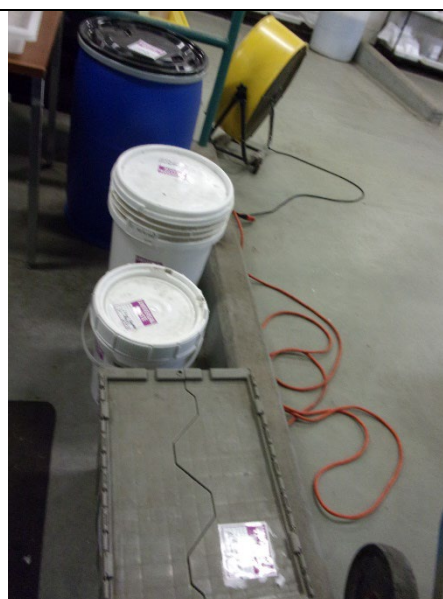
EPSC manages universal waste batteries in the Universal Waste Storage Area. The inspectors observed four (4) containers of universal waste batteries in this area during the inspection. One 35-gallon container, one 8-gallon container, two 5-gallon containers, and one 2-foot by 1-foot box container of batteries, which were closed and marked with an accumulation start date, was

labeled universal waste used batteries (Figures 32 and 33). The oldest date observed on any container of batteries was February 13, 2023.

Figure 32: 10:18 AM Universal Waste Section  
One 35-gallon container, one 8-gallon container, one 5-gallon container, and one 2-foot by 1-foot box container of universal waste batteries observed.

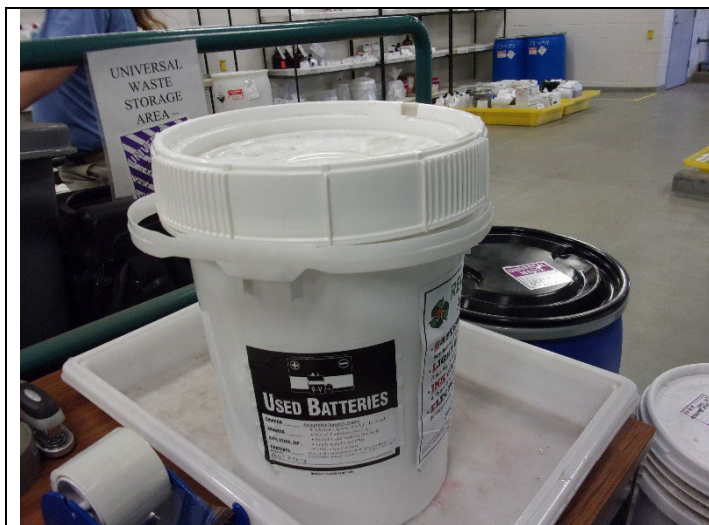
Figure 33: 10:20 AM Universal Waste Section  
One 5-gallon container of universal waste batteries observed.

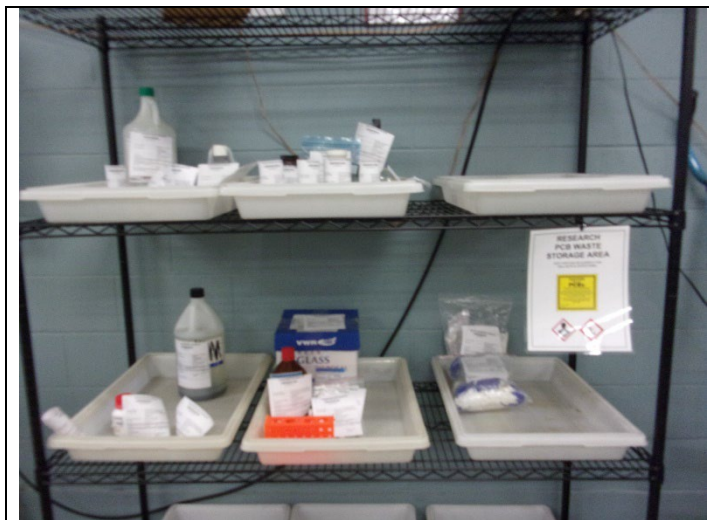
EPSC manages acutely toxic wastes in the Acute Toxic Section that is generated by research labs, teaching labs, and art studios within the university (Figures 34). The inspectors observed five (5) plastic bins with containers in this area (Figure 35). The containers were equipped with bottle caps, which were closed. The containers were properly labeled and identified with an indication of the hazards of the contents.

Figure 35: 10:21 AM Acute Toxic Section  
Five (5) plastic bins with containers observed.
