## Clean Water Act Section 404: Site Visit/Case Development

| Site Name | Calion Lumber Company, Inc. (Oil and Gas Activity) | | | | |

| Inspection Purpose | Initial site visit | | |

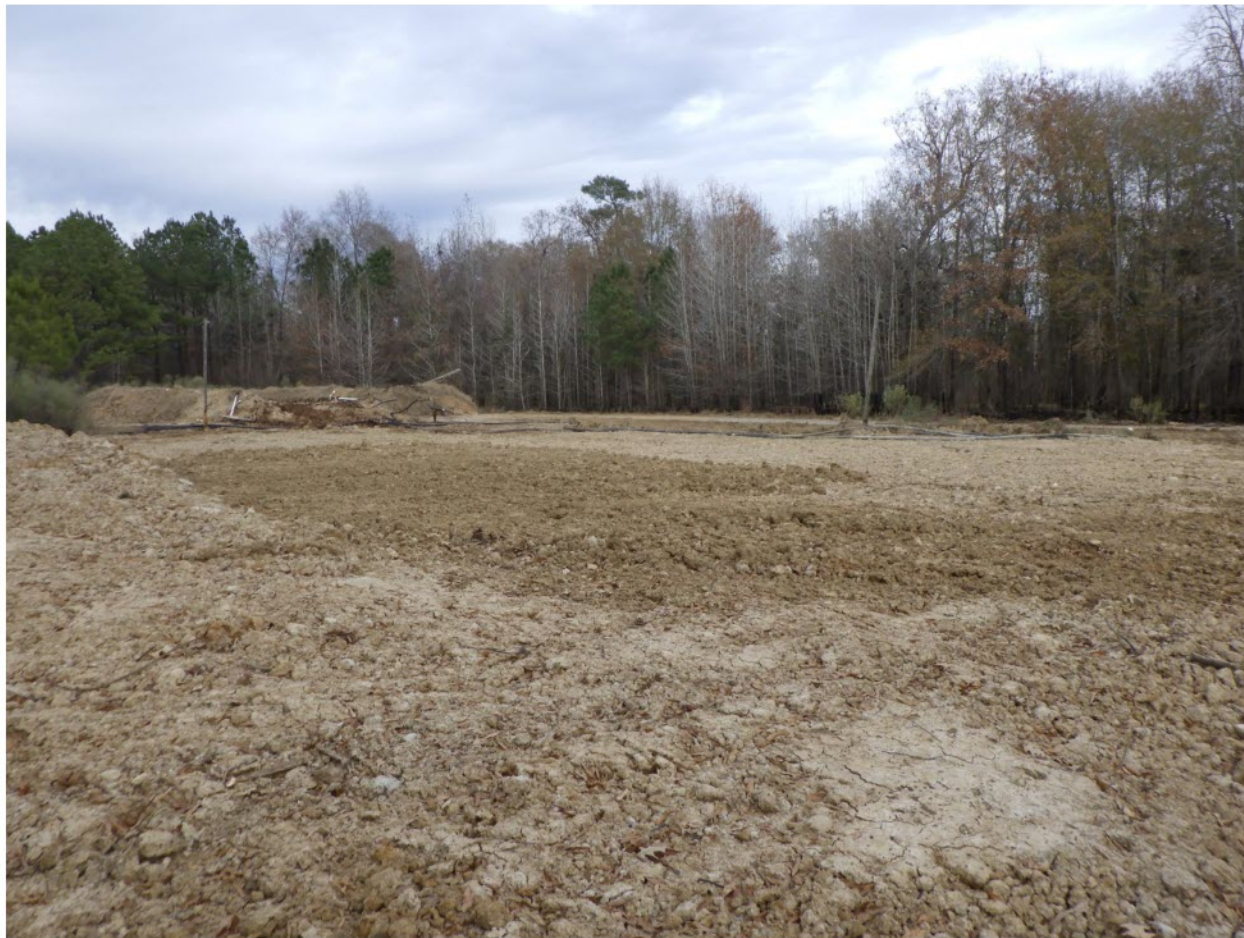
Photo No. 1

**Description:** This photo was taken looking NE showing fill material. Note: observed heavy equipment tire tracks throughout site.

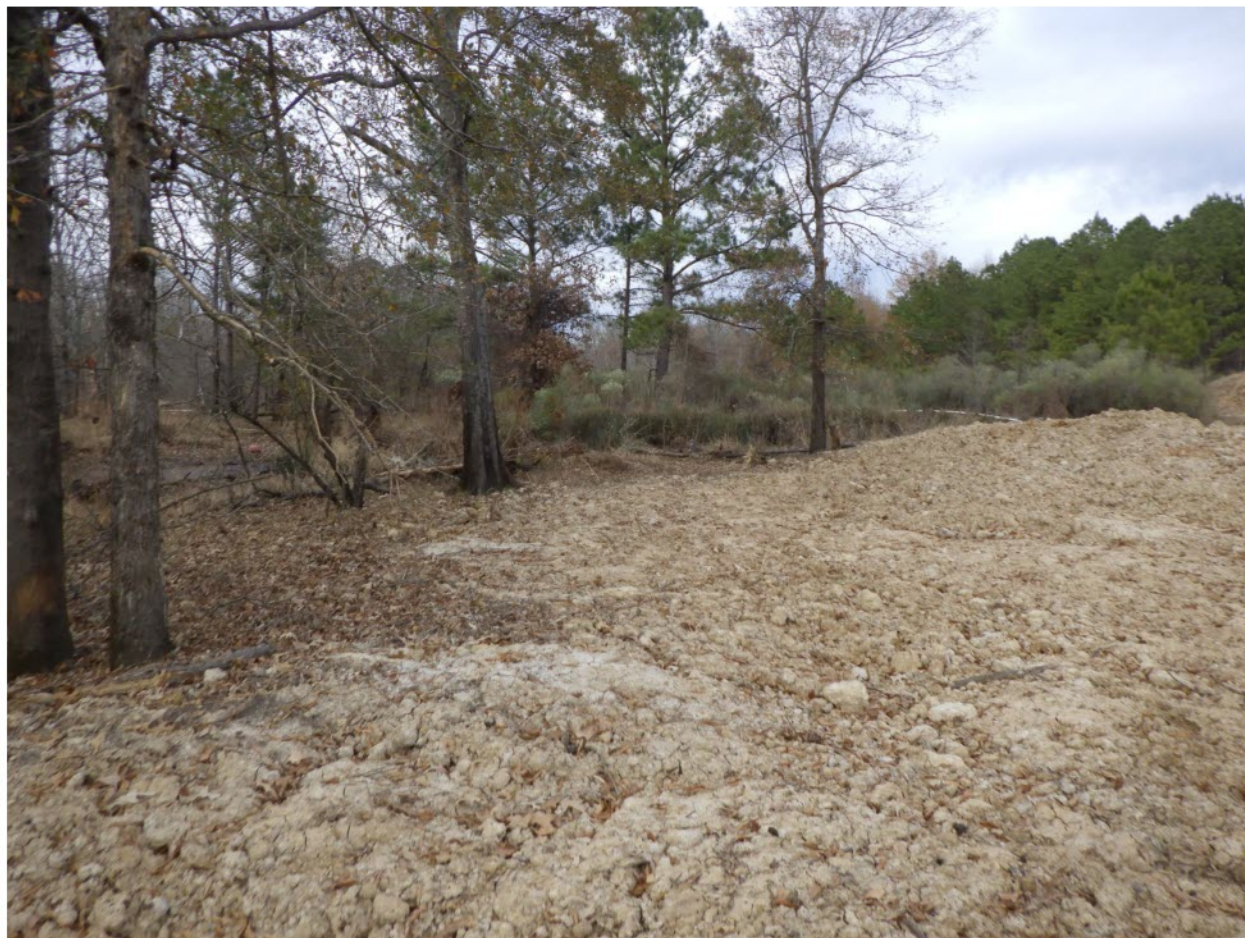
Photo No. 2

**Description:** This photo was taken looking NW showing fill material. Note observed crystallization and oil staining on ground.

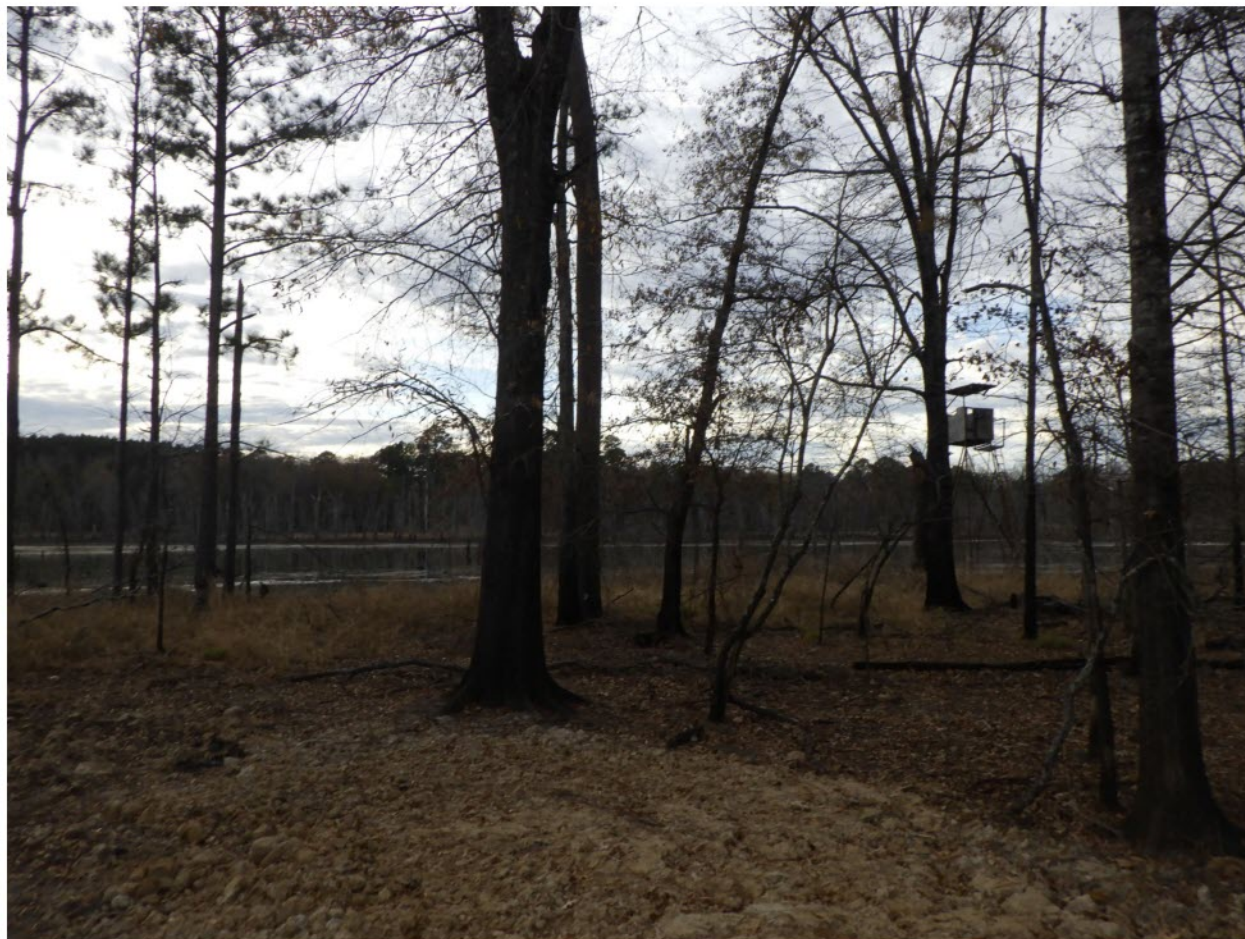
Photo No. 3

**Description:** This photo was taken looking SW showing fill material.

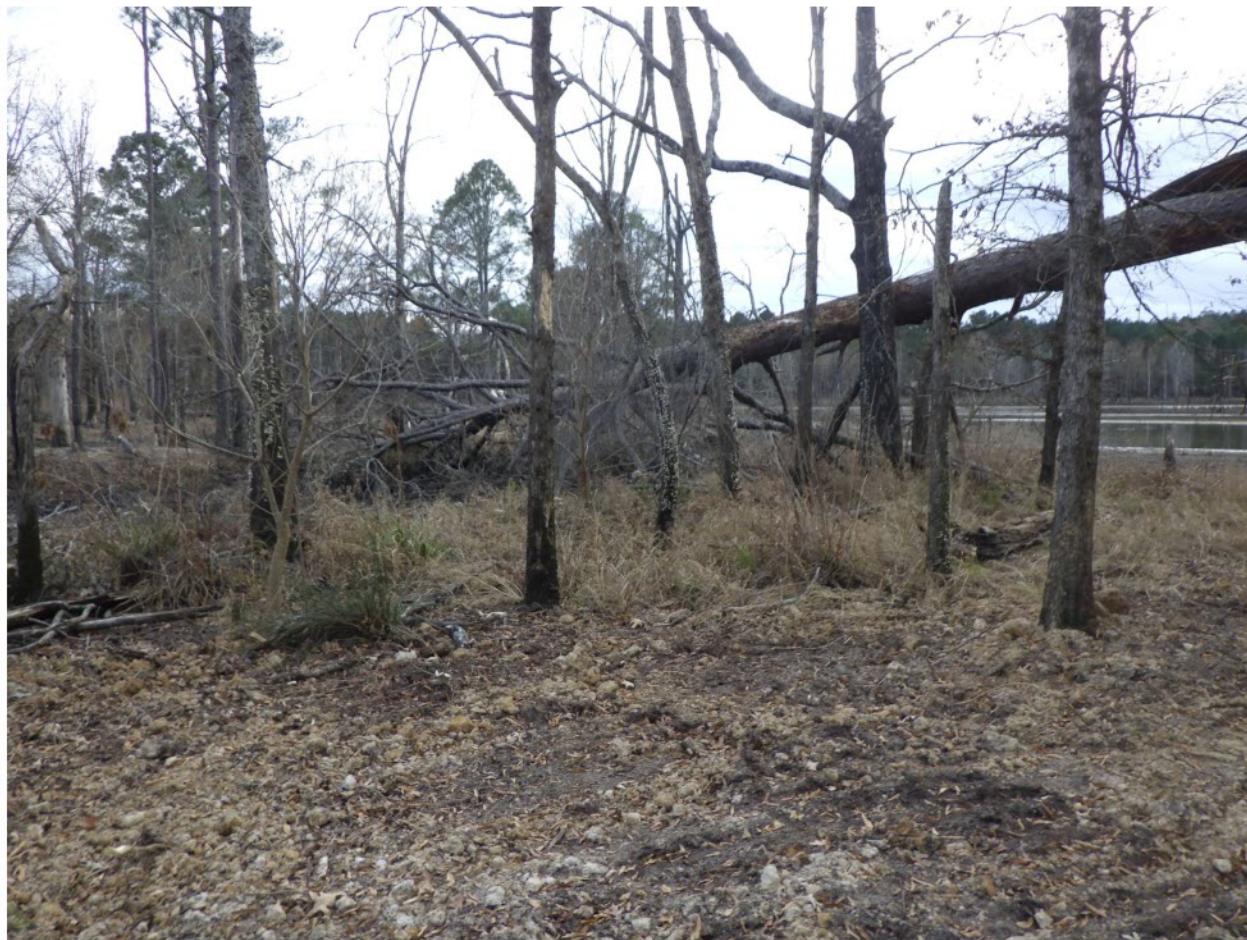
Photo No. 4

**Description:** This photo was taken looking S showing fill material. Note: observed stressed vegetation and black oil staining on vegetation and soil.

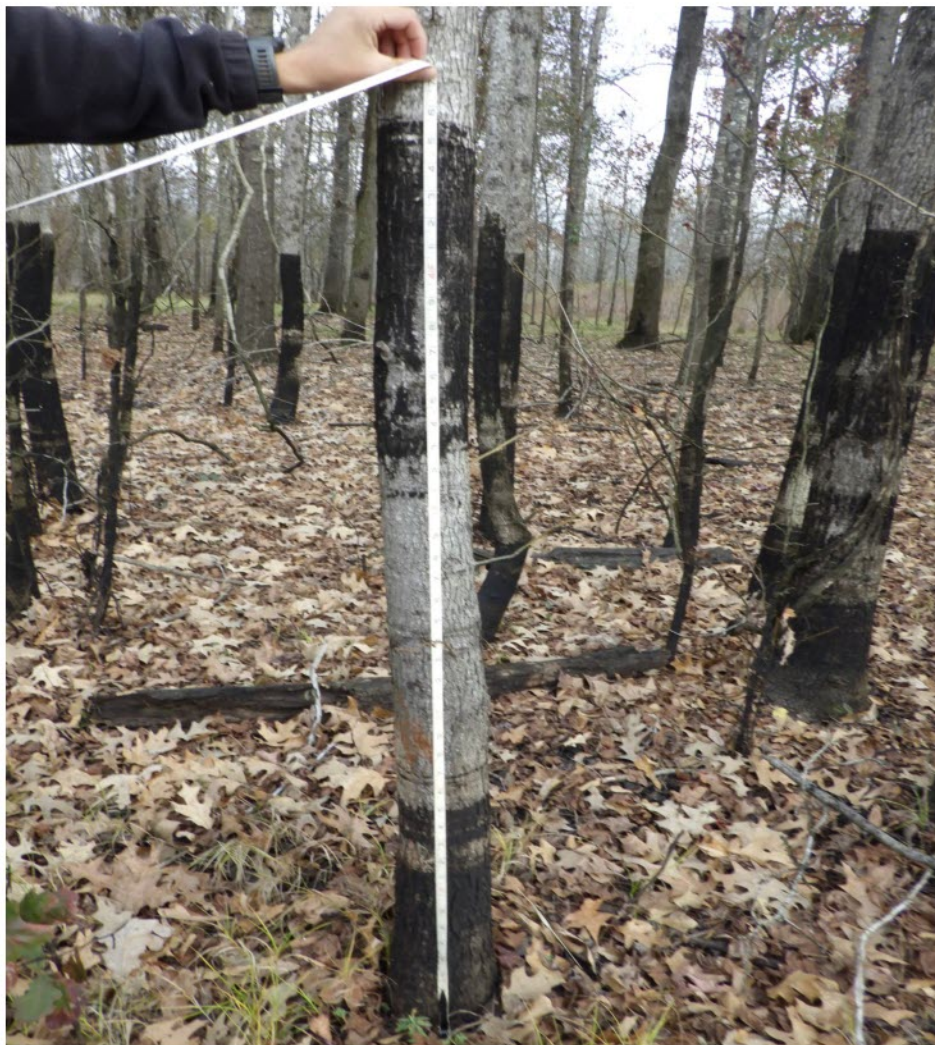
Photo No. 5

**Description:** This photo was taken looking SE showing water marks/oil stain marks along trees indicating flood inundation.

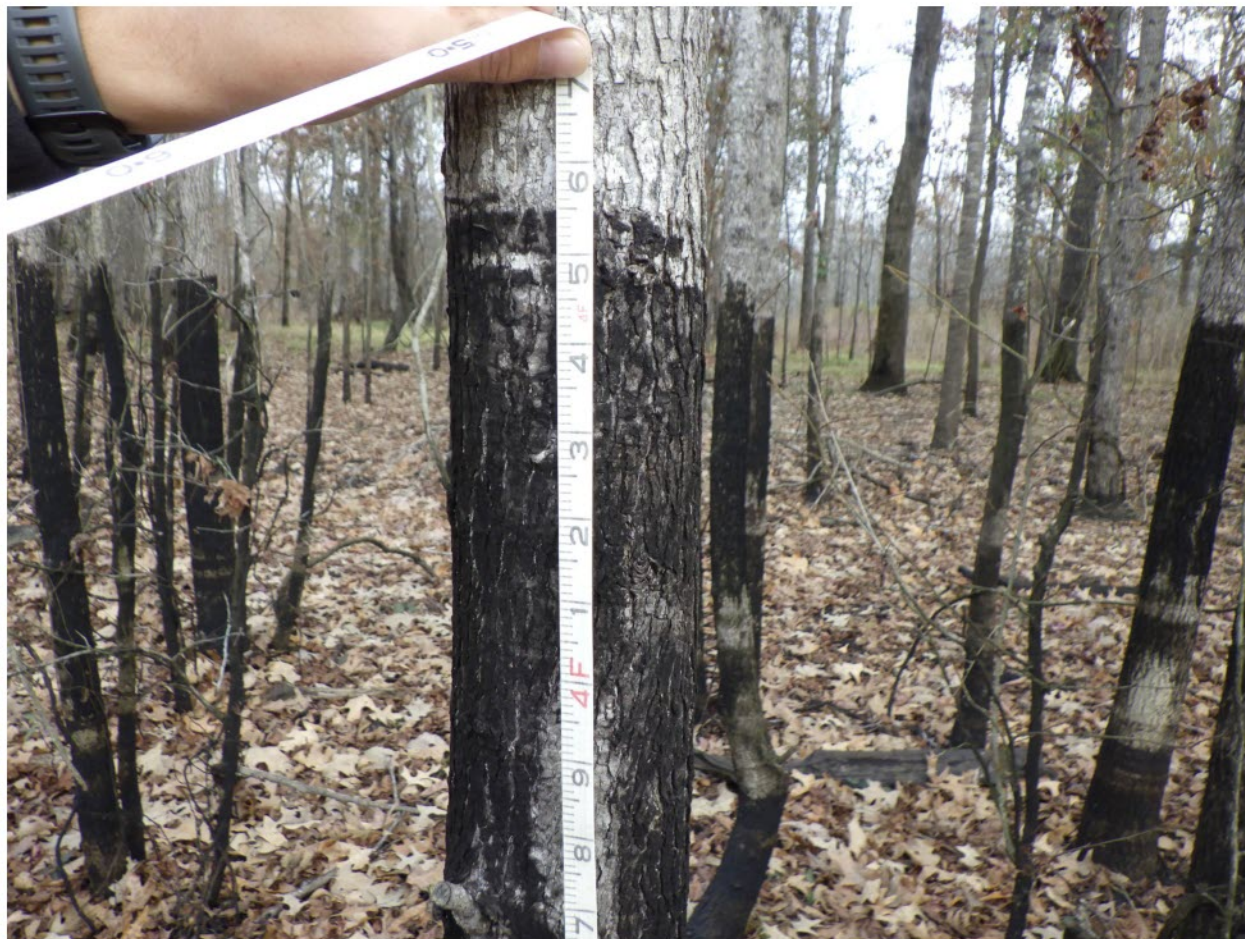
Photo No. 6

**Description:** This photo was taken looking SE showing water marks/oil stain marks on trees over 4.5 feet from ground.

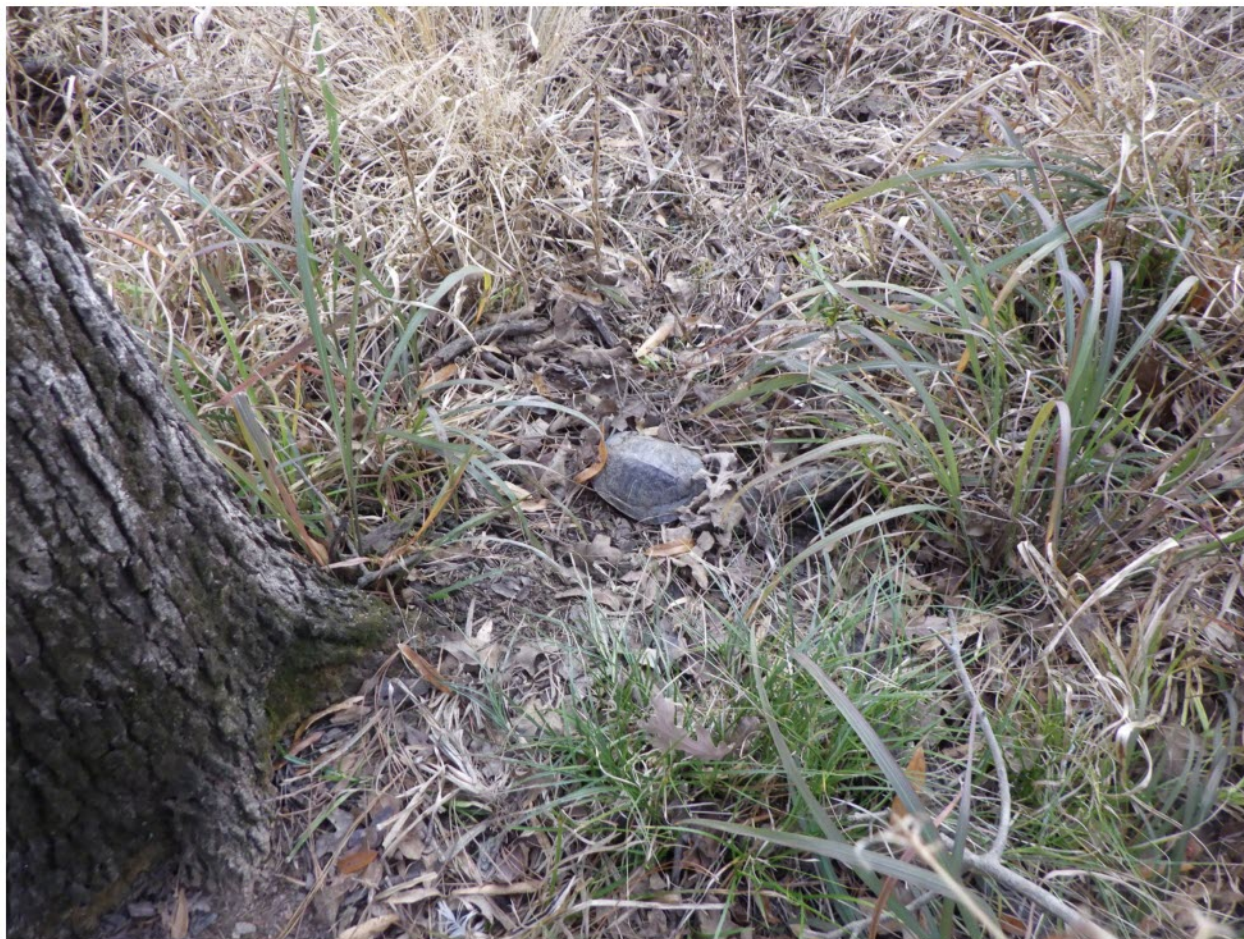
Photo No. 7

| Potential unauthorized activity of discharging fill material and changing the bottom elevation of wetlands. There are also water quality concerns and effects on aquatic life as we noted extremely elevated Total Dissolved Solids (TDS) of 5012 milligrams per liter (mg/L). We also observed a dead aquatic turtle, stressed vegetation, brine and oil staining on soil, and oil staining/water marks on trees. We completed a Brine inspection along with the Section 404 inspection. The report will be sent to the Vicksburg District Corps of Engineers to determine compliance with Section 404. | | | |

**Description:** This photo is showing dead turtle found beside wetland and site activity.

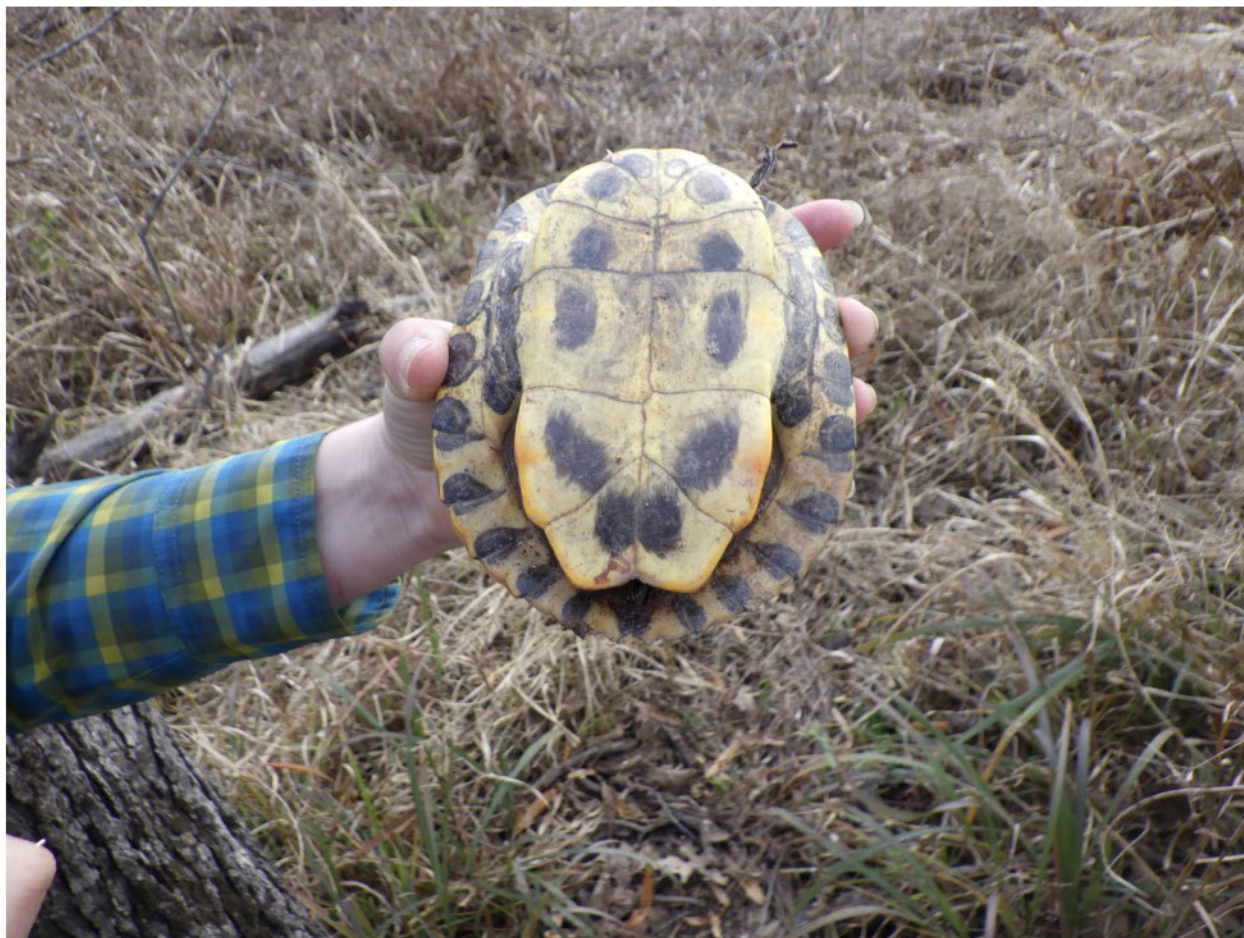
Photo No. 8

**Description:** This photo is showing turtle shell plastron, basking turtle in the family Emydidae.
