## **RCRA Inspection Report**

Mitsubishi Chemical America, Inc.  
Electrolyte Division  
2665 Fite Road, Suite 101  
Memphis, Tennessee 38127

April 11, 2024 at 9:30 A.M.

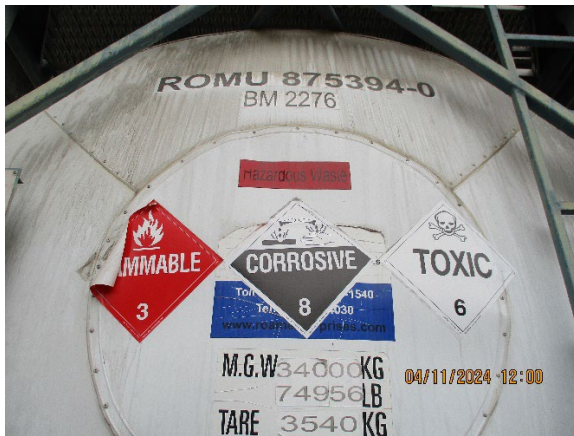
The last bay in the Solvent Feed Area is used to store the 6,340-gallon hazardous waste horizontal above-ground storage tank (Photos 1-4). Waste generated from cleaning out reactor vessels is hard piped to the hazardous waste tank. The tank also has a secondary containment pit. Rainwater accumulating in the containment pit gets analyzed before being pumped out and sent for proper disposal. The hazardous waste tank is continuously monitored with an Emerson Delta V Distributed Control System (DCS) which monitors tank level and other sensors. The tank appeared in good condition and was labeled with the words "Hazardous Waste" and marked with an indication of the hazard of the contents. In order to maintain compliance with the 90-day accumulation limit, hazardous waste is emptied out every 1-2 months and tracked by the facility's electronic tank inventory logs. The tank's ancillary equipment appeared to be tagged pursuant to Subpart BB Air Emission Standards for Equipment Leaks. Fire control equipment and spill control equipment are also located next to the hazardous waste tank. A "No Smoking" sign and a "Hazardous Waste 90-Day Accumulation Area" sign was observed in this area (Photo 5).

Photo 1: Hazardous waste tank in Solvent Feed Area.

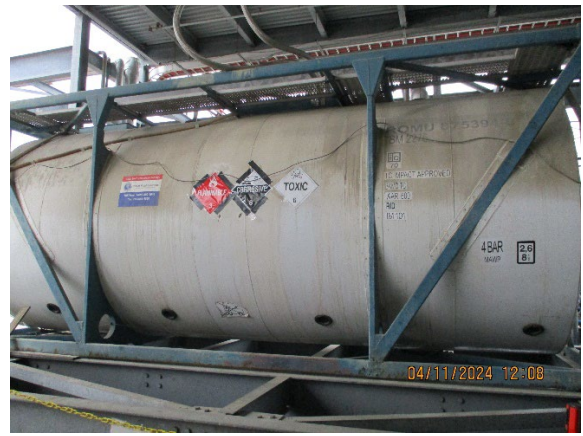
Photo 2: Hazardous waste tank in Solvent Feed Area.

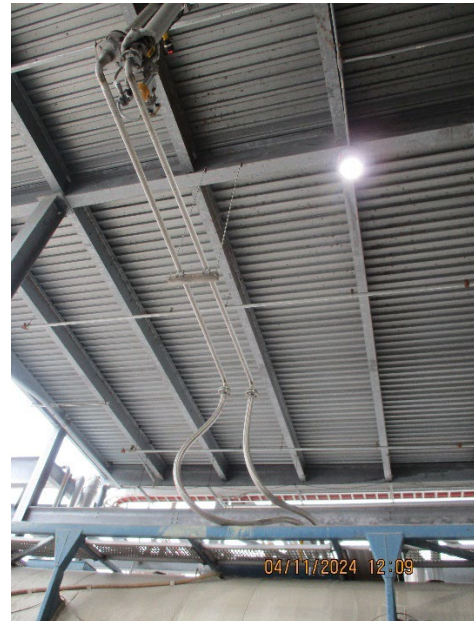
Photo 4: Top of hazardous waste tank and piping connections.

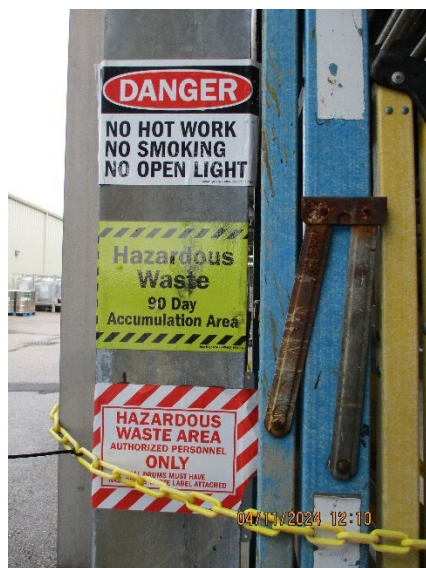
Photo 5: Signage posted near hazardous waste tank in Solvent Feed Area.

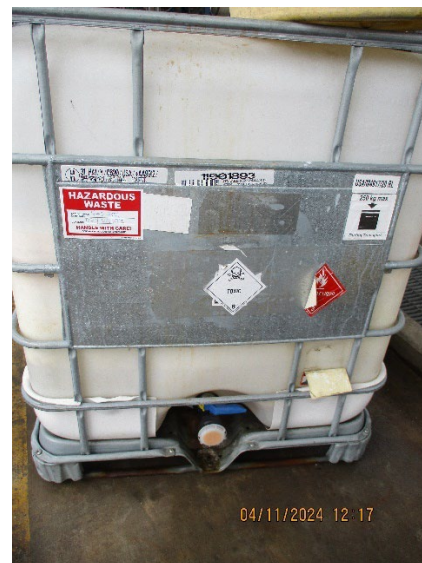
Adjacent to the tank was a 250-gallon tote labeled "ISO Sample Waste" and labeled "Hazardous Waste" (Photo 6). The tote was marked with an indication of the hazard of the content and had an indicator to show the 55-gallon level on the tote. The tote was being managed as a satellite accumulation area (SAA) container for residual waste generated from the transfer of waste

from the hazardous waste tank. At the time of the inspection, the waste inside the tote was below the 55-gallon marker. After some discussion and concern expressed by the inspectors for ensuring that the container does not pass 55-gallons of hazardous waste, the facility decided to manage the 250-gallon tote as a less than 90-day CAA container. Facility representatives added a date to the container for 04/03/2024 and will be managing the container according to CAA requirements and include this area on the weekly inspections for CAAs from now on.

Photo 6: 250-gallon tote labeled "ISO Sample Waste" and labeled "Hazardous Waste" next to hazardous waste tank.

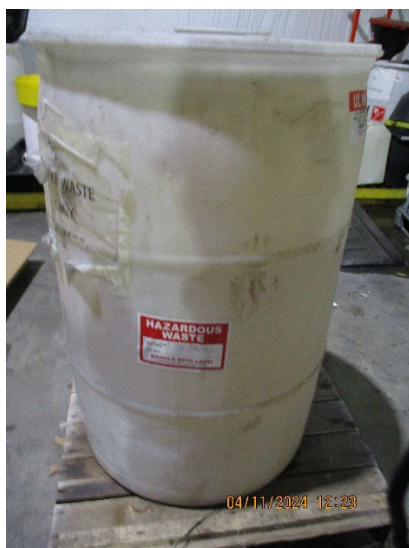
- One 55-gallon container labeled "Filter Waste" (Photo 7). The container was closed, labeled with the words "Hazardous Waste", marked with an indication of the hazard of the contents, but was missing an accumulation start date;

**(C) The date upon which each period of accumulation begins clearly visible for inspection on each container.**

Photo 7: Raw Materials Warehouse CAA. 55-gallon container of filter waste.

Facility representatives labeled and marked containers that were missing “Hazardous Waste” labels, hazard indications, and accumulation start dates during the inspection.

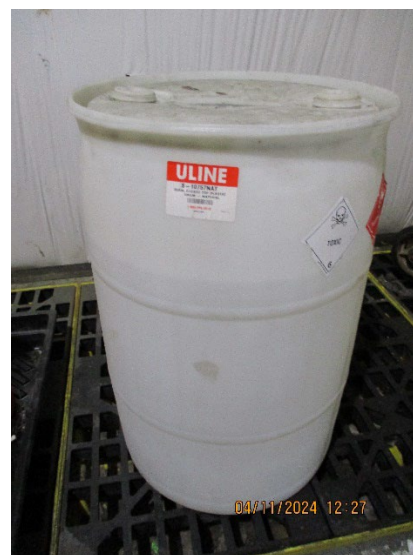
- One 55-gallon container labeled "Flammable and Toxic" (Photo 8). The container was closed but was missing a hazardous waste label and an accumulation start date;

**Pursuant to Tenn. Comp. R. & Regs. 0400-12-01-.03(1)(h)1.(v)(I)I-III. [40 C.F.R. § 262.17(a)(5)(i)(A-C)], a large quantity generator must mark or label its containers with the following:**

Photo 8: Raw Materials Warehouse CAA. 55-gallon container of flammable, toxic waste.

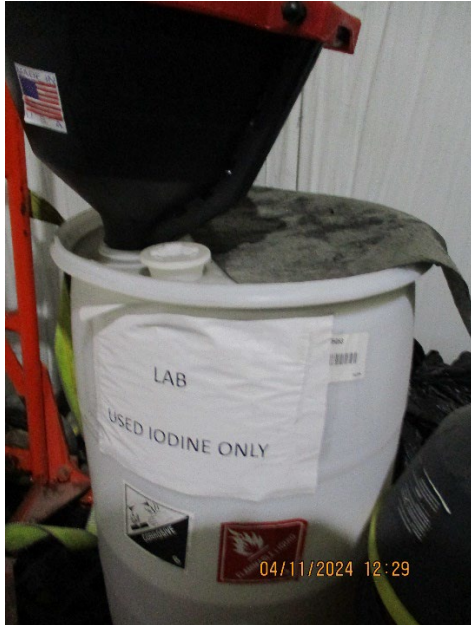
- One 30-gallon container labeled "Used Iodine Only" (Photo 9). The container had a funnel on it which contained a latch that was not closed and secured. The container was also marked with an indication of the hazard of the contents; however, the container did not have a hazardous waste label on it and no accumulation start date;

**Pursuant to Tenn. Comp. R. & Regs. 0400-12-01-.03(1)(h)1.(i)(IV)I. [40 C.F.R. § 262.17(a)(1)(iv)(A)], a container holding hazardous waste must always be closed during accumulation, except when it is necessary to add or remove waste.**

Photo 9: Raw Materials Warehouse CAA. 30-gallon container of used iodine waste.

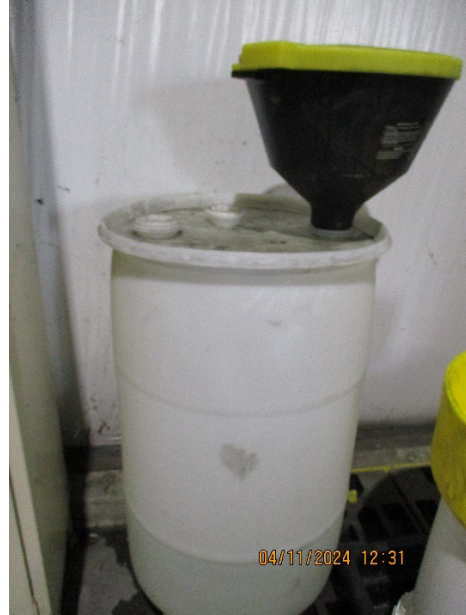
- One 30-gallon container as observed with no hazardous waste label, no indication of the hazard of the contents, no accumulation start date, and the container had a funnel on it which contained a latch that was not closed and secured (Photo 10);

Photo 10: Raw Materials Warehouse CAA. 30-gallon container with no labeling at all.

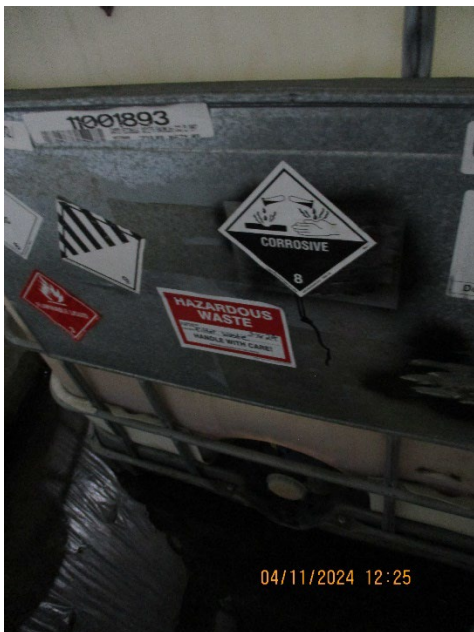
- One 250-gallon tote labeled filter waste. The container was closed, labeled with the words "Hazardous Waste", marked with an indication of the hazard of the contents, and dated 03/16/2024 (Photo 11); and

Photo 11: Raw Materials Warehouse CAA. 250-gallon tote of filter waste.

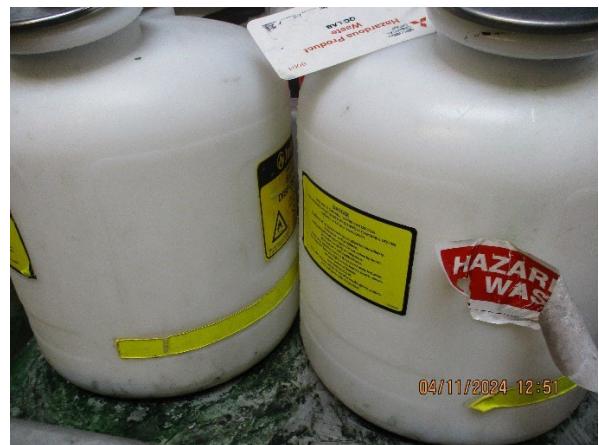
The inspectors also observed two one-gallon closed containers for used syringes from research and development (R&D) labeled “Hazardous Waste” but were missing an indication of the hazard of the contents (Photo 12).

**Pursuant to Tenn. Comp. R. & Regs. 0400-12-01-.03(1)(b) [40 C.F.R. § 262.11], a person who generates a solid waste, as defined in 40 CFR 261.2, must make an accurate determination as to whether that waste is a hazardous waste in order to ensure wastes are properly managed according to applicable RCRA regulations. A hazardous waste determination is made using the steps listed in 40 C.F.R. § 262.11(a-g).**

Photo 12: QC Laboratory—1-gallon containers of used syringes from R&D.

Mr. Tim McCaffery stated that these syringes were used in R&D and were empty of liquid are non-hazardous waste and were being incorrectly labeled as hazardous waste. Mr. McCaffery stated that the facility would be completing a new waste determination and will be managing these containers as non-hazardous waste going forward.

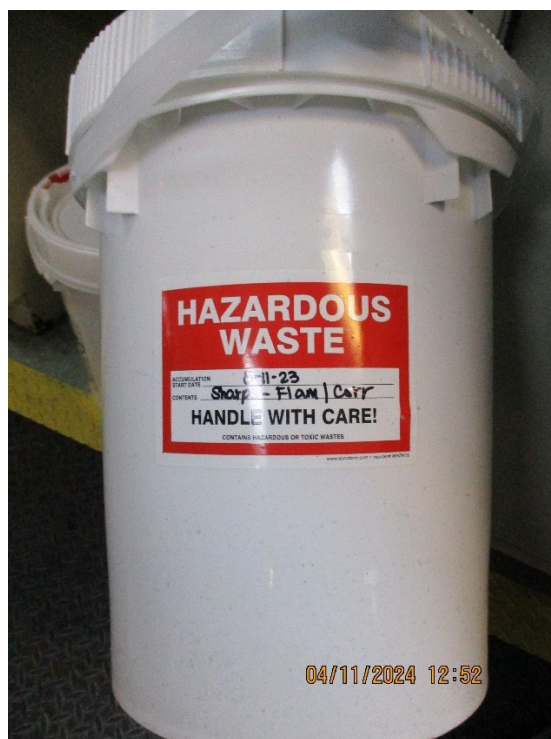
The inspectors also observed a 5-gallon closed container labeled “Hazardous Waste Sharps” (Photo 13). The container was labeled Flammable/ Corrosive to indicate the hazard of the contents. The container had a date of 05/11/2023.

**Pursuant to Tenn. Comp. R. & Regs. 0400-12-01-.03(1)(b) [40 C.F.R. § 262.11], a person who generates a solid waste, as defined in 40 CFR 261.2, must make an accurate determination as to whether that waste is a hazardous waste in order to ensure wastes are properly managed according to applicable RCRA regulations. A hazardous waste determination is made using the steps listed in 40 C.F.R. § 262.11(a-g).**

Photo 13: QC Laboratory—5-gallon container of used sharps form R&D.

Mr. McCaffery stated the sharps container was the same as the syringes and was mis-labeled as hazardous waste but are non-hazardous. The facility will be making a new waste determination as mentioned above and manage the syringes as non-hazardous waste. SAA containers are not labeled with an accumulation start date until the 55-gallon threshold is reached.
