**Well Inspection**  
**Osage DNR / Environmental Protection Agency**  
**1201 Elm Street, Suite 500**  
**Dallas, Texas 75270**

| <b>Operator Info</b> | Short Oil Company<br>2536 East 51st Street<br>Tulsa, OK 74105<br>Phone: 918-747-8200 | <b>Inventory ID</b> | OS4706000 | | |
| <b>Inspection Reason</b> | Plugging Witnessed | <b>Responsible Company at Time of Inspection</b> | Short Oil Company | | |

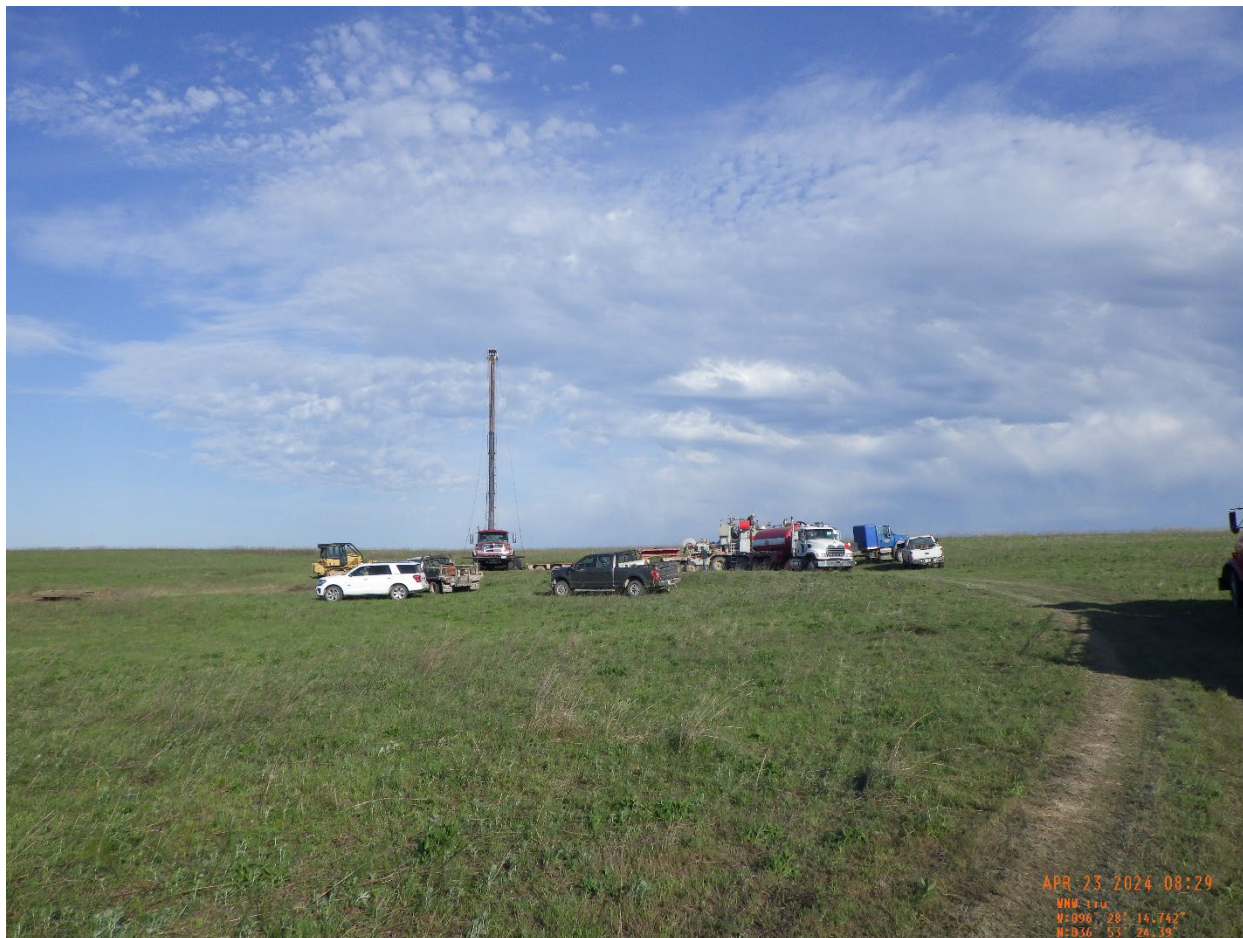
Photo No. 1

**Description:** This was an overview of the well location and equipment being used at the time of the inspection.

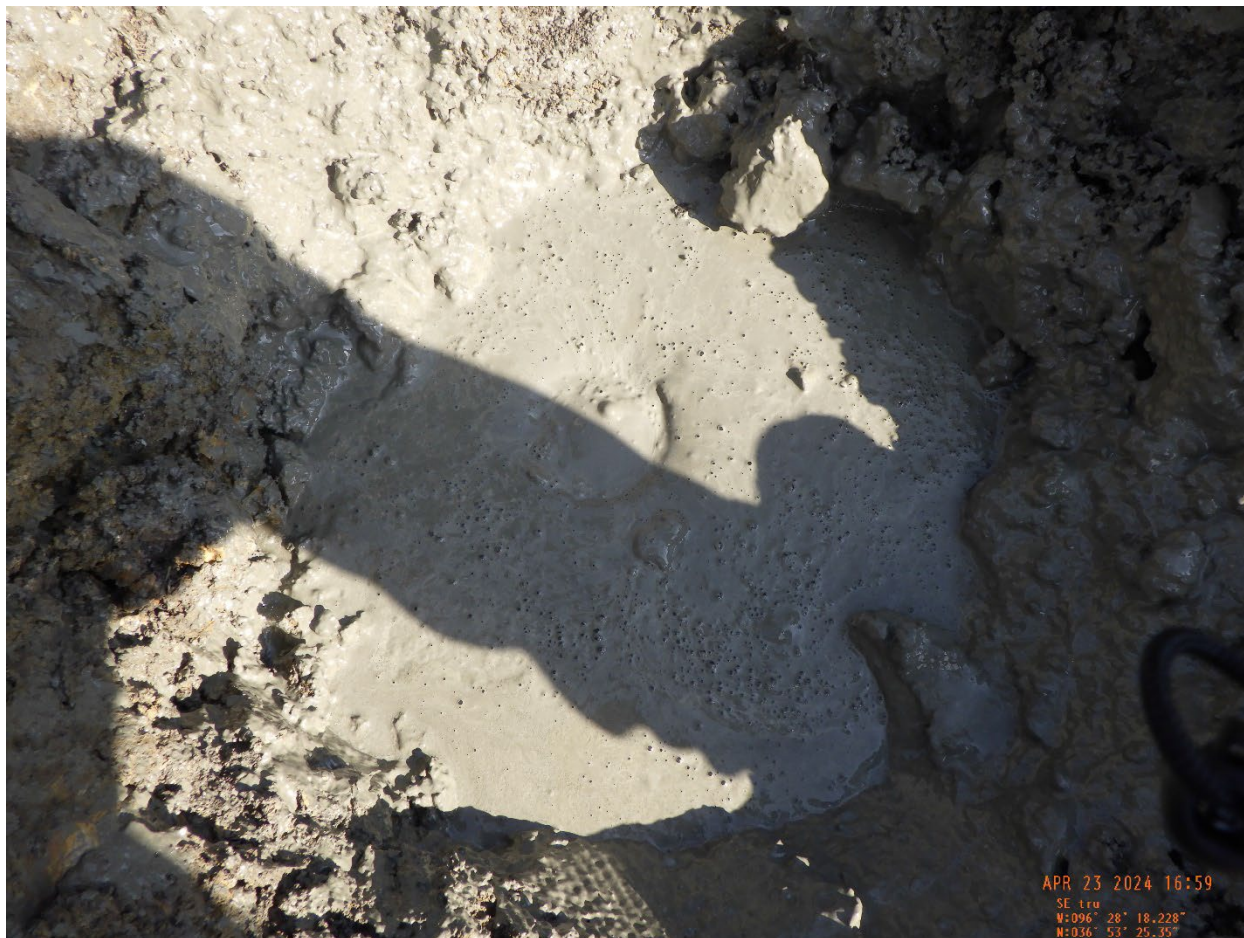
Photo No. 2

| <b>Inspection Comments</b> | Inspector observed the plugging of well OS4706000. The Short Oil Company workover rig ran tubing to 2656 feet below the land surface and Hurricane Services Inc. pumped 65 sacks of 14.1 lbs/gallon cement at 9:05 AM. The tubing was pulled out of the well and the bottom plug was allowed to harden for 4+ hours. At 1:30 PM, Osage Wireline ran in hole and tagged the top of cement (TOC) at 1690 feet below the land surface. Osage wireline then shot casing perforations as defined in the EPA approved plugging plan. Short Oil Company ran tubing in the well to 1690 feet, pulled up a few feet and Hurricane Services, Inc. circulated 9+ lbs/gallon mud to the surface. Short Oil Company pulled the tubing up to 632 feet below the land surface and Hurricane Services, Inc. circulated 50 sacks of 14.1 lbs/gallon Class A cement to the surface. Inspector observed cement standing at the surface in the well casing, well apparently plugged. | | | | |

**Description:** This was the casing of well OS4706000 standing full of cement. Well apparently plugged.
