**Region 6 - Enforcement & Compliance Assurance Division**  
**INSPECTION REPORT**

| Company Name: | <b>Espanola, City of</b> | |
| Facility Name: | <b>Espanola Wastewater Treatment Plant</b> | |
| Identification/Permit Number: | NM0029351 | |

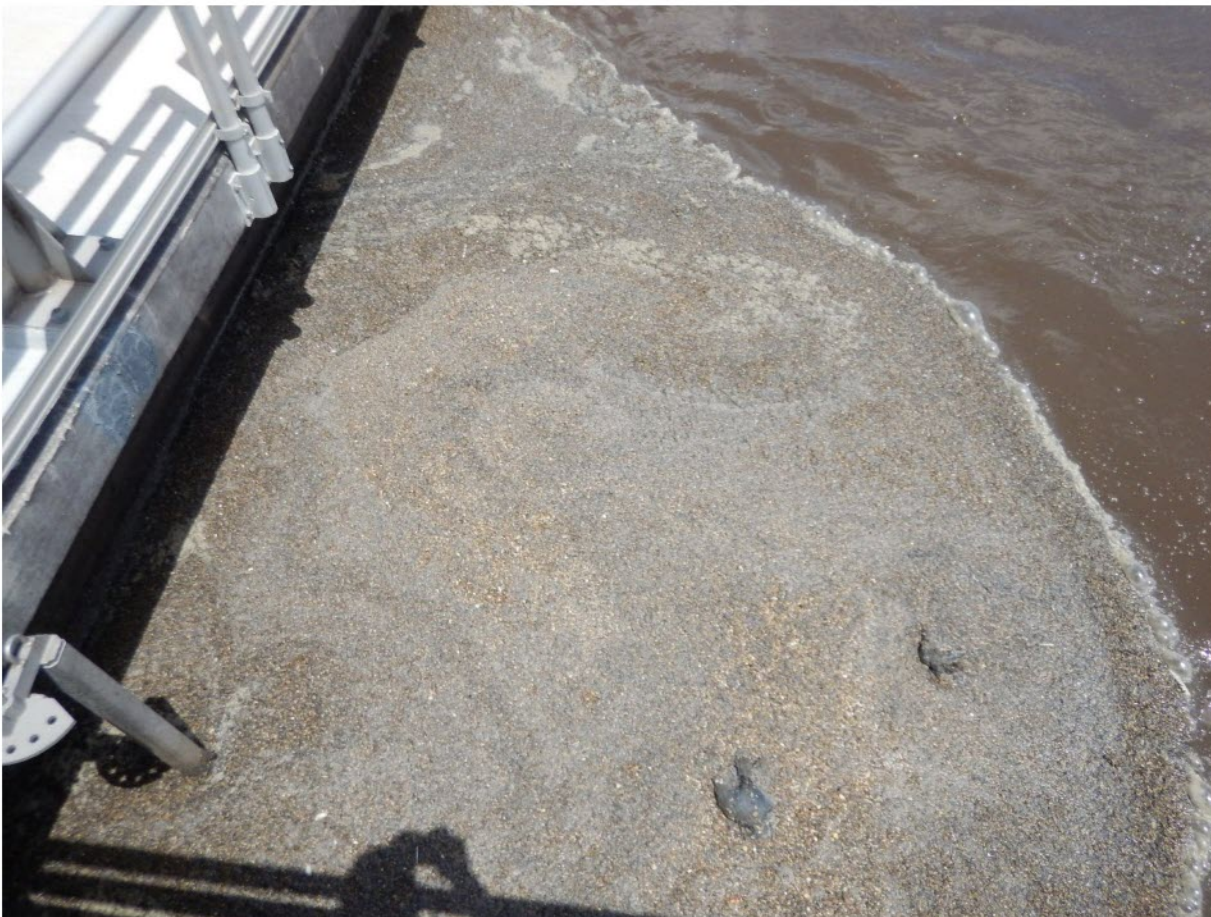
Photo File Name: DSCN2019.JPG

1. The grit removal system has been down for more than a year, allowing grit to pass into the treatment basin. During the inspection grit was floating in the anoxic zone of the treatment basins, see Appendix 1, Photo 1. The grit is likely causing significant equipment damage to aeration nozzles, pumps, piping, sludge thickening centrifuges, as well as to treatment basin and digester basin walls. The reduced oxygen circulation in the treatment basins also likely compromises the biological treatment efficiency, which reduces the efficiency of the entire plant treatment process.

The grit removal system has been down for over a year, allowing significant damage to the entire plant. Even if the grit removal system were replaced today, this damage will continue to cost the City of Espanola money for years to come, in all the other downstream systems affected. The biological treatment processes are not operating properly, as evidenced by the effluent violations, and the denitrification taking place in the clarifiers. The clarifier weirs are not level, and the effluent flow meter has not been cleaned often enough to prevent algae buildup. The outfall pipe has not been repaired in a timely manner.

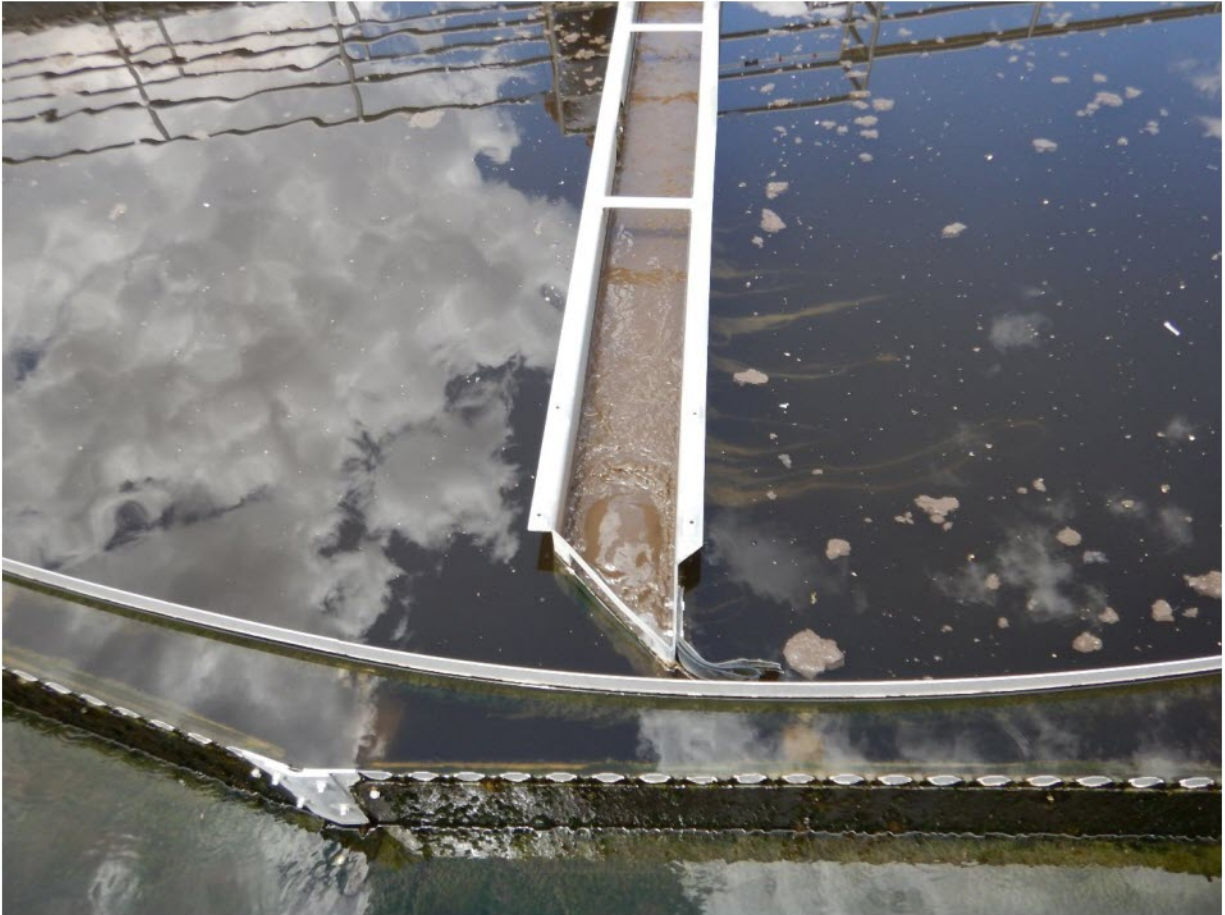
Photo File Name: DSCN2025.JPG

3. Denitrification is occurring in the clarifiers, causing floating solids that have the potential to go over the clarifier weirs. Grit is present with the floating solids, and clarifier weirs are not level, see Appendix 1, Photo 2.

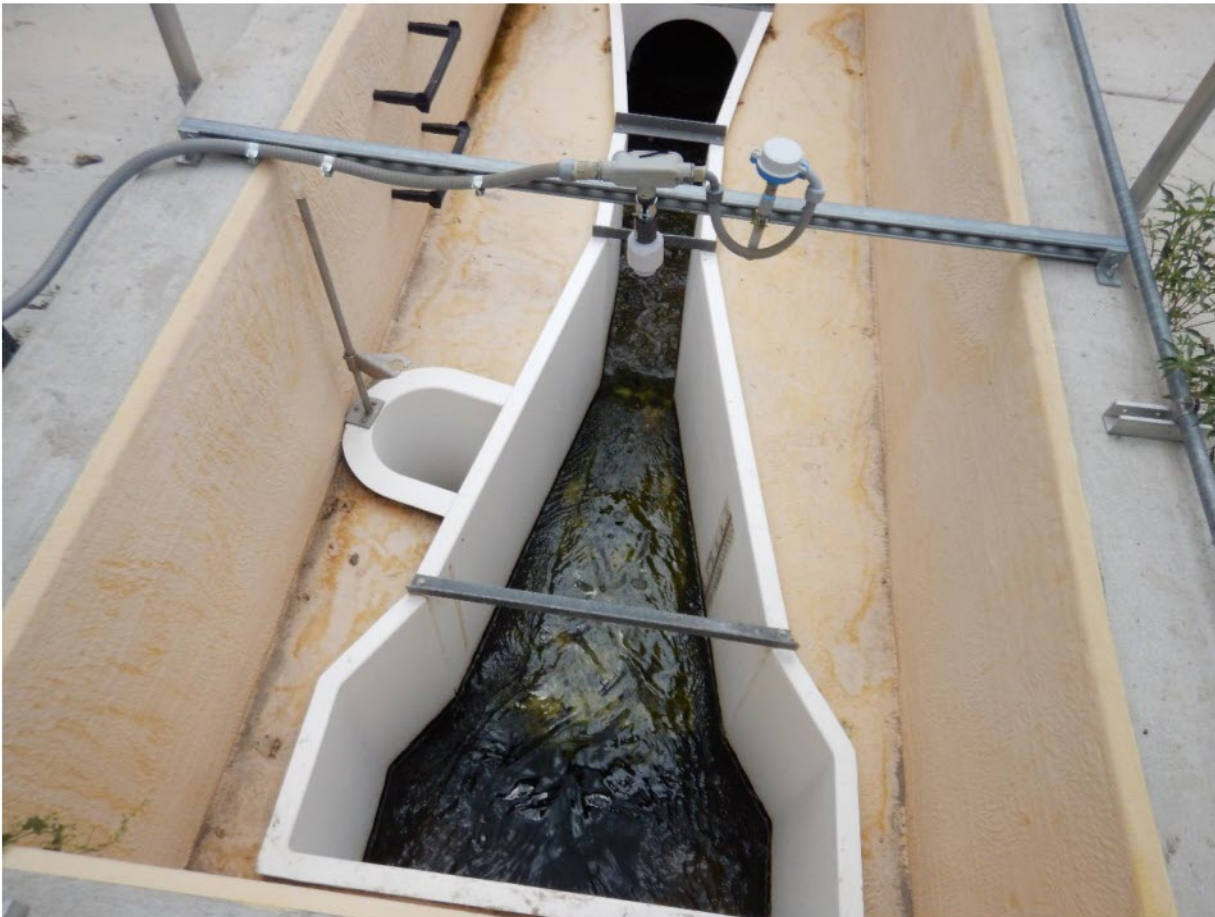
Photo File Name: DSCN2037.JPG

6. The effluent Parshall Flume had algae buildup on the bottom, see Appendix 1, Photo 3. All flow meters were last calibrated on March 25, 2022. Facility personnel stated that they verify the calibration of the flow meter daily, but they do not keep records of the verification. After the inspection, facility personnel stated verbally that the flow meters had been calibrated.

At the time of the inspection the Parshall Flume had not been calibrated in over a year, and there was excess algae growing on the bottom of the Flume that could cause turbulence and/or inaccurate readings by the ultrasonic secondary flow meter.

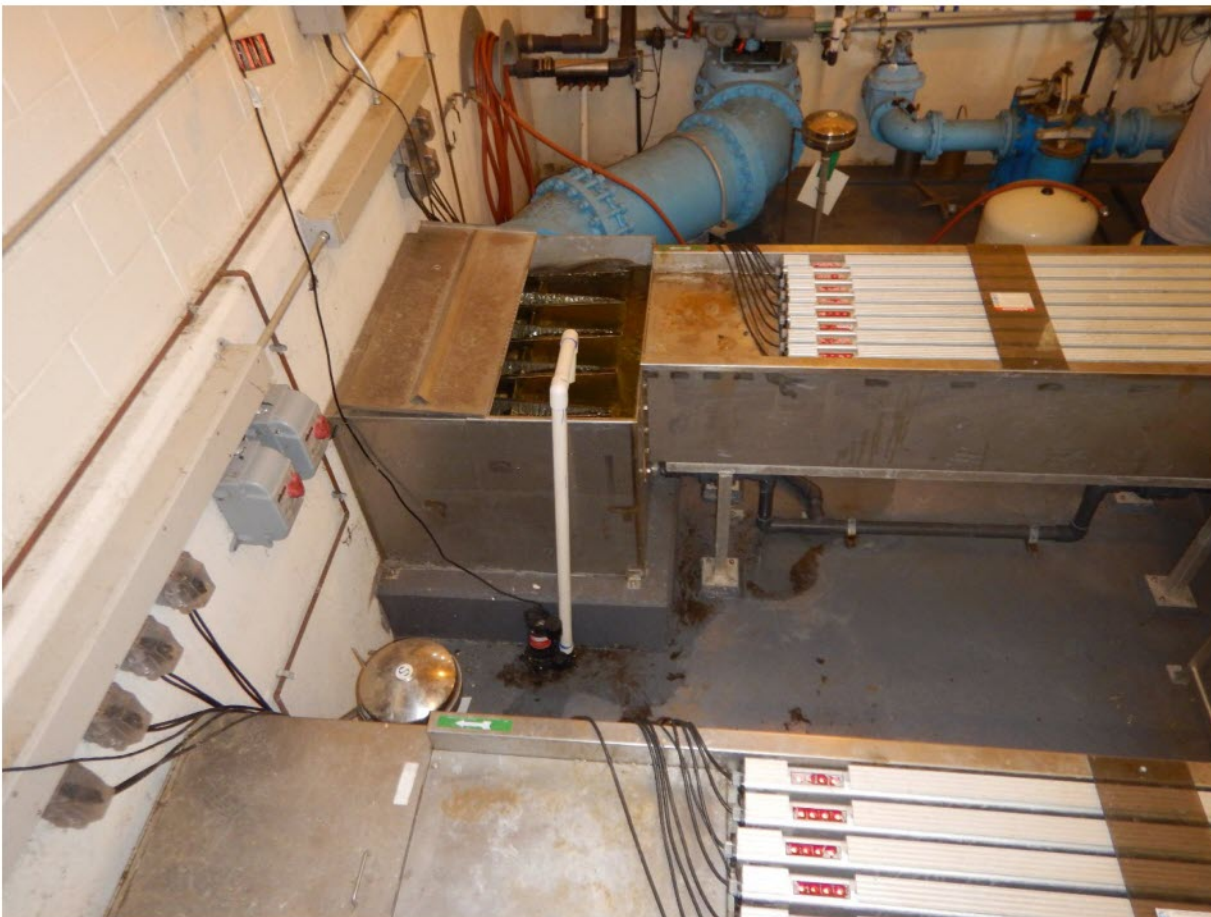
Photo File Name: DSCN2035.JPG

7. Due to the outfall being located within the boundaries of the Pueblo of Santa Fe reservation, the outfall was not visited during this inspection. Facility personnel stated that approximately two years ago, a large rainfall caused massive flooding at the river which clogged the end of the outfall pipe. This resulted in effluent backing up in the pipe and flooding the UV building. Facility personnel at the time punched a hole in the top of outfall pipe to allow the water to flow out to the river. The clogged outfall pipe has not been fixed. On the day of the in-person inspection, a sump pump was present in the UV building, plugged in, and plumbed such that pumped water

would go into the UV trough after the UV disinfection, see Appendix 1, Photo 4. Facility personnel stated that this sump pump had been installed during the flooding event.

All water pumped from the floor of the UV building into the effluent flow trough after the UV disinfection is a bypass and is not allowed unless the above conditions have been met. The sump pump has been present and possibly bypassing for the last two years, since the UV building flooded.
