EPA REGION 6 Enforcement Division  
INSPECTION REPORT

| Type of Inspection | Focused Compliance Inspection (FCI) | | | |
| Facility or Site Name | PBI International | | | |
| Facility/Site Physical Address | 1220 Miller Cut Off Rd | | | |

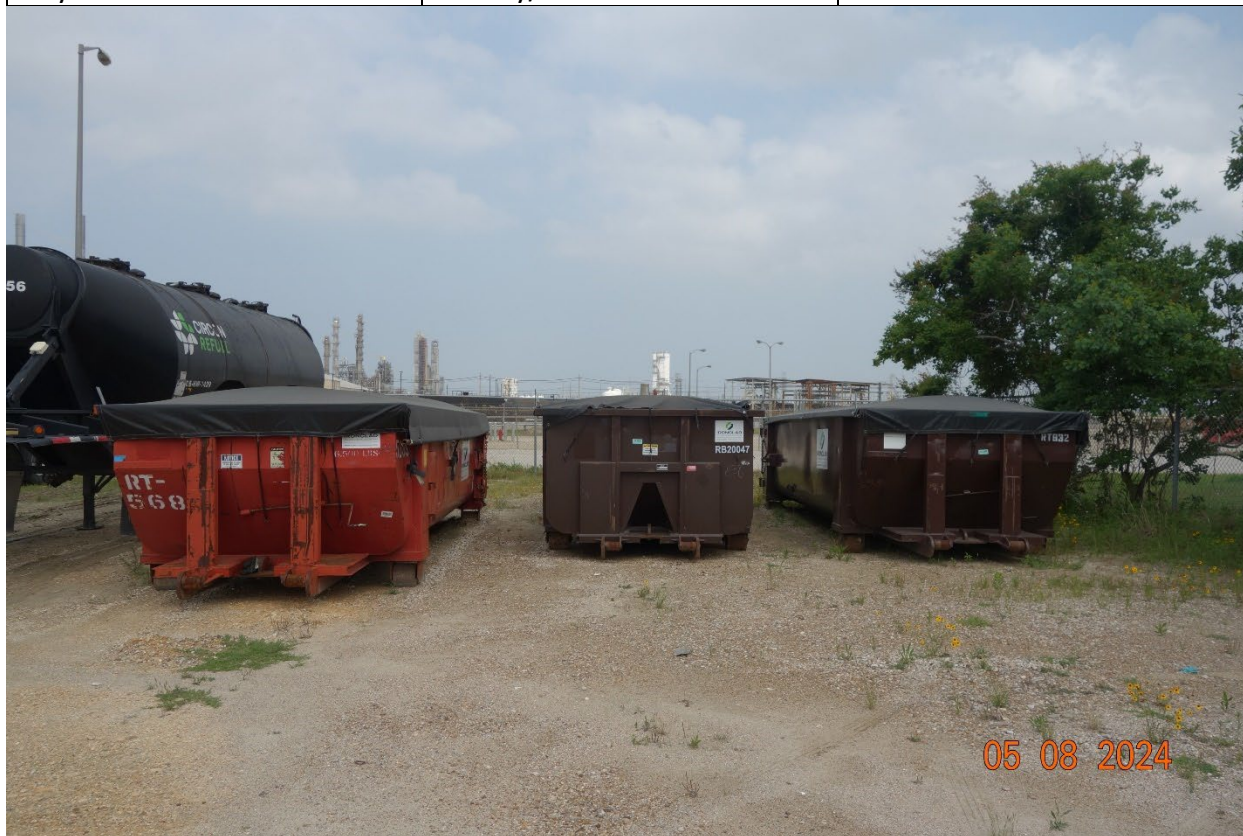
Photo No. 1

| <b>Tenant:</b> PBI International | | |
|---|---|---|
| <b>AOC #1</b> – PBI International must make an accurate determination as to whether the sandblast media in the roll-offs is a hazardous waste to ensure wastes are properly managed according to applicable RCRA regulations. | <b>Citation:</b> 40 CFR 262.11 | Section: 2.1 |

Description: Overview of three roll off containers onsite dating back to 8.11.2023. The containers are believed to be from the previous owners. All three containers had what appeared to be sandblast media and two of them had faded hazardous waste labels.

I apologize for the delayed response as your emailed went to my other inbox. We have pulled samples to be sent for analytical then based on the results we will develop a disposal plan.

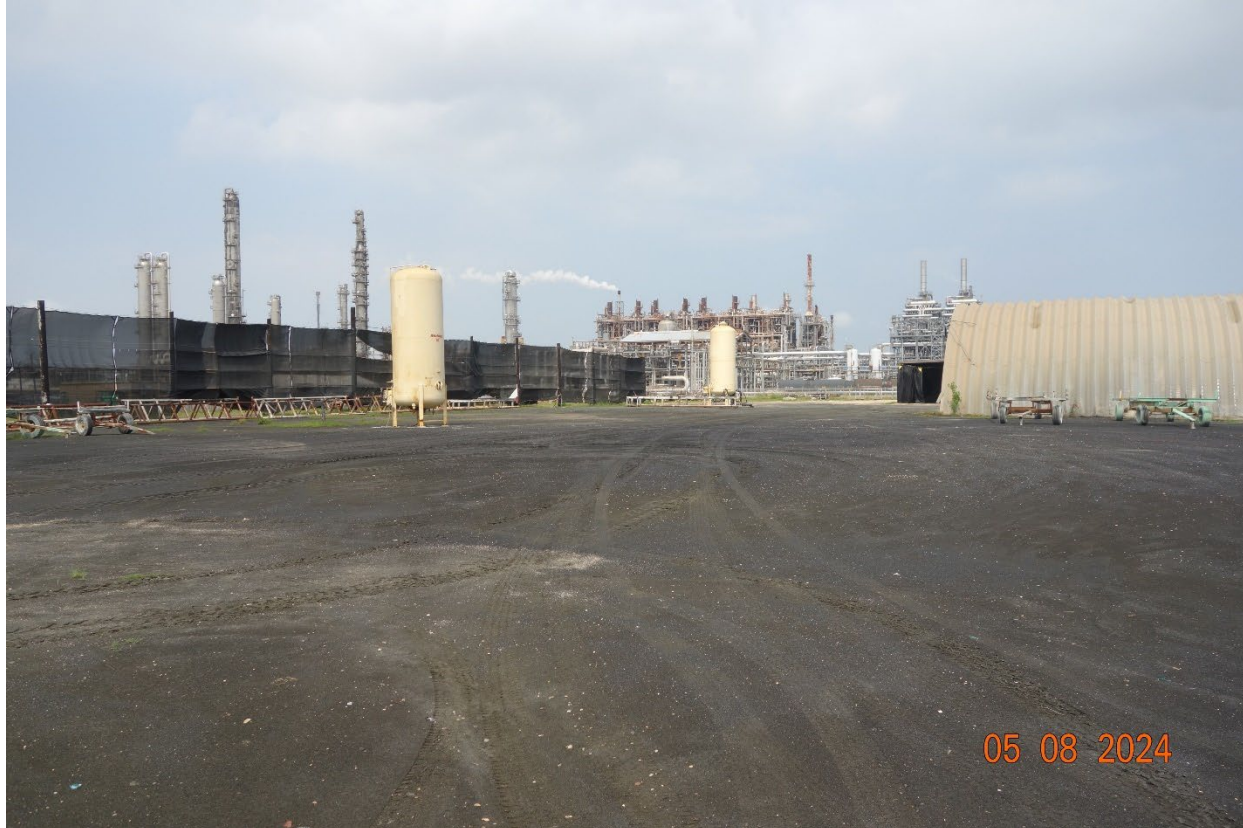
Photo No. 5

| <b>Tenant:</b> PBI International | | |
|---|---|---|
| <b>AOC #2</b> – PBI International must make an accurate determination as to whether the sandblast media on the ground is a hazardous waste to ensure wastes are properly managed according to applicable RCRA regulations. | <b>Citation:</b> 40 CFR 262.11 | Section: 2.1 |

Description: Overview of the area covered with sandblast media.
