**Well Inspection**  
**Osage DNR / Environmental Protection Agency**  
**1201 Elm Street, Suite 500**  
**Dallas, Texas 75270**

| <b>Inspector</b> | Matthew Allen | <b>Inspection Date</b> | 06/10/2022 | <b>Time</b> | 12:30 |
| <b>Operator Info</b> | Terminated Lease | <b>Inventory ID</b> | OS5581000 | | |
| <b>Location</b> | NW 26 22N 10E | <b>Status</b> | Inactive | <b>Well Type</b> | Disposal |

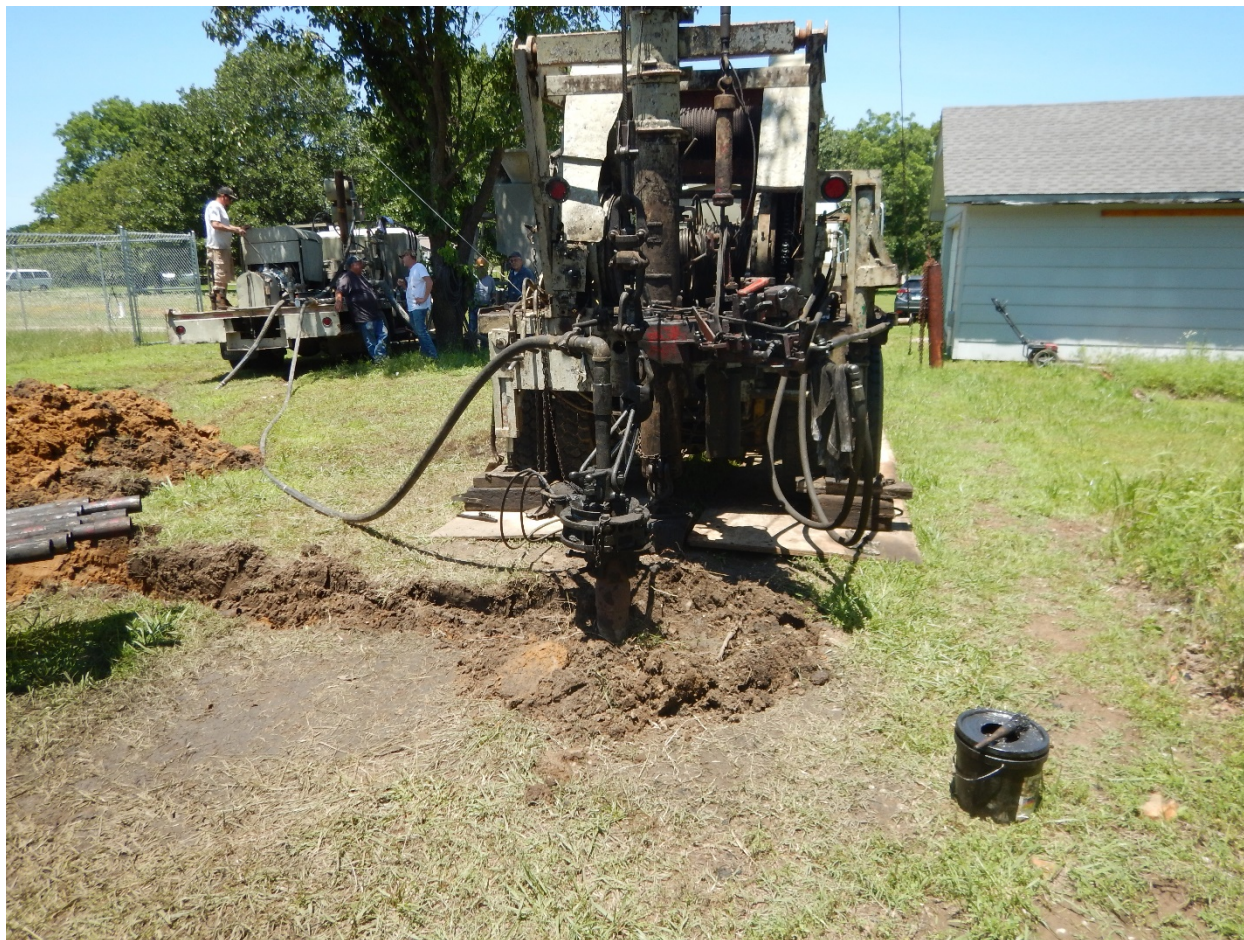
Photo No. 1

**Description:** This was the Reed No. 19 well. At the time of inspection/plugging, the Reed 19 well (OS5581000) was abandoned and located on a terminated lease. The Osage Minerals Council led the plugging operation. A workover rig and cement pumping truck were both on location at the time of the plugging operation.

| <b>Inspection Comments</b> | I observed the bottom cement plug placement on the Reed No. 19 well (OS5581000). The workover rig ran in the well with tubing to 1,267.5 feet and pumped 5 sacks of gel and 15 barrels of water to load the hole. P&P cement company pumped 32 sacks of cement beginning at 1,267.5 feet. The top plug placement was scheduled to take place 06/13/2022. The Reed 19 well was abandoned at the time of plugging. The plugging operation was led by the Osage Minerals Council. | | | | |
