**Region 6 - Enforcement & Compliance Assurance Division**  
**INSPECTION REPORT**

| Inspection Date(s): | 07/16/2024 | |
| Company Name: | <b>B Pharr Operating, LLC</b> | |
| Facility Name: | <b>Stylite Townsend Tank Battery</b> | |

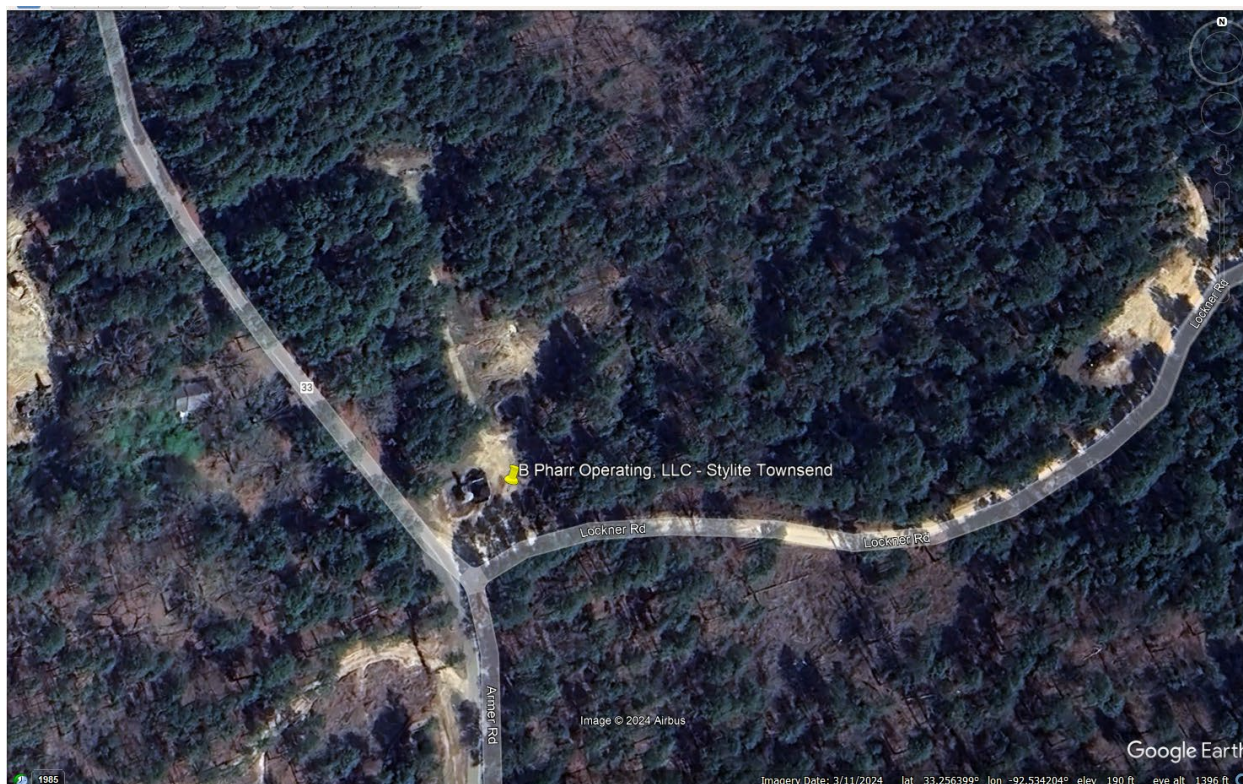
**Map 1. Aerial imagery (Google Earth dated 03/11/2024) of the B Pharr Operating, LLC – Stylite Townsend Tank Battery.**

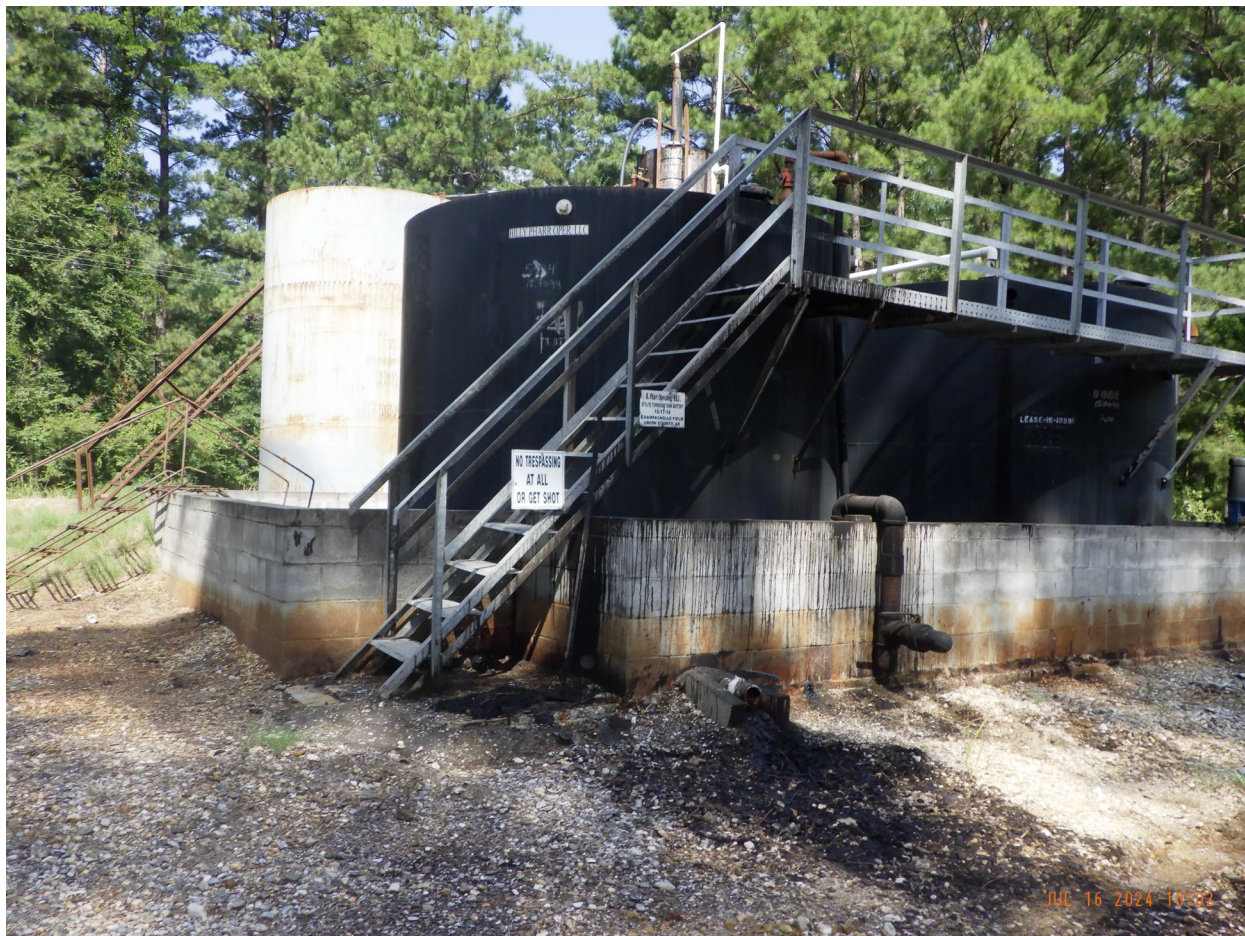
I observed the B Pharr Operating, LLC – Stylite Townsend Tank Battery, signage, and associated secondary containment, storage tanks, separators/treaters, and saltwater disposal (SWD) well; see Appendix 1 (Photographs Log), Photo No. 1 and No. 2. For additional GPS location and photo metadata, see Appendix 1.

**Description:** Looking W, this photo shows an overview of the Stylite Townsend Tank Battery.

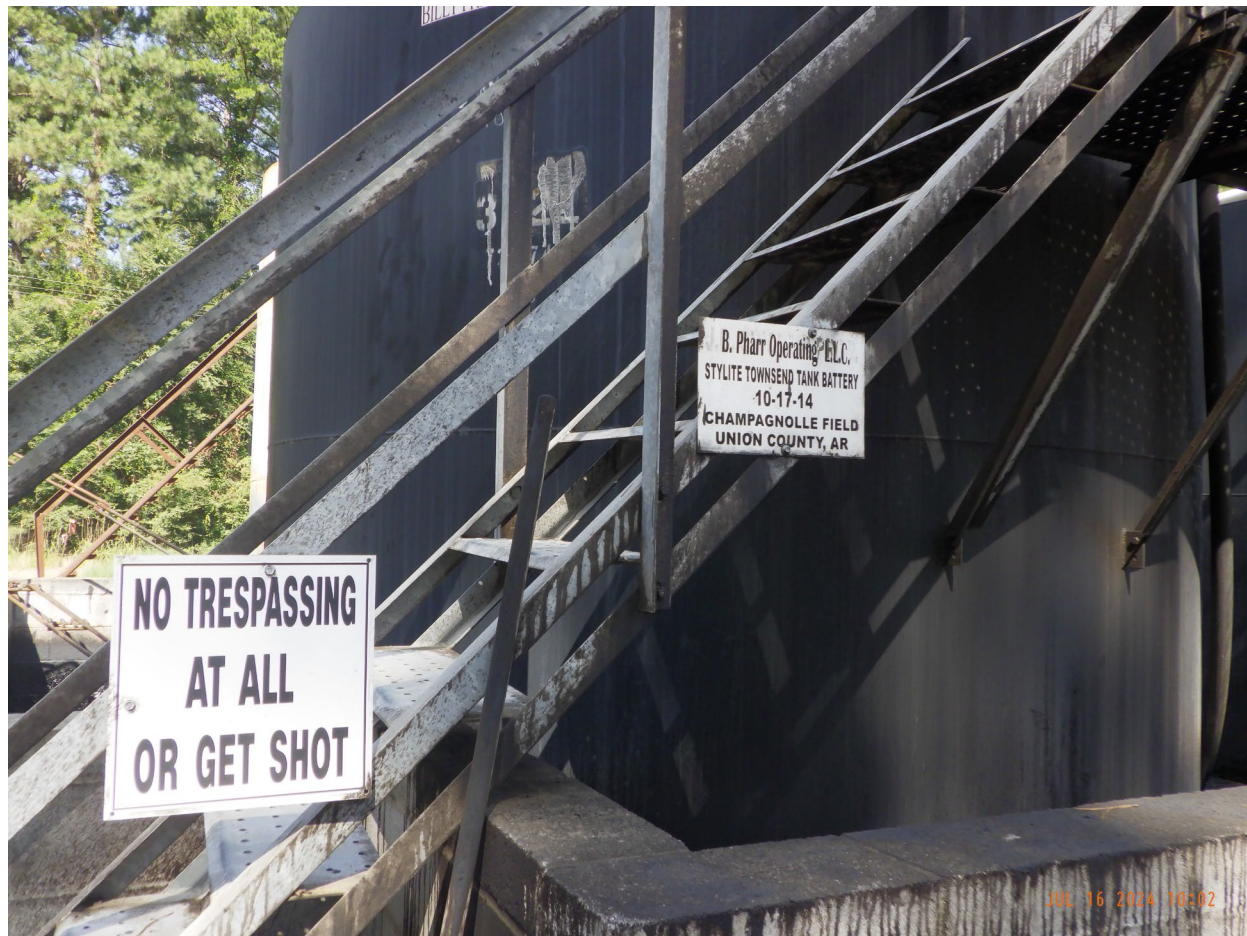
Photo No. 2

**Description:** Looking W, this photo shows the signage at the facility.

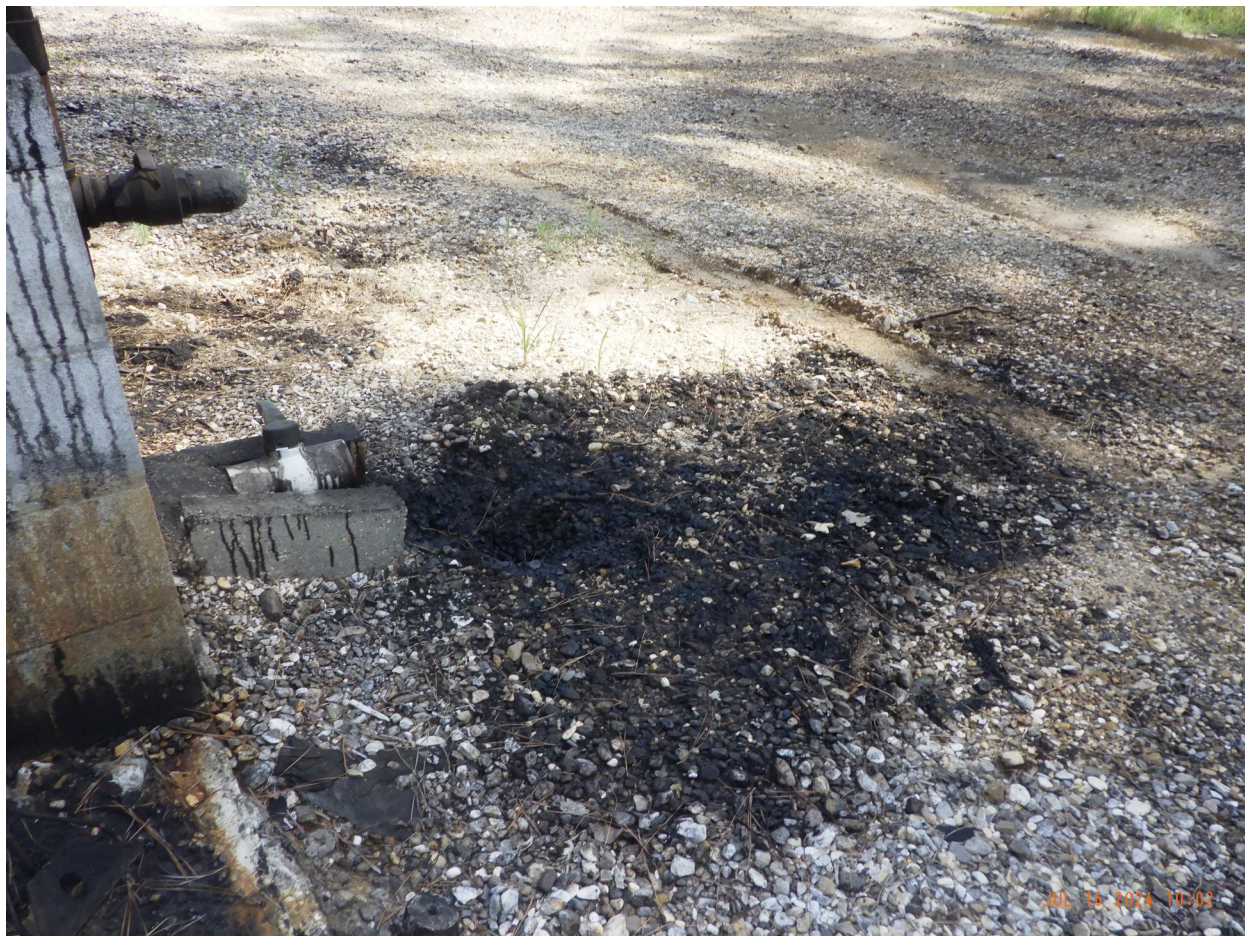
Photo No. 3

I observed loose oil around the drainpipe for the secondary containment for the main tank battery and a transfer pipe without a catchment bucket, see Photo No. 1 and No. 3.

- Loose, residual oil on the ground outside the secondary containment drainpipe for the main tank battery,
- A transfer pipe outside secondary containment without a catchment bucket,

**Description:** Looking NNW, this photo shows loose oil around the drainpipe for the secondary containment for the main tank battery and a transfer pipe without a catchment bucket.

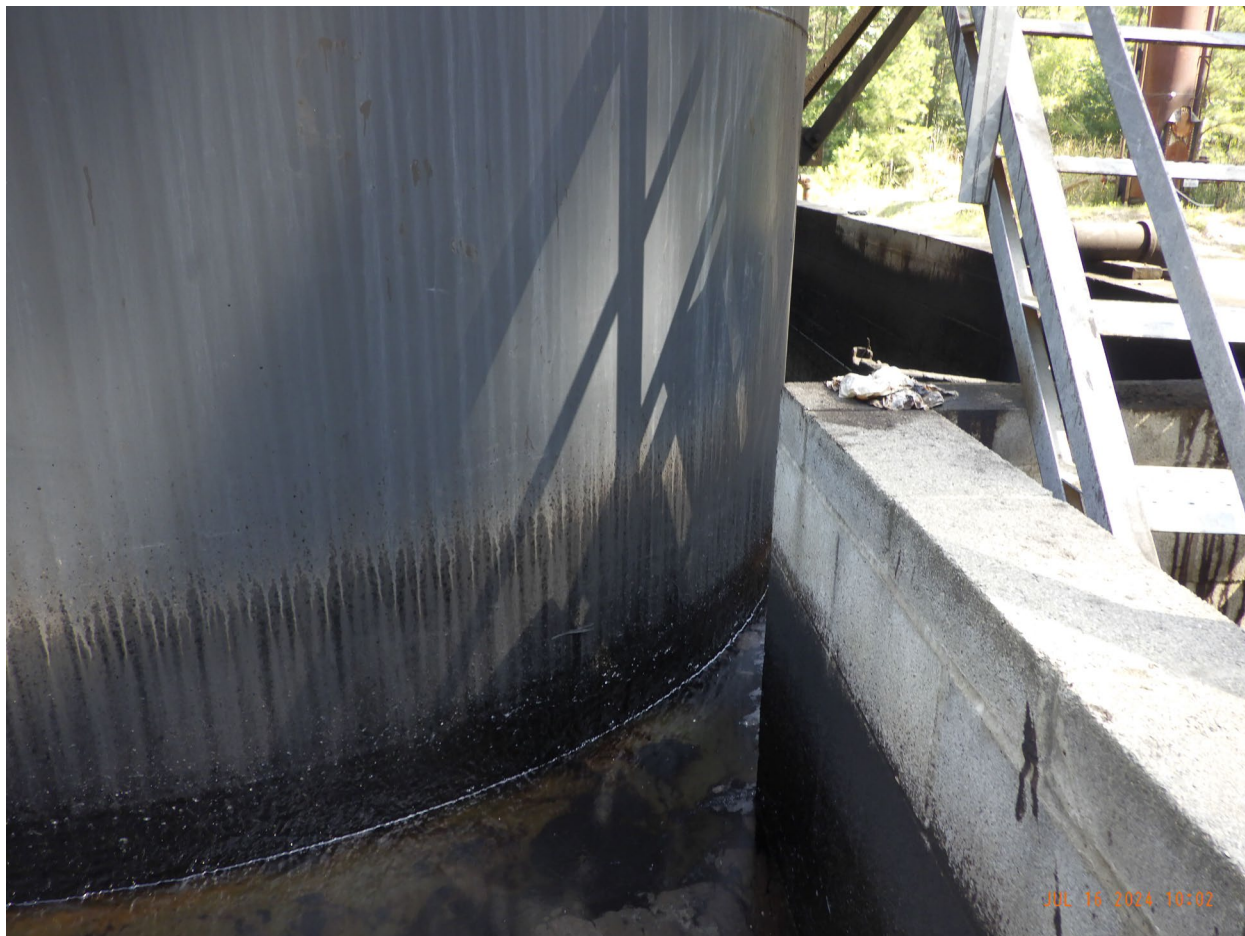
I observed loose oil floating on top of stormwater commingled with saltwater inside the secondary containment for the main tank battery, see Photo No. 4 through No. 6.

- Loose oil on top of stormwater commingled with saltwater inside the secondary containment for the main tank battery,
- An active leak from a valve on the transfer pipe inside the secondary containment for the main tank battery,
- Oil actively seeping from the secondary containment structure for the main tank battery indicating inadequate permeable secondary containment,
- Loose oil inside the secondary containment for the individual oil-water separator,
- The drainpipe for the oil-water separator tank battery without a cap or shutoff valve, and
- Erodible soils denuded of vegetation and dead trees from previous saltwater discharge(s).

**Description:** Looking NNW, this photo shows loose oil, saltwater, and stormwater inside the secondary containment for the main tank battery.

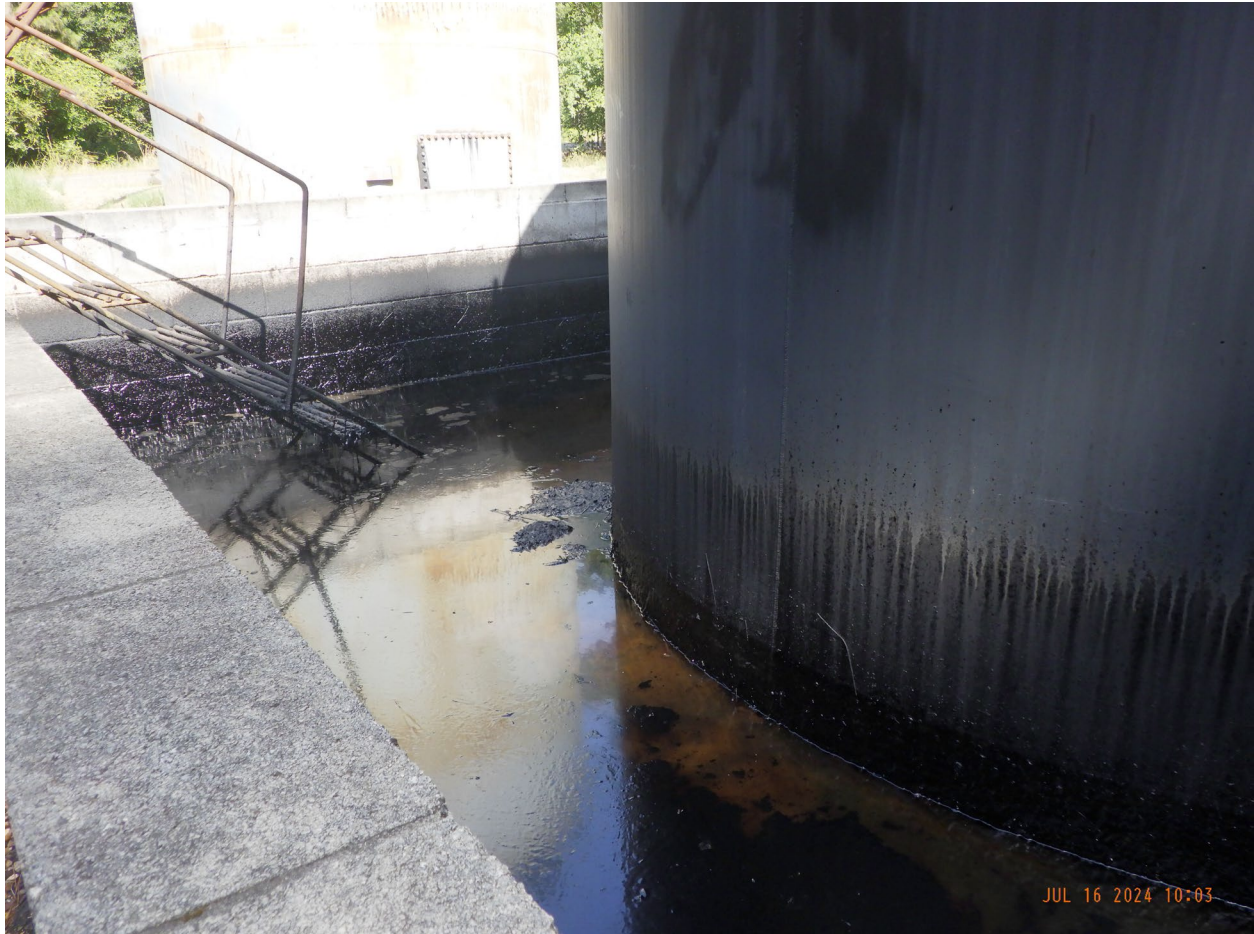
Photo No. 5

**Description:** Looking WNW, this photo shows an additional view of the loose oil, saltwater, and stormwater inside the secondary containment for the main tank battery.

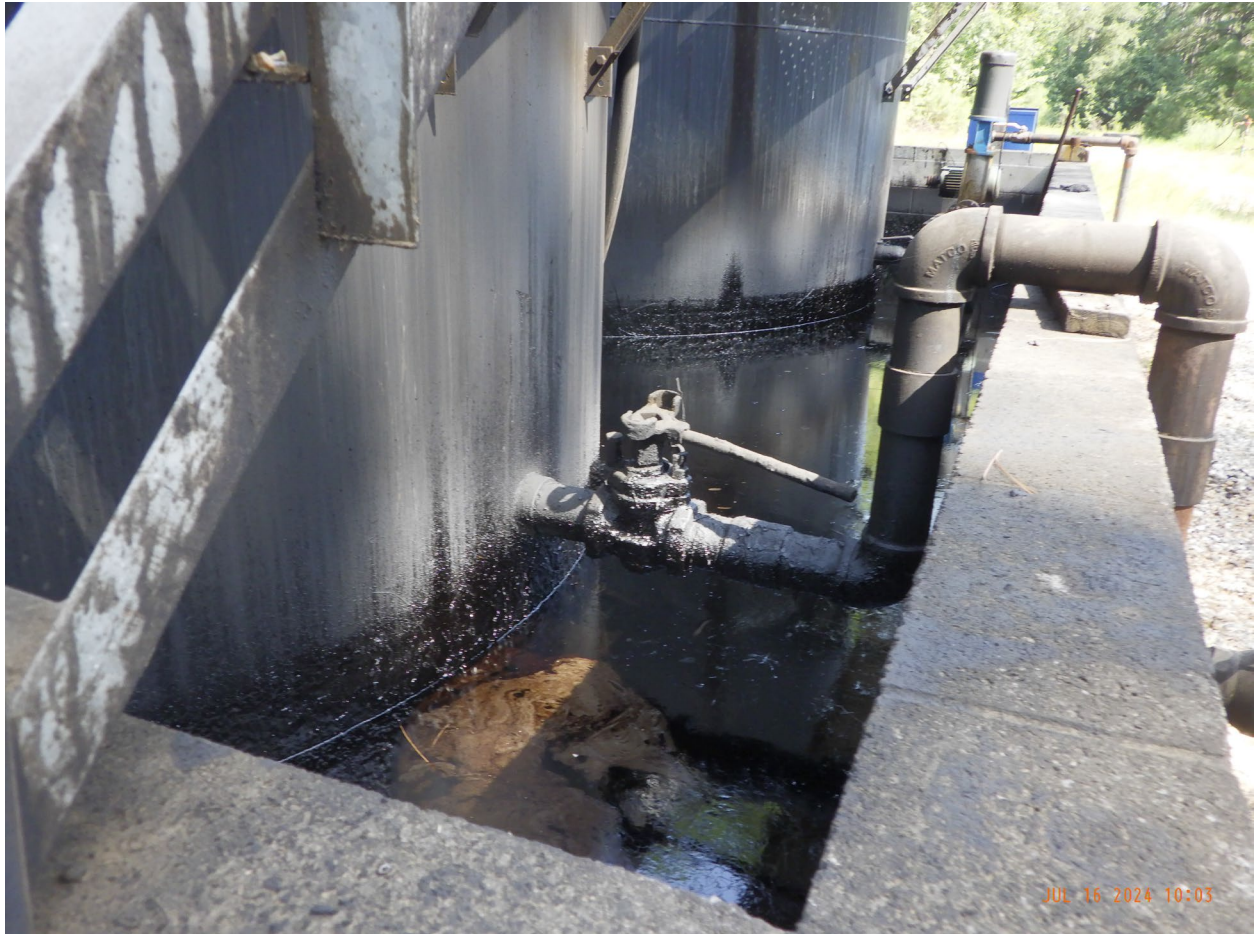
Photo No. 6

I observed an active leak from a valve for piping inside the secondary containment for the main tank battery, see Photo No. 6.

**Description:** Looking NW, this photo shows an active leak at valve and pipe within secondary containment for the main tank battery.

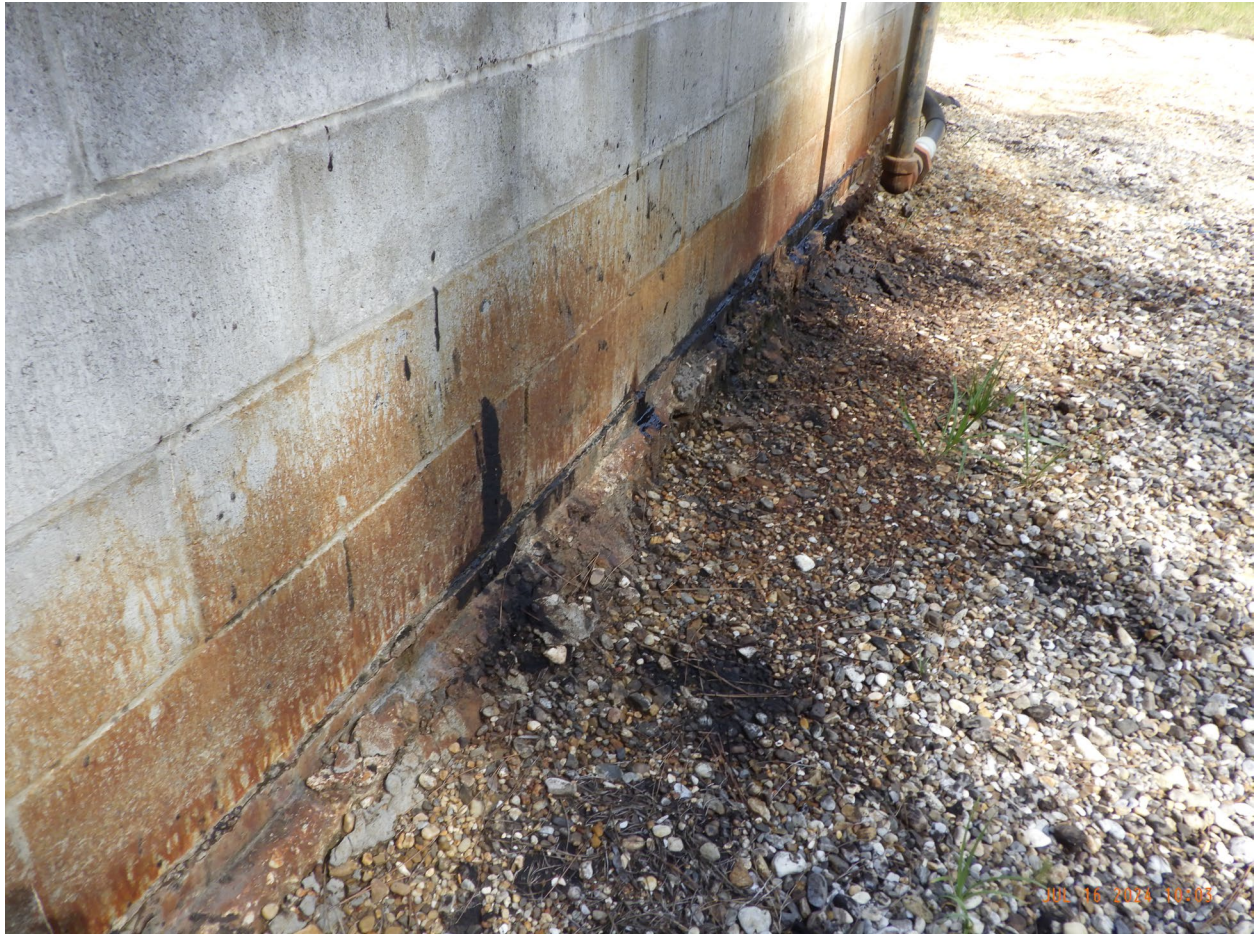
I observed oil seeping from the secondary containment structure for the main tank battery, see Photo No. 7 and No. 8.

**Description:** Looking WNW, this photo shows oil actively seeping through the secondary containment for the main tank battery.

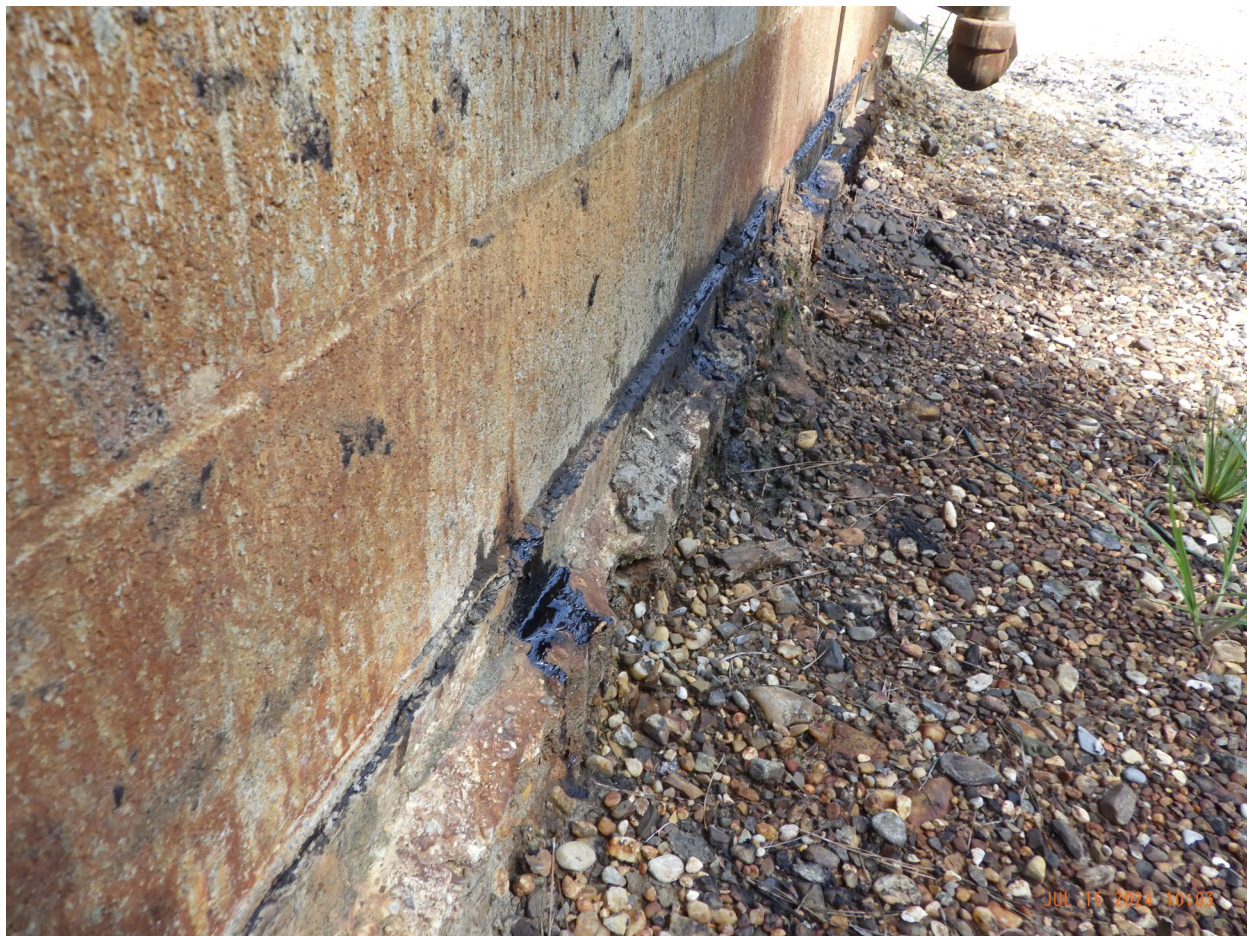
Photo No. 8

**Description:** Looking NW, this photo shows a closeup of crude oil the actively leaking from the secondary containment for the main tank battery.

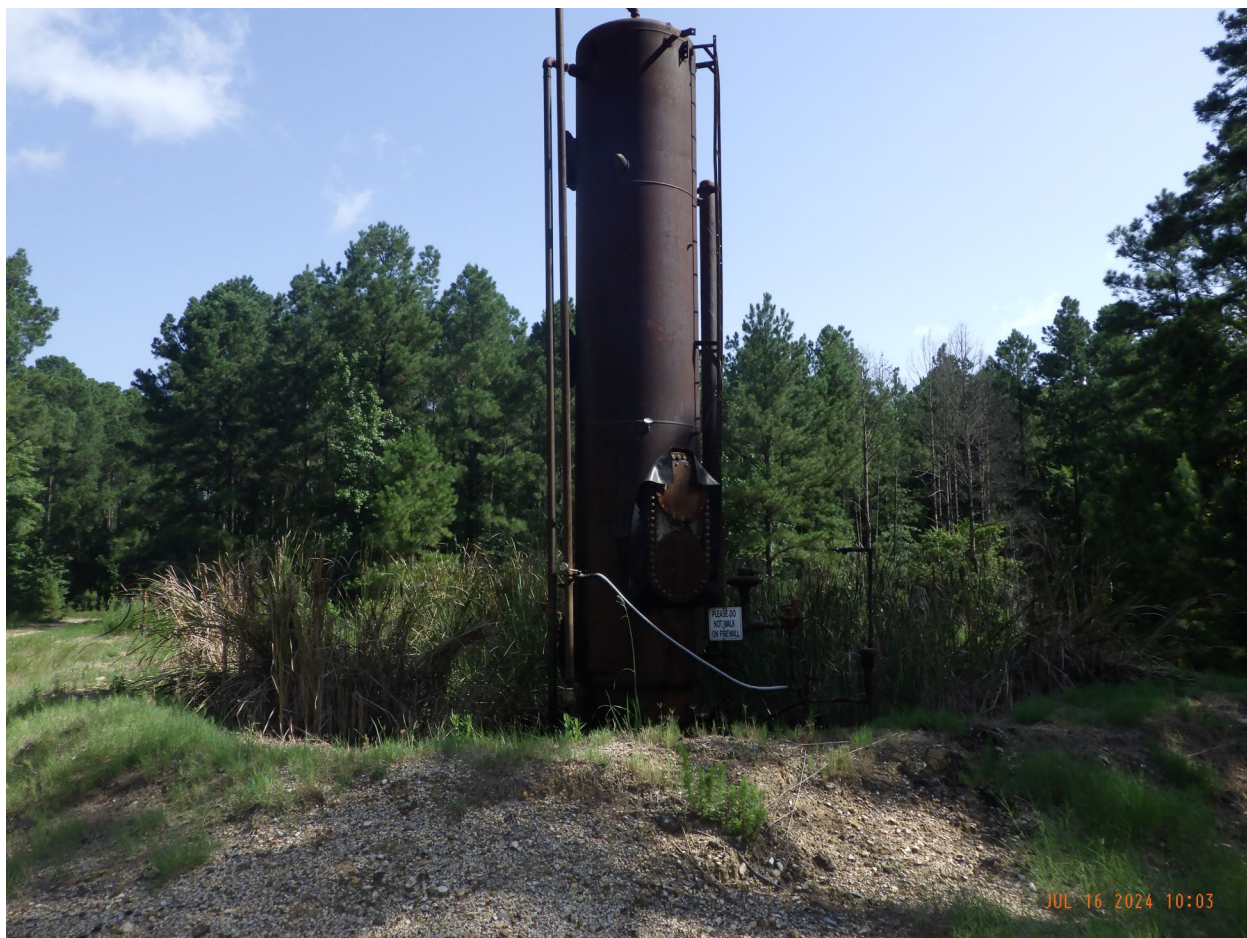
Photo No. 9

I observed an additional secondary containment structure and a drainpipe for an oil-water separator adjacent to the main tank battery, see Photo No. 9, No. 10, and No. 12.

**Description:** Looking N, this photo shows an additional secondary containment for an oil-water separator at the facility.

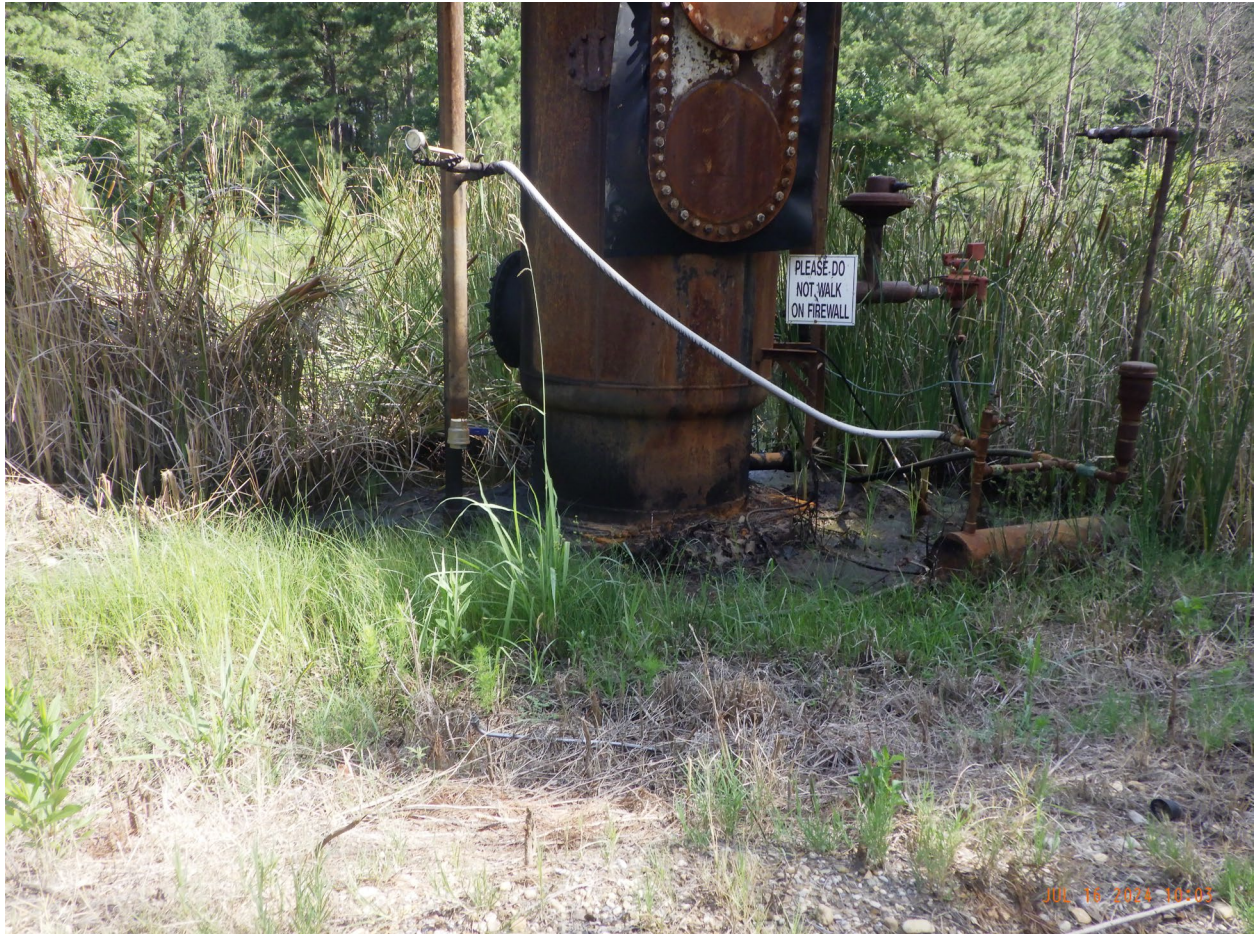
Photo No. 10

I observed loose oil inside the secondary containment for the oil-water separator, see Photo No. 10.

**Description:** Looking NNW, this photo shows a closer view of the additional secondary containment for the oil-water separator with loose oil inside the containment.

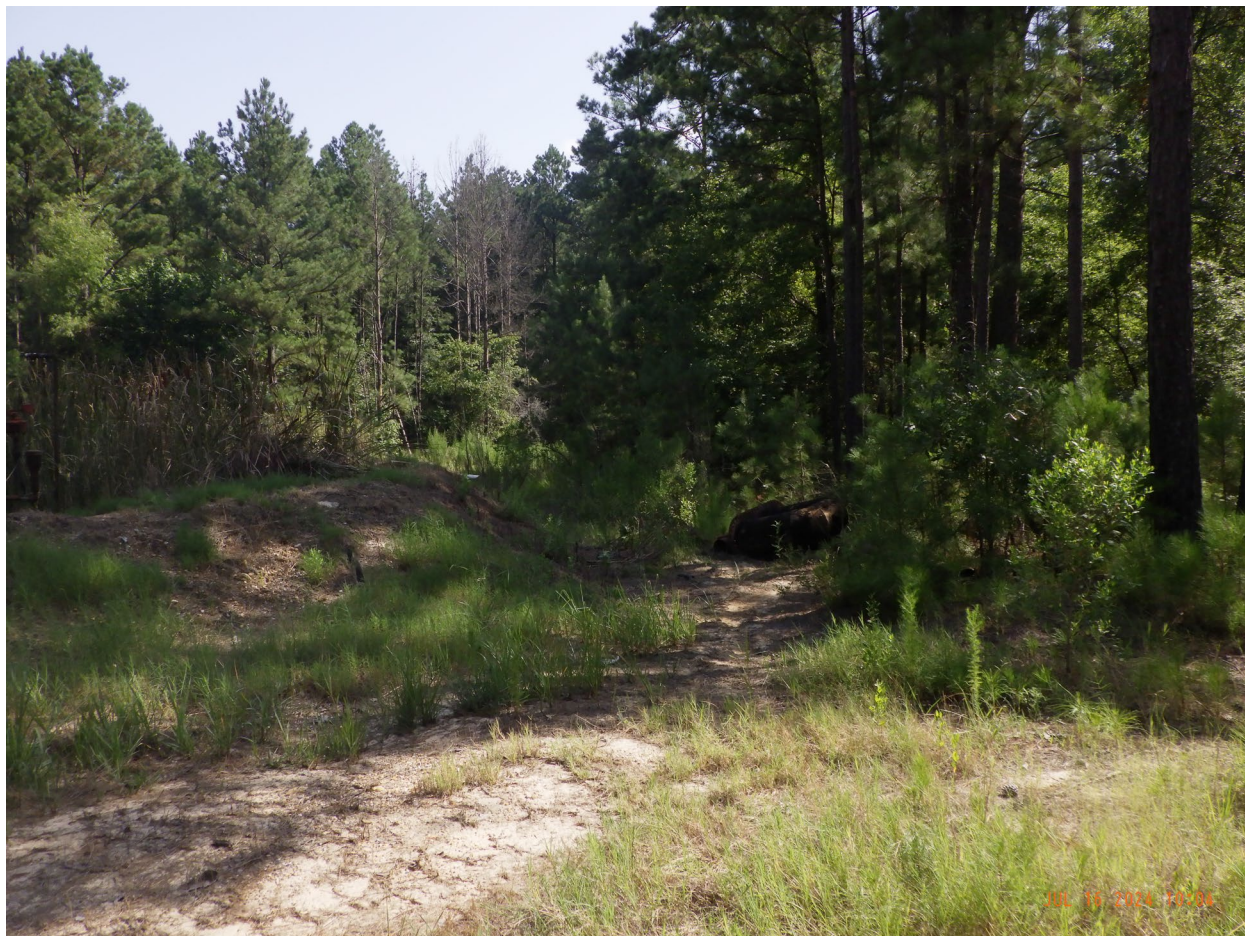
Photo No. 11

I observed the stormwater and discharge flowpath for the secondary containments for the main tank battery and the oil-water separator tank battery, see Photo No. 11, No. 13, and No. 14.

**Description:** Looking NNE, this photo shows the drainage path for the main tank battery in Photos No. 1 through 8.

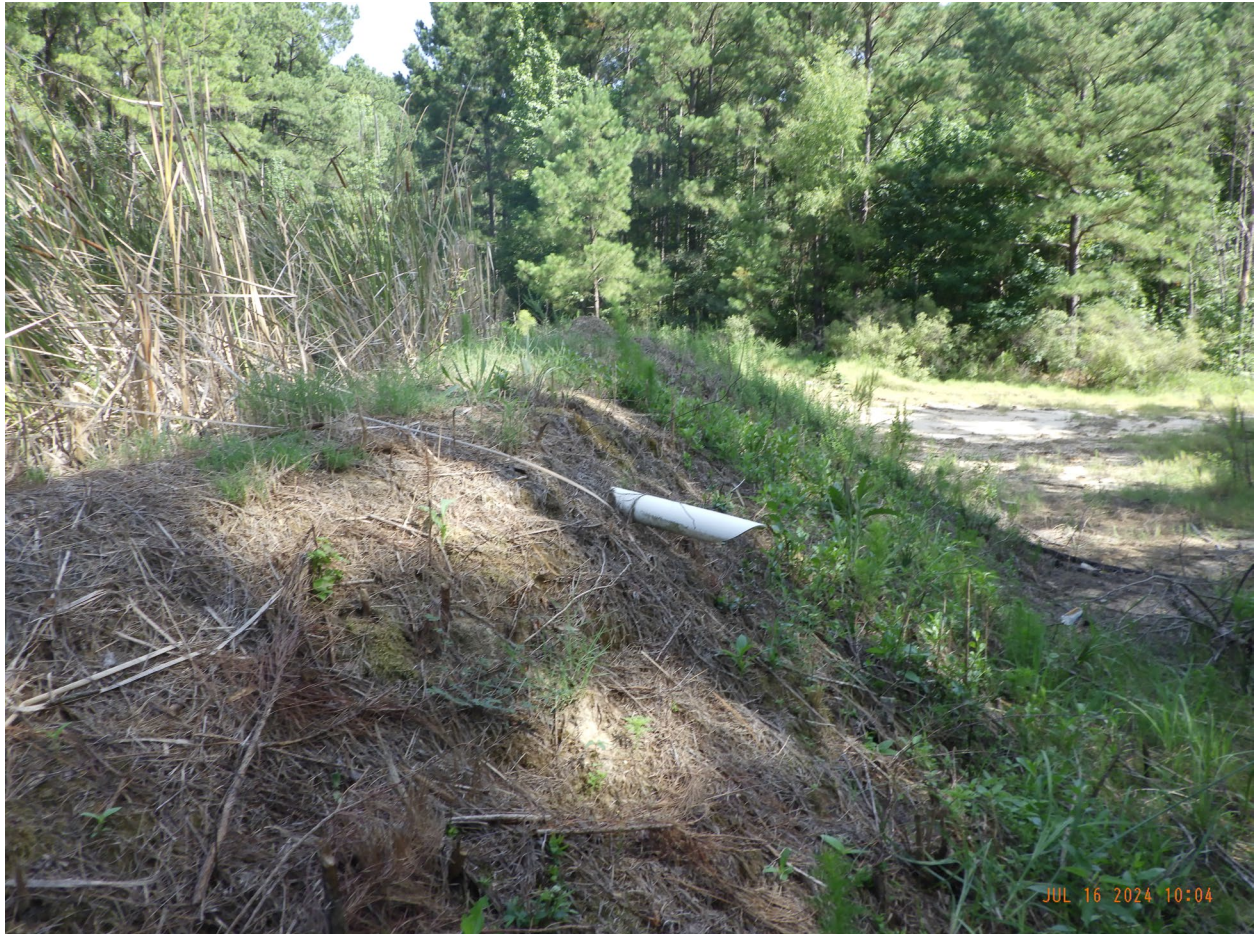
Photo No. 12

**Description:** Looking NNW, this photo shows the drainpipe for the secondary containment for the oil-water separator in Photos No. 9 through 11 without a cap or shutoff valve.

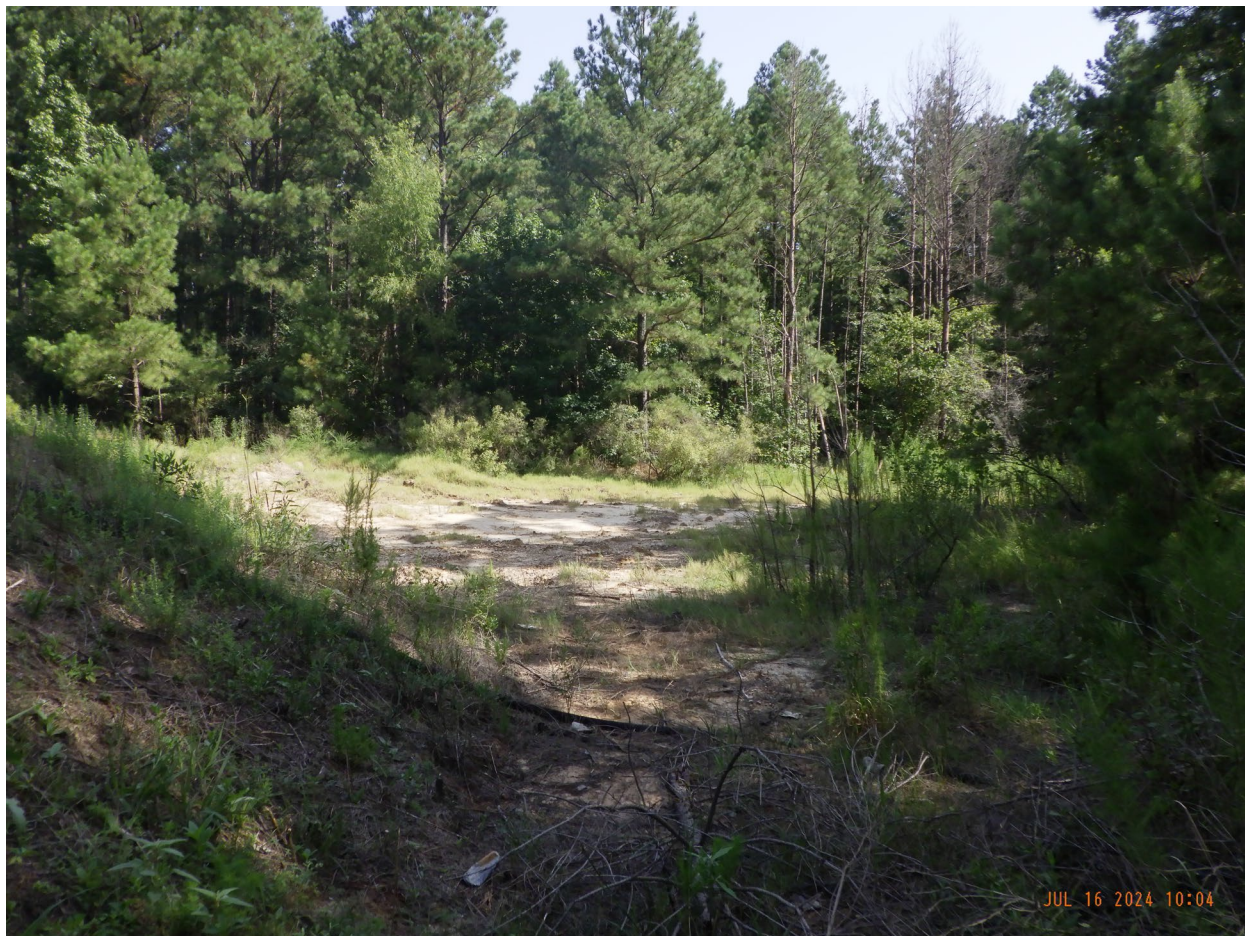
Photo No. 13

**Description:** Looking NNW, this photo shows the combined drainage path for both secondary containments at the Stylite Townsend facility.

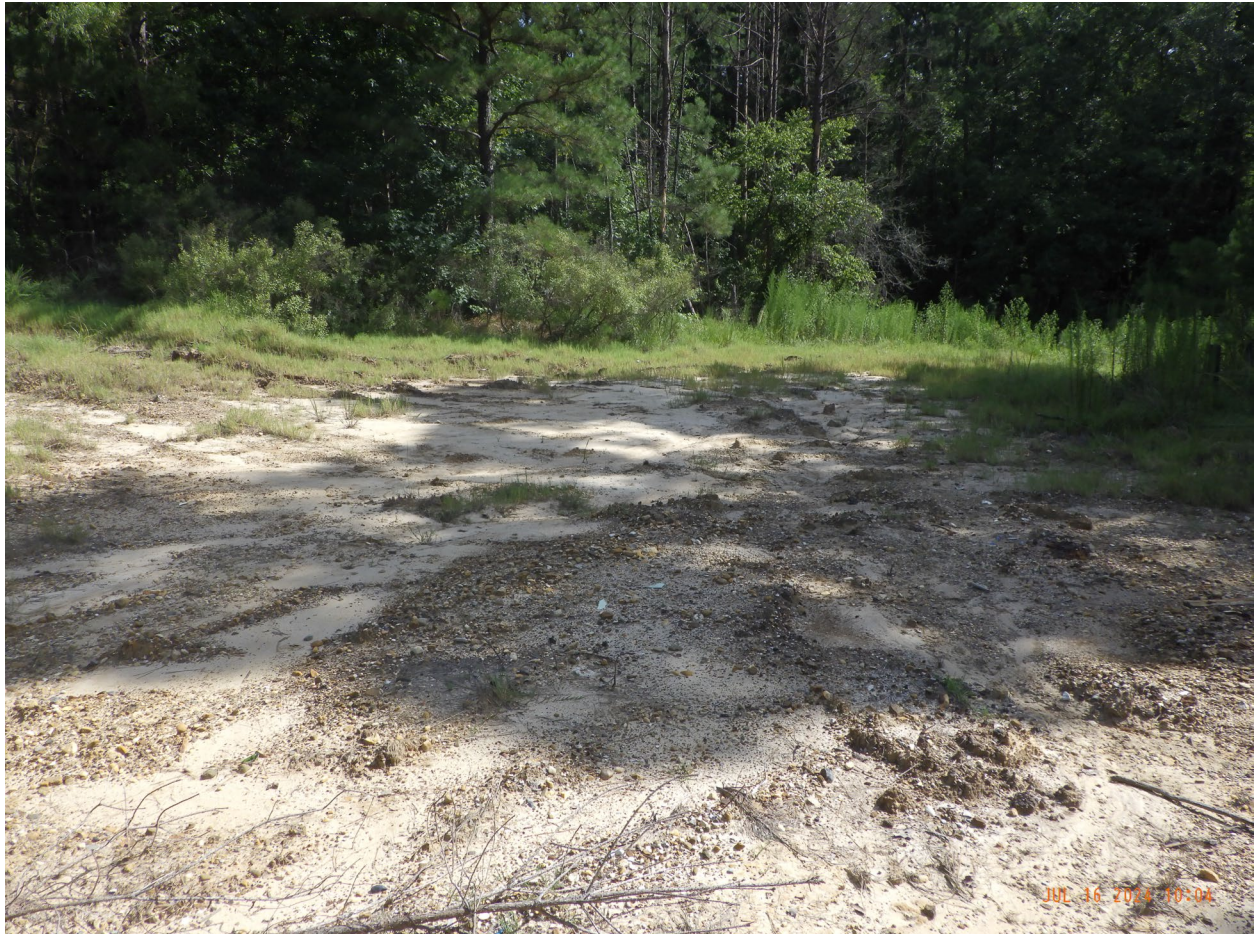
Photo No. 14

I observed erodible soils denuded of vegetation and a grouping of dead trees from a previous saltwater discharge that was downstream of the tank batteries and SWD well, see Photo No. 14, No. 15, No. 17, and No. 19.

**Description:** Looking NNE, this photo shows erodible soils denuded of vegetation from a previous saltwater discharge to the area.

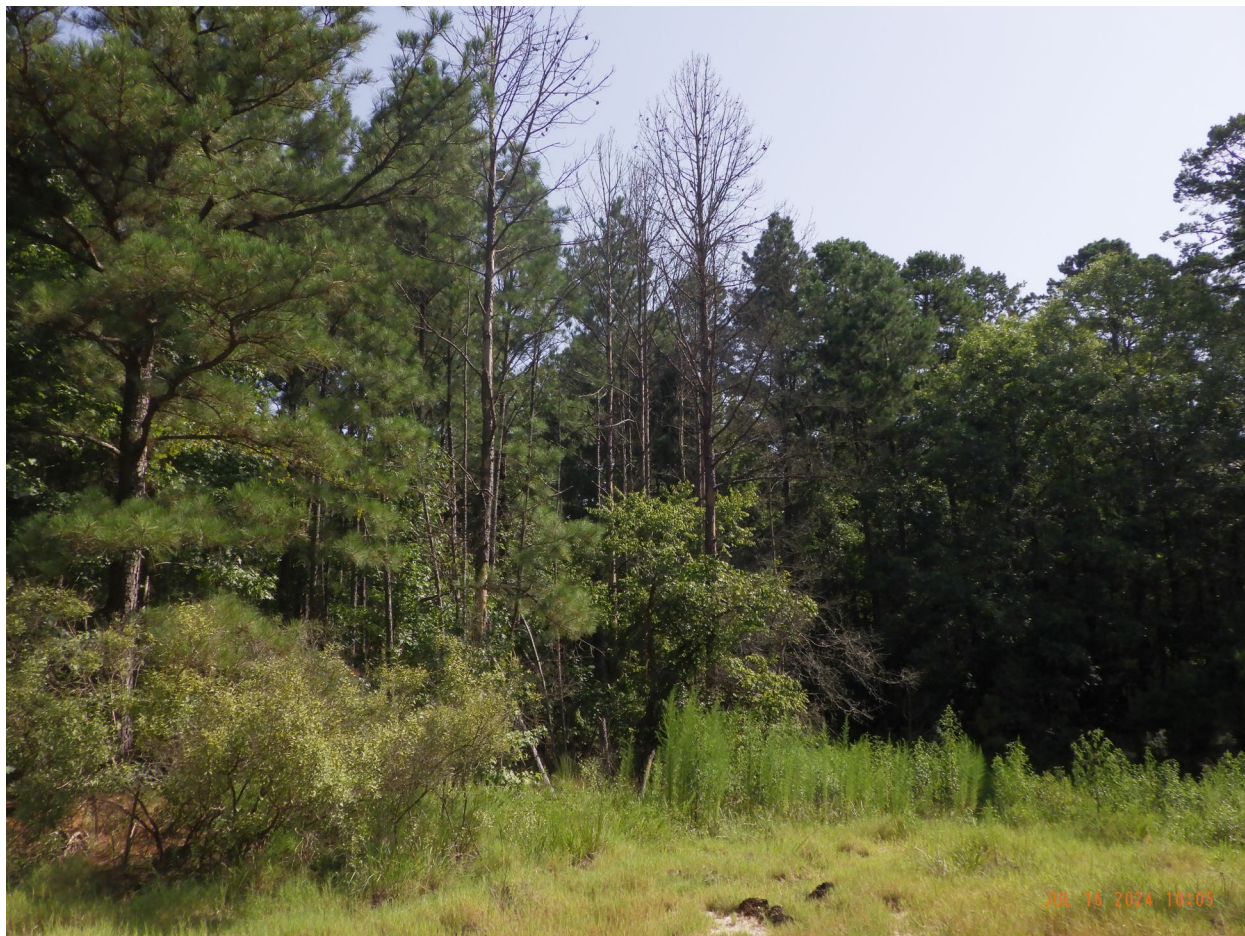
Photo No. 15

**Description:** Looking NNE, this photo shows a grouping of dead trees from a previous discharge of saltwater to the area.

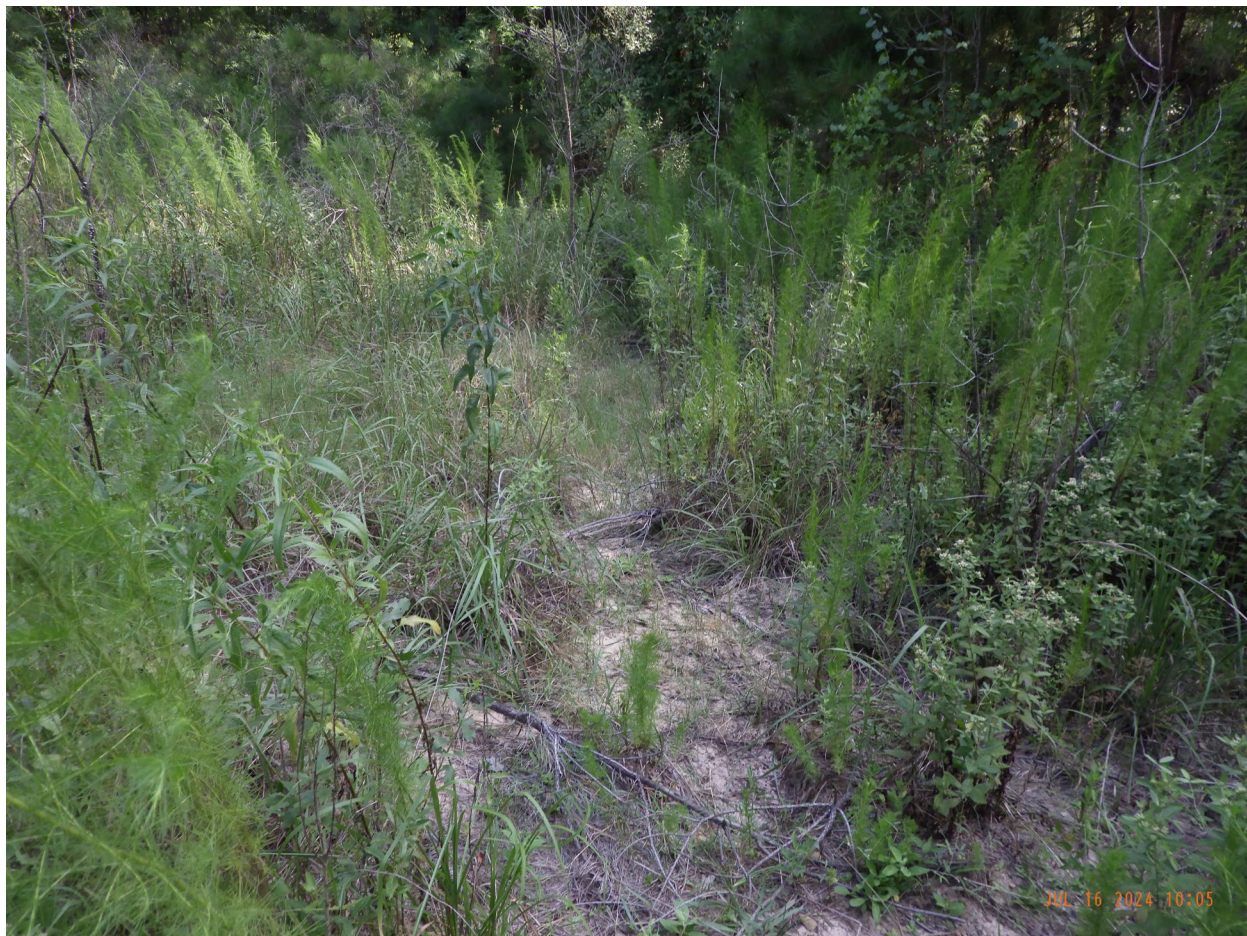
Photo No. 16

I observed a dry ephemeral stream that receives stormwater and discharges from the B Pharr Operating, LLC – Stylite Townsend Tank Battery and Stylite Townsend #1 SWD, see Photo No. 16. This is the point of entry (POE) for stormwater and discharges.

**Description:** Looking N, this photo shows the point of entry from the drainage paths of the tank batteries into the ephemeral stream adjacent to the facility.

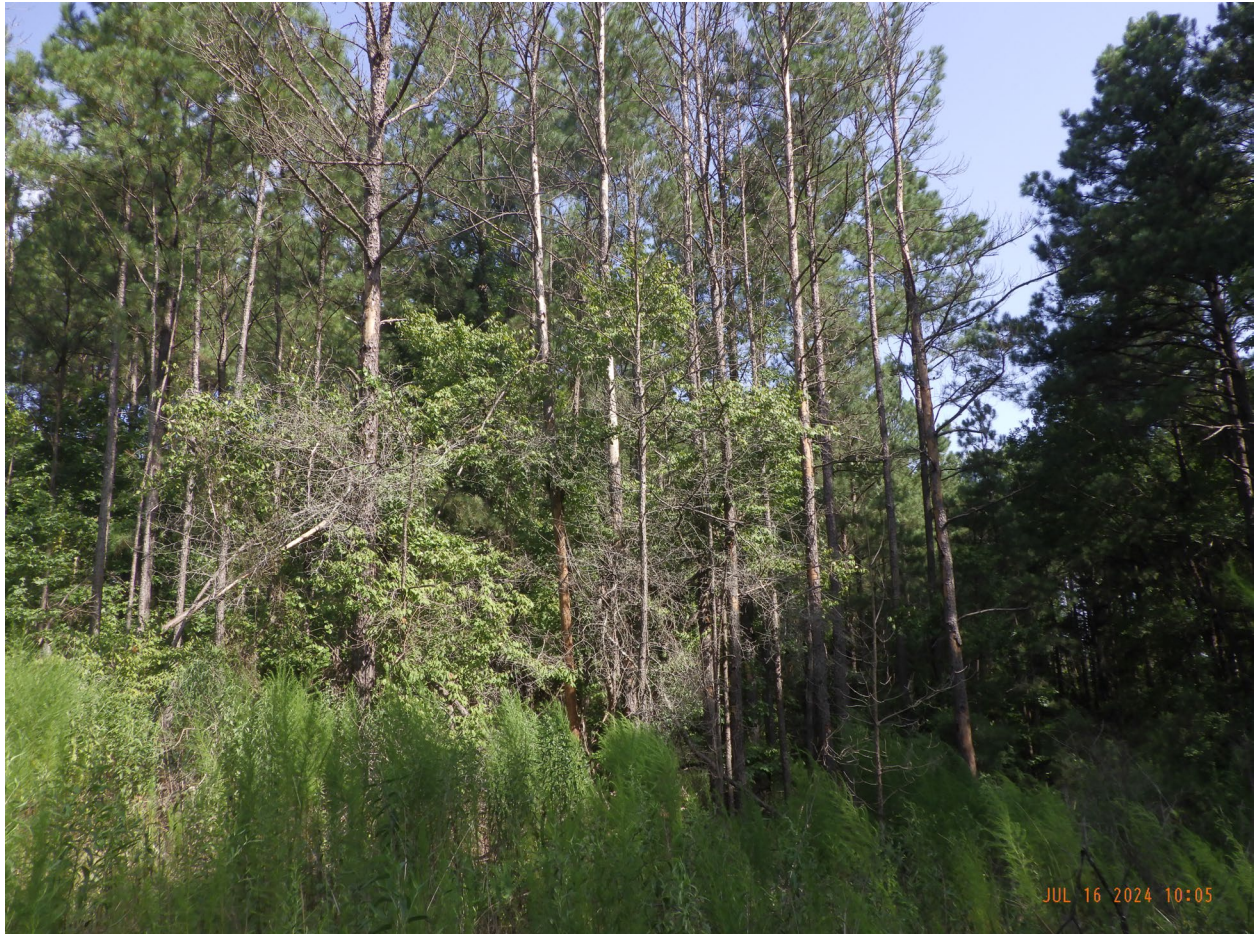
Photo No. 17

**Description:** Looking NW, this photo shows a closer view of the grouping of dead trees in Photo No. 15.
