**Region 6 - Enforcement & Compliance Assurance Division**  
**INSPECTION REPORT**

| Inspection Date(s): | 07/16/2024 | |
| Company Name: | <b>B Pharr Operating, LLC</b> | |
| Facility Name: | <b>Stylite Townsend Tank Battery</b> | |

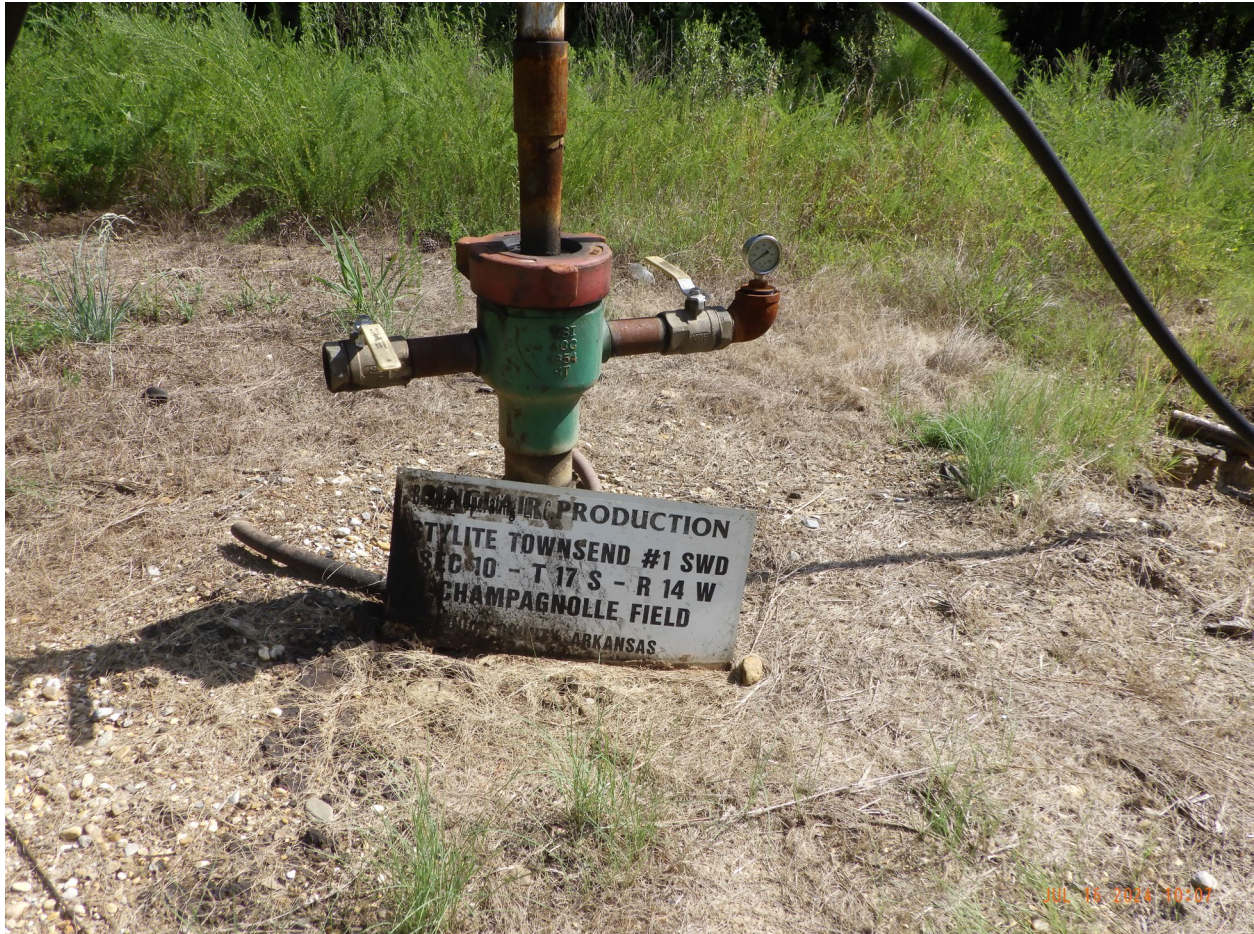
I observed the Stylite Townsend #1 SWD well and associated flowlines, see Photo No. 18 and No. 19.

**Description:** Looking N, this photo shows the signage for the Stylite Townsend #1 SWD well located onsite.

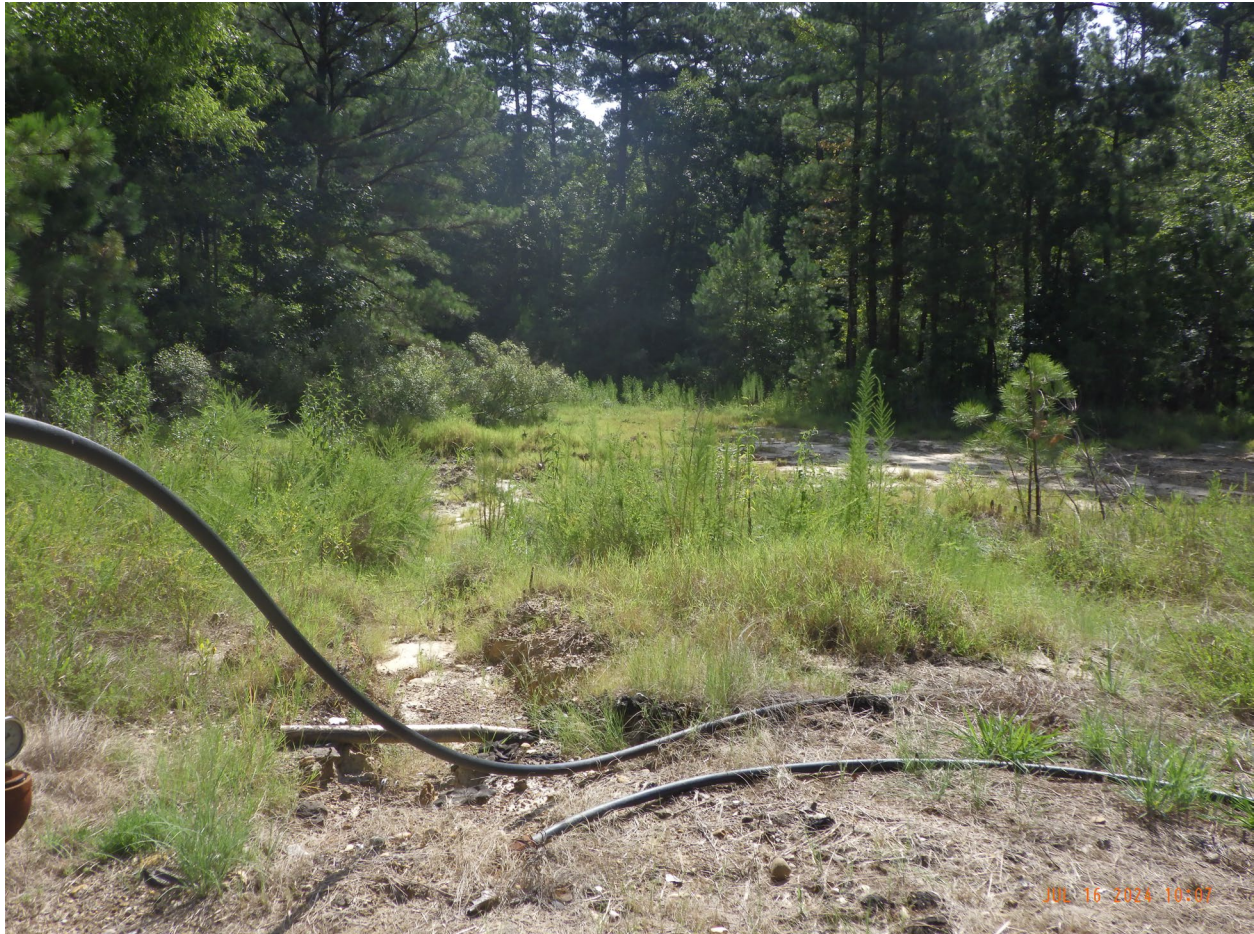
Photo No. 19

I observed erodible soils denuded of vegetation and a grouping of dead trees from a previous saltwater discharge that was downstream of the tank batteries and SWD well, see Photo No. 14, No. 15, No. 17, and No. 19.

**Description:** Looking ENE, this photo shows the drainage path for the SWD in Photo No. 18. Note erodible soils denuded of vegetation from a previous saltwater discharge.
