**NPDES Stormwater Reconnaissance Inspection  
Industrial Facility**

**VEGA BAJA SOLID WASTE MUNICIPAL LANDFILL**  
Road PR-668 Int., Cibuco Ward, Vega Baja, PR 00694  
Coordinates: 18.478408°N, 66.359097°W (Decimal)

**NPDES MSGP ID: PRR053137**

**Inspection Date: April 7, 2022**

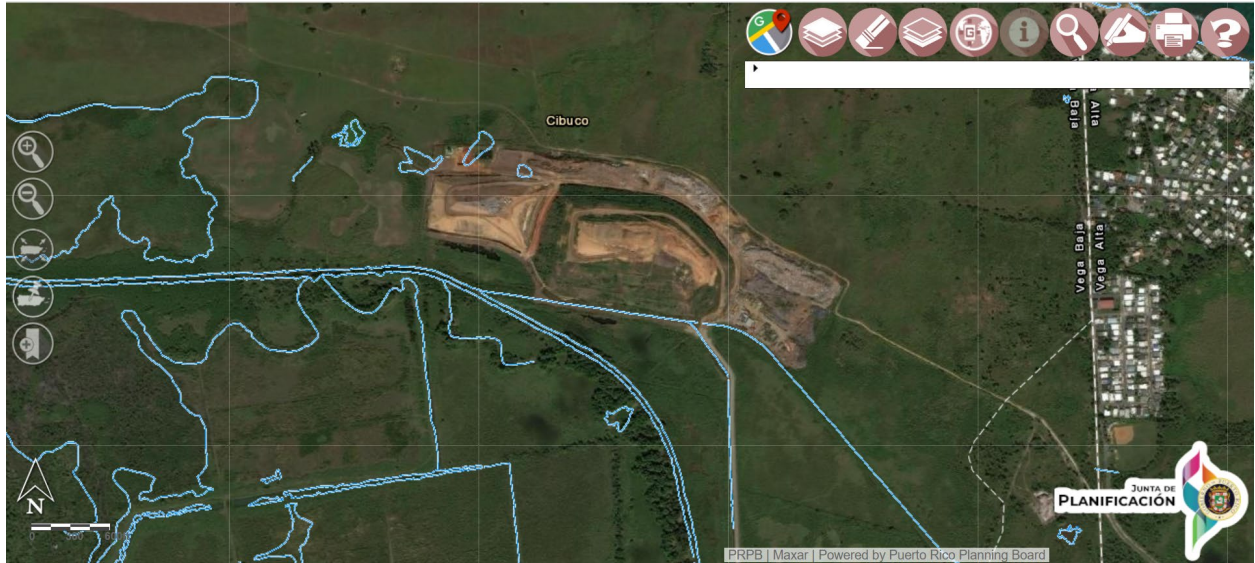
Image 2

The storm water runoff from the drainage areas associated with Outfall 004 flow from the west and the northwest sides of the Landfill into a drainage channel located northwest of the Landfill, which in turn flows and discharges into the Cibuco River. Silt fences and synthetic hay bales were installed. **Figure 1** (next page) depicts a site map of the area where the Landfill is located and flow schematic of the Facility. **Image 2** (page 7) depicts the hydrographic area near the Facility and the location of Cibuco River.
