**Region 4 Enforcement Division**  
**61 Forsyth Street, SW**  
**Atlanta, GA 30303**  
**INSPECTION REPORT**

| <b>Regulatory Program(s)</b> | NPDES – Industrial Pretreatment Program | | |
| <b>Company Name:</b> | Daewon America, Inc. | | |

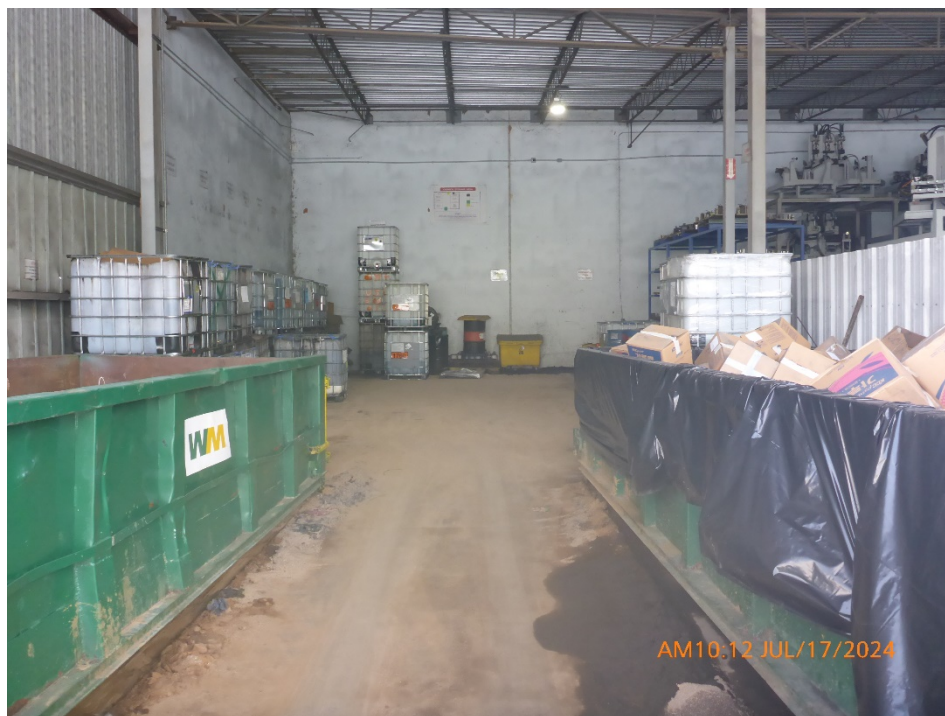
The inspection team proceeded outside to the facility's non-hazardous waste storage area (see Photograph 1). The facility stored non-hazardous waste in 55-gallon drums and totes outside under cover. Non-hazardous waste stored at the time of the inspection included oily rags, shop rags, baghouse dust, and waste paint.

**Photograph 1:** Non-hazardous waste storage area.

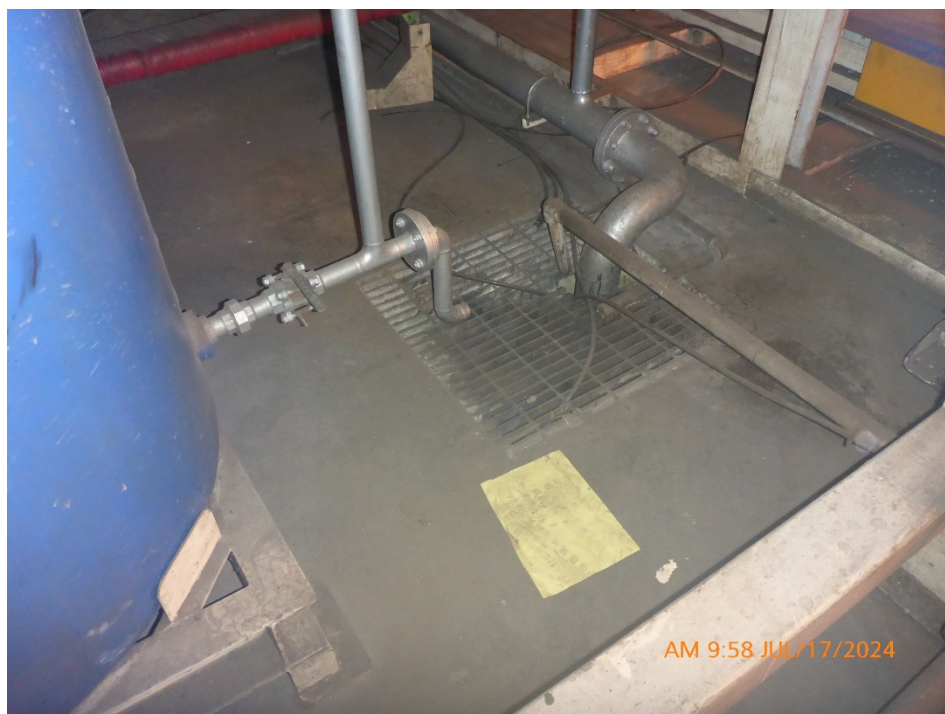
The inspection team then proceeded to the wastewater pretreatment area. Phosphating wastewater from both coil spring and stabilizer bar production lines overflows into a pit under each phosphate line (see Photograph 2). Wastewater from this pit flows to a 38,000-gallon pit (holding tank) located outside the building. From the holding tank, wastewater is pumped to a 500-gallon treatment tank where an emulsion breaker and a short-chain polymer are added. Wastewater is then pumped into another 500-gallon treatment tank where the pH is adjusted using sodium hydroxide. Wastewater is then pumped into a 250-gallon tank, where a long-chain polymer is added (see Photographs 3 and 4). Wastewater then flows through a clarifier before being discharged to the City.

**Photograph 2:** Drain from the phosphate line to the wastewater pit.

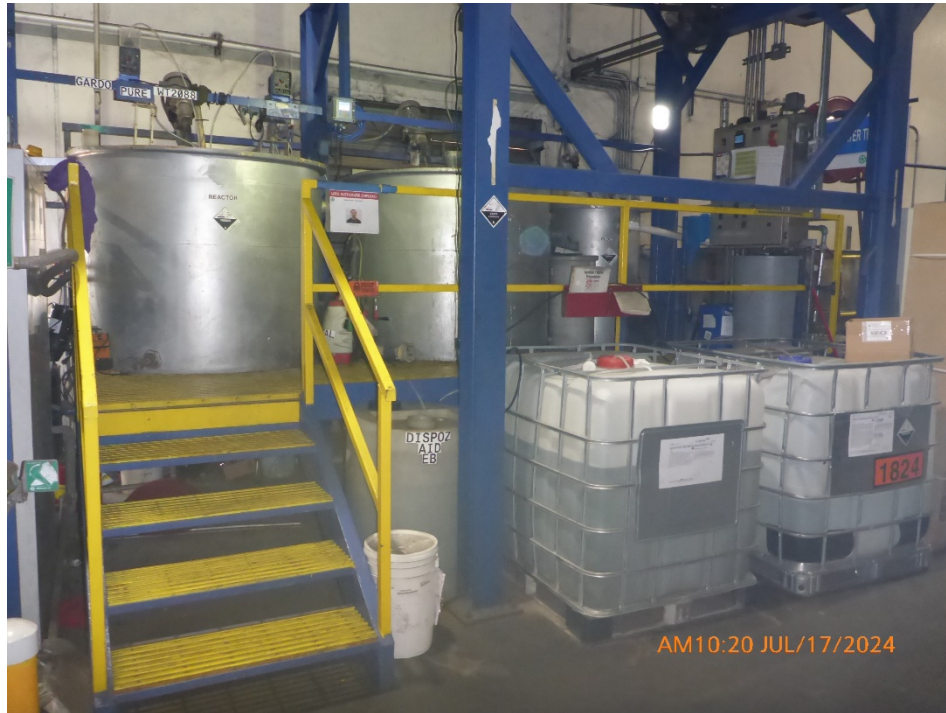
**Photograph 3:** Current wastewater pretreatment area inside the building.

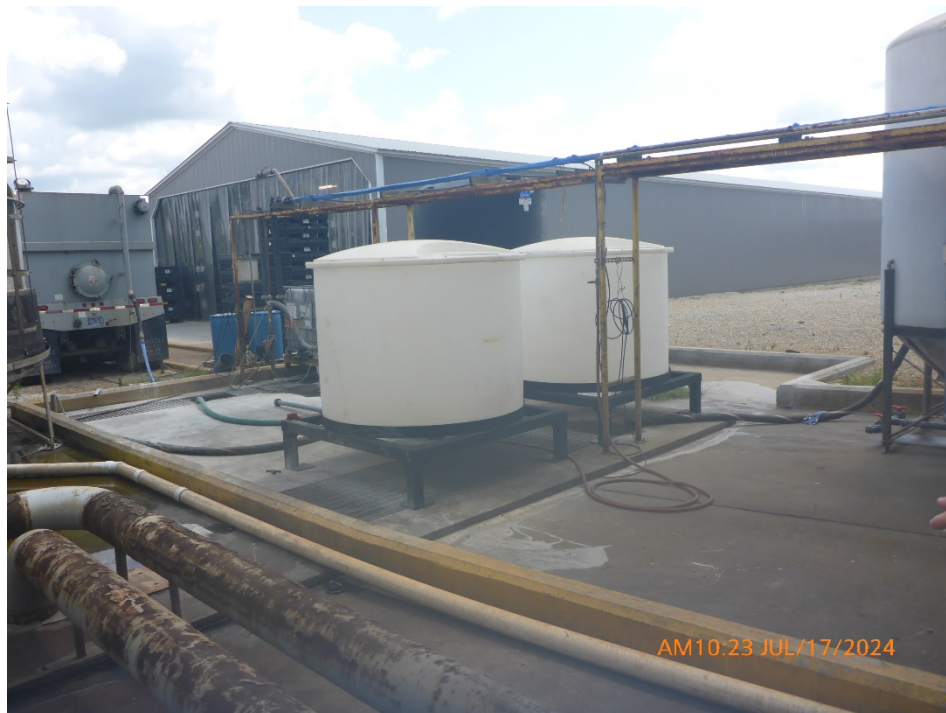
The facility's wastewater pretreatment system consists of flow equalization, pH adjustment, and solids separation. The facility representative stated that there have been no recent significant changes to the wastewater pretreatment system. The facility plans to move the entire wastewater pretreatment system outside the building and under cover by May 2025.

**Photograph 4:** View of the future wastewater pretreatment area. The wastewater holding tank is below ground and not visible.

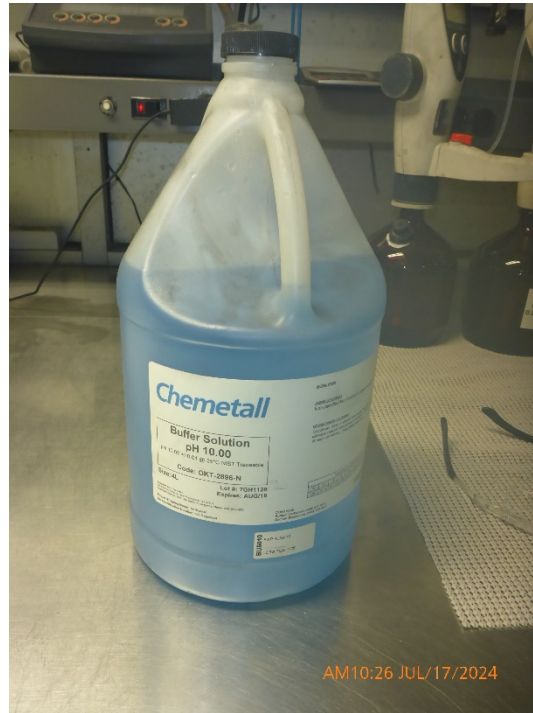
2. During the site inspection, it was discovered that the facility's pH 10 buffer solution for calibrating the pH meter expired in August 2019 (see Photograph 5). The inspection team observed the facility representative dispose of the expired buffer solution by pouring it into the sink in the quality lab in the coil production area. During the site inspection, the facility representative was able to locate an unopened bottle of pH 10 buffer that expires in March 2026 (see Photograph 6). It is recommended that the facility ensure that pH buffers used to calibrate the pH meter are not expired and that the facility properly dispose of expired solutions.

**Photograph 5:** Expired pH 10 buffer solution used for calibrating the pH meter.

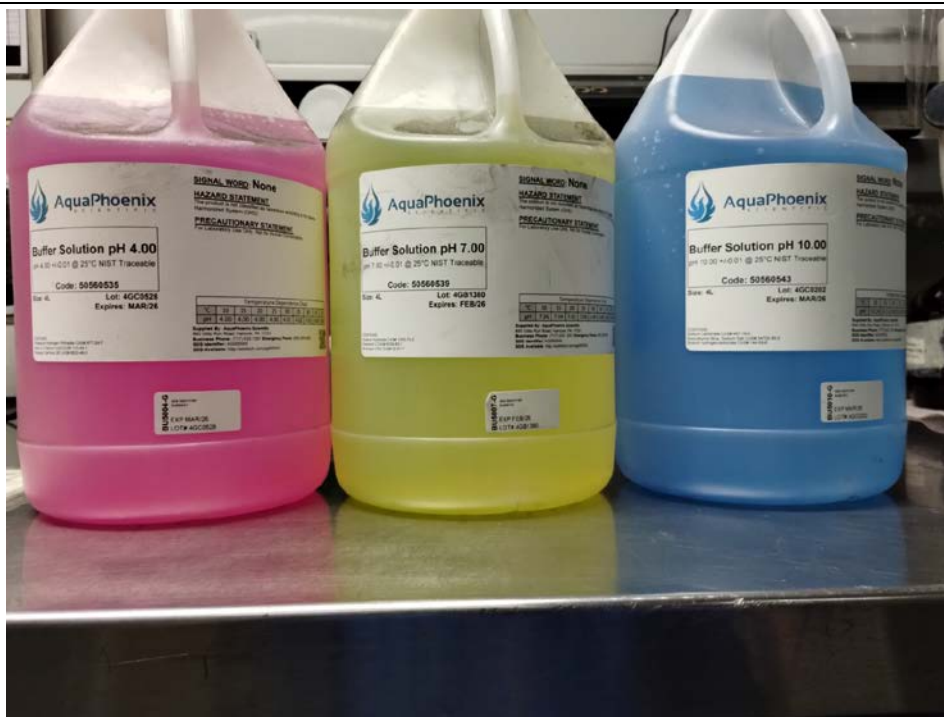
**Photograph 7:** Unexpired pH 4, 7, and 10 buffers located by facility representative post inspection.

1. During the site inspection, it was discovered that the facility is calibrating its pH meter using only a pH 10 buffer solution. However, the pH of the facility's effluent during the June 2022 – June 2024 period varied from below 6.0 to above 10 s.u. After the inspection, the facility representative was able to locate pH 4, 7, and 10 buffers (see Photograph 7). It is recommended that the facility perform a three-point calibration of the pH meter using buffer solutions that cover the entire anticipated range of the facility's discharge.
