## RCRA Compliance Evaluation Inspection Report

Dill Air Control Products, LLC  
1500 Williamsboro Street  
Oxford, North Carolina 27565  
County: Granville

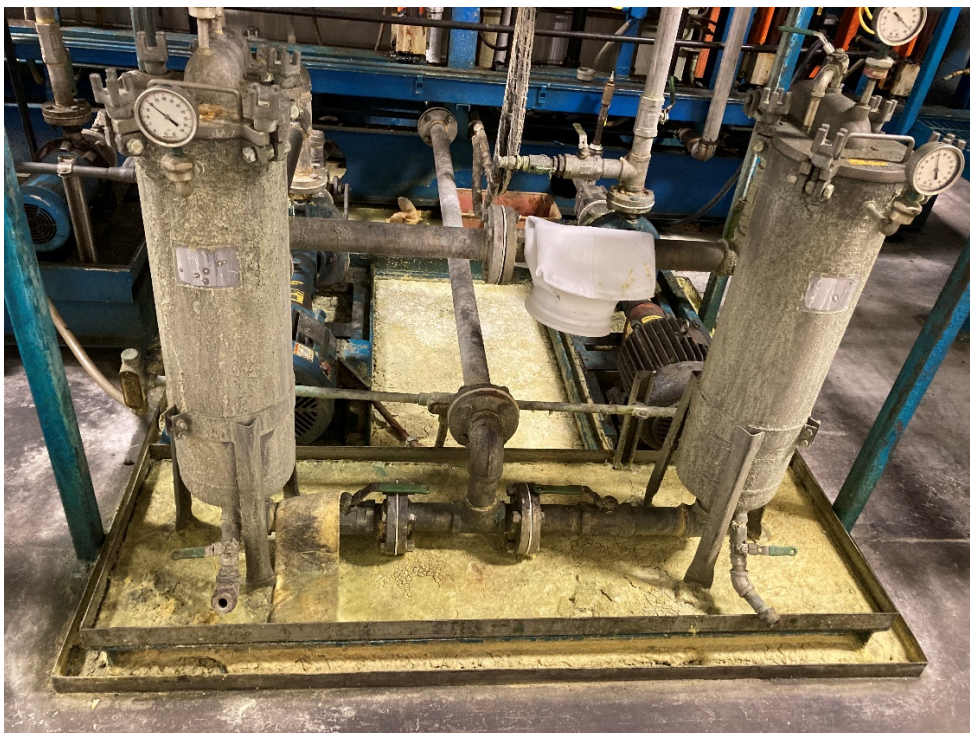
The inspectors observed yellow dried debris under the washing filtration system on the containment pans (Photo # 1). The facility representative indicated that wash water leaks on the pans once the filter pump seal fails. According to Dill, the spent wash water is a D008 waste. The facility has not made a waste determination of the dried yellow debris/materials stored on the pans. The inspector instructed the facility to clean-up the containment pans and dispose of the yellow materials accordingly.

Photo #1 – Yellow dried debris under the washing filtration system.
