## **RCRA Inspection Report**

Safety-Kleen Systems, Inc. (SKS)  
4800 South Old Peachtree Road  
Norcross, Georgia 30071  
EPA ID # GAD980842777  
Permit# HW-078 (S)

September 27, 2021 at 9:00 a.m.

**COMPLIANCE EVALUATION INSPECTION PHOTOGRAPHS**

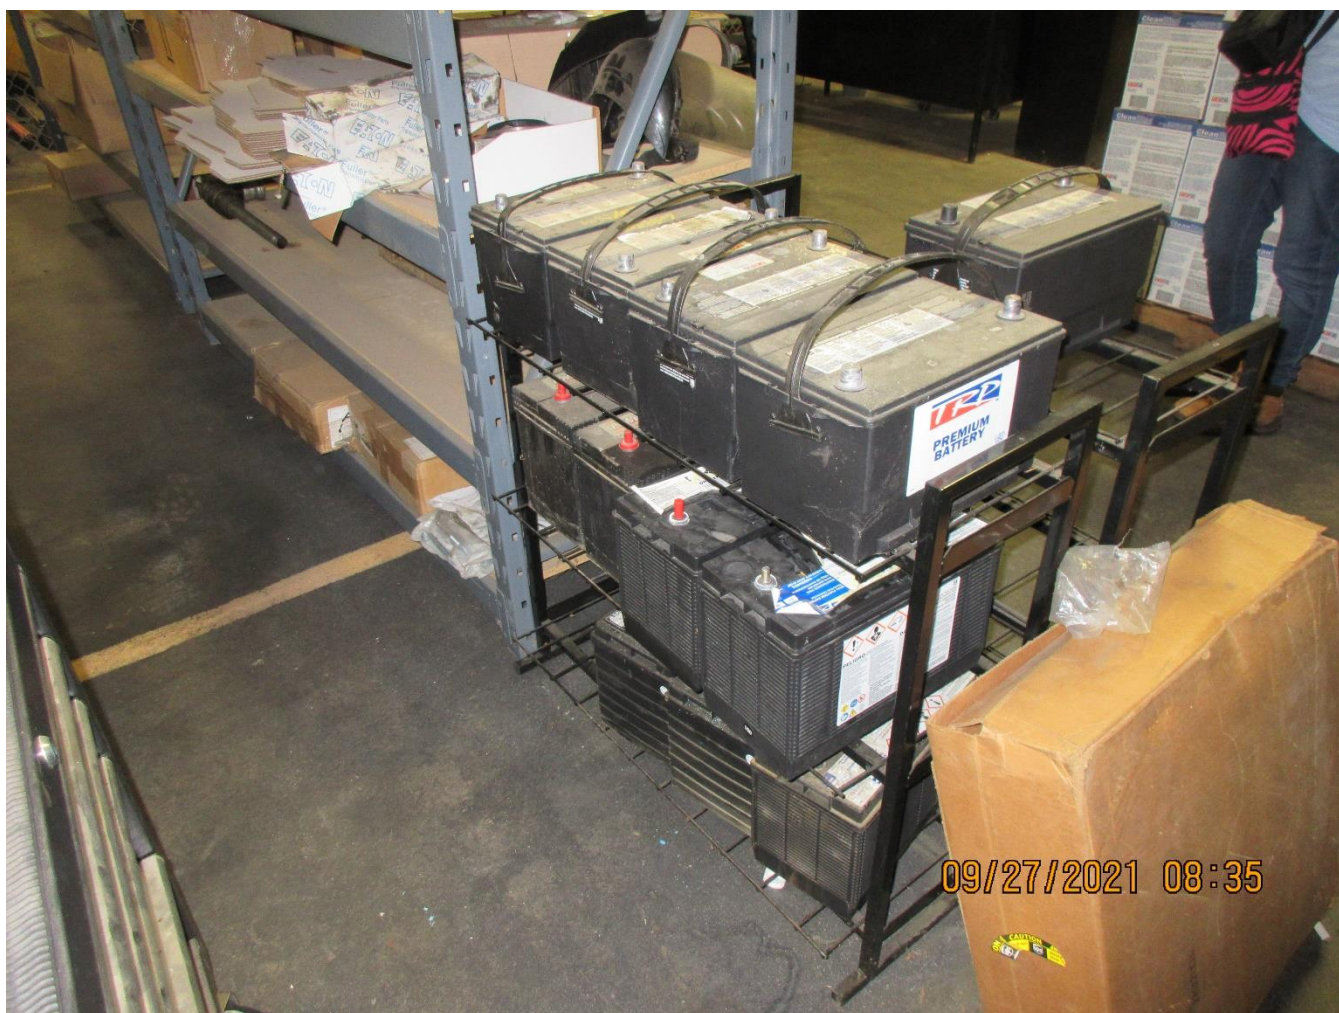
Eleven lead acid car-type batteries were observed in this area at the time of the inspection (Photo1). The batteries were not marked with any universal waste labels or markings. In addition, the batteries were not marked with accumulation start dates.

Photo 1 – Lead acid universal waste batteries in the Mechanic Shop

**Pursuant to Ga. Comp. R. and Regs. 391-3-11-.18 [40 C.F.R. § 273.14(a)], a Small Quantity Handler of Universal Waste (SQHUW) must label or mark each Universal Waste battery or container or tank in which the batteries are contained clearly with one of the following phrases: "Universal Waste - Battery(ies)," or "Waste Battery(ies)," or "Used Battery(ies)."**

**Pursuant to Ga. Comp. R. and Regs. 391-3-11-.18 [40 C.F.R. § 273.15(a) and (c)], a SQHUW may accumulate universal waste no longer than one year and must be able to demonstrate the length of time that the universal waste has accumulated from the date that it became a waste or was received.**

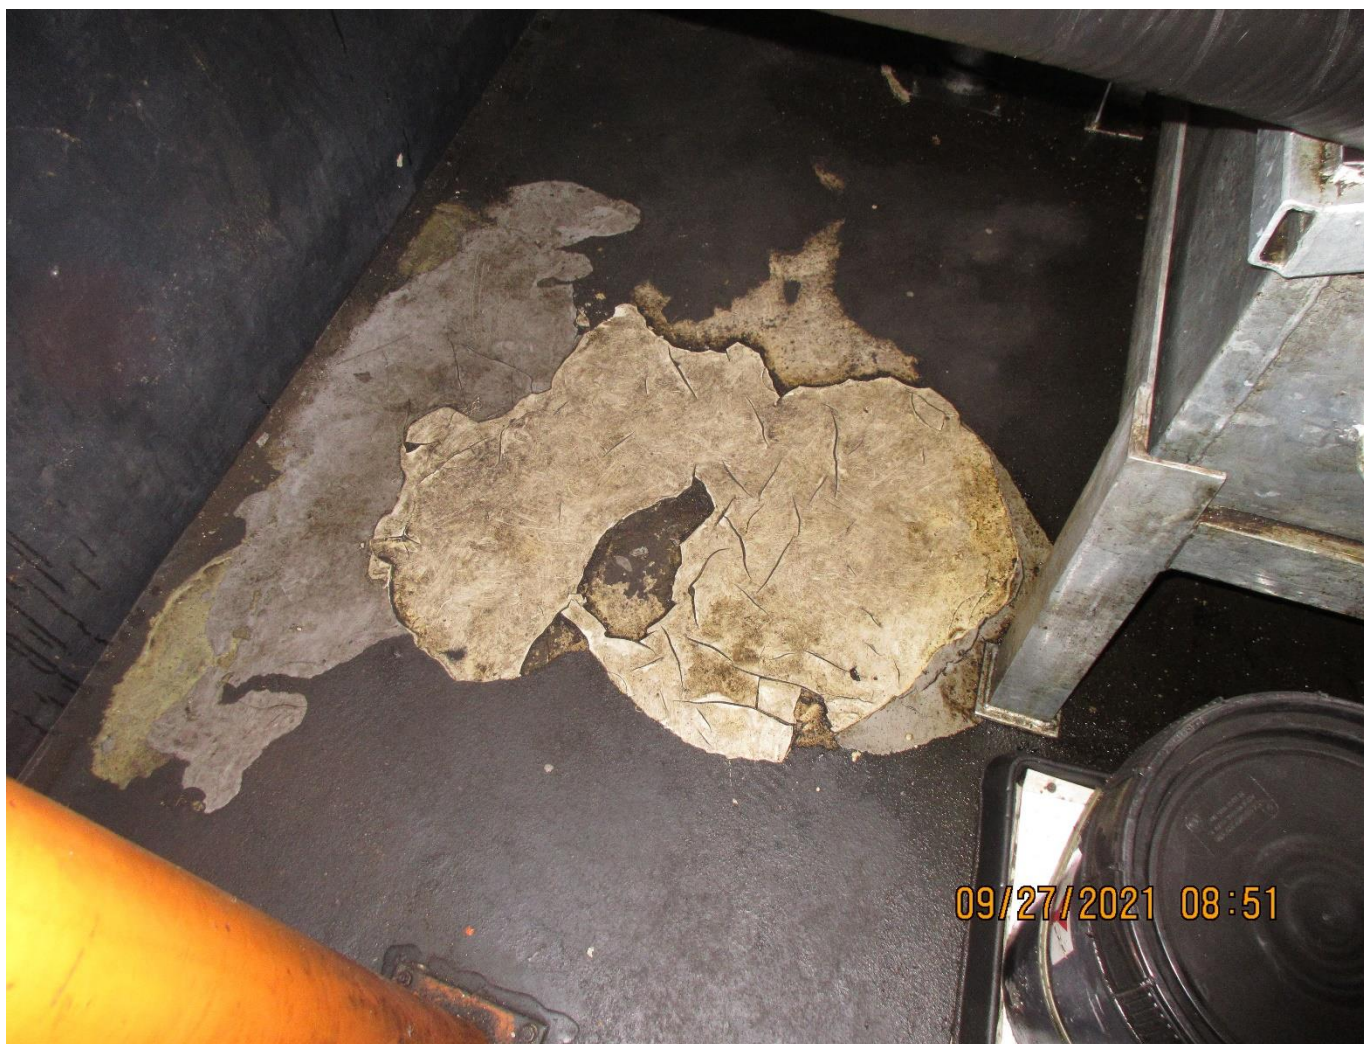
The Tank Farm consists of two 15,000-gallon storage tanks; one horizontal tank, permitted to store hazardous waste spent mineral spirits, and one vertical tank that contains used oil. The two 15,000-gallon tanks, including the high-level alarm systems, eye wash, fire extinguisher, spill control kit and the secondary containment were all inspected. The eyewash was inspected and appeared to be in good working order. The fire extinguisher was up to date and there was a spill control kit near the permitted tank. The secondary containment system was observed to have an area of approximately 10 square feet to which the sealant on the secondary containment system was not in good condition (Photo 2).

In addition, the facility's inspection records did not document any damage to the coatings for the tanks secondary containment system.

Photo 2 – Floor of secondary containment system for facility’s permitted hazardous waste storage tank.

**Pursuant to Georgia Hazardous Waste Permit Number HW-078(S), Section III.E.1., "Inspection Schedule and Procedures," states that "the Permittee shall inspect the tank system in accordance with 40 CFR Section 264.195 and inspection schedule including Section F in the Permit Renewal Application received March 5, 2018. Section F-2(b)(2) of the Permit Renewal Application states "The secondary containment system for the tanks must be checked for cracks or other deterioration. Any damage to tanks or secondary containment must be noted and repairs initiated."**
