## **RCRA Inspection Report**

Glasforms Inc. BLDGS #1-4  
3943 Valley East Industrial Dr.  
Birmingham, Alabama 35217  
EPA ID No: ALR000013128

November 02, 2021

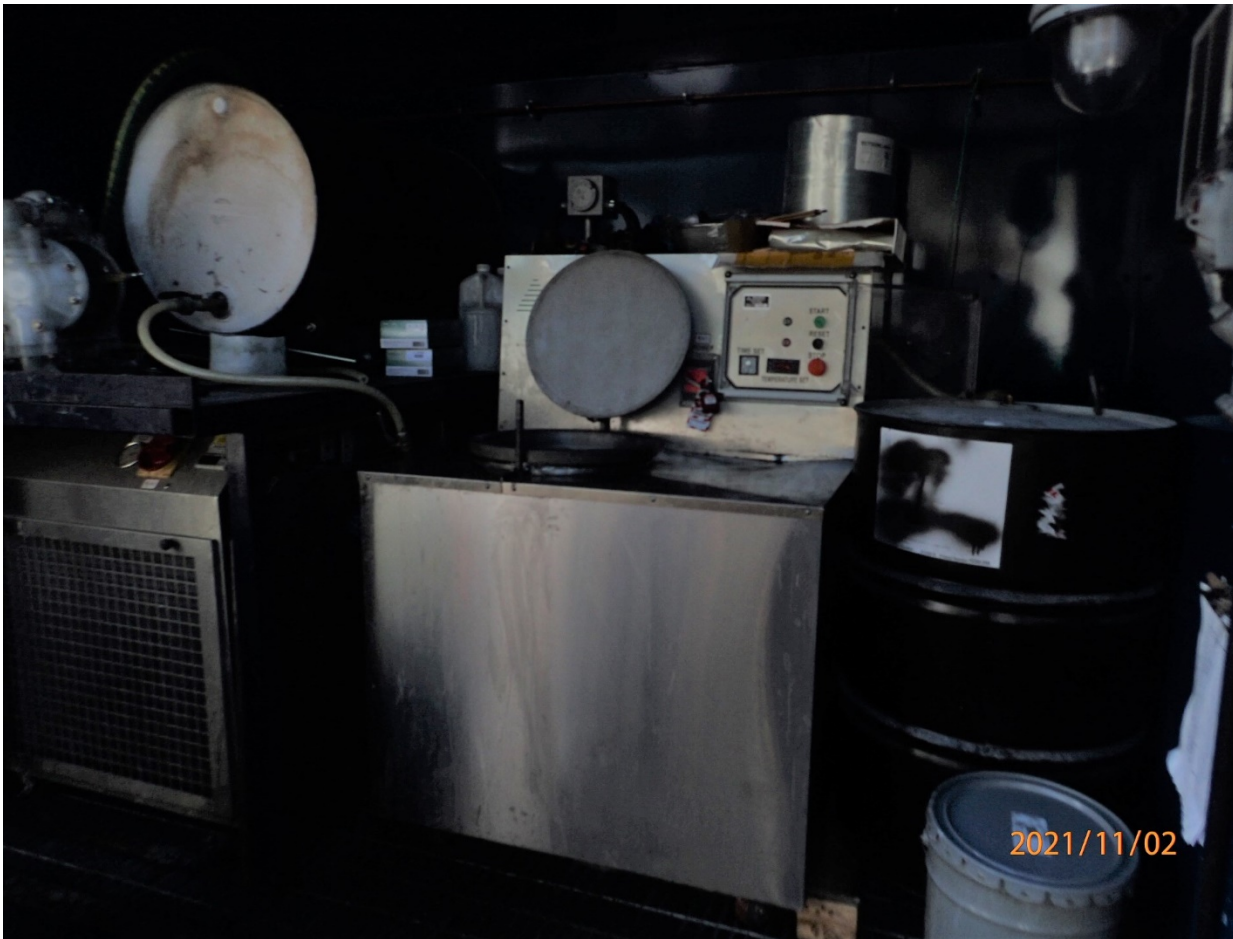
Next to the facility's 90-day hazardous waste central accumulation area (CAA) is the acetone recovery unit (located just behind Building #4) (Photo #2). Spent acetone is processed into reusable product. A 55-gallon drum labeled hazardous waste was observed on the pavement next to the reclamation area but was empty. No hazardous waste was observed in this area.

**Photo 2:** Acetone Recovery Unit. Not currently operating.

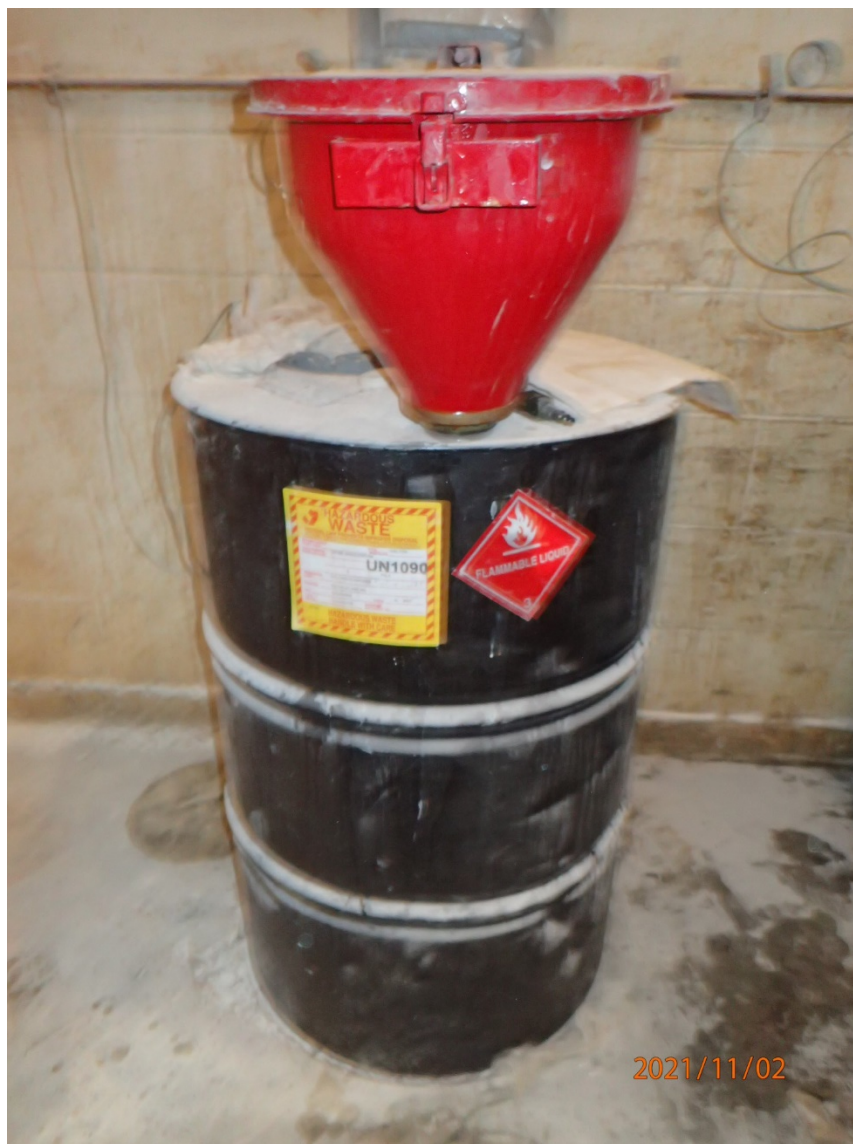
- One (1) 55-gallon drum of waste acetone. The container was closed and labeled with the words “Hazardous Waste”. The drum was not marked with the indication of hazard. This was corrected immediately onsite (Photo #8).

**Photo 8:** One (1) 55-gallon drum of waste acetone. The container was closed and labeled with the words "Hazardous Waste". The drum was not marked with the indication of hazard. This was corrected immediately onsite.

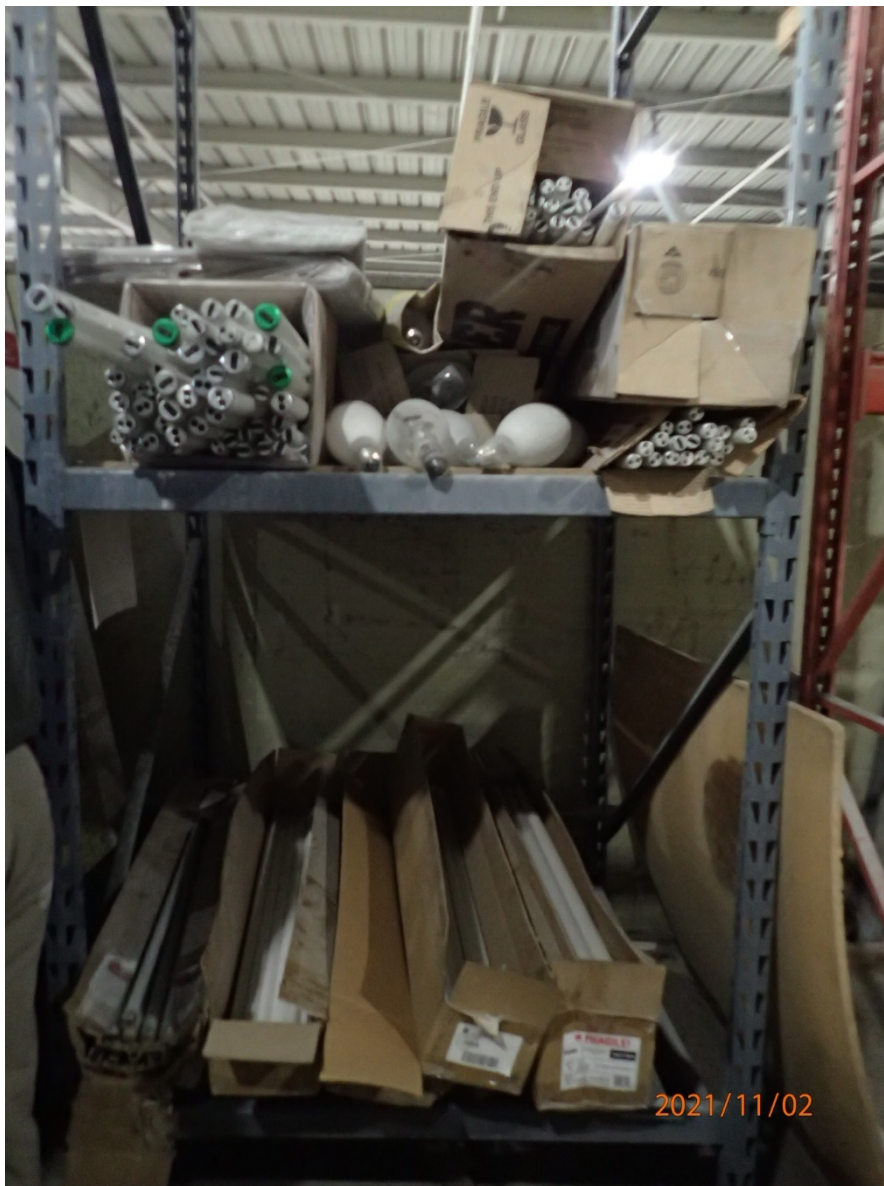
**Pursuant to ADEM Admin. Code r. 335-14-11-.02(4)(d) [40 CFR 273.13(d)], a small quantity handler of universal waste must manage lamps in a way that prevents releases of any universal waste or component of a universal waste to the environment, as follows: (1) A small quantity handler of universal waste must contain any lamp in containers or packages that are structurally sound, adequate to prevent breakage, and compatible with the contents of the lamps. Such containers and packages must remain closed and must lack evidence of leakage, spillage or damage that could cause leakage under reasonably foreseeable conditions. (2) A small quantity handler of universal waste must immediately clean up and place in a container any lamp that is broken and must place in a container any lamp that shows evidence of breakage, leakage, or damage that could cause the release of mercury or other hazardous constituents to the environment. Containers must be closed, structurally sound, compatible with the contents of the lamps and must lack evidence of**

Pursuant to ADEM Admin. Code r. 335-14-11-.02(5)(e) [40 CFR 273.14(e)], each lamp or a container or package in which such lamps are contained must be labeled or marked clearly with one of the following phrases: “Universal Waste - Lamp(s),” or “Waste Lamp(s),” or “Used Lamp(s)”.

Pursuant to ADEM Admin. Code r. 335-14-11-.02(6)(c) [40 CFR 273.15(c)], a small quantity handler of universal waste who accumulates universal waste must be able to demonstrate the length of time that the universal waste has been accumulated from the date it becomes a waste or is received. The handler may make this demonstration by:

**Photo 11:** Eleven (11) boxes of Universal Waste (UW) fluorescent lamps. The boxes of UW were open, not labeled, and not dated.

UPDATE: Mr. Shaver submitted photos of universal waste fluorescent bulbs contained in closed boxes which were all labeled and dated. Photos of both containers of spent aerosol cans were submitted showing the containers labeled “Hazardous Waste”. (Photo #13 and #14)

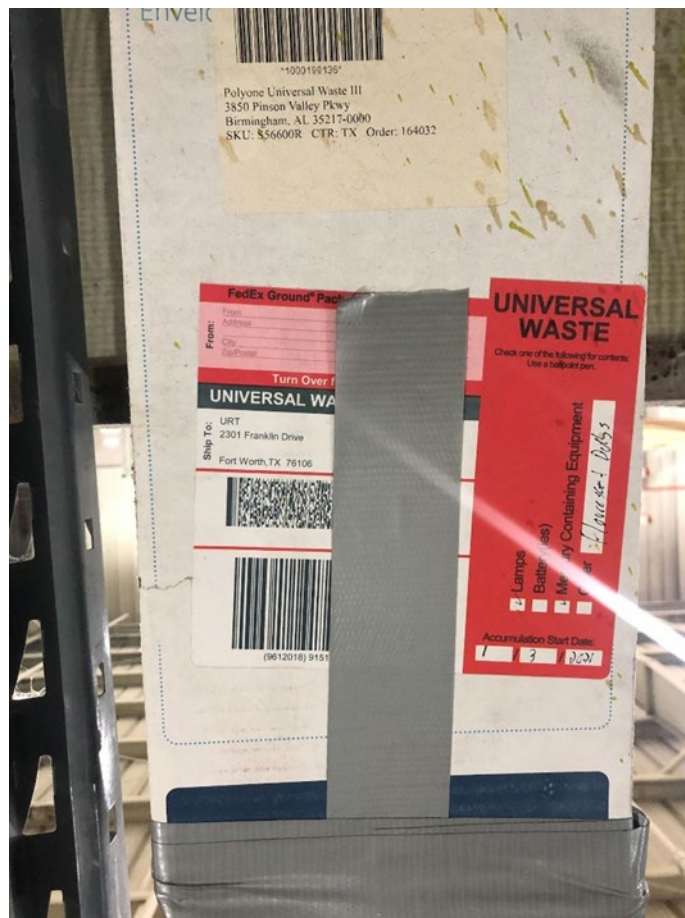
**Photo 13:** Mr. Shaver submitted photos of universal waste fluorescent bulbs contained in closed boxes which were all labeled and dated.

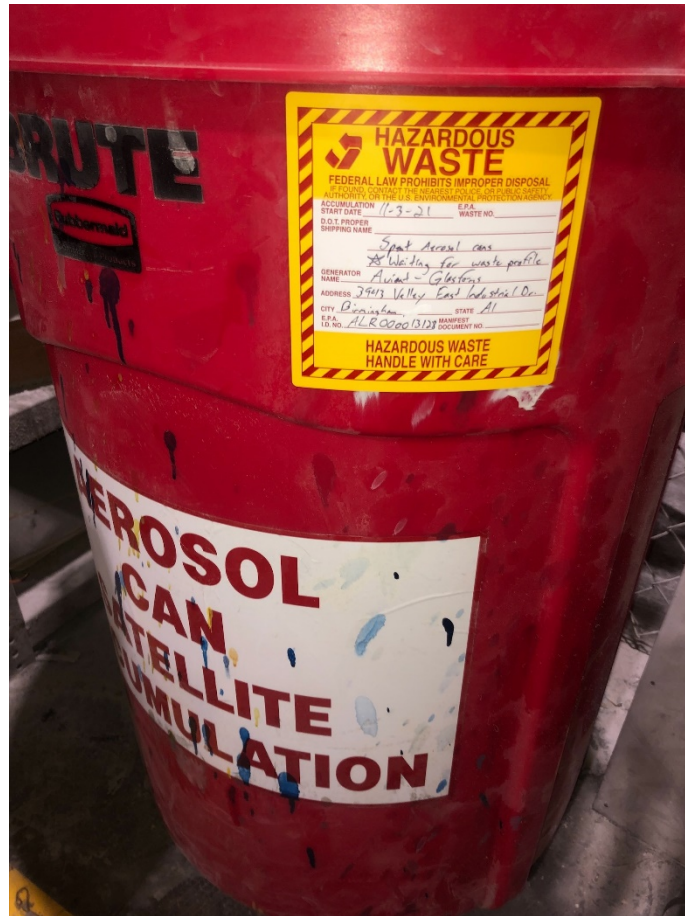
**Photo 14:** Photos of both containers of spent aerosol cans were submitted showing the containers labeled "Hazardous Waste".
