**UNITED STATES
ENVIRONMENTAL PROTECTION AGENCY**
REGION 5
25063 CENTER RIDGE ROAD
WESTLAKE, OHIO 44145-4114

DATE: November 2, 2021

SUBJECT: CLEAN AIR ACT INSPECTION REPORT
MPC Plating, LLC, Brooklyn, Ohio

Purpose of Inspection: evaluate compliance with standards for emissions from chromium electroplating tanks

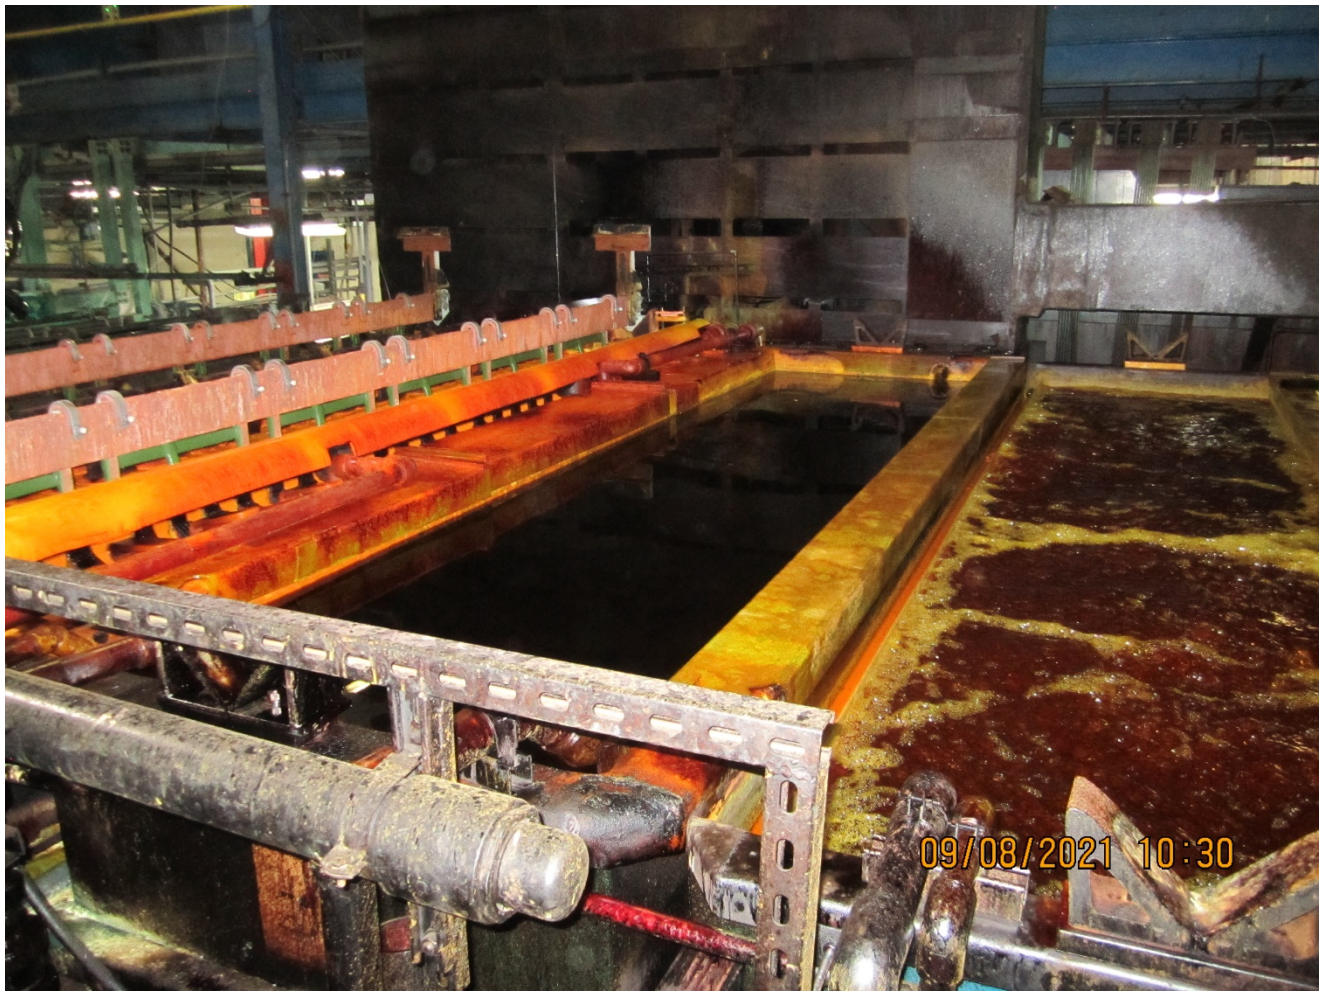
Date and Time: 9/8/2021, 10:30 AM	File: MPC Plating IMG_0001	Photo No.: 1
--	-----------------------------------	---------------------

Description: The tank in the center of the photo is the drag out tank. The chromium electroplating tank is to its left. There is a drip shield between the tanks. The composite mesh-pad scrubber is at the far side of the tanks.

- 40 CFR 63.342, Table 2 – The chromium electroplating tank is followed by a drag-out tank with a drip shield between the tanks (see photo #1). Excess chromic acid is not removed from parts by spraying them. The elevated plating line has a collection system beneath it that drains to an onsite wastewater treatment system (see photo #3).

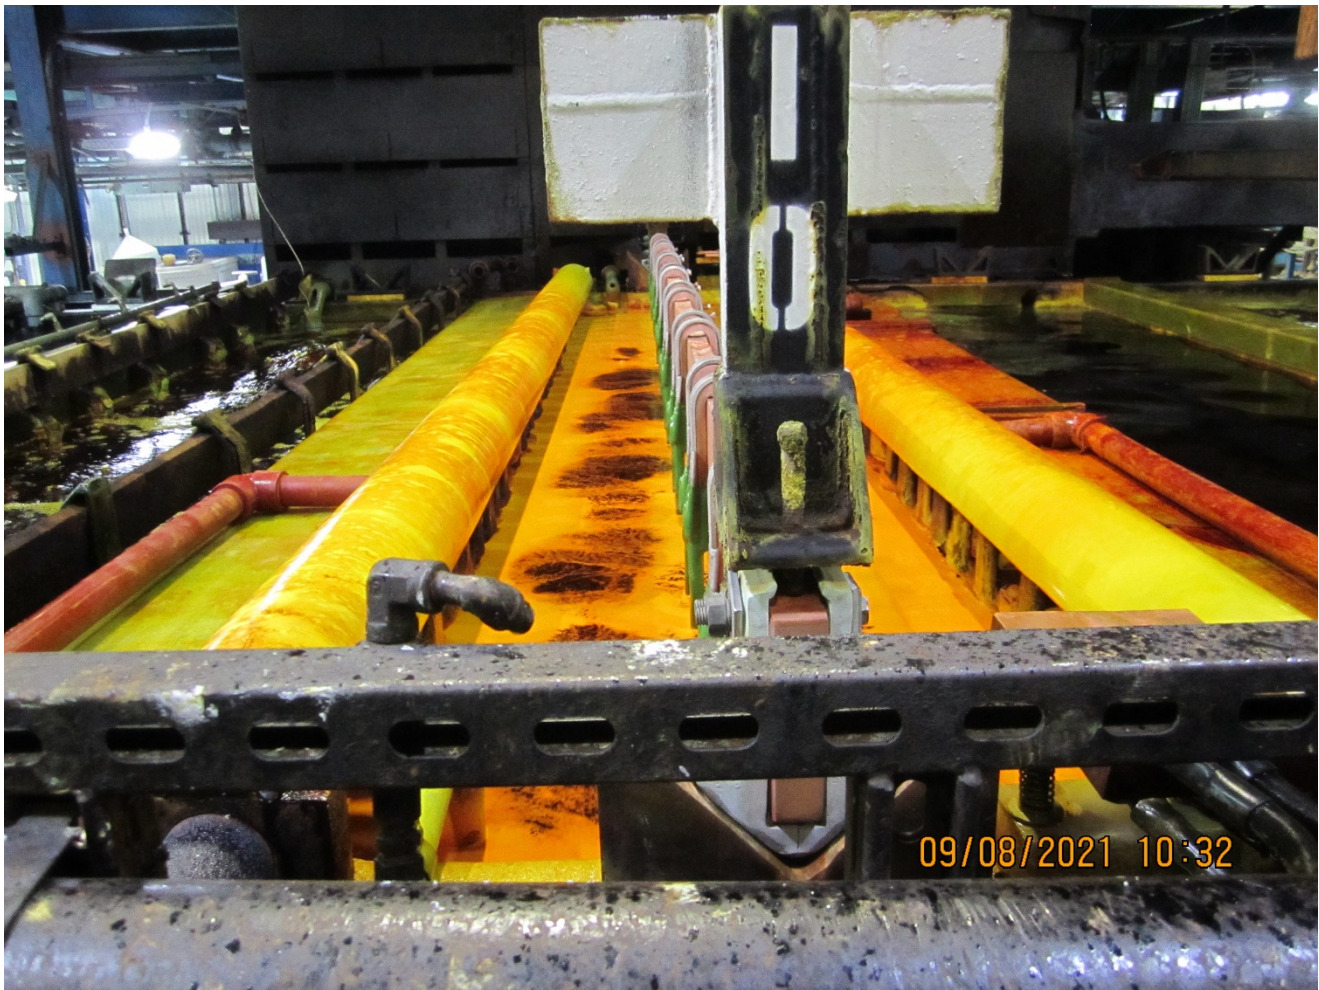
Facility Name and Location: MPC Plating, LLC 9921 Clinton Road, Brooklyn, Ohio	Photographed By: Mark Conti	Camera: Canon PowerShot SD1400 IS S/N 212065043406
Date and Time: 9/8/2021, 10:32 AM	File: MPC Plating IMG_0002	Photo No.: 2

Description: This is the chromium electroplating tank. Air is blown across the surface of the tank to assist with pushing emissions toward the composite mesh-pad scrubber across from the tank.

- The facility has a composite mesh-pad scrubber for reducing chromium emissions from the chromium electroplating tank. There is a push-pull ventilation system to direct emissions to the scrubber (see photos #2, 5, and 6). The water used for mesh-pad washdown is collected and concentrated in a Chemtrec Systems chrome evaporation unit that also has a mesh-pad scrubber (see photos #7 and 8). Concentrated chromic acid solution is periodically returned to the chromium electroplating tank. Compliance is demonstrated through use of a chemical fume suppressant containing a wetting agent rather than the air pollution control device.

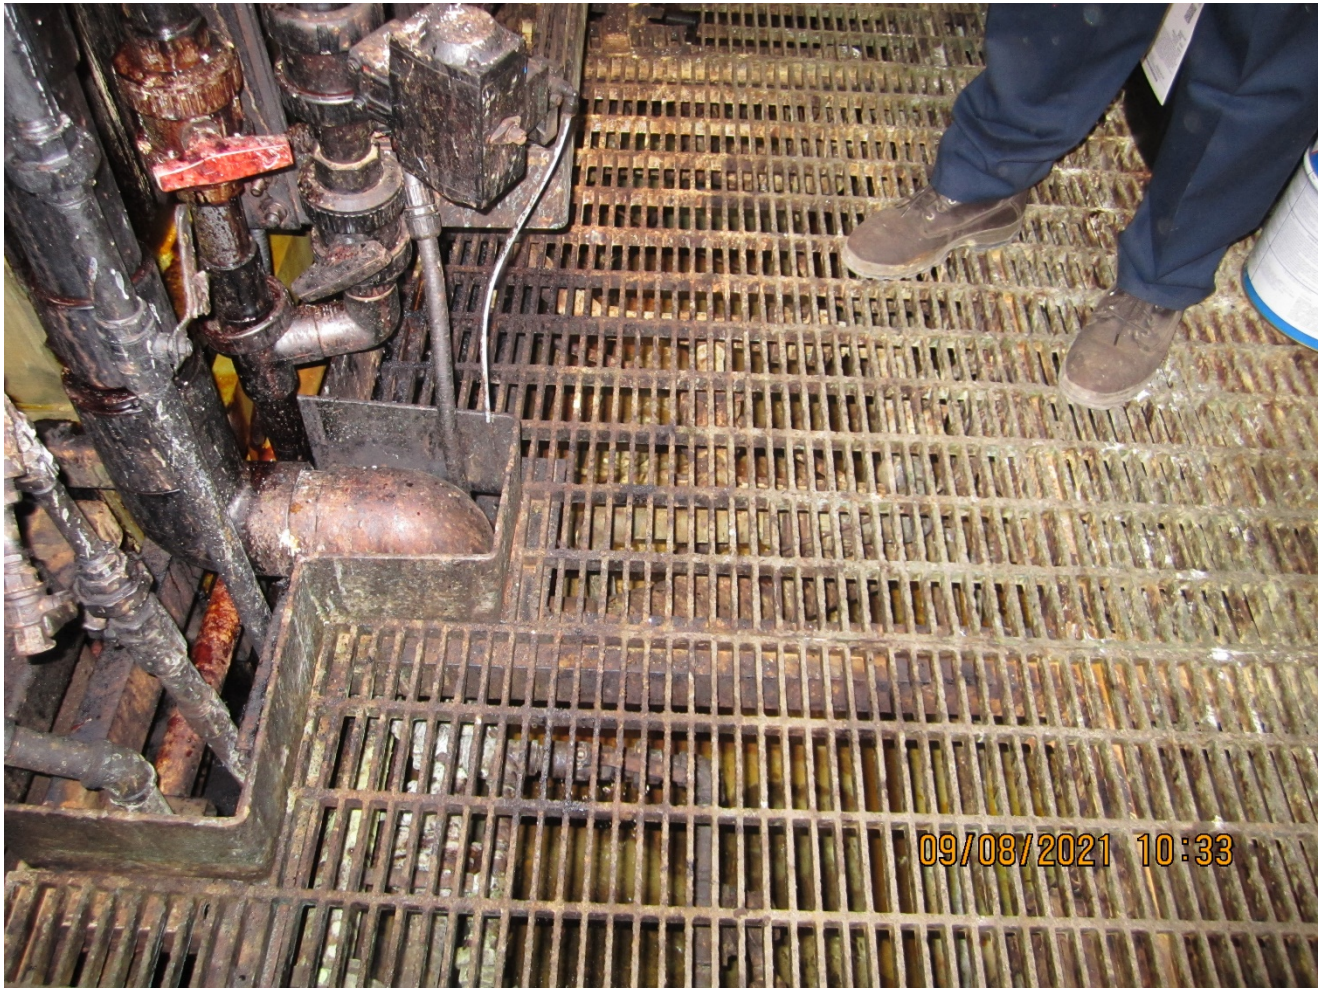
Facility Name and Location: MPC Plating, LLC 9921 Clinton Road, Brooklyn, Ohio	Photographed By: Mark Conti	Camera: Canon PowerShot SD1400 IS S/N 212065043406
Date and Time: 9/8/2021, 10:33 AM	File: MPC Plating IMG_0003	Photo No.: 3

Description: This is next to the chromium electroplating tank. The elevated plating line has a collection system beneath it that drains to an onsite wastewater treatment system.

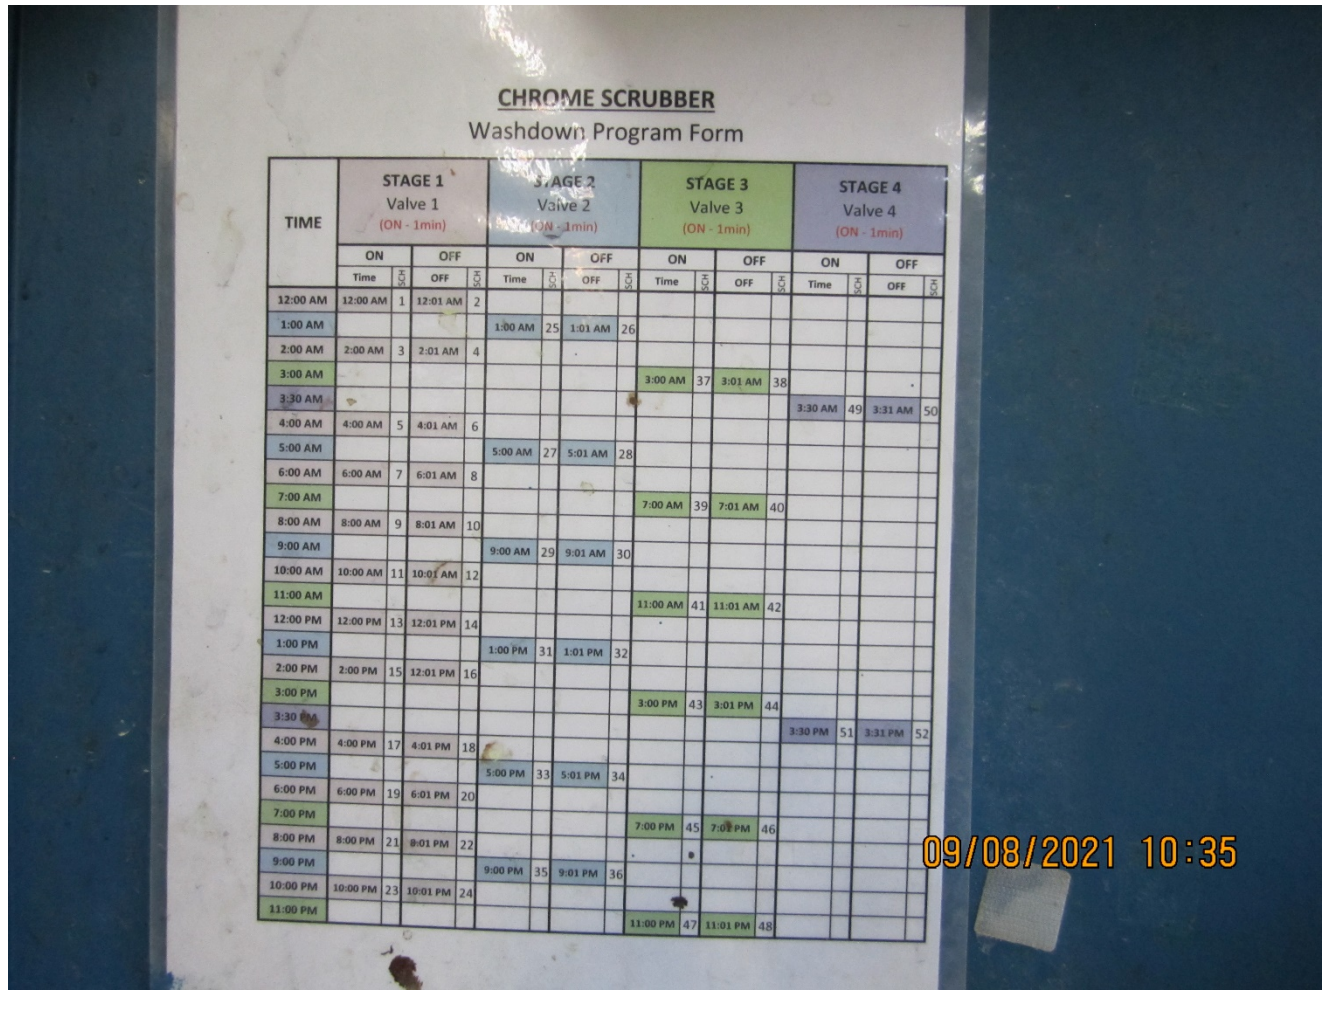
Facility Name and Location: MPC Plating, LLC 9921 Clinton Road, Brooklyn, Ohio	Photographed By: Mark Conti	Camera: Canon PowerShot SD1400 IS S/N 212065043406
Date and Time: 9/8/2021, 10:35 AM	File: MPC Plating IMG_0004	Photo No.: 4

Description: This is the washdown schedule for the chromium electroplating tank composite mesh-pad scrubber.

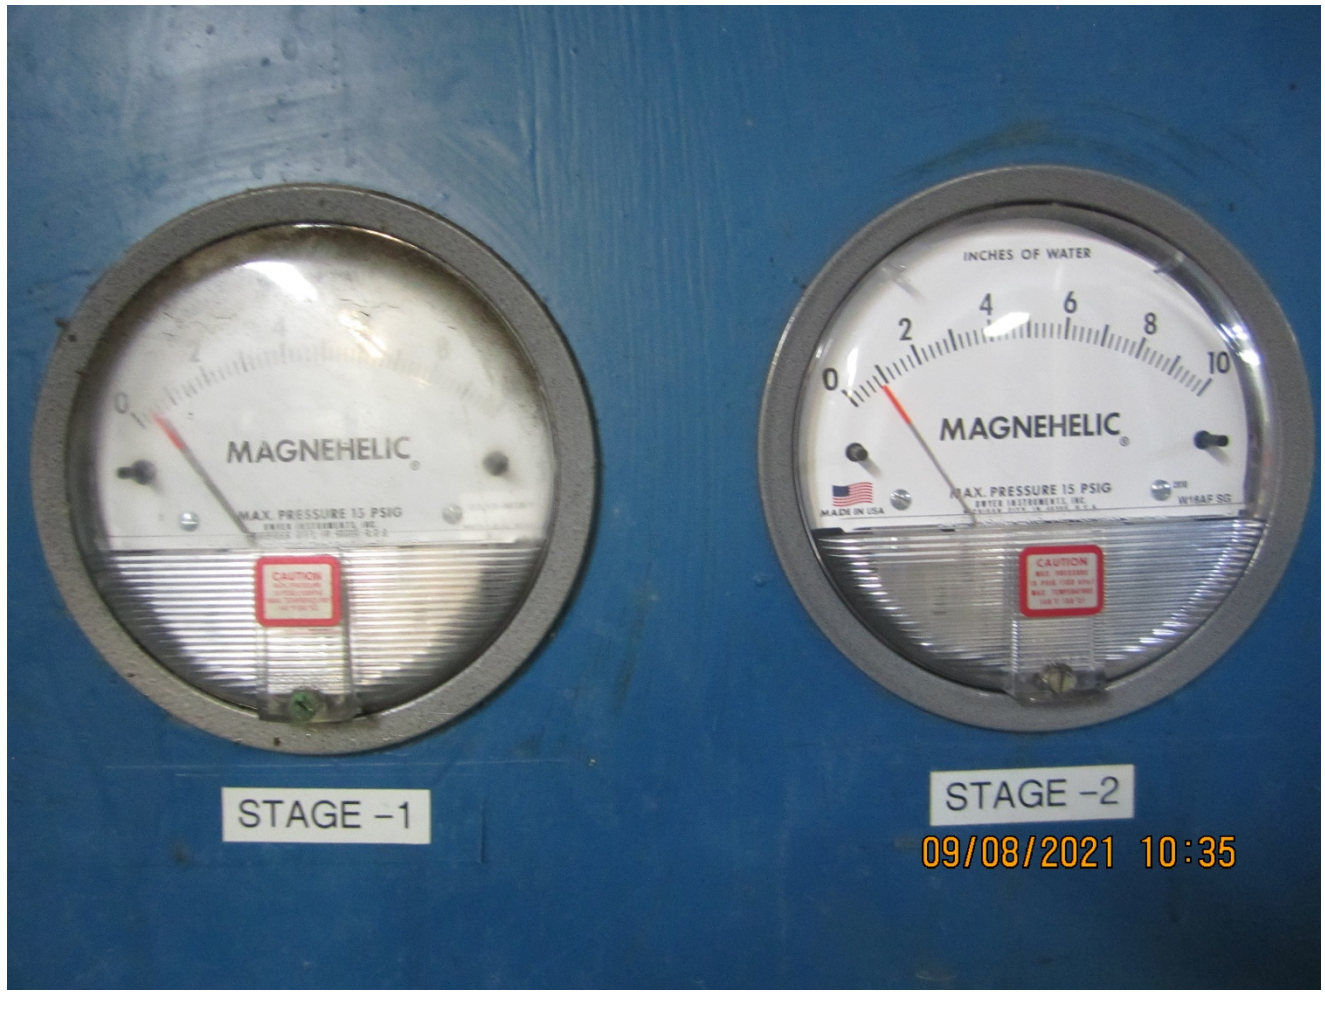
Facility Name and Location: MPC Plating, LLC 9921 Clinton Road, Brooklyn, Ohio	Photographed By: Mark Conti	Camera: Canon PowerShot SD1400 IS S/N 212065043406
Date and Time: 9/8/2021, 10:35 AM	File: MPC Plating IMG_0005	Photo No.: 5

Description: Magnehelic gauges indicate the pressure drop across the individual chromium electroplating tank composite mesh-pad scrubber stages.

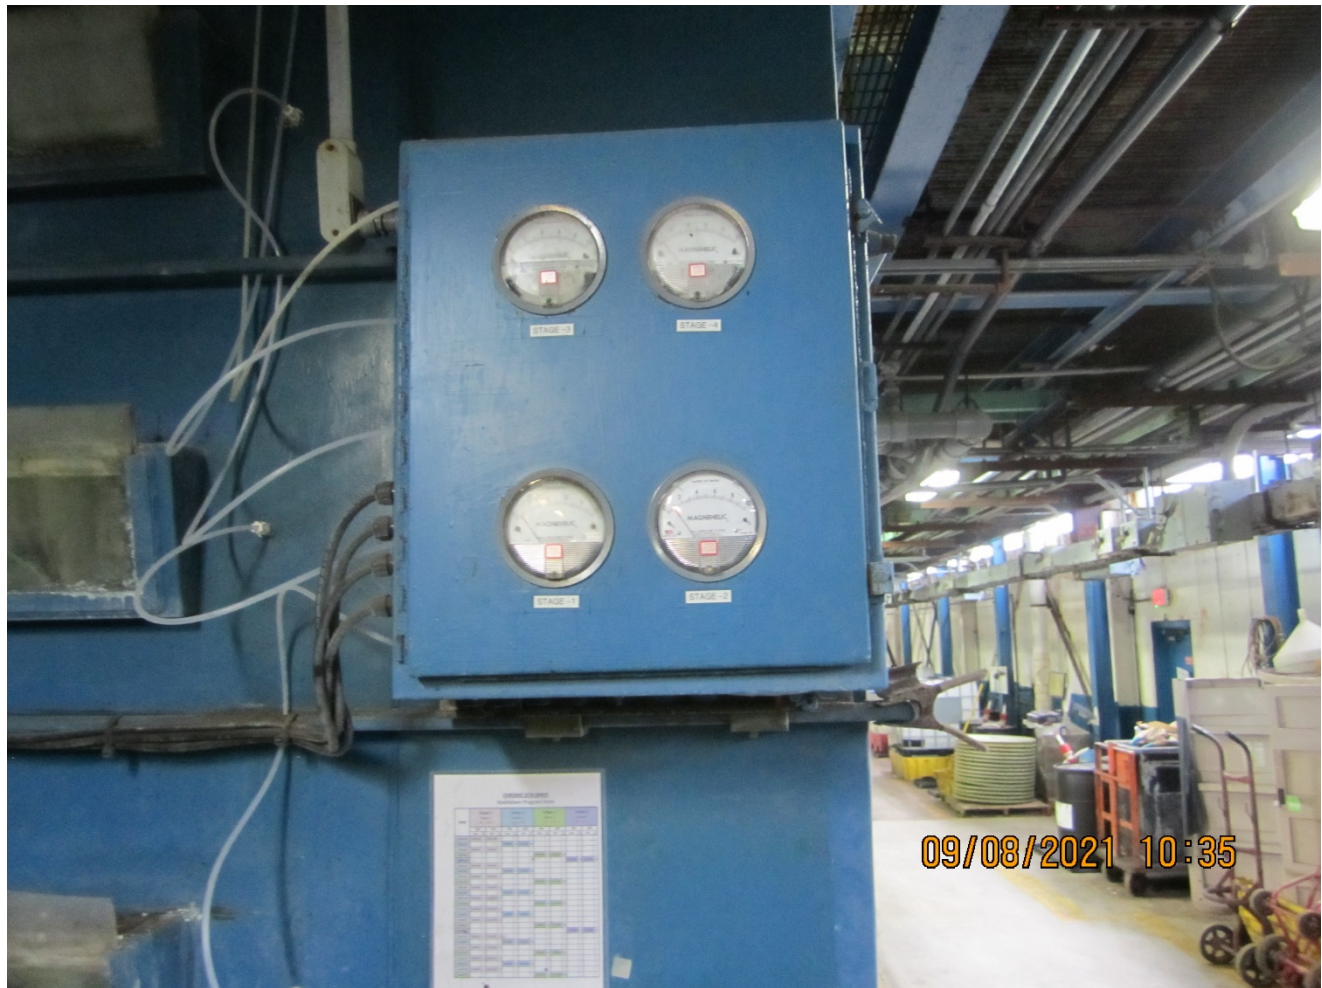
Facility Name and Location: MPC Plating, LLC 9921 Clinton Road, Brooklyn, Ohio	Photographed By: Mark Conti	Camera: Canon PowerShot SD1400 IS S/N 212065043406
Date and Time: 9/8/2021, 10:35 AM	File: MPC Plating IMG_0006	Photo No.: 6

Description: Magnehelic gauges indicate the pressure drop across the individual chromium electroplating tank composite mesh-pad scrubber stages.

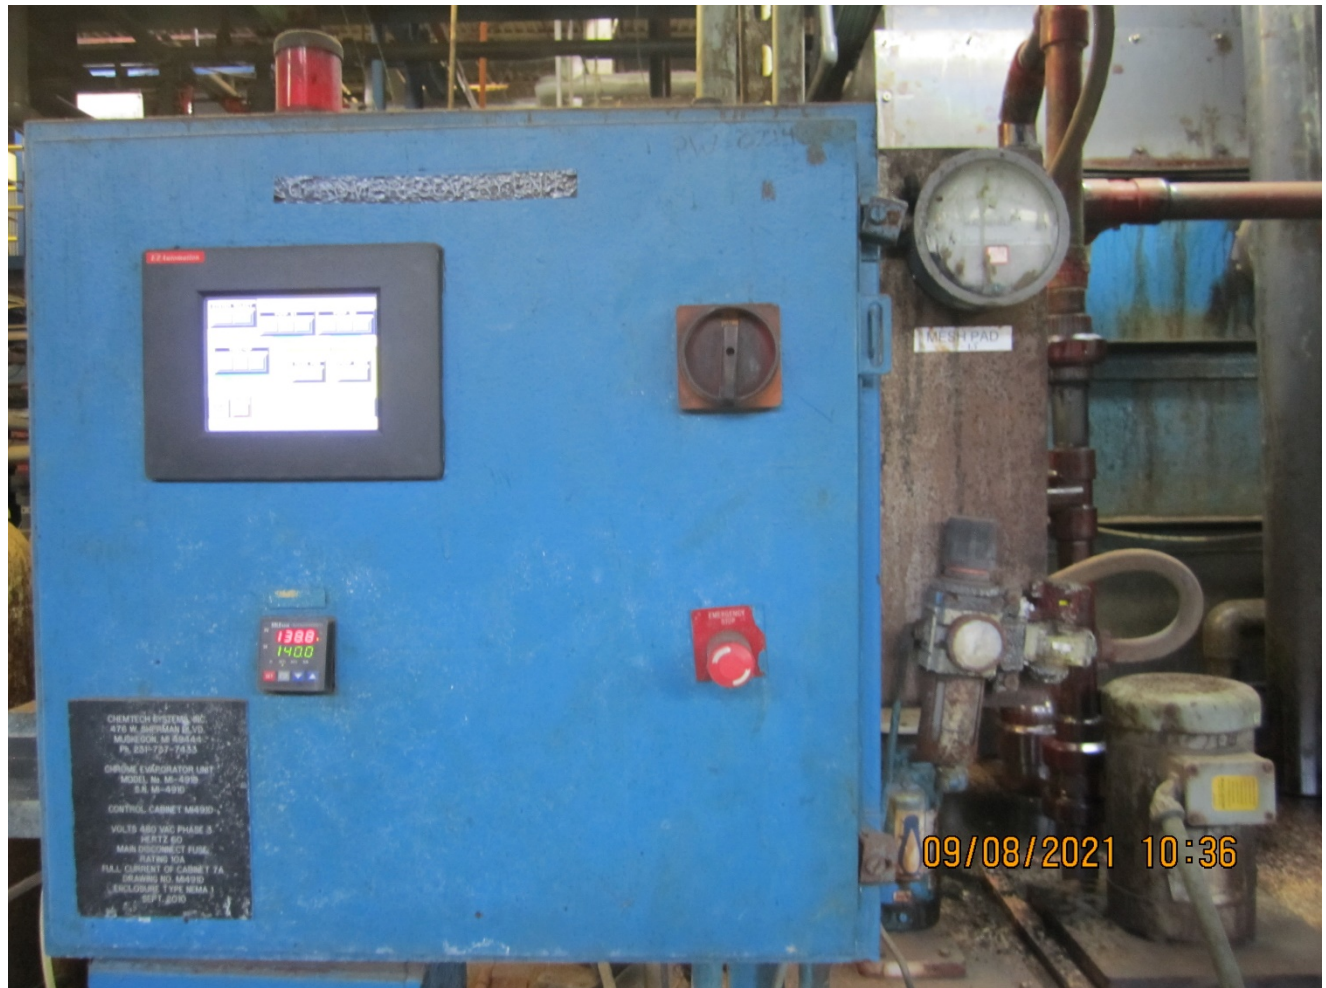
Facility Name and Location: MPC Plating, LLC 9921 Clinton Road, Brooklyn, Ohio	Photographed By: Mark Conti	Camera: Canon PowerShot SD1400 IS S/N 212065043406
Date and Time: 9/8/2021, 10:36 AM	File: MPC Plating IMG_0007	Photo No.: 7

Description: This is the Chemtrec Systems chrome evaporator unit. It has its own mesh-pad scrubber. Concentrated chromic acid solution is periodically returned to the chromium electroplating tank.

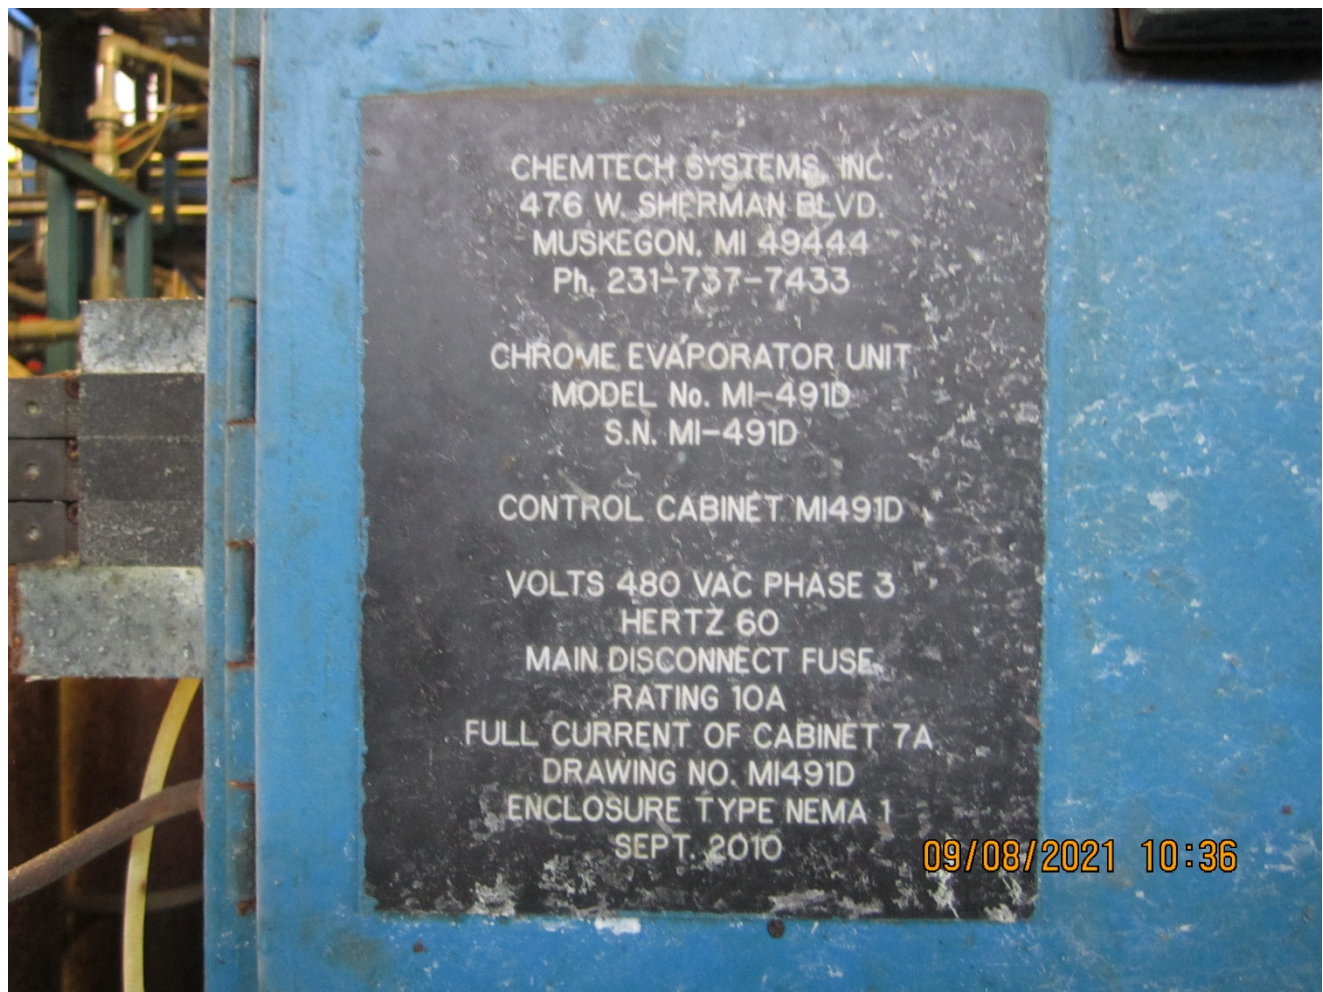
Facility Name and Location: MPC Plating, LLC 9921 Clinton Road, Brooklyn, Ohio	Photographed By: Mark Conti	Camera: Canon PowerShot SD1400 IS S/N 212065043406
Date and Time: 9/8/2021, 10:36 AM	File: MPC Plating IMG_0008	Photo No.: 8

Description: This is the nameplate on the Chemtrec Systems chrome evaporator unit.

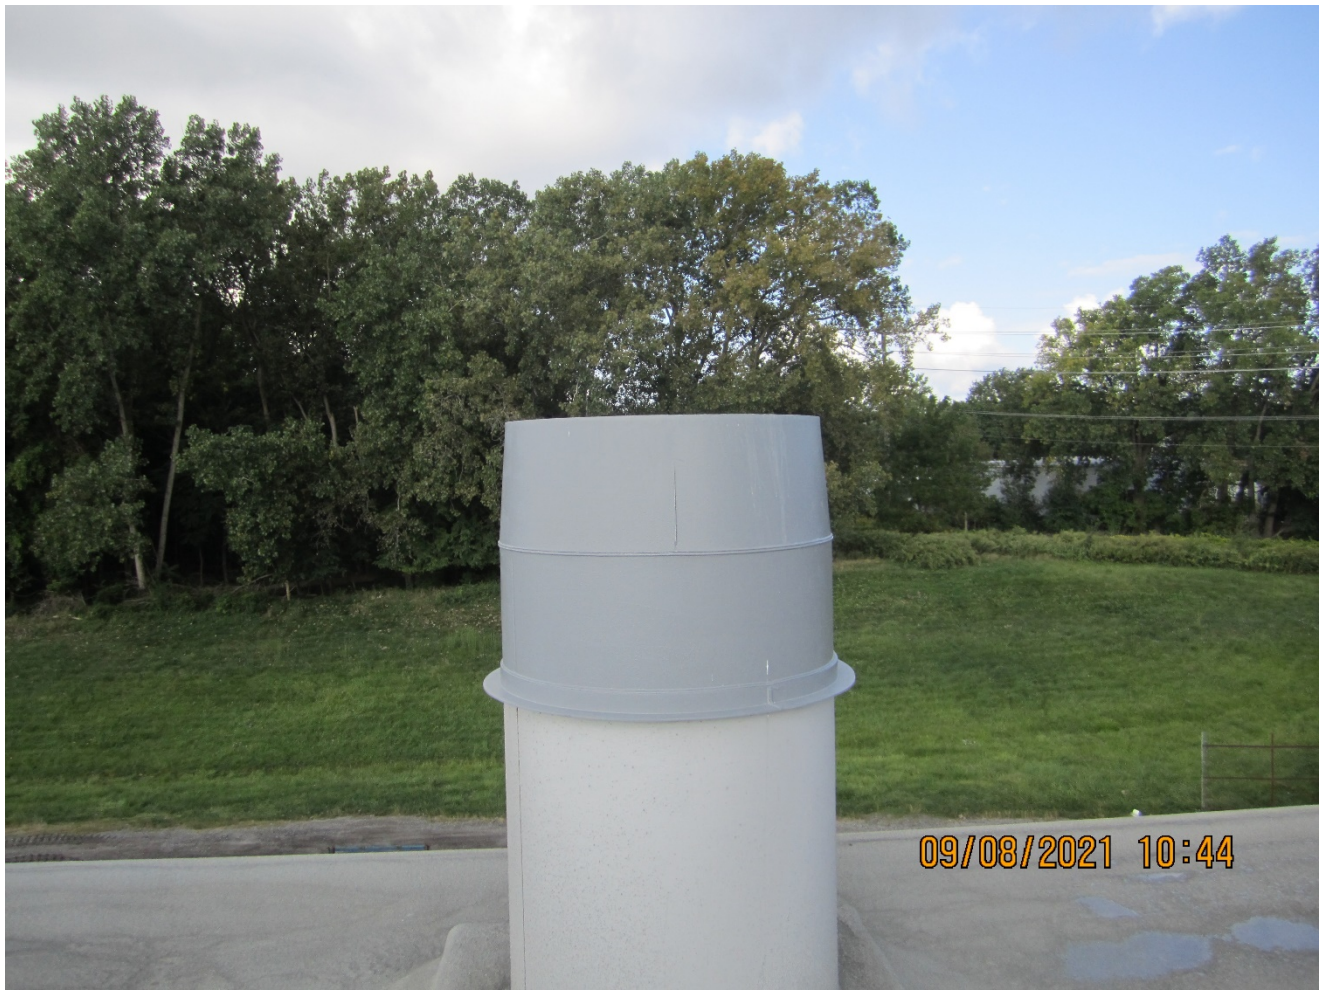
Facility Name and Location: MPC Plating, LLC 9921 Clinton Road, Brooklyn, Ohio	Photographed By: Mark Conti	Camera: Canon PowerShot SD1400 IS S/N 212065043406
Date and Time: 9/8/2021, 10:44 AM	File: MPC Plating IMG_0009	Photo No.: 9
Direction Taken: facing east		
Description: There were no visible emissions from the composite mesh-pad scrubber stack when I observed it.

- EPA permit P0111904, condition C.1.b.1.a. – There were no visible emissions from the composite mesh pad scrubber stack when I observed it. The stack is shown in photo #9.

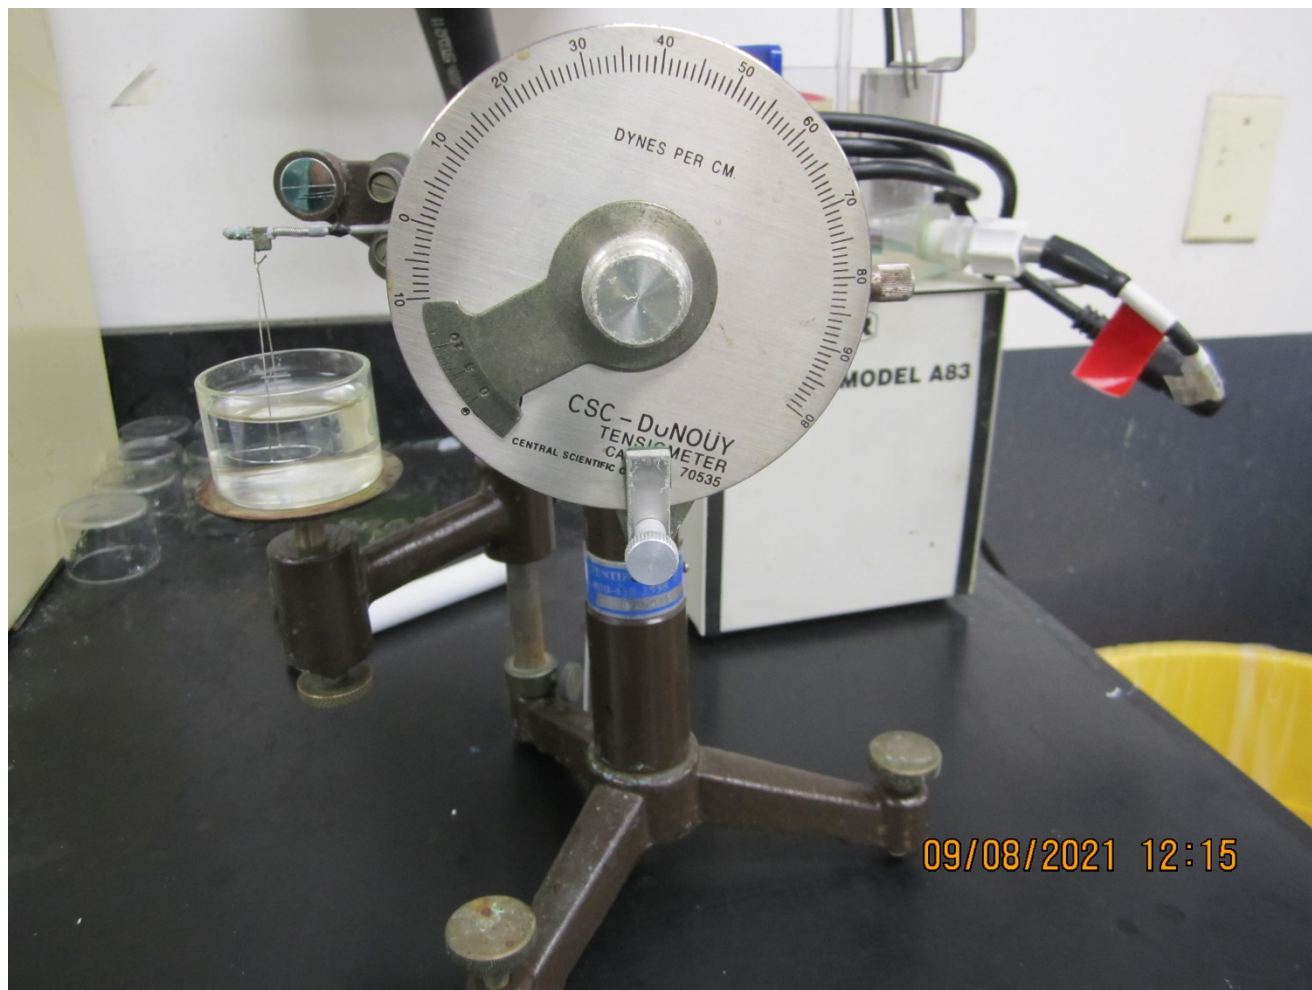
Facility Name and Location: MPC Plating, LLC 9921 Clinton Road, Brooklyn, Ohio	Photographed By: Mark Conti	Camera: Canon PowerShot SD1400 IS S/N 212065043406
Date and Time: 9/8/2021, 12:15 PM	File: MPC Plating IMG_0010	Photo No.: 10
Direction Taken: indoors		
Description: Surface tension measurements were taken with a CSC Scientific Company DuNouy Tensiometer No. 70535.

- Surface tension measurements are taken with a CSC Scientific Company DuNouy Tensiometer No. 70535 (see photo #10).
