## Clean Water Act Section 404: Site Visit/Case Development

| Site Name | Wedington Mine, LLC | | | | |

| Inspection Purpose | Initial site visit | | |

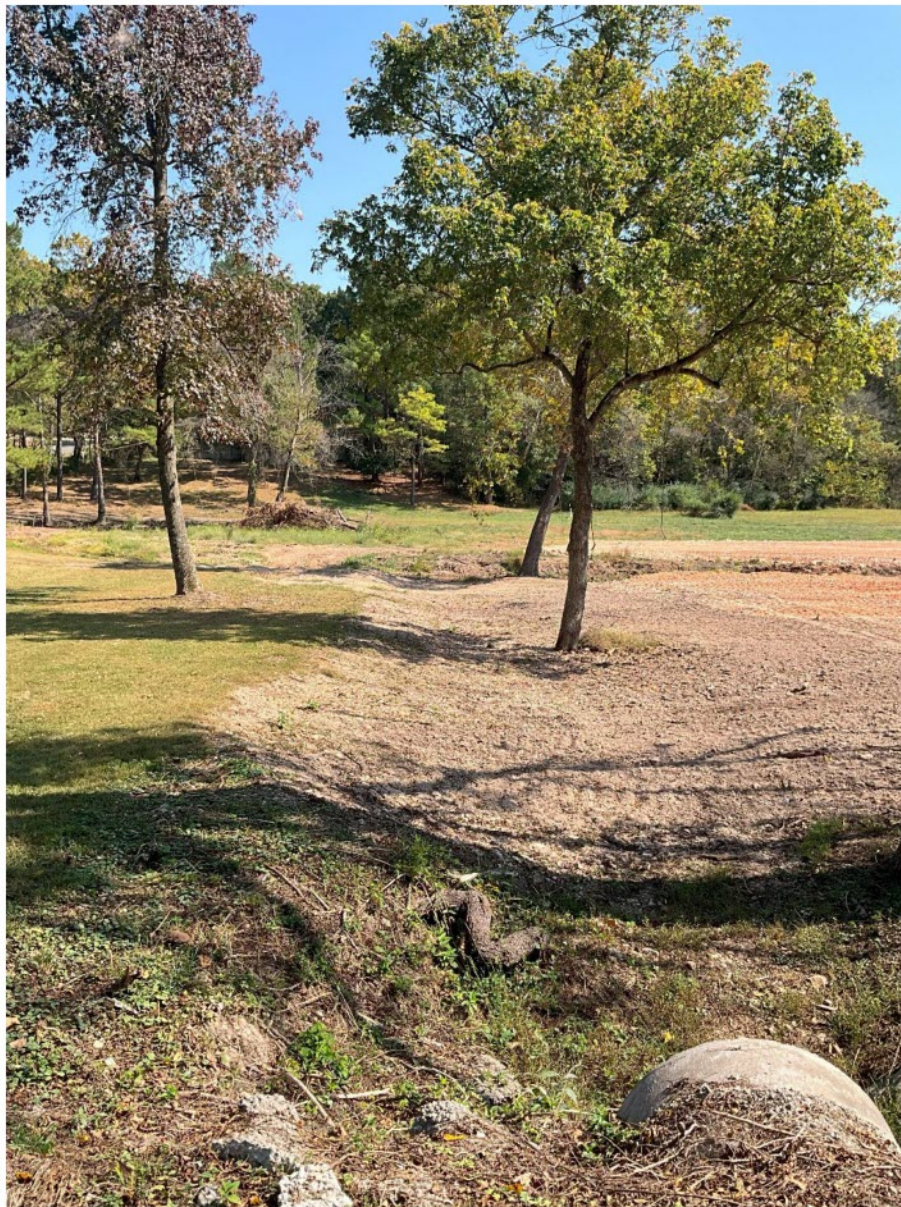
Photo No. 1

| Photo File Name | Date and Time of Photo | Photographer | Description |
|---|---|---|---|
| IMG_0045.JPG | 10/08/2024, 1:18 PM | Chelsey Sherwood | Showing site cleared and stream banks graded. Picture taken facing east. |

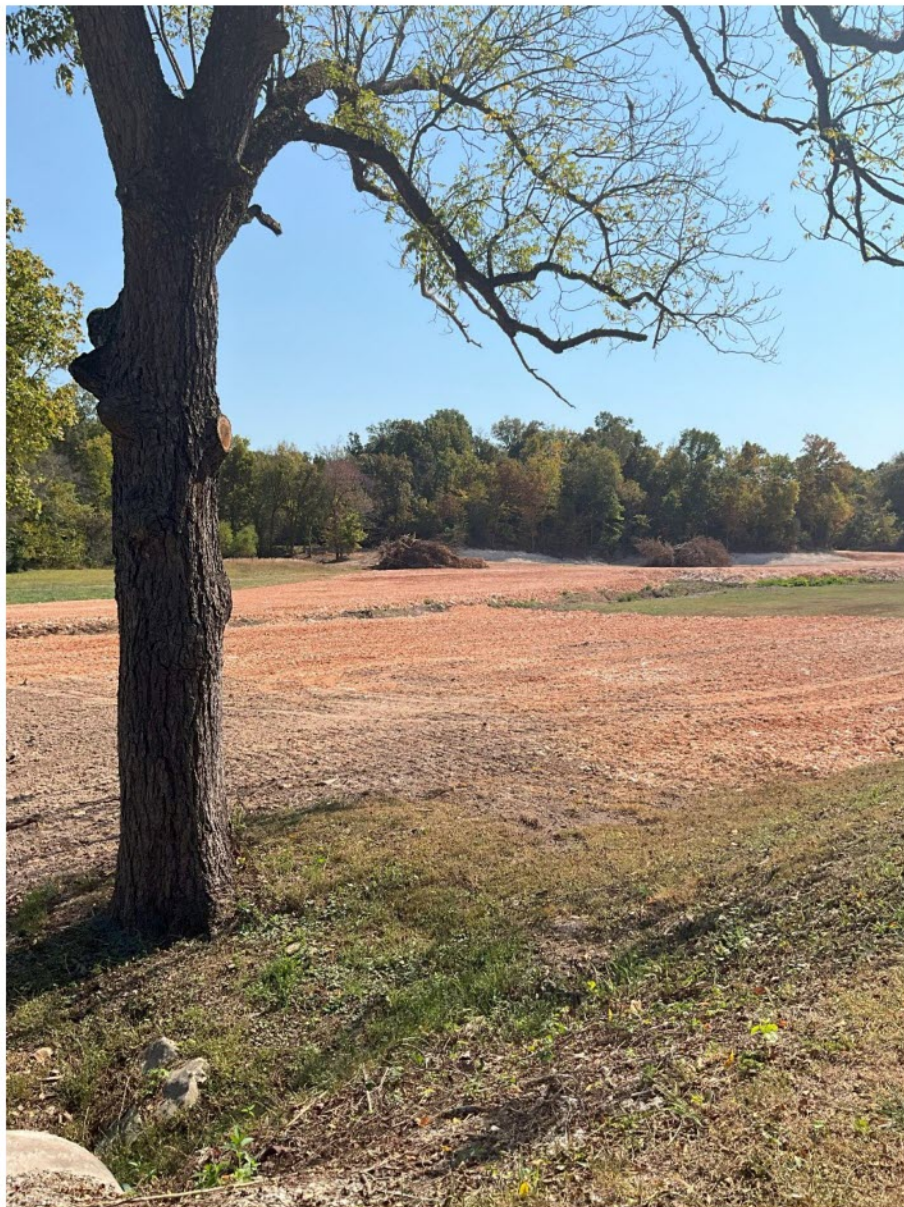
Photo No. 2

| Photo File Name | Date and Time of Photo | Photographer | Description |
|---|---|---|---|
| IMG_0046.JPG | 10/08/2024, 1:18 PM | Chelsey Sherwood | Showing site cleared and stream banks graded. Picture taken facing southeast. |

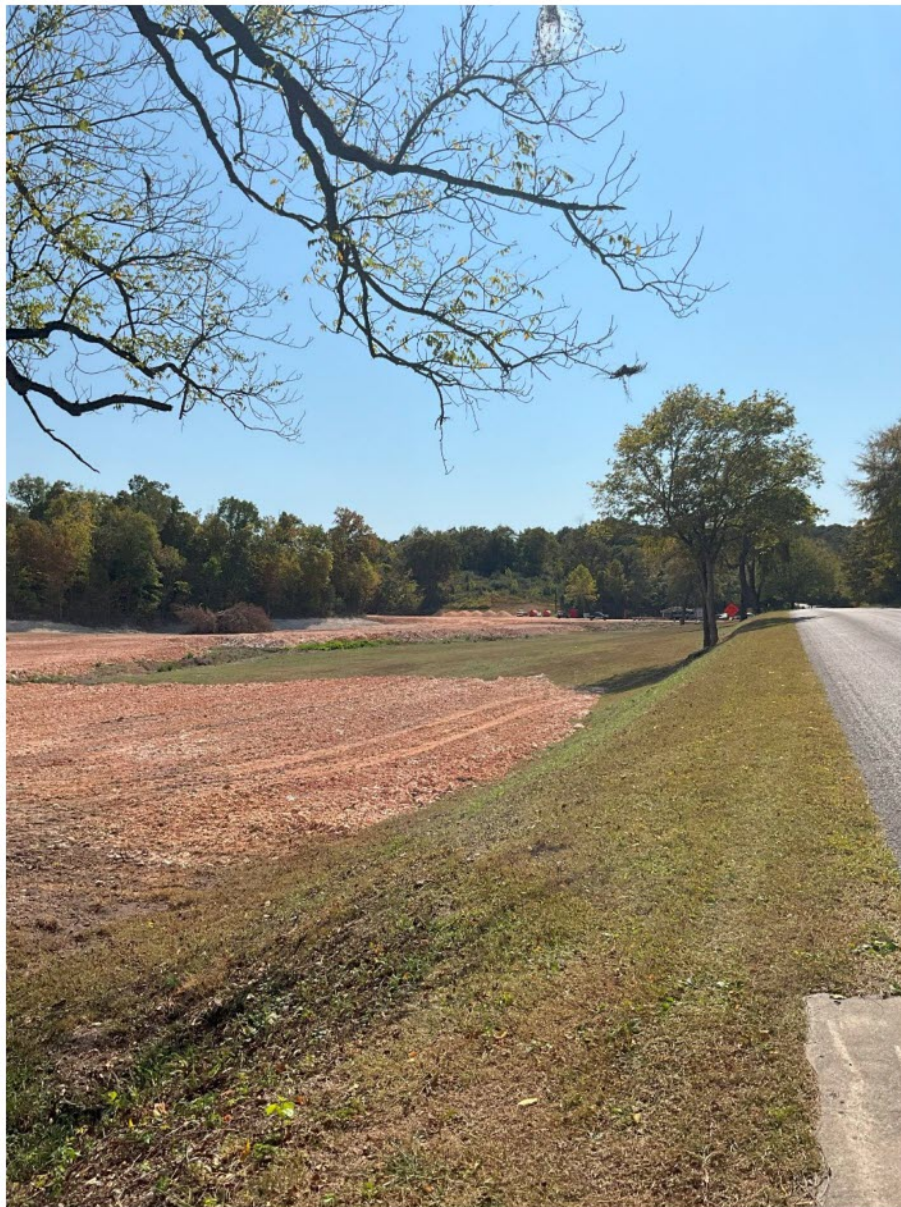
Photo No. 3

| Photo File Name | Date and Time of Photo | Photographer | Description |
|---|---|---|---|
| IMG_0047.JPG | 10/08/2024, 1:18 PM | Chelsey Sherwood | Showing site cleared and stream banks graded. Picture taken facing south. |

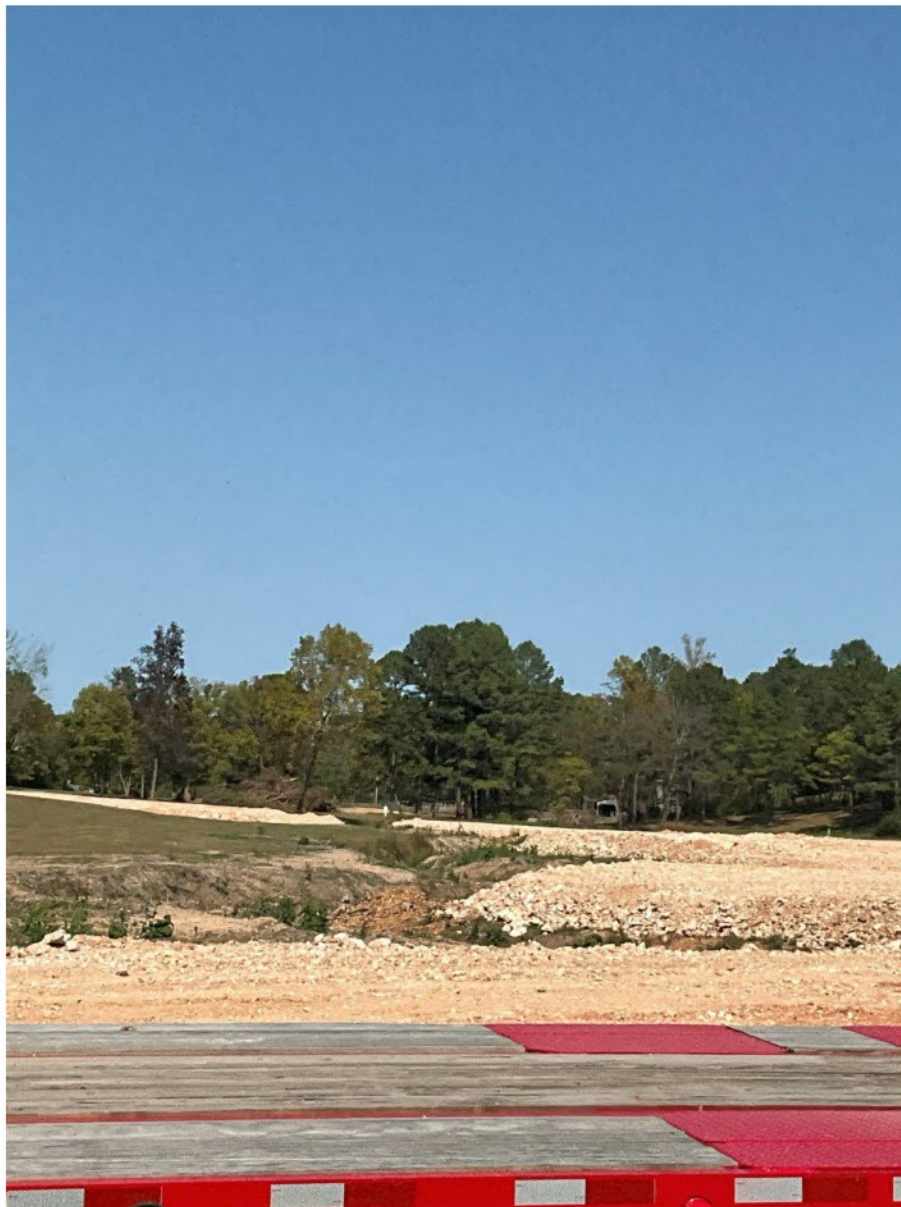
Photo No. 4

| According to the Corps, there was no Section 404 permit obtained for the discharge of fill material and work conducted below the Ordinary High Water Mark in the unnamed tributary to Hamestring Creek. The inspection was to assess potential impacts to Waters of the United States. This report will be sent to the Little Rock Corps District for evaluation and to determine if they will be referring this to EPA. Refer to photos and map attachments. | | | |

| Photo File Name | Date and Time of Photo | Photographer | Description |
|---|---|---|---|
| IMG_0048.JPG | 10/08/2024, 1:23 PM | Chelsey Sherwood | Showing fill below the Ordinary High Water Mark. Picture taken facing north. |

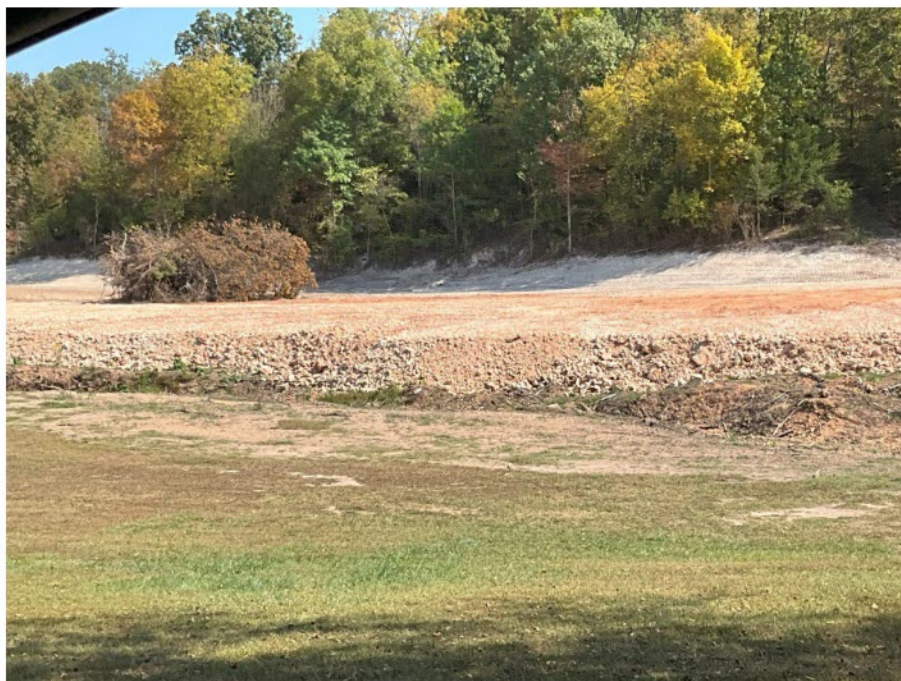
Photo No. 5

| Photo File Name | Date and Time of Photo | Photographer | Description |
|---|---|---|---|
| IMG_0049.JPG | 10/08/2024, 1:24 PM | Chelsey Sherwood | Showing fill below the Ordinary High Water Mark. Picture taken facing east. |
