# NPDES Compliance Inspection Report

## White River Fabrication

**NPDES Permit Tracking Number  
# WAU000668**

**Inspection Date: 05/12/2023**

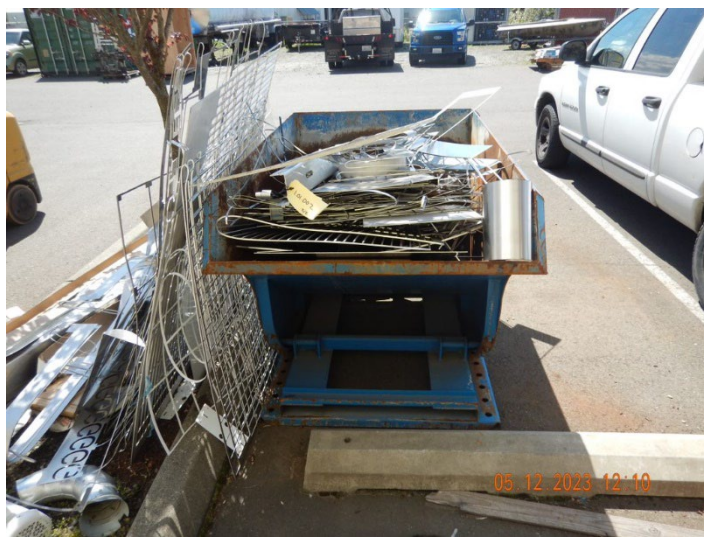
Photo #: 01 (DSCN0605)

We moved outside the main shop and walked through the outdoor area. Next to the shop, across from the main shop entrance, we saw an open blue metal bin holding scrap metal of various sizes and shapes (**Photo 1**). The bin did not appear to have a storm-resistant lid. We also saw additional metal materials stored on the ground. As we walked through the paved area we saw a wide variety of metal materials stored outside (**Photo 2**). We did see closed dumpsters holding municipal solid waste and cardboard recycling.

During the inspection I observed an approximately 6-foot-long open bin holding scrap metal without a lid (**Photo 1**).

Description: Facing south, photo of an open bin holding various scrap metal pieces, with additional materials on the ground next to it.

*Section S3.B.4.2.d of the Permit states: “keep all dumpsters under cover or fit with a storm-resistant lid that must remain closed when not in use.”*

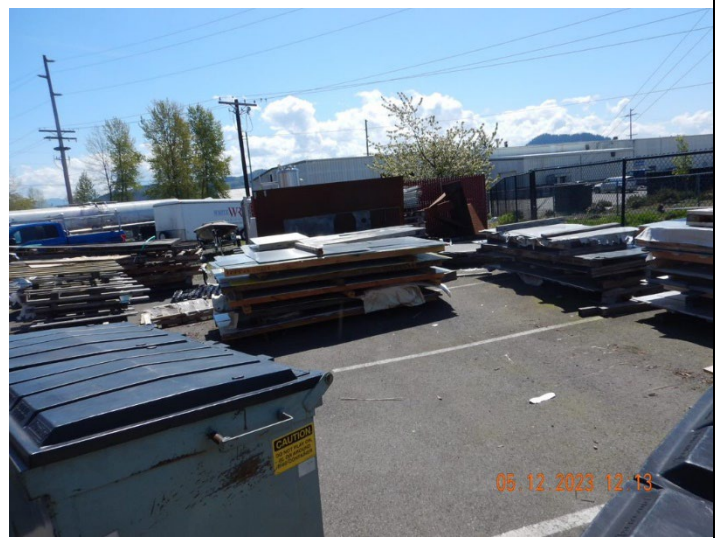
Photo #:02 (DSCN0606)

Description: Facing southeast, overview photo of product storage outside

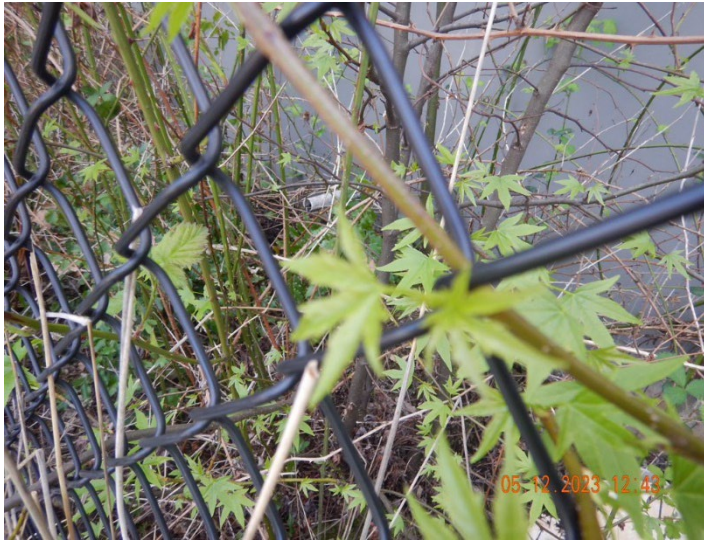
Photo #: 3 (DSCN0617)

Later, during an inspection of a neighboring facility, we saw a white pipe protruding from

the northern wall of the Facility (Photo 3). It appeared to be actively discharging water. At the time, I was unable to determine if the pipe discharged roof runoff, or some other source of water. We did not observe water used in the processes inside the Facility.

Description: The northern exterior of the Facility with a white pipe extruding. We observed water flowing out of the pipe.

Note, this photo was taken during a subsequent inspection of another facility.
