**UNITED STATES ENVIRONMENTAL PROTECTION AGENCY, REGION 2**  
**CARIBBEAN ENVIRONMENTAL PROTECTION DIVISION**  
**MULTIMEDIA PERMITS AND COMPLIANCE BRANCH**

**NPDES COMPLIANCE EVALUATION INSPECTION**

The Westin and Buoy Haus at Morning Star  
Frenchman's Reef Resort & Spa  
No. 5 Estate Bakkeroe, St. Thomas, USVI 00802  
Latitude: 18° 19' 14.47" N; Longitude: 64° 55' 20.09" W  
Telephone Number: 340-249-0123  
Web Page: [www.frenchmansreefstthomas.com](http://www.frenchmansreefstthomas.com)

Inspection Date: September 25, 2024

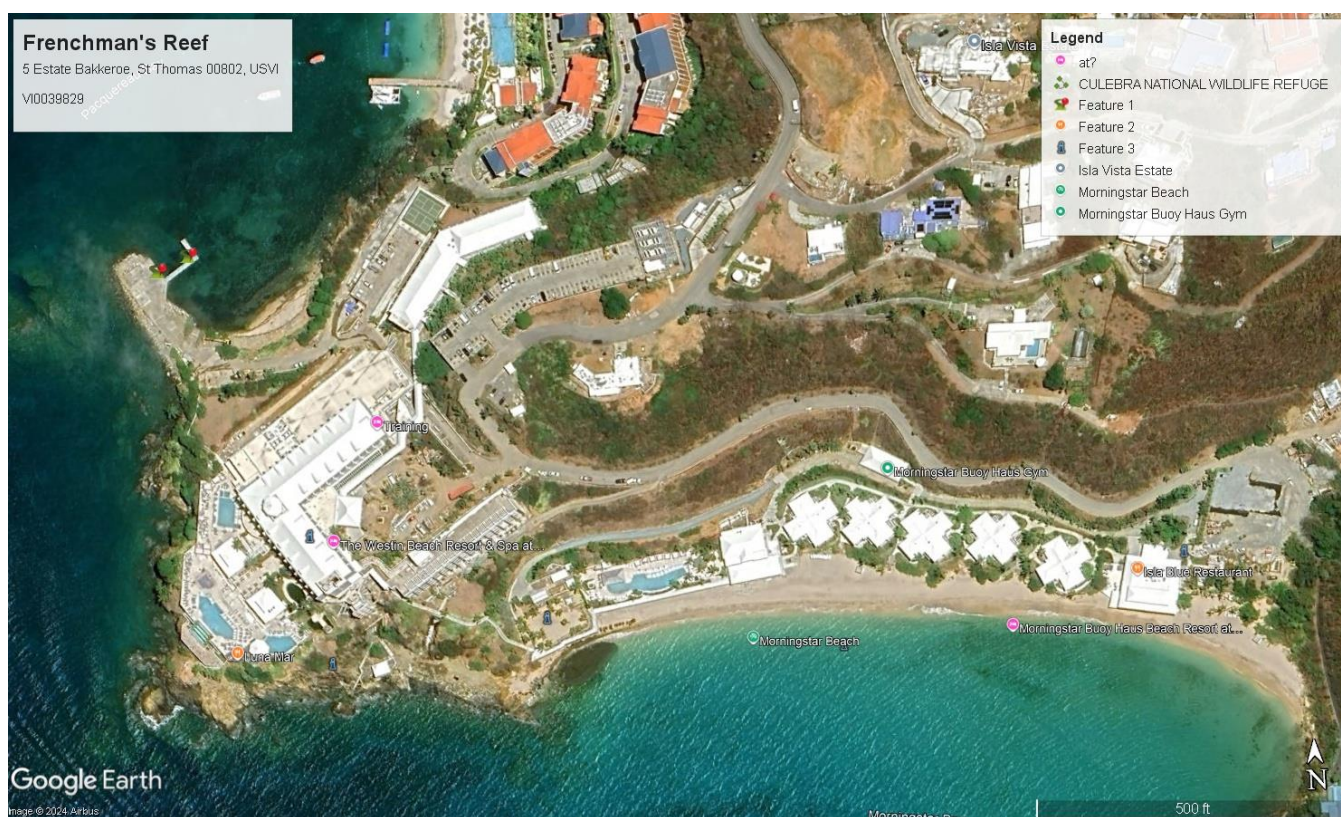
**Image 1 – Aerial photograph, featuring the Frenchman's Reef Compound<sup>5</sup>**

Since the passage of the 2017 major hurricanes, during which the USVI experienced severe impacts, the Facility which was heavily damaged underwent a complete renovation of its physical premises. Presently, Frenchman’s Reef is comprised of the Frenchman’s Reef Resort, and the Morning Star Beach Resort compounds, as previously referenced in Section 1 of this Report. The Facility features accommodations of 486 rooms, two (2) beaches, five (5) restaurants, four (4) pools, various gift shops, and many amenities typically associated with the Caribbean hospitality industry; including near-shore snorkel sites, and other marine recreational activities. Based on description of the business operations of Frenchman’s Reef, it is best characterized under the Standard Industrial Classification (SIC) Code 7000 (Hotels and Motels)<sup>3</sup>. An aerial photograph of the Facility is presented in **Image 1** (on page 6) of this Inspection Report.

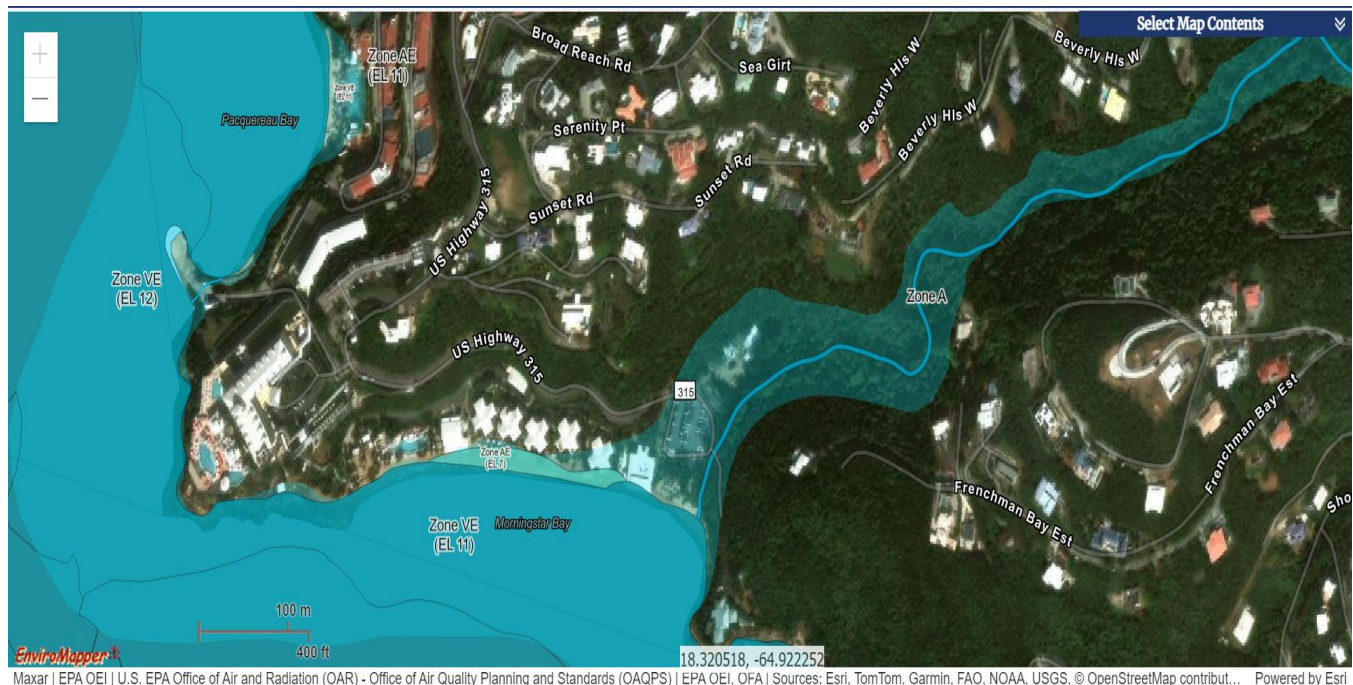
**Image 2 – Frenchman's Reef Resort Watershed**

The Facility is situated along a peninsular projecting into the Caribbean Sea that forms the south-central shoreline of St. Thomas and situated within the Frenchman's Bay watershed which drains into Morning Star Bay (Caribbean Sea). An aerial view of the location of the Facility and immediate surroundings are depicted in a satellite imagery of the referenced Watershed featured in **Image 2 (Frenchman's Reef Resort Watershed)**, below (Source: <https://nepassisttool.epa.gov/nepassist/nepamap.aspx>).
