## **RCRA Inspection Report**

Hager Companies  
150 Folmar Parkway  
Montgomery, Alabama 36105  
Montgomery County

EPA ID No.: ALD000608216

July 28, 2021, at 9:15 a.m.

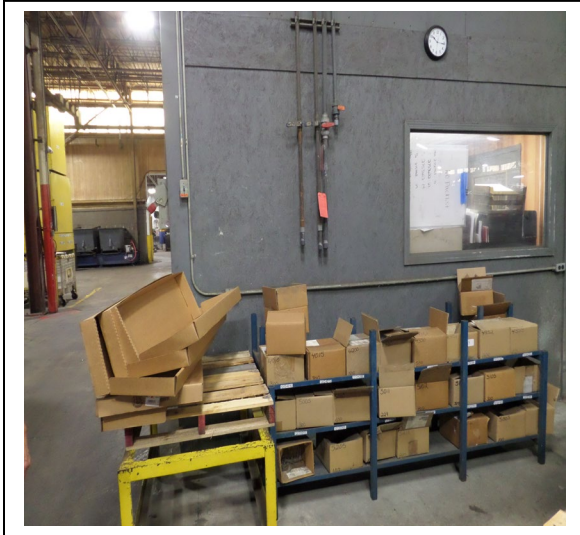
This area is used to package finished products and was formerly the trim and auxiliary area. The oxidizing operations that generated selenium waste noted during ADEM's May 20, 2020, inspection have been relocated next to the plating department. The inspectors did not observe hazardous waste accumulating in this area (Photograph 1).

Hager Companies, (Hager). Packaging Area  
The oxidizing operations (selenium waste) noted during ADEM's May 20, 2020, CEI have been relocated next to the Plating Department. Photograph 1 taken at 10:13 a.m.

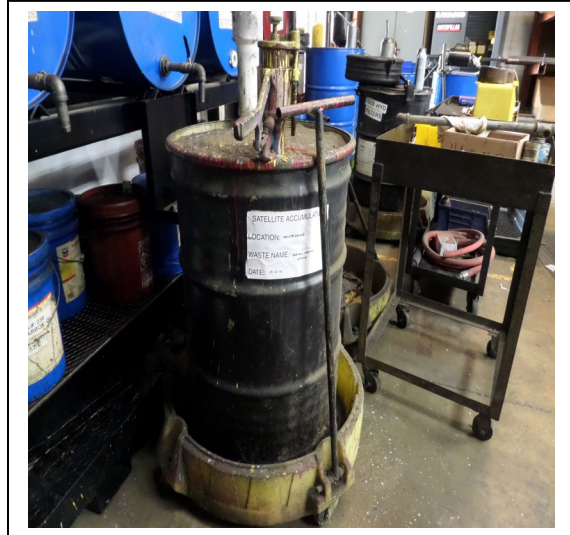
Equipment maintenance and repairs are completed in this area. Maintenance shop operations generate used oil and used oil filters. Waste aerosol cans generated throughout the facility are brought to the Maintenance Shop to be punctured so that the empty cans can be managed as scrap metal. Universal waste lamps and batteries are also collected and accumulated in this area. The inspectors observed one closed 55-gallon Satellite Accumulation Area (SAA) container with an aerosol can puncture unit inserted in the container's top opening. The container was not labeled or marked with the words "Hazardous Waste" and was not labeled or marked with an indication of the hazards of the contents (Photographs 2 and 3). Ms. Williamson marked the word "Flammable" on the container's hazardous waste label, prior to inspectors leaving this area. The inspectors observed one closed 55-gallon container of used oil with a funnel attached to the container's top opening. The used oil container was not labeled or marked with the words "Used Oil". The facility marked the container with the words used oil (Photograph 5). The inspectors also observed three cardboard boxes marked "Universal Waste Lamps", one 5-gallon plastic container marked "Universal Waste–Used Ballasts", one 5-gallon plastic container marked "Universal Waste–Used Lead Acid Batteries", and one 3-gallon plastic container marked "Universal Waste–Used Dry Cell Batteries". The containers of universal waste were closed, labeled, and dated (Photograph 4).

Hager. Maintenance Shop. Inspectors observed a 55-gallon SAA container not labeled/marked as hazardous waste and no hazard indicator. Photograph 2 taken at 10:24 a.m.

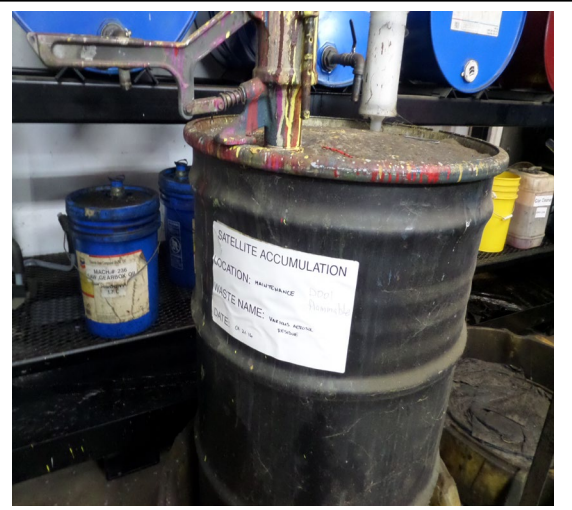
Hager. Maintenance Shop. Inspectors observed a 55-gallon SAA container not labeled/marked as hazardous waste and no hazard indicator. Photograph 3 taken at 10:24 a.m.

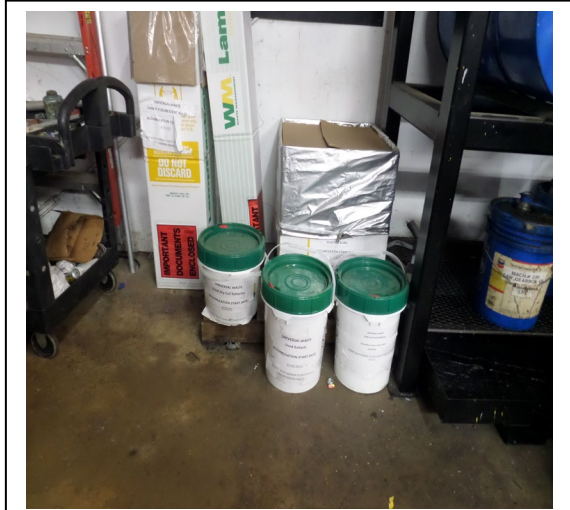
Hager. Maintenance Shop. Inspectors observed several containers accumulating spent lamps and spent batteries. Managed as universal waste. Photograph 4 taken at 10:26 a.m.

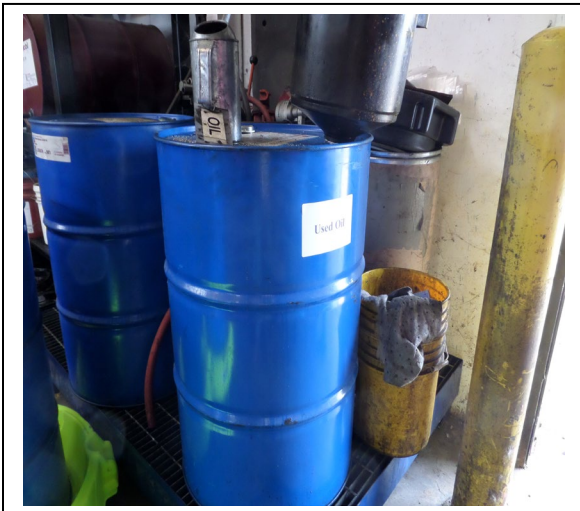
**Pursuant to ADEM Admin. Code r. 335-14-17-.03(4)(c)(1), [40 C.F.R. § 279.22(c)(1)]. Containers and above-ground tanks used to store used oil at generator facilities must be labeled or marked clearly with the words “Used Oil.”**

Hager. Maintenance Shop. Inspectors observed a 55-gallon container not labeled/marked as used oil. The facility labeled the container used oil. Photograph 5 taken at 10:27 a.m.

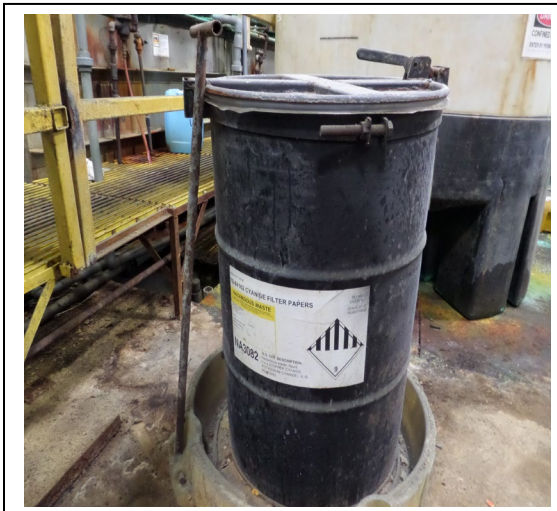
Three plating lines provide bright nickel, bright chrome, or dull chrome finishes. The plating lines generate waste from the rinse baths, spent nitric acid, and spent filter paper (hazardous and non-hazardous). The clean out operation from the plating lines also generate sludges. Spent plating baths and spills are removed from this area via an inline pipe system to the facility's WWTS. The inspectors observed three 55-gallon SAA containers in this area accumulating hazardous waste, one for each plating line. The inspectors observed all were closed, labeled with the words “Hazardous Waste”, and staged on a spill catch roller or a secondary containment pallet. The inspectors observed one 55-gallon SAA container accumulating waste copper and potassium cyanide filter papers (F008). The container was closed, labeled with the words “Hazardous Waste”, and labeled with a DOT Class 9 (miscellaneous hazardous materials)

pictogram to indicate the hazard of the contents (Photograph 6). The inspectors observed the container appeared not labeled or marked with an indication of the hazard of the contents.

**Pursuant to ADEM Admin. Code r. 335-14-3-.01(5)(a)5.(ii), [40 C.F.R. § 262.15(a)(5)(ii)], which is a condition of the SAA Permit Exemption, a generator is required to mark or label its containers with an indication of the hazards of the contents (examples include, but are not limited to, the applicable hazardous waste characteristic(s) (i.e., ignitable, corrosive, reactive, toxic); hazard communication consistent with the Department of Transportation requirements at 49 CFR part 172 subpart E (labeling) or subpart F (placarding); a hazard statement or pictogram consistent with the Occupational Safety and Health Administration Hazard Communication Standard at 29 CFR 1910.1200; or a chemical hazard label consistent with the National Fire Protection Association code 704).**

Hager. Plating Department – Line 505  
Inspectors observed a DOT Class 9 (miscellaneous hazardous materials) pictogram on the 55-gallon SAA container. The inspectors observed the container appeared not labeled or marked with an indication of the hazard of the contents. Photograph 6 taken at 10:36 a.m.

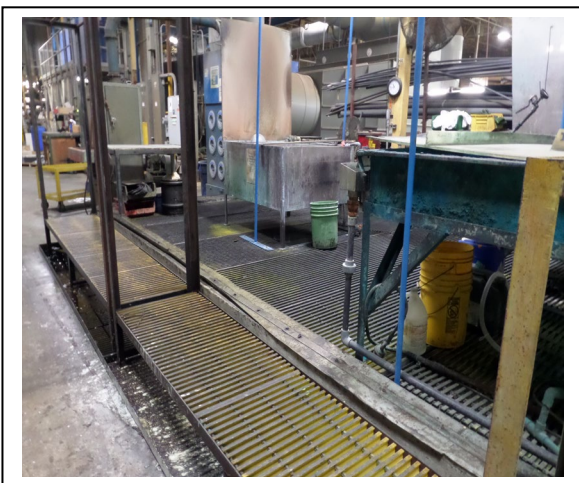
Steel and brass parts such as hinges, lock plates, and pull handles are degreased then sent through the oxidizer station before they are plated. The oxidizer station dips parts in a selenium bath to ensure the plating metal will bond tightly to the base metal. The inspectors observed the 100-gallon capacity selenium process tank was staged on a grated metal platform over a secondary containment system to capture any spills from the process tank. Ms. Williamson indicated waste selenium accumulated in the secondary containment system is removed weekly through an inline pipe system to the facility's WWTS (Photograph 7). Hazardous waste selenium sludge (D010) and spent wipes saturated with selenium (D010) are generated in this area. The inspectors observed one closed 55-gallon SAA container accumulating selenium sludge labeled with the words “Hazardous Waste” and staged on a spill-catch roller. The inspectors observed the container was labeled with a DOT Class 9 (miscellaneous hazardous materials) pictogram. The inspectors observed the container appeared not labeled or marked with an indication of the hazard of the contents (Photographs 8 and 9). Ms. Williamson marked the word “Toxic” on the container's hazardous waste label, prior to inspectors leaving this area. Inspectors also observed one empty 55-gallon SAA container to accumulate waste selenium wipes. The container was closed, labeled with the words “Hazardous Waste”, and labeled with a flammable and toxic indication of the hazard of the contents.

Hager. Oxidizing Line. The inspectors observed the 100-gallon capacity selenium process tank in this area. Photograph 7 taken at 10:42 a.m.

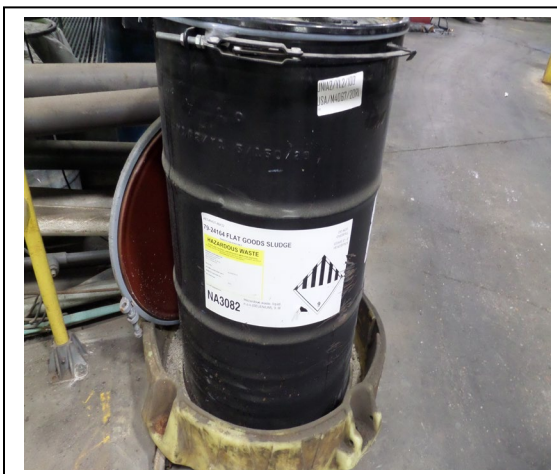
**Pursuant to ADEM Admin. Code r. 335-14-3-.01(5)(a)5.(ii), [40 C.F.R. § 262.15(a)(5)(ii)], which is a condition of the SAA Permit Exemption, a generator is required to mark or label its containers with an indication of the hazards of the contents (examples include, but are not limited to, the applicable hazardous waste characteristic(s) (i.e., ignitable, corrosive, reactive, toxic); hazard communication consistent with the Department of Transportation requirements at 49 CFR part 172 subpart E (labeling) or subpart F (placarding); a hazard statement or pictogram consistent with the Occupational Safety and Health Administration Hazard Communication Standard at 29 CFR 1910.1200; or a chemical hazard label consistent with the National Fire Protection Association code 704).**

Hager. Oxidizing Line. Inspectors observed a DOT Class 9 (miscellaneous hazardous materials) pictogram on the 55-gallon SAA container. The inspectors observed the container appeared not labeled or marked with an indication of the hazard of the contents. Photograph 8 taken at 10:45 a.m.

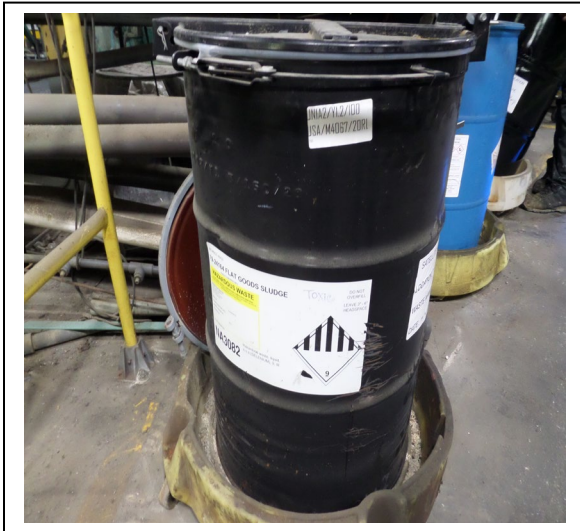
Hager. Oxidizing Line. Inspectors observed a DOT Class 9 (miscellaneous hazardous materials) pictogram on the 55-gallon SAA container. The inspectors observed the container appeared not labeled or marked with an indication of the hazard of the contents. Photograph 9 taken at 10:45 a.m.

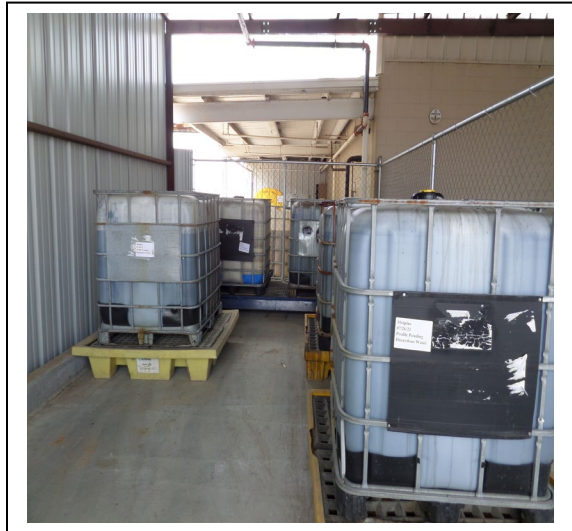
Accumulation Area (90-Day) is constructed with metal walls, a metal roof, over a concrete pad, a sloped concrete ramp, and secured by a chain-link fence and locked gate. A concrete berm is constructed along the perimeter of the concrete pad. The inspectors observed Danger signs posted on the chain-link fence and gate (Photograph 11). Waste acid and waste alkaline are accumulated in separate bays and separated by a chain link fence to ensure they remain segregated. The inspectors observed five 275-gallon totes accumulating waste alkaline (“Molplus”) in the 90-Day. The totes were closed, in good condition, with aisle space, labeled with the words “Hazardous Waste” and “Profile Pending”, and the oldest date marked on the totes was July 26, 2021. Ms. Williamson indicated that the totes were from a new process at the facility and that samples had been sent for analysis and the hazard indication was pending a determination (Photograph 10). The inspectors observed at the time of inspection, no hazardous waste was accumulating in the acid bay.

Hager. Acid and Alkaline Hazardous Waste Storage Area – 90-Day. Inspector observed five 275-gallon totes, closed, labeled with the words hazardous waste, pending analysis. Photograph 10 taken at 10:52 a.m.

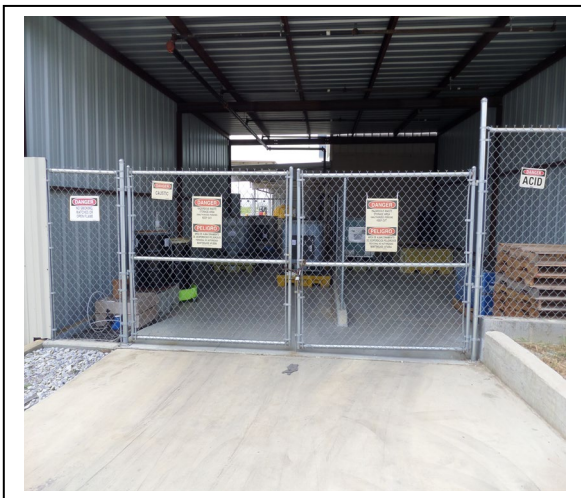
Acid and alkaline hazardous waste is managed in a 972 square foot hazardous waste storage building located at the southeast end of the facility next to the WWTS. The 90-Day or Less

Hager. Acid and Alkaline Hazardous Waste Storage Area – 90-Day. Front view of 90-Day. Photograph 11 taken at 11:01 a.m.

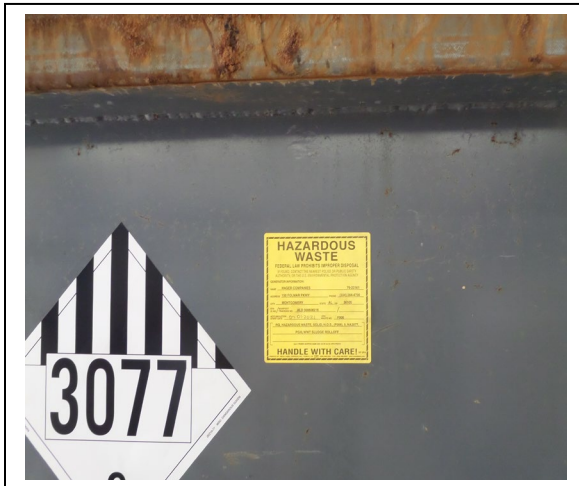
2021 (Photograph 12). The inspectors observed the 20-cubic yard container was labeled with a DOT Class 9 (miscellaneous hazardous materials) pictogram. The inspectors observed the container appeared not labeled or marked with an indication of the hazard of the contents. Ms. Williamson marked the word “Toxicity” on the container’s hazardous waste label, prior to inspectors leaving this area (Photographs 13 and 14).

**Pursuant to ADEM Admin. Code r. 335-14-3-.01(5)(a)5.(ii), [40 C.F.R. § 262.15(a)(5)(ii)], which is a condition of the SAA Permit Exemption, a generator is required to mark or label its containers with an indication of the hazards of the contents (examples include, but are not limited to, the applicable hazardous waste characteristic(s) (i.e., ignitable, corrosive, reactive, toxic); hazard communication consistent with the Department of Transportation requirements at 49 CFR part 172 subpart E (labeling) or subpart F (placarding); a hazard statement or pictogram consistent with the Occupational Safety and Health Administration Hazard Communication Standard at 29 CFR 1910.1200; or a chemical hazard label consistent with the National Fire Protection Association code 704).**

Hager. WWTS Filter Press. Inspectors observed a DOT Class 9 (miscellaneous hazardous materials) pictogram on the container under the filter press. The inspectors observed the container appeared not labeled or marked with an indication of the hazard of the contents. Photograph 13 taken at 11:09 a.m.

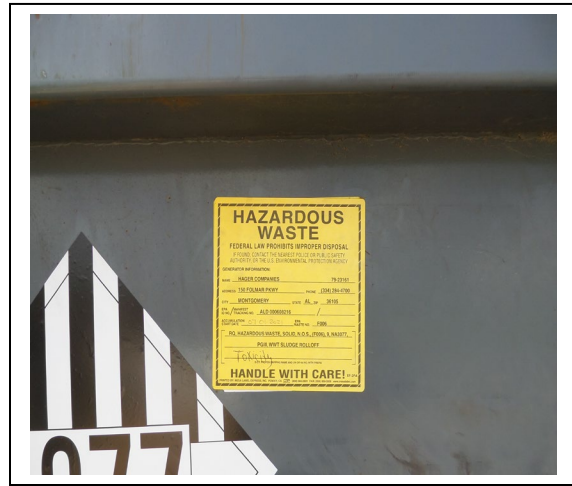
Hager. WWTS Filter Press. The facility marked the container's label with the word "Toxicity" indicating the hazard of the contents. Photograph 14 taken at 11:09 a.m.

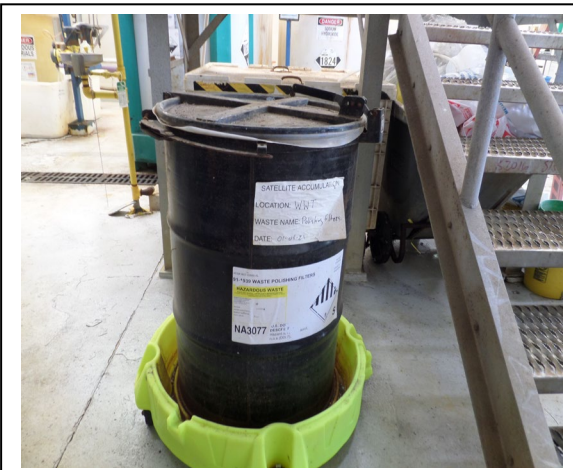
Hager operates an on-site wastewater treatment system (WWTS) to treat wastewater generated from plating and anodizing processes. The WWTS is in its own building at the southeast end of the facility. The wastewater is pumped directly from the process tanks using the in-line piping system and transferred to the WWTS using 250-gallon totes. Two large tanks are staged directly behind the building for the treatment of wastewater. The treated wastewater is discharged to the Catoma Creek Wastewater Treatment Plant. The facility currently has a State Industrial Discharge Permit (IU375100071) that was issued on July 28, 2020 and is scheduled to expire on July 31, 2025. The WWTS has a recessed floor with grated drains covering all entrances. The drains are connected to a pump system that feeds back to the WWTS. Warning signs with “Hazardous Waste”, “Notice: Authorized Personnel Only”, and several placards indicating the types of hazards were posted at each entrance. The inspectors observed one 55-gallon SAA container in this area accumulating waste polishing filters (D007). The container was closed, labeled with the words “Hazardous Waste”, and staged on a spill catch roll. The inspectors observed the container was labeled with a DOT Class 9 (miscellaneous hazardous materials) pictogram. The inspectors observed the container was not labeled or marked with an indication of the hazard of the contents. Ms. Williamson marked the word “Toxic” on the container’s hazardous waste label, prior to inspectors leaving this area (Photograph 15).

**Pursuant to ADEM Admin. Code r. 335-14-3-.01(5)(a)5.(ii), [40 C.F.R. § 262.15(a)(5)(ii)], which is a condition of the SAA Permit Exemption, a generator is required to mark or label its containers with an indication of the hazards of the contents (examples include, but are not limited to, the applicable hazardous waste characteristic(s) (i.e., ignitable, corrosive, reactive, toxic); hazard communication consistent with the Department of Transportation requirements at 49 CFR part 172 subpart E (labeling) or subpart F (placarding); a hazard statement or pictogram consistent with the Occupational Safety and Health Administration Hazard Communication Standard at 29 CFR 1910.1200; or a chemical hazard label consistent with the National Fire Protection Association code 704).**

Hager. WWTS Filter Press. Inspectors observed a DOT Class 9 (miscellaneous hazardous materials) pictogram on the 55-gallon SAA container. The inspectors observed the container appeared not labeled or marked with an indication of the hazard of the contents. Photograph 15 taken at 11:09 a.m.
