## **RCRA Inspection Report**

Lockheed Martin Space Company (LMS)  
5100 Standy Road  
Stennis Space Center, Mississippi 39529

February 24, 2021

**COMPLIANCE EVALUATION Inspection**

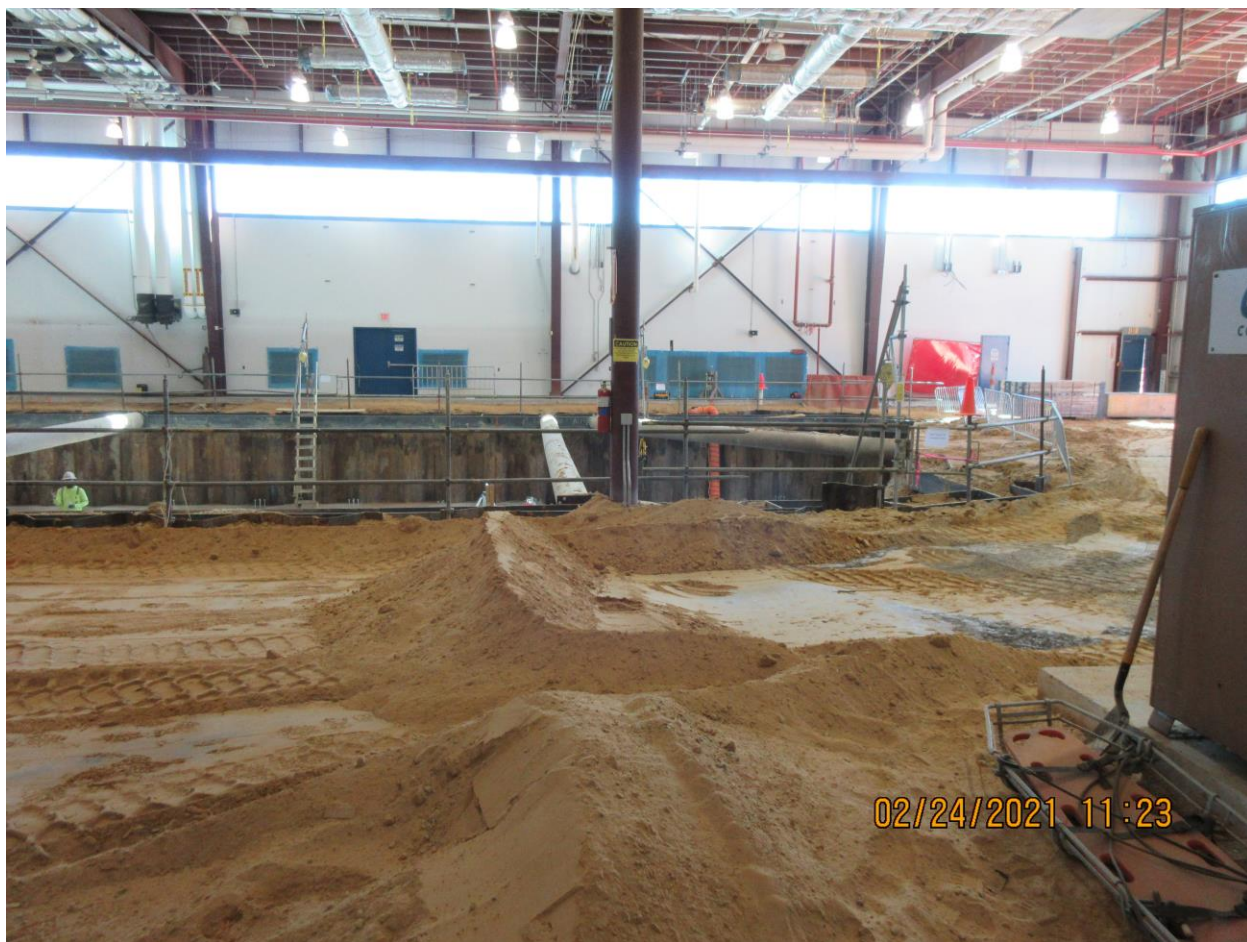
Photo 1 – New Electroplating Area

This area is was also currently under new construction (Photos 1 & 2) and will be used for the future for electroplating and possible chemical conversion coating of various parts. No hazardous wastes were observed in this area at the time of the inspection. After the CEI, a phone meeting was conducted on March 4, 2021, between representatives of EPA, MDEQ, LMS and the operator of the Stennis Space Center wastewater treatment plant.

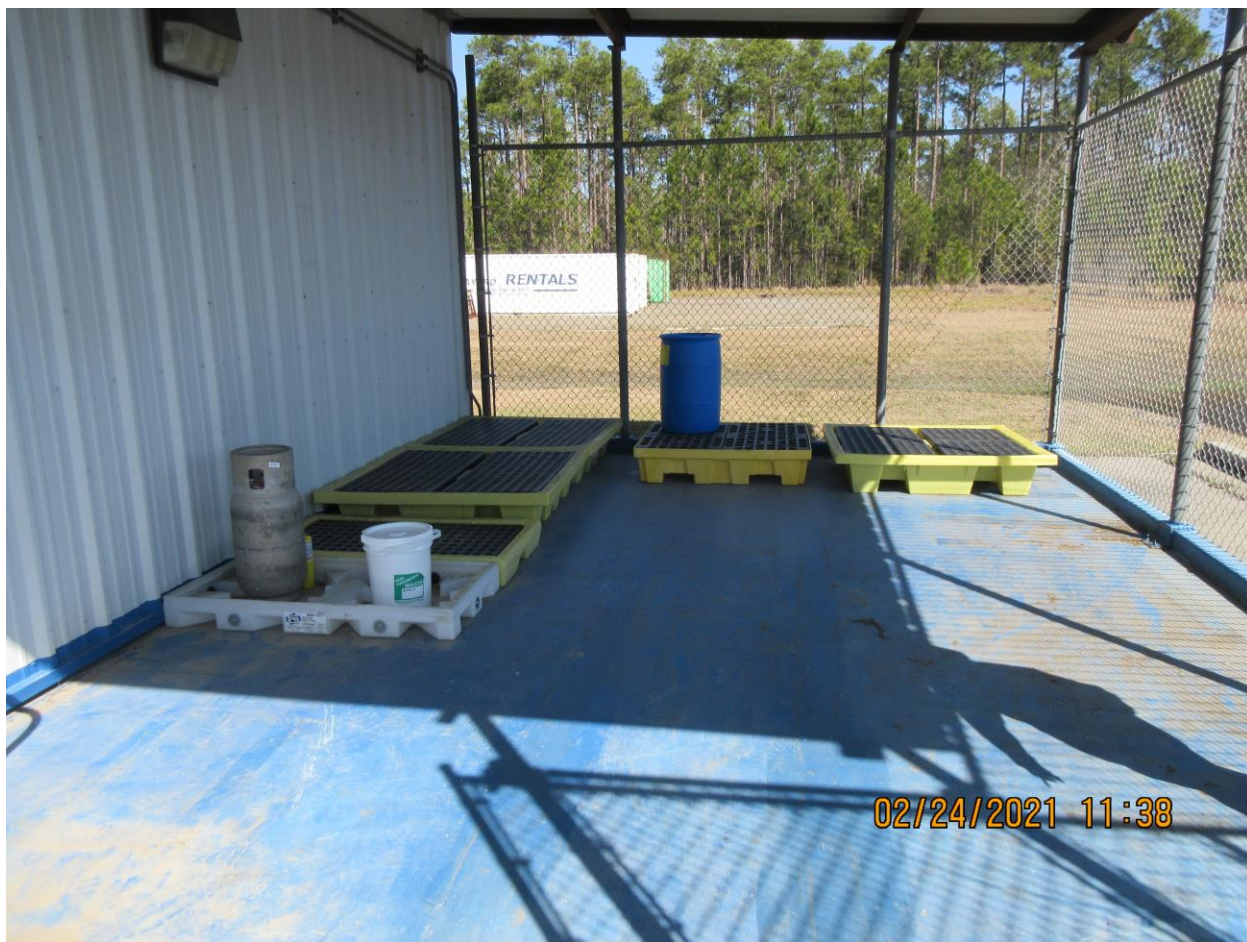
Photo 3 – Hazardous Waste Accumulation Area

This area consisted of a fenced cage on top of a bermed concrete pad beneath a metal roof (Photo 3).

this area at the time of the inspection. The container was closed, marked with the words “Hazardous Waste,” an accumulation start date (2/22/2021) and an indication of the hazard of the contents. One 5-gallon container of nonhazardous alkaline batteries were also observed in this area. The area was equipped with a fire extinguisher and spill equipment at the time of the inspection.

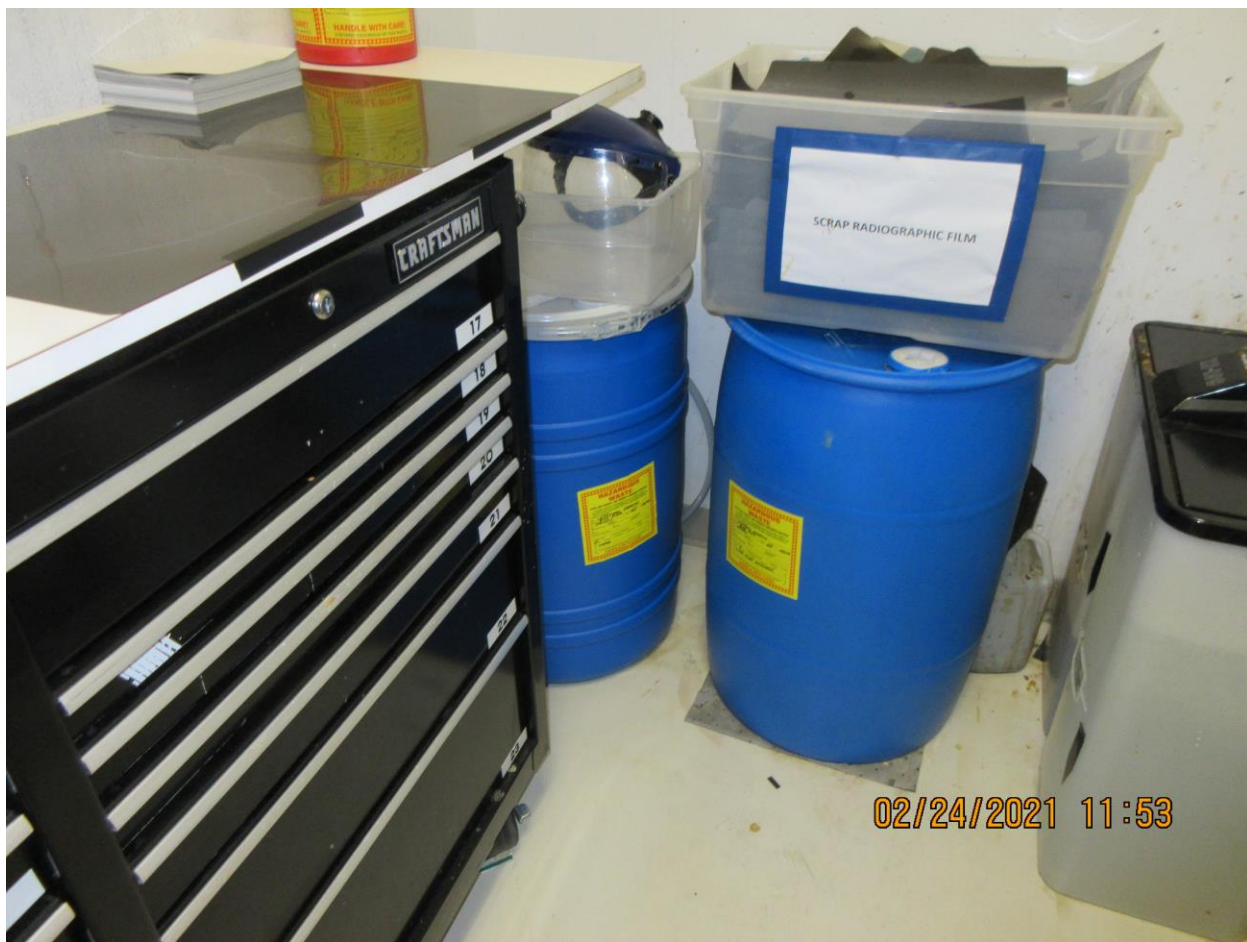
Photo 5 – X-ray Dark Room

This area is used for the X-ray of parts for quality control. Two 30-gallon containers (Photo 5) of hazardous waste were managed within SAAs in this area at the time of the inspection. One of the containers managed spent x-ray developer. The other container managed spent lead materials from the x-ray process. Each of the containers were closed, marked with the words “Hazardous Waste” and an indication of the hazard of the contents.
