## **RCRA Compliance Evaluation Inspection Report**

Yamaha Jet Boat Manufacturing USA  
2000 Cobia Drive  
Vonore, Tennessee 37885  
Monroe County

July 19, 2023, 9:00 a.m.

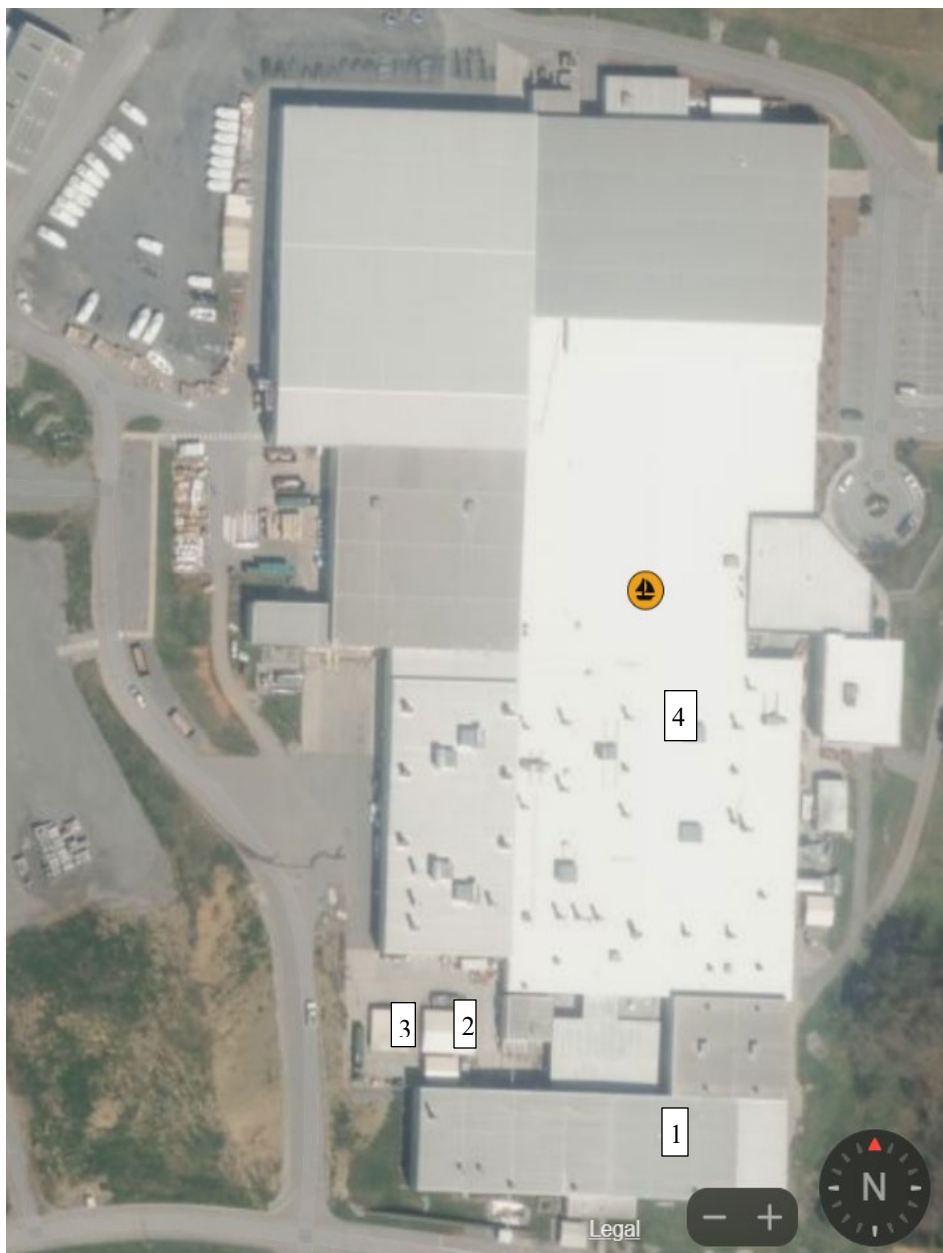
### Yamaha Jet Boats facility Areas

Area 1-Mold fabrication

Area 2-“Kick-off” shed and SAA

Area 3-Hazardous/universal waste building,  
CAA

Area 4-Lamination lines and boat assembly

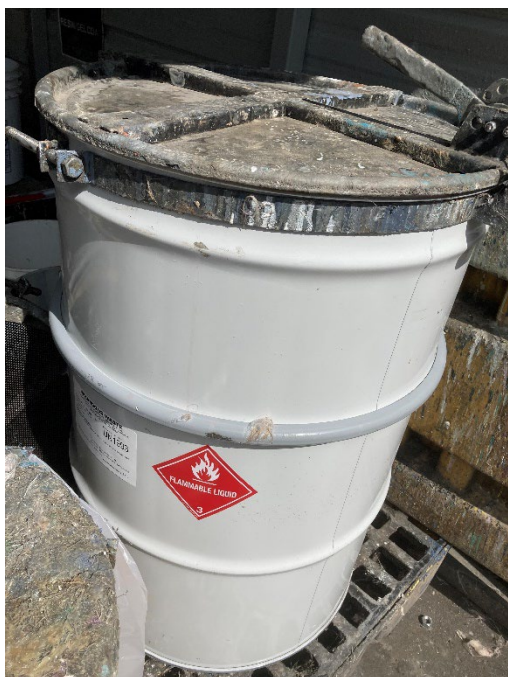
Spent Thermaclean solvent from the 275-gallon tote in the Kick-off Shed is re-used to flush sprayer-lines in the Lamination building, as a result, it becomes hazardous waste because it is contaminated with gelcoat (D001). Waste Thermaclean solvent from Lamination and from the Robo-Sprayer is accumulated in a 55-gallon satellite container (WS #11). At the time of the inspection, the satellite container was closed, in good condition and stored on a secondary-containment pallet. The satellite container was observed to be marked with the words “Hazardous Waste” and with indication of hazards of the contents as “Flammable.” However, because the waste Thermaclean is generated in the Lamination building (Area 4), the SAA container observed in the Kick-off Shed is not “at or near the point of generation where wastes initially accumulate, and nor is under the control of the operator of the process generating the waste” (Photo 1).

Photo 1, SAA container for spent Thermaclean,  
Kick-off Shed

**Pursuant to Tenn. Comp. R. & Regs. 0400-12-.03(1)(f)1 [40 C.F.R. § 262.15(a)], a generator may accumulate as much as 55 gallons of non-acute hazardous waste in containers at or near the point of generation where wastes initially accumulate, which is under the control of the operator of the process generating the waste, without a permit or without having interim status, as required by Section 68-212-108 of the THWMA, Tenn. Code Ann. § 68-212-108 [Section 3005 of RCRA, 42 U.S.C. § 6925], and without complying with Tenn. Comp. R. & Regs. 0400-12-.01-.03(1)(f)1 [40 C.F.R. § 262.15(a)], except as required in Tenn. Comp. R. & Regs. 0400-12-01-.07 and 0400-12-01-.09 [40 C.F.R. § 262.15(a)(7) and (8)], provided that the generator complies with the satellite accumulation area conditions listed in Tenn. Comp. R. & Regs. 0400-12-.03(1)(f)1- [40 C.F.R. § 262.15(a)] (hereinafter referred to as the “SAA Permit Exemption”).**

After the inspection, Mr. Wolfe stated that Yamaha re-designated the Kick-off Shed as a CAA, marked the used Thermaclean and waste adhesive containers with accumulation start-dates, and added those two containers to the weekly inspection list. Safety equipment and trained personnel required for a CAA were already in place.

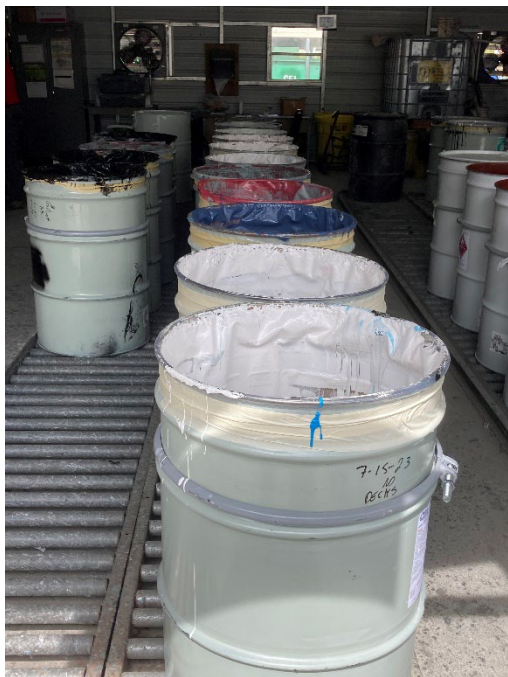
Fifteen drums with residual gelcoat were observed, to which residual organic peroxide catalyst collected from ‘empty’ peroxide containers is added to “kick-off” the hardening reaction (Photo 2).

At the time of inspection, there were 10 55-gallon containers undergoing various stages of reaction, the remainder had already solidified. There were at least two reacting containers that had fumes visibly rising from the containers. The containers undergoing solidification treatment are open so that fumes and heat from the containers are released during the reaction.

Hardening is accomplished by adding the appropriate amount of organic peroxide catalyst into the open gelcoat drums, which is then stirred manually by an employee using a paddle to mix catalyst into the gelcoat. The entire solidification process takes 24 hours to complete. Once the treatment is completed, the hardened gelcoat is disposed of as a special waste pursuant to TDEC solid waste regulations along with paper floor sheets and air filters from Lamination, and the fiberglass scraps from the Deck Hole-cut.

Steve Wolfe later explained that these containers come from Mold Fabrication (Area 1) and the Lamination (Area 4) where they are ‘generated’ as follows: gelcoat sprayers in Area 1 and Area 4 draw directly from a full drums of gelcoat product, but when a gelcoat drum is near-empty it is replaced with a full drum. The near-empty drum is transferred to the Kick-off Shed (Area 2) for the hardening process; this removal is done for fire safety purposes according to the previous inspections.

Gelcoat residue containers were handled as though they were not waste because of the definition of “empty container” under RCRA and because they are handled in the Kick-off Shed as a best management practice according to recommendation from the fire department, as stated to the inspectors during previous site inspections.

Photo 2, Drums of gelcoat residue hardening,  
Kick-off Shed

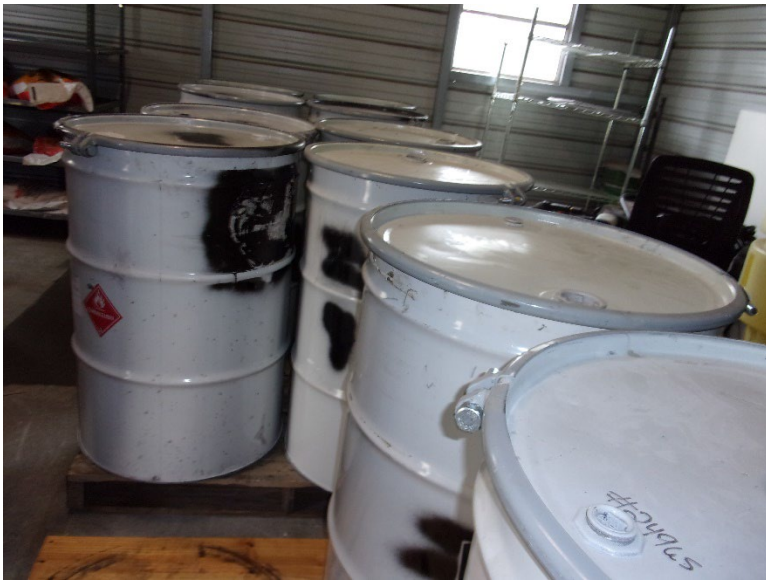
Inside the CAA building, ten 55-gallon drums of hazardous waste were observed (Photo 3). All containers were closed, on secondary-containment pallets, in good condition, marked “Hazardous Waste,” “Flammable” or other applicable hazard-indication. The containers were also marked with an accumulation start date (“ASD”) of which the oldest was March 3, 2023. There was adequate aisle-space and there were no leaks or spills observed in the CAA. The storage area is equipped with spill equipment, fire extinguisher, and a current list of emergency contact information is posted on the wall. Personnel who work in this area carry facility-issued cell phones for emergency communication.

Photo 3, Hazardous Waste Containers in the CAA Shed
