### INSPECTION REPORT

| Regulatory Program(s) | NPDES Stormwater/CWA 402 | |
| Company Name: | <b>CB Jeni Homes DFW LLC</b> | |
| Facility Name: | Painted Tree Village District (Townhomes Phase 1) | |

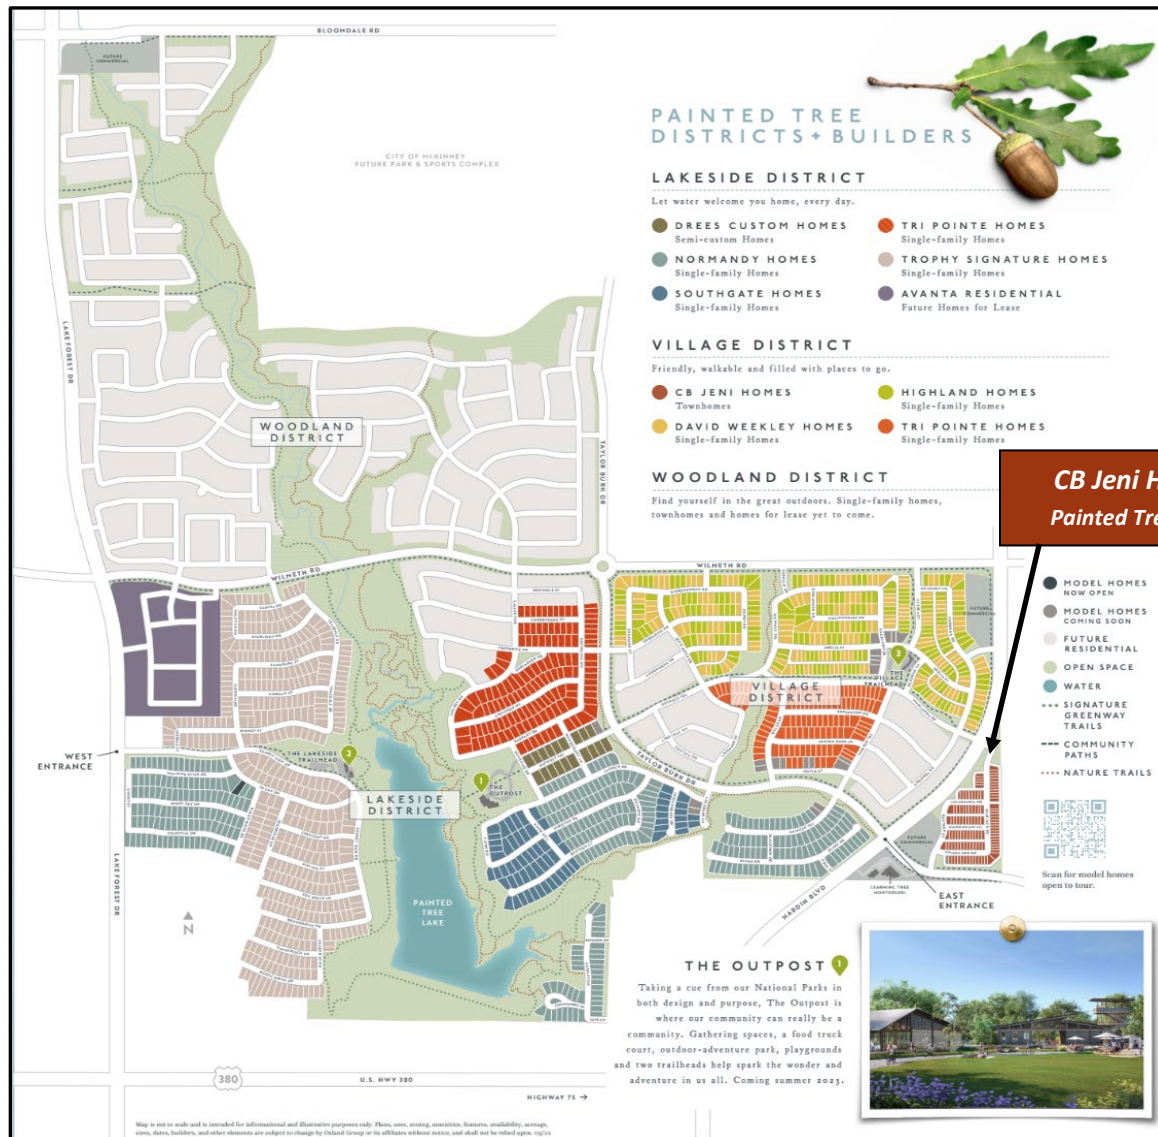
**Site Map #1:** The overall site map of the Painted Tree Community. The inspection area is in the Village District by CB Jeni Homes located southeast of Taylor Burk Dr., located on Jacaranda Dr., Maidenhair Ln., and Chisos Red Rd., boarded between Bastrop St. and Blackjack Rd. (depicted by dark rusted-colored lots). The site map was obtained from the Painted Tree Digital Map Guide on the community [website](#).

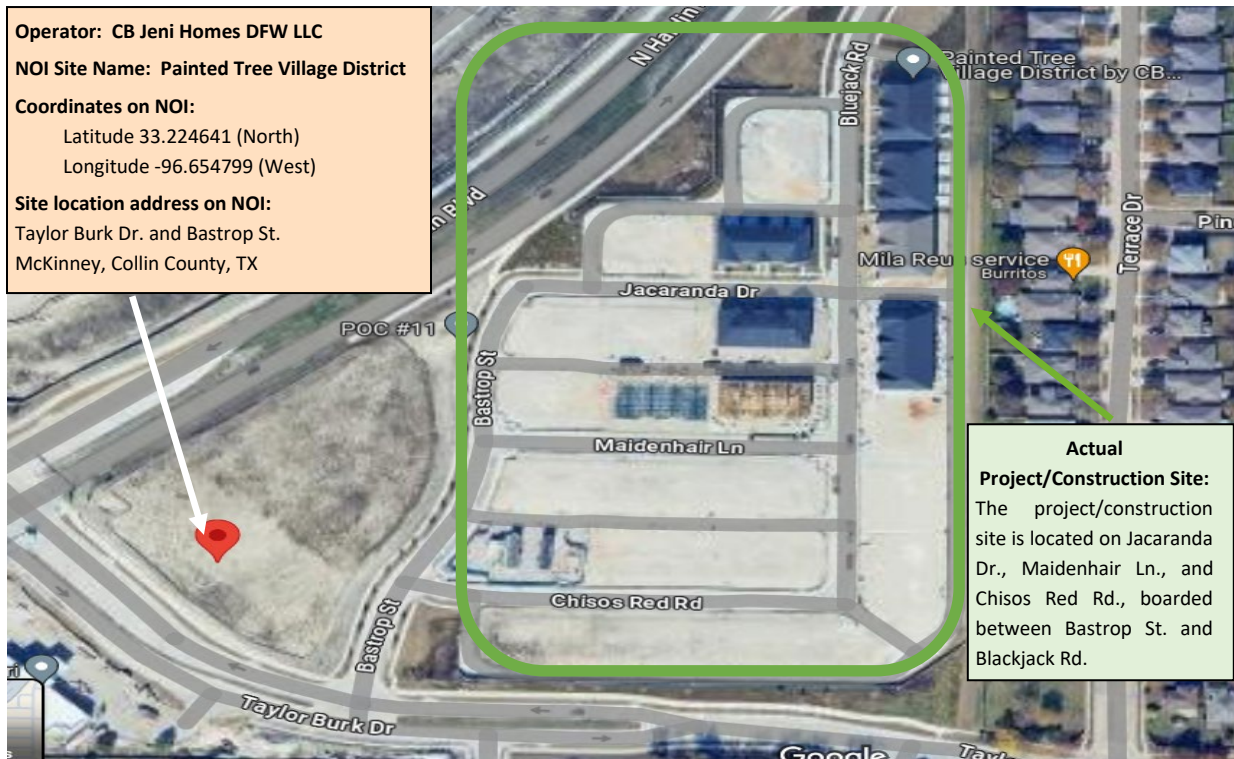
**Aerial Image #1:** Overall view of the CB Jeni Homes DFW LLC – Painted Tree Village District. **Note:** Aerial from Google Maps Imagery, 2024. The latitude and longitude (33.224641 and -96.654799) provided on the Notice of Intent (NOI) (white arrow), submitted differs from the actual project/construction site area (green arrow and green boarded area).

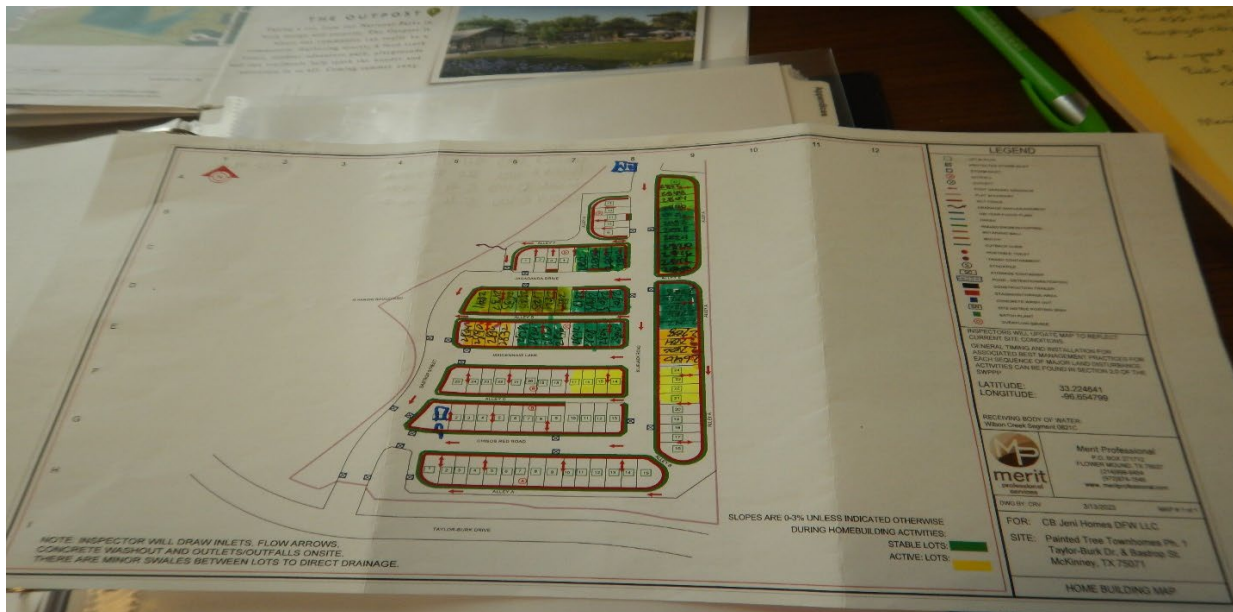
**Site Map #2:** CB Jeni Homes (Village District) Home Building Map dated March 13, 2023, denoting lot numbers. The site map was provided by Mr. Steve Murphy. **Note:** The street nomenclature reflected on the Site Map, Aerial Image, and the North Phase 1 Map differs. As such, photographs contained in this report will list the true-to-date street name and intersecting streets, where applicable.

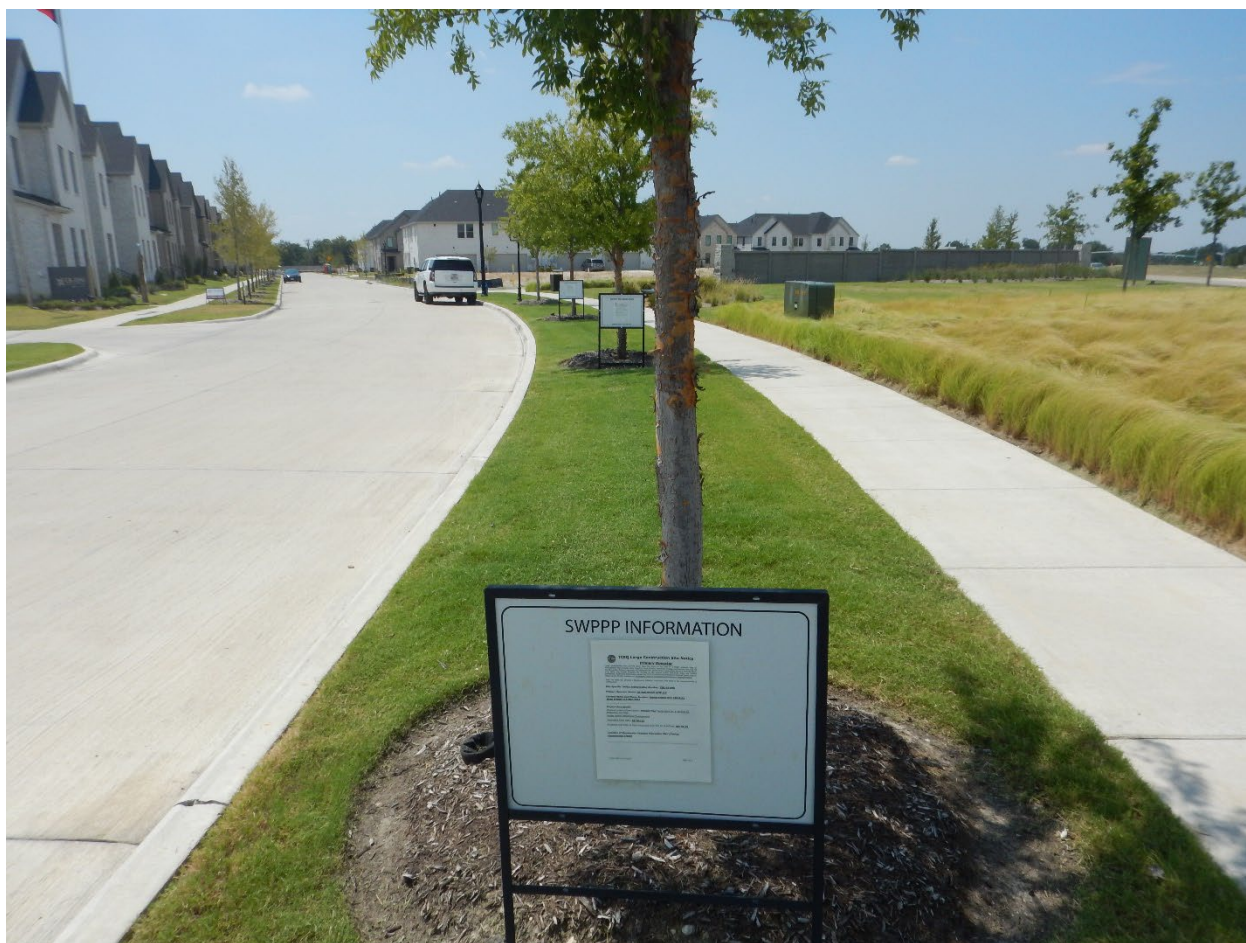
Photo No. 1

Description: Picture/view, of Stormwater Pollution Prevention (SWPPP) Large Construction Site Notice posted at the end of Bluejack Rd. (facing south).

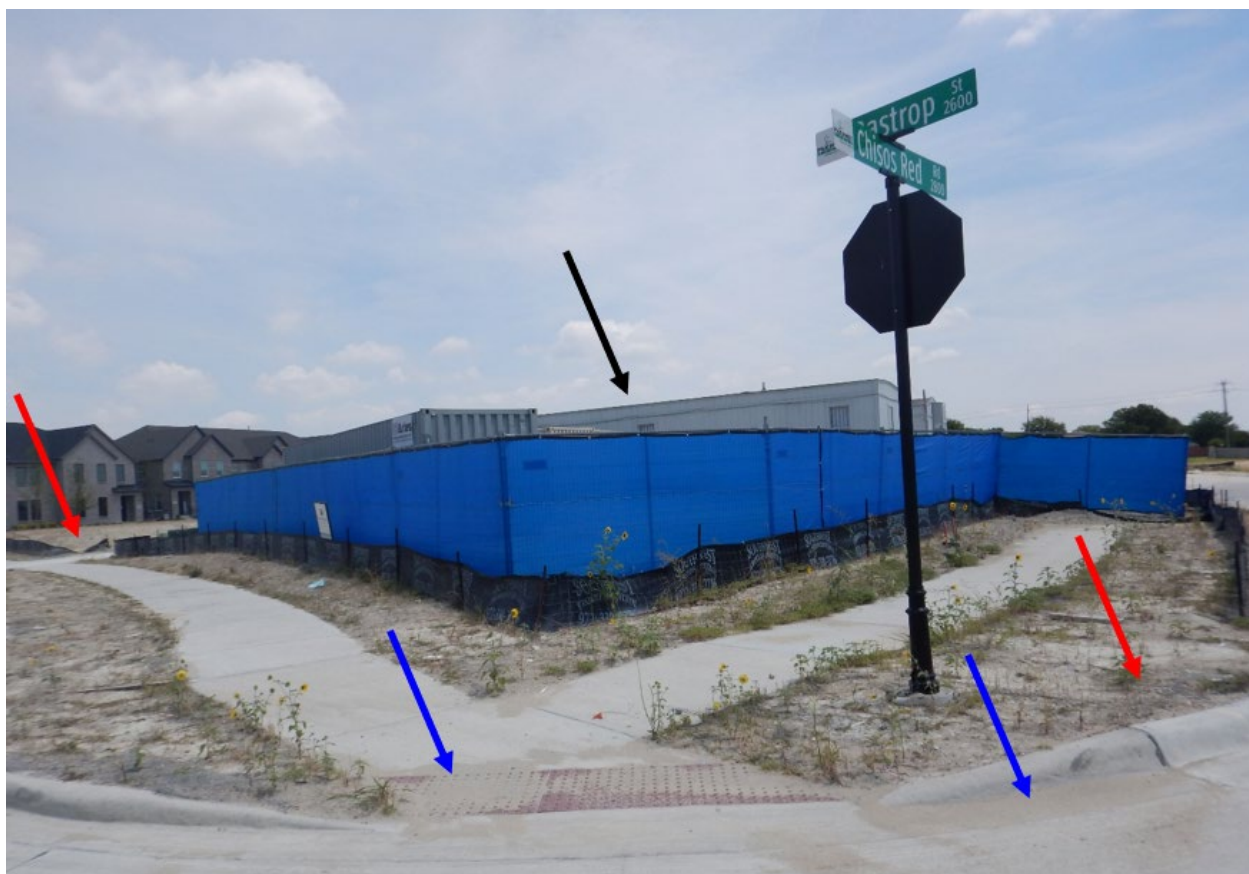
Photo No. 2

- i. Absent or damaged silt fencing and/or erosion blanket(s), and/or accumulated sediment observed in multiple areas (see Appendix 1, Photograph Log, Photo Nos. 2, 5, 6, 9, 10, 13, 16, and 19);

- ii. Sediment carry over into the access street from the construction area (see Appendix 1, Photograph Log, Photo Nos. 2, 3, 6, 14, 15, and 16);
    - iii. Inlet protection was not maintained in an effective operating condition in multiple areas. The inlet protection was full of sediment and/or trash with the presence of sediment leading to the inlet (see Appendix 1, Photograph Log, Photo Nos. 3, 7, 8, 14, 15, 16, and 17);

Description: View, of intersection of Bastrop St. and Chisos Rd. with view of construction trailers boarded by silt and blue-netted fencing (black arrow) and construction area(s) on each side with damaged and/or no silt fencing (red arrows). Closer view of referenced construction area captured in Photo #5. Sediment carry over observed on the sidewalk and in the access street (blue arrows) from the area bordering the construction trailers.

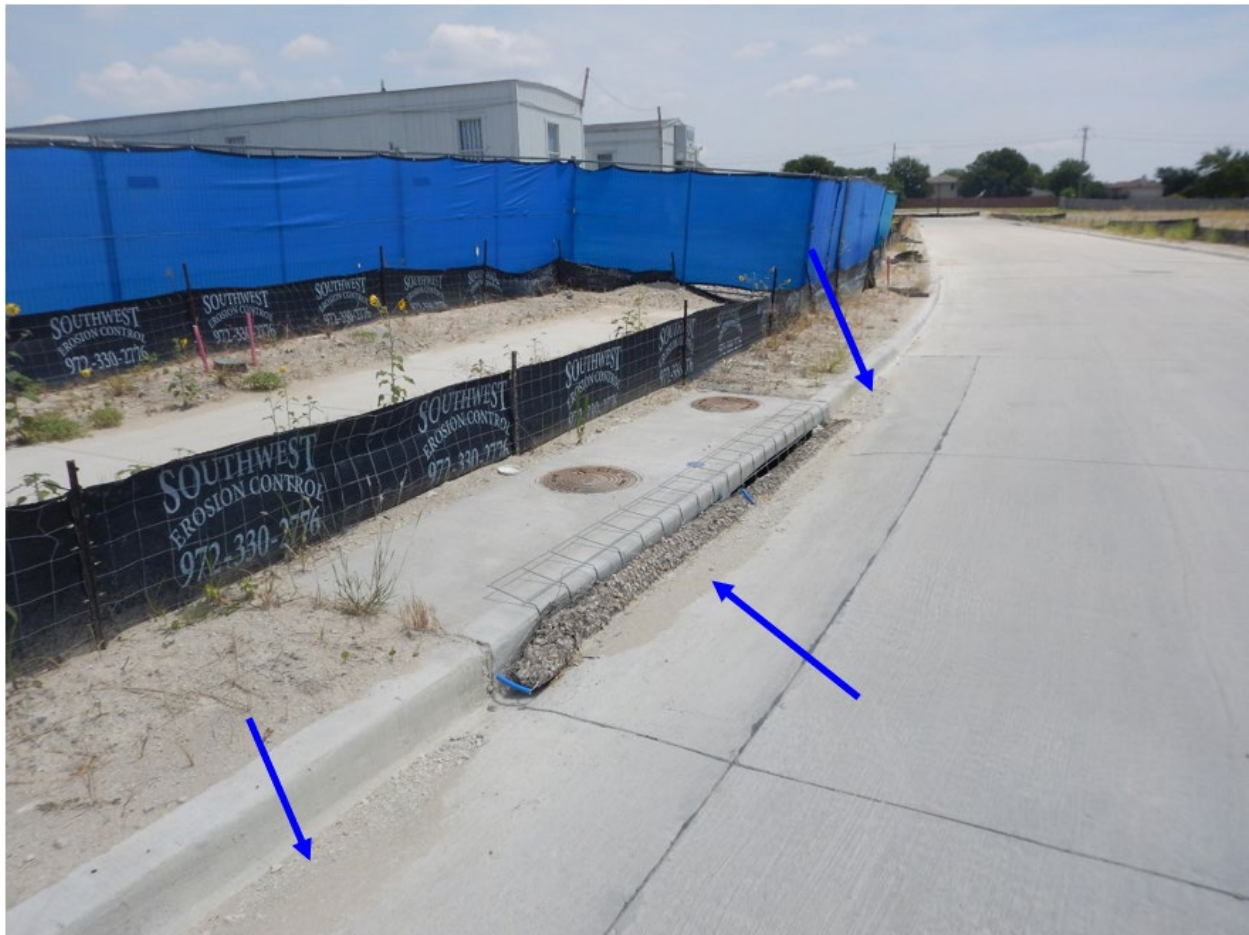
Photo No. 3

Description: View, of inlet protection on Chisos Rd., not maintained in an effective operating condition (e.g., inlet protection was surrounded by sediment and there was additional sediment carry over observed in the in the access street.

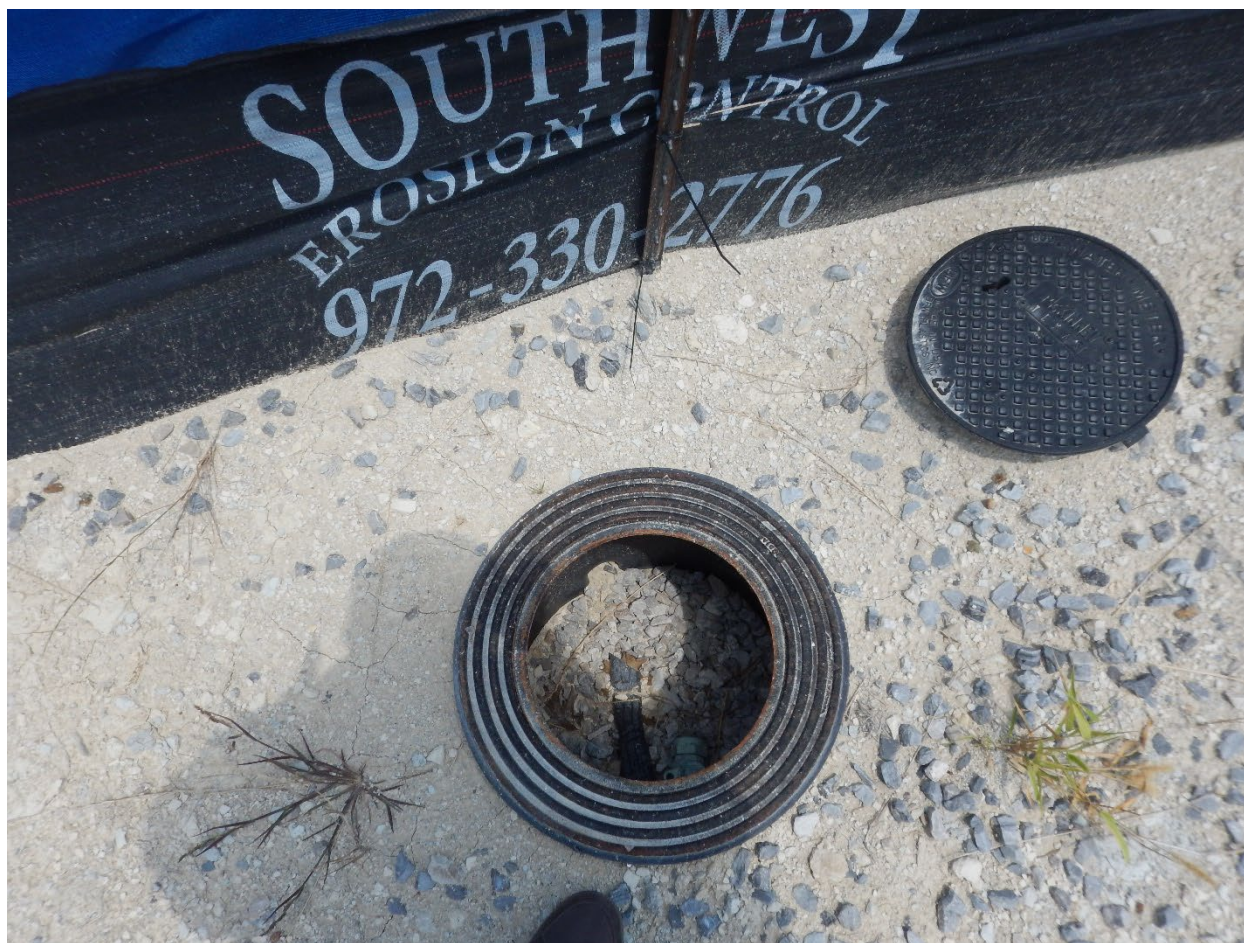
Photo No. 4

- iv. Uncovered internal compartment of a City of McKinney Water Meter was full of sediment, gravel and/or trash. The water meter was not visible during the time of the inspection (see Appendix 1, Photograph Log, Photo No. 4); and

Description: View, of the inside compartment of the City of McKinney Water Meter on Chisos Rd. Note: The meter cover was off to the side, and the inside compartment was full of sediment and gravel, and covering the water meter gauge.

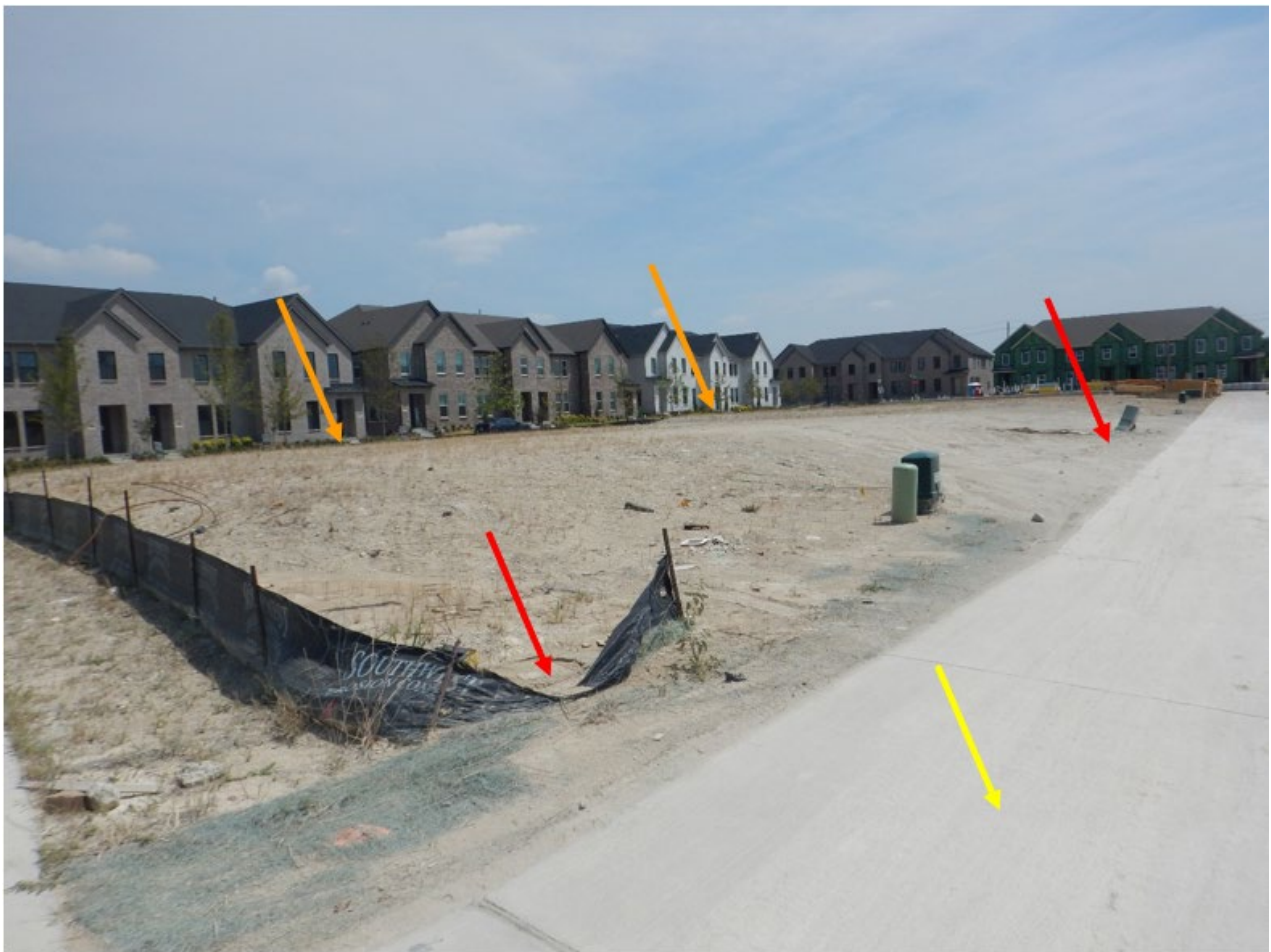
Photo No. 5

Description: View, of construction area immediately in front of the construction trailer area, which is located between Maidenhair Ln. and Chisos Rd. with ineffective BMPs indicated by red arrows (i.e., damaged and/or no silt fencing). It was also noted that the area without silt fencing was sloped southwest (orange arrows) to a nearby alley/driveway (yellow arrow).

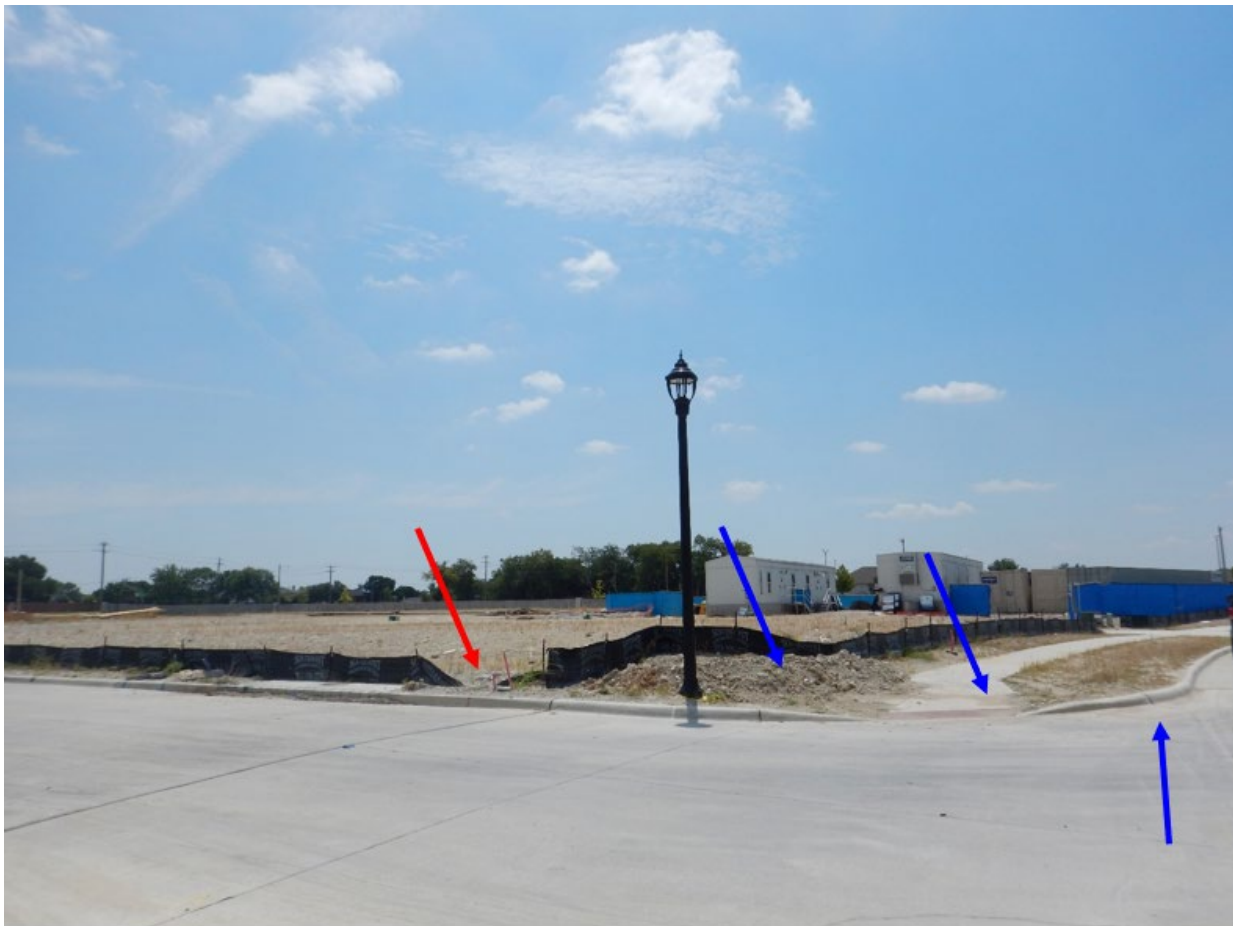
Photo No. 6

Description: View, of construction area at the corner of Maindenhair Ln. and Bastrop St., with an additional view of the construction trailer area in the rear. Ineffective BMPs indicated by red arrows (i.e., damaged and/or no silt fencing). A mound of loose gravel and silt located outside of the silt fencing was also observed on the sidewalk and light sediment carry over into the access street (blue arrow).

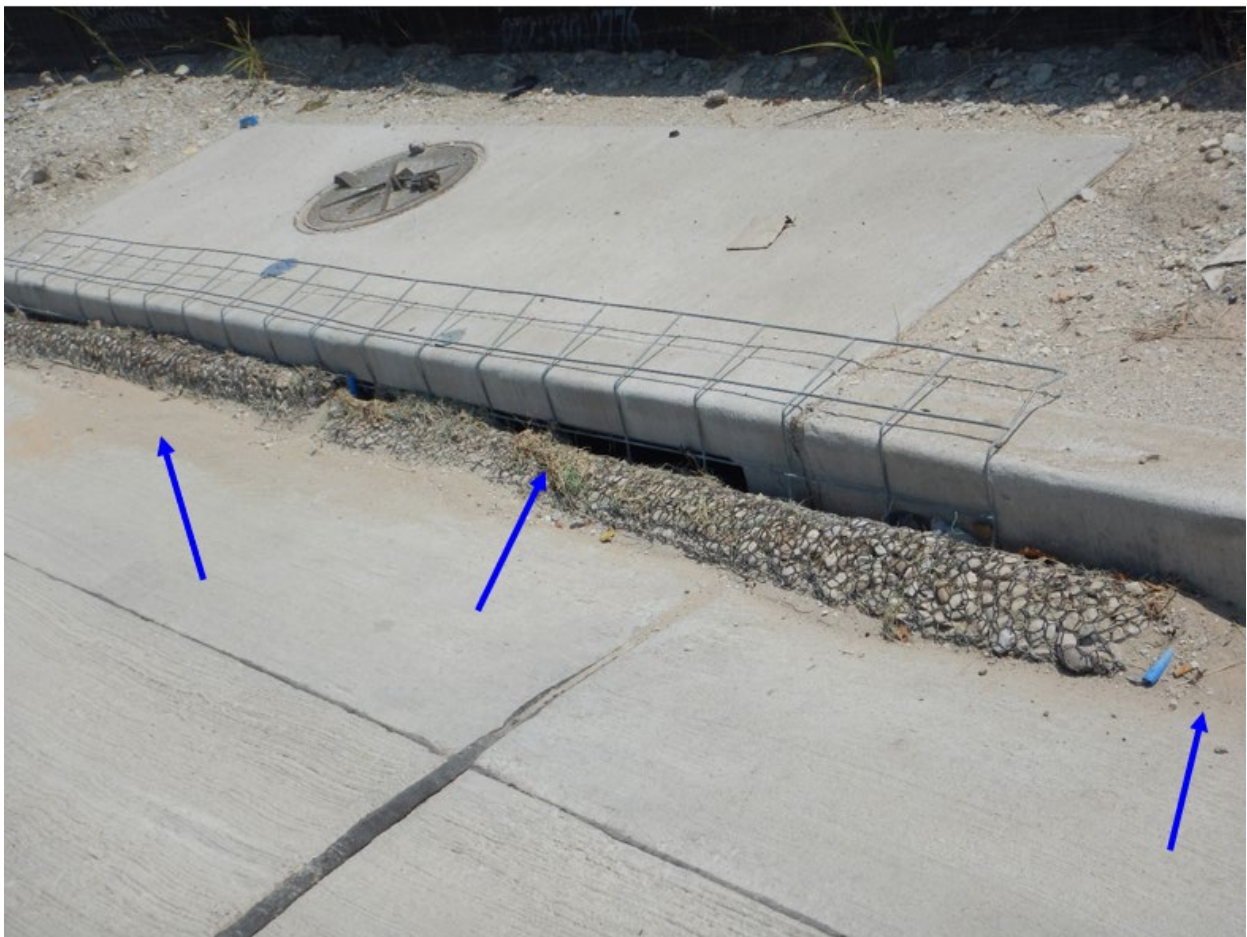
Photo No. 7

Description: View, of inlet protection on Bluejack Rd. (near Chisos Rd.), not maintained in an effective operating condition (e.g., inlet protection filled with sediment and vegetative growth, and there was additional sediment carry over observed in the in the access street. Closer view of inlet captured in Photo #8.

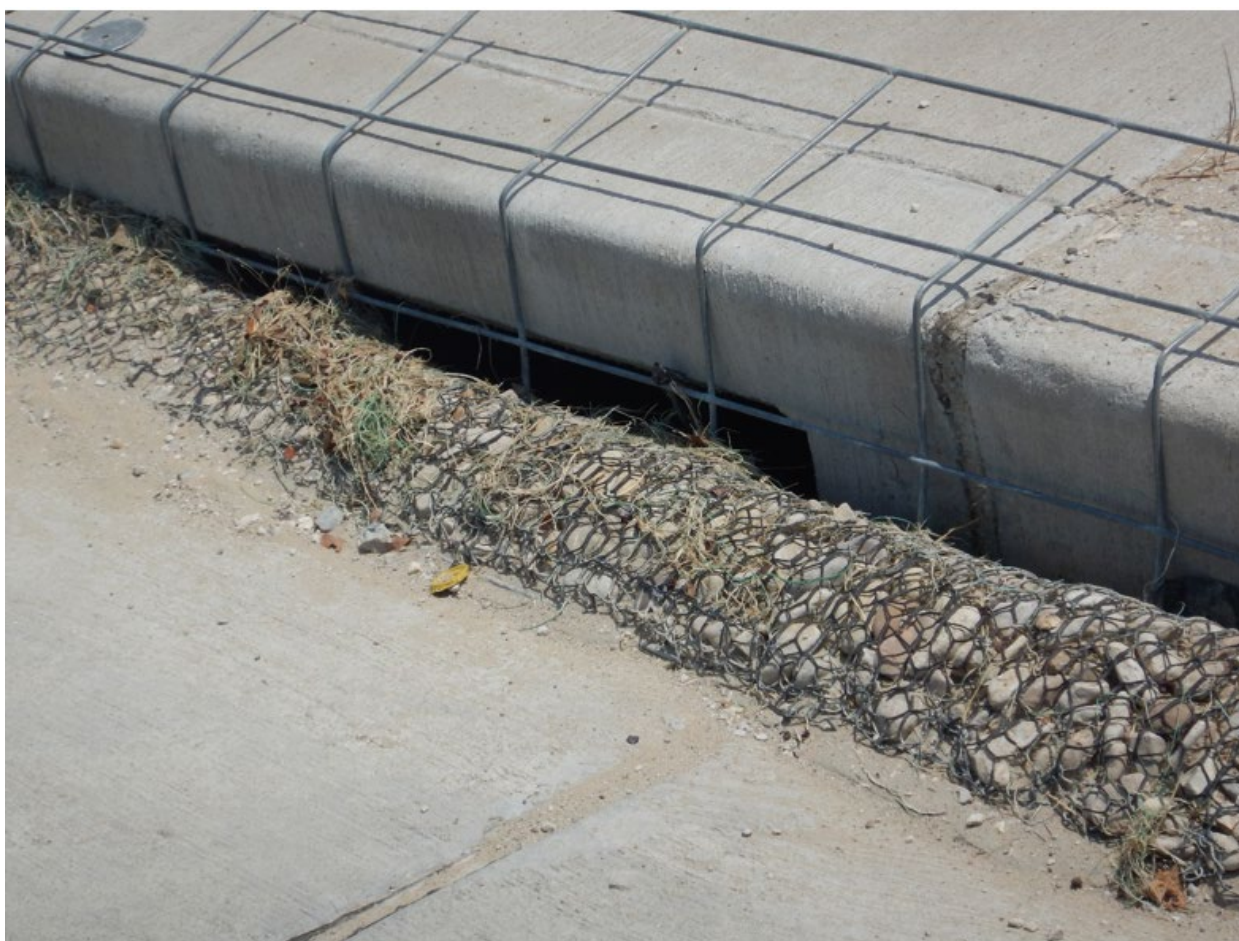
Photo No. 8

Description: Closer view, of inlet protection on Bluejack Rd. (near Chisos Rd.), not maintained in an effective operating condition (e.g., inlet protection filled with sediment and vegetative growth, and there was additional sediment carry over observed in the in the access street.

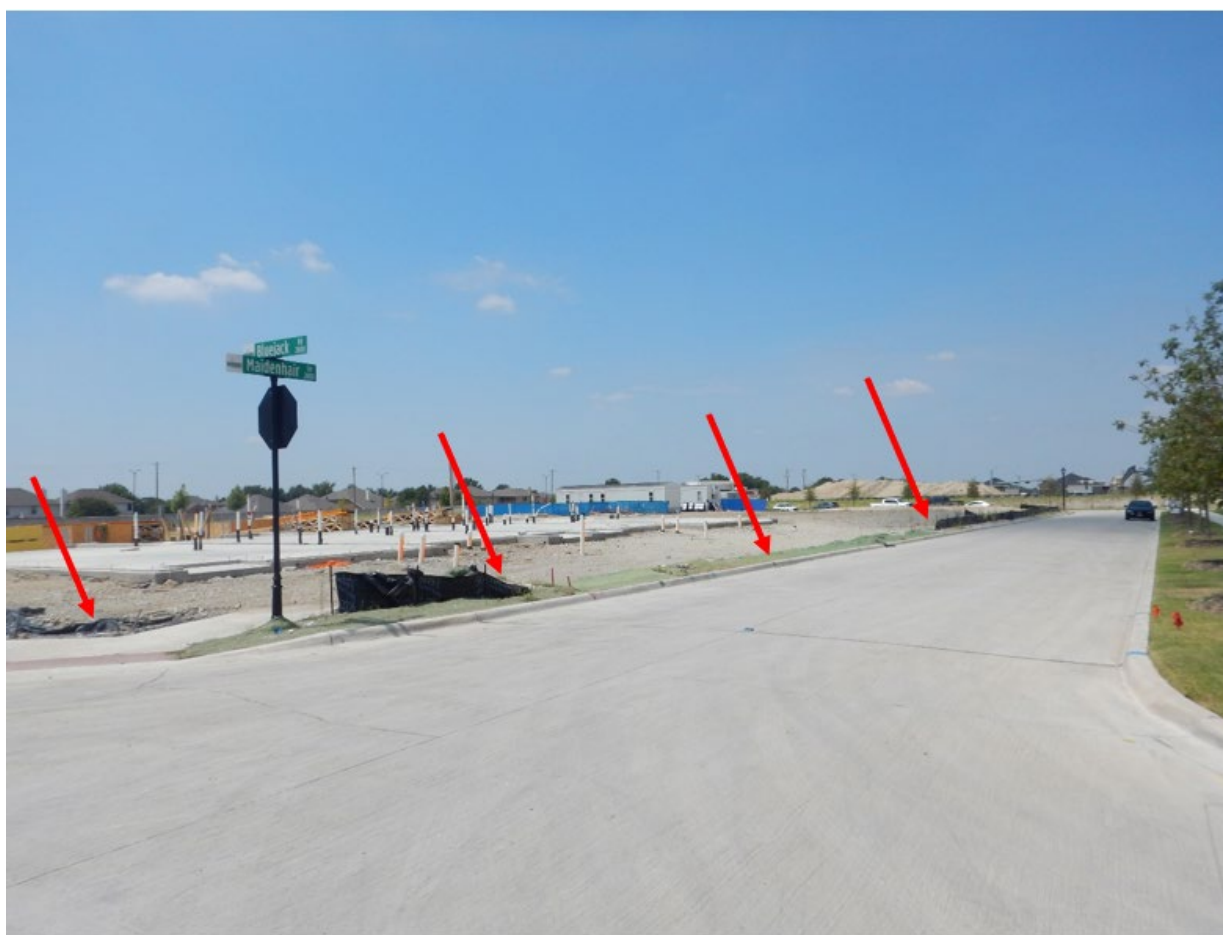
Photo No. 9

Description: View, of construction area at the corner of Bluejack Rd. and Maidenhair Ln., with an additional view of the construction trailer area in the rear. Ineffective BMPs indicated by red arrows (i.e., damaged and/or no silt fencing).

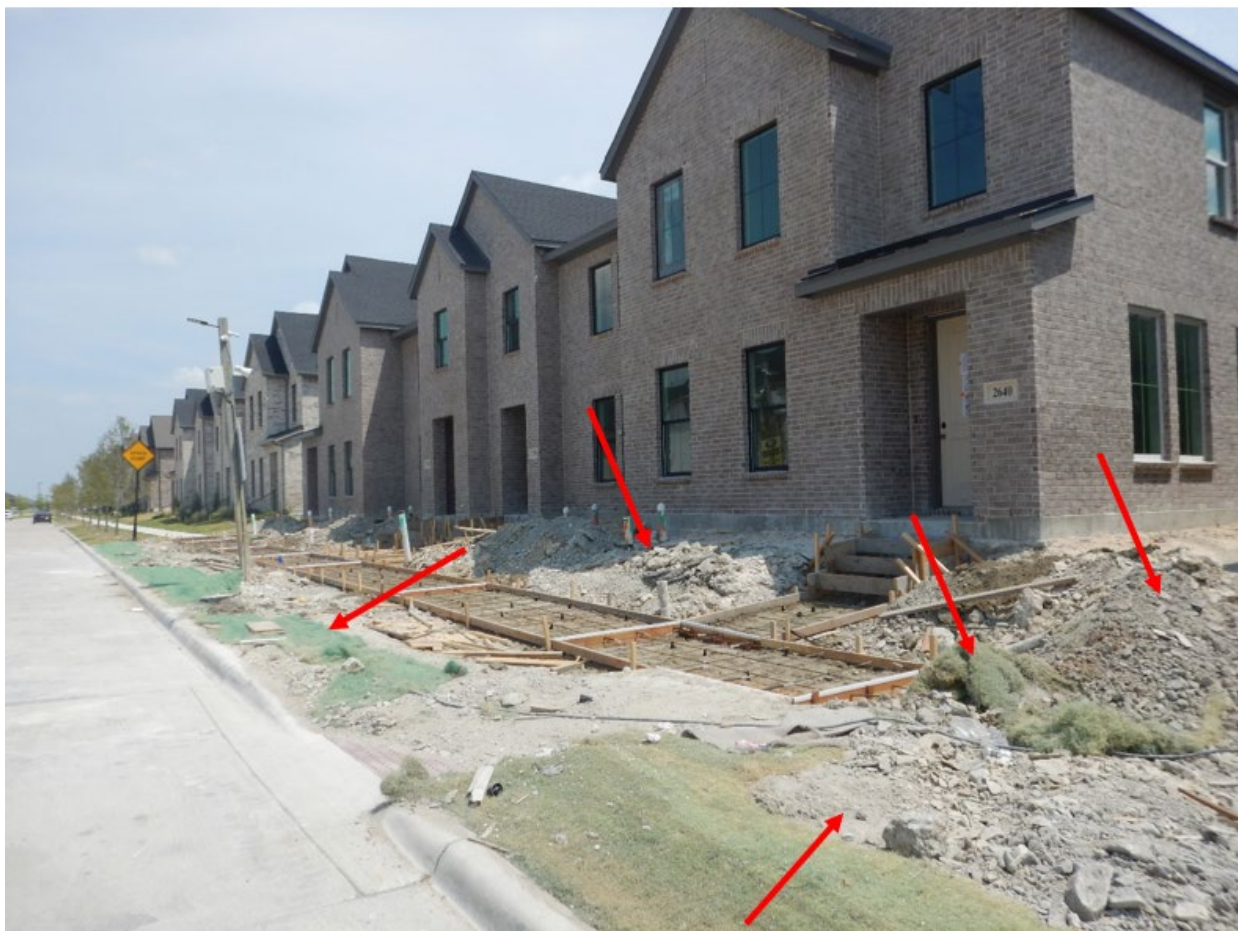
Photo No. 10

Description: View, of construction area on Bluejack Rd. (near Maidenhair Ln.), a view of ineffective BMPs indicated by red arrows (i.e., damaged erosion blankets and no silt fencing). Mounds of loose gravel and dirt were noted.

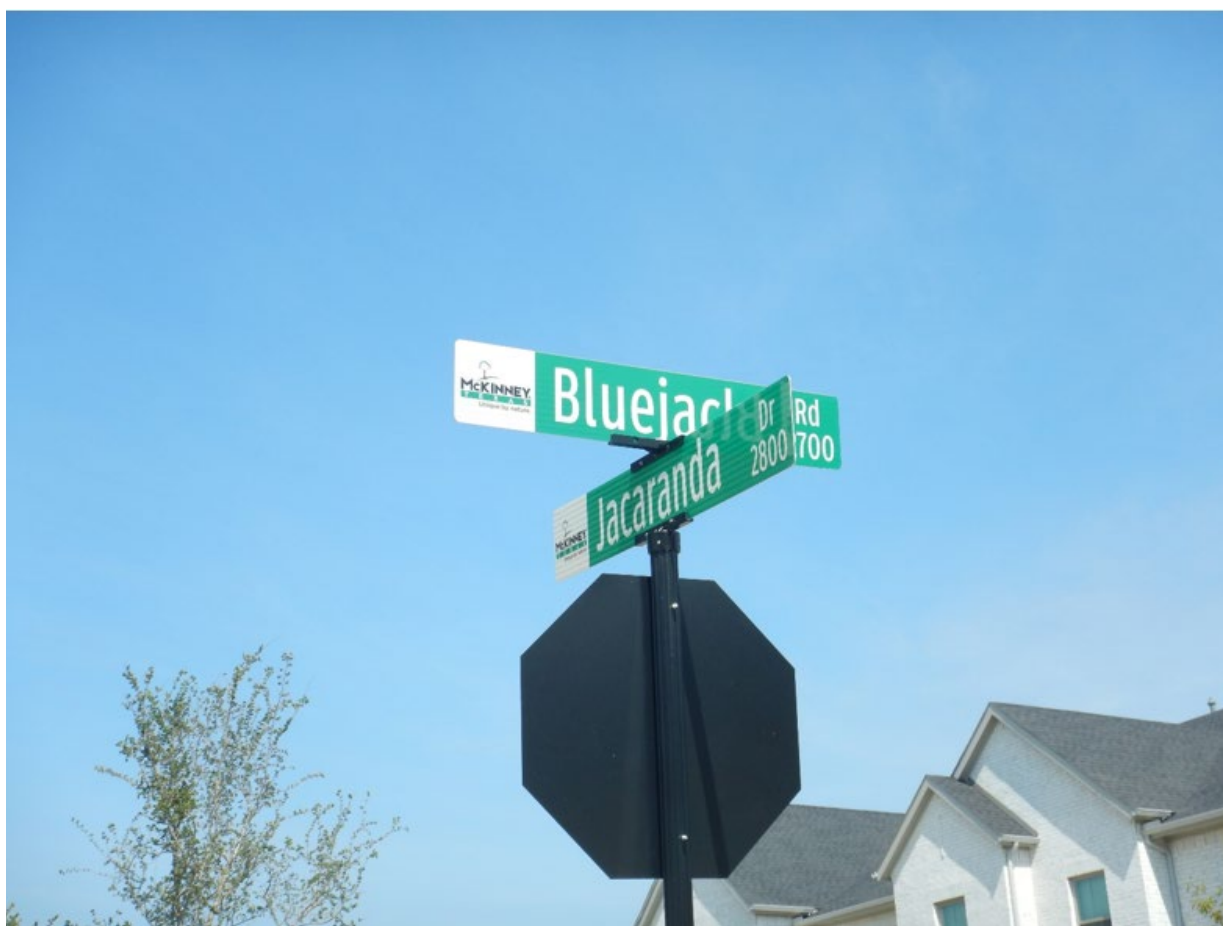
**Description:** Intersection of Bluejack Rd. and Jacaranda Dr.

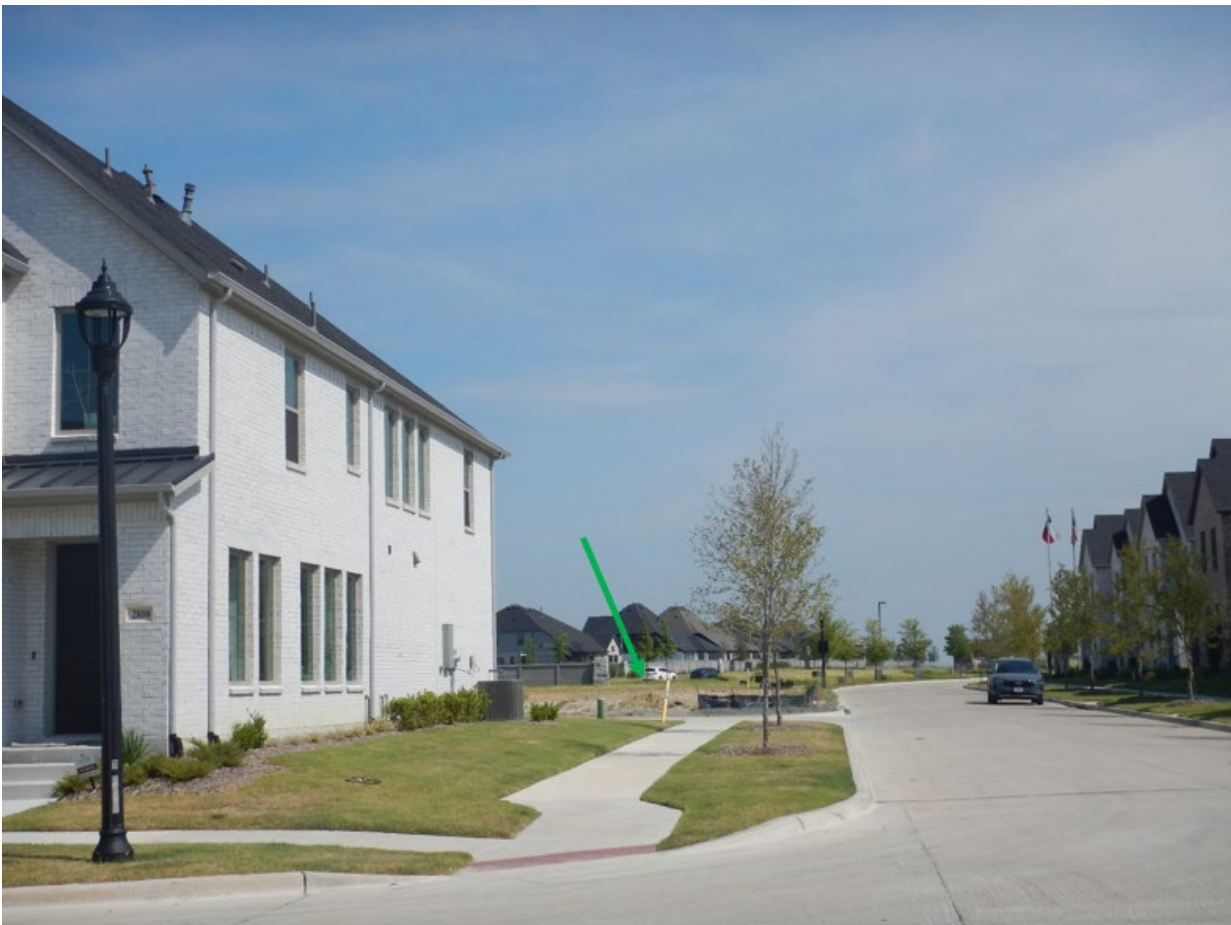
Description: View facing north at the intersection of Bluejack Rd and Jacaranda Dr. Note: Construction area in the background on the corner of Bluejack and an unnamed street (indicated by green arrow). Closer view of construction area captured in in Photo #13.

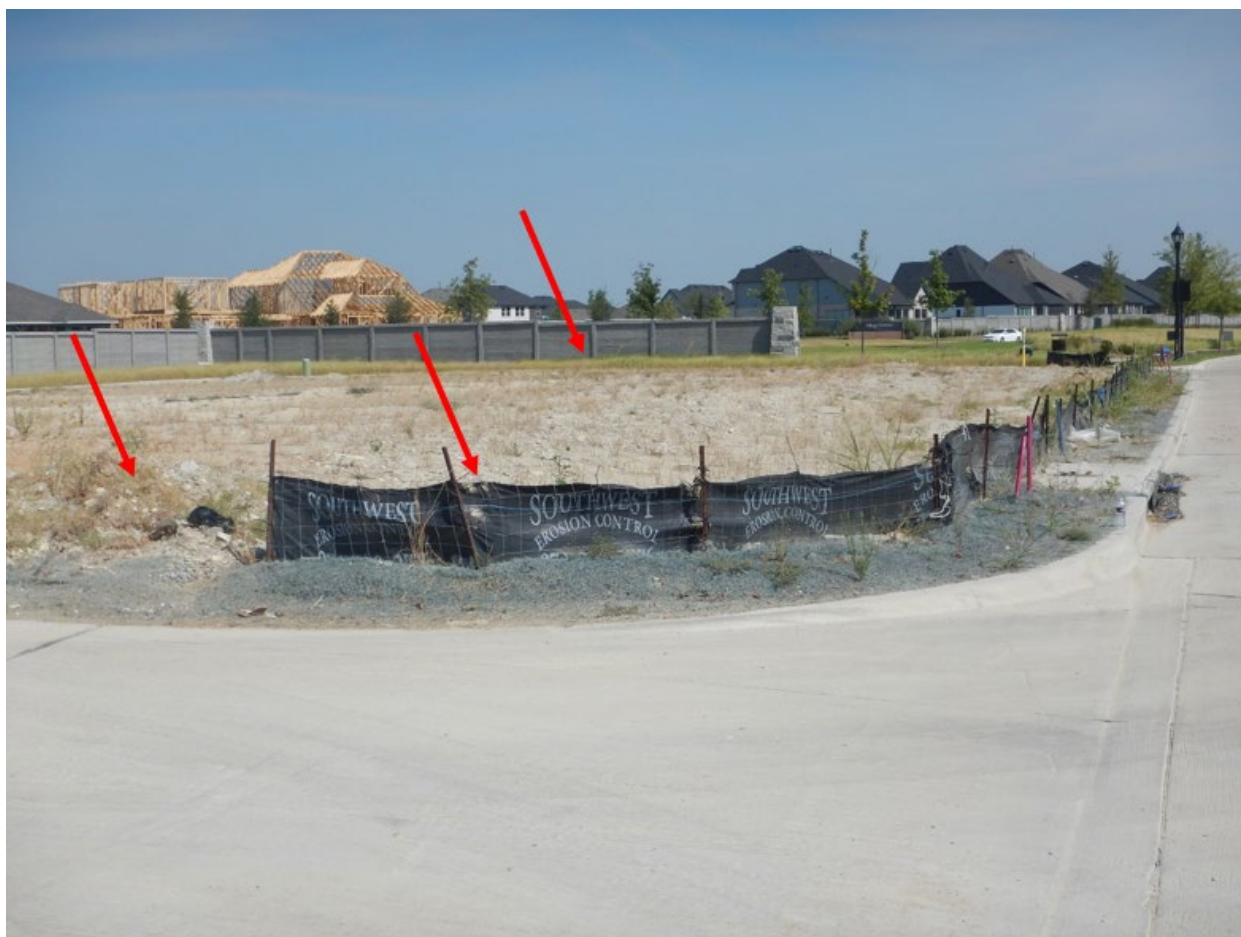
Photo No. 13

Description: Closer view of construction area, facing north on the corner of Bluejack Rd. and an unnamed street with ineffective BMPs indicated by red arrows (i.e., damaged and/or no silt fencing).

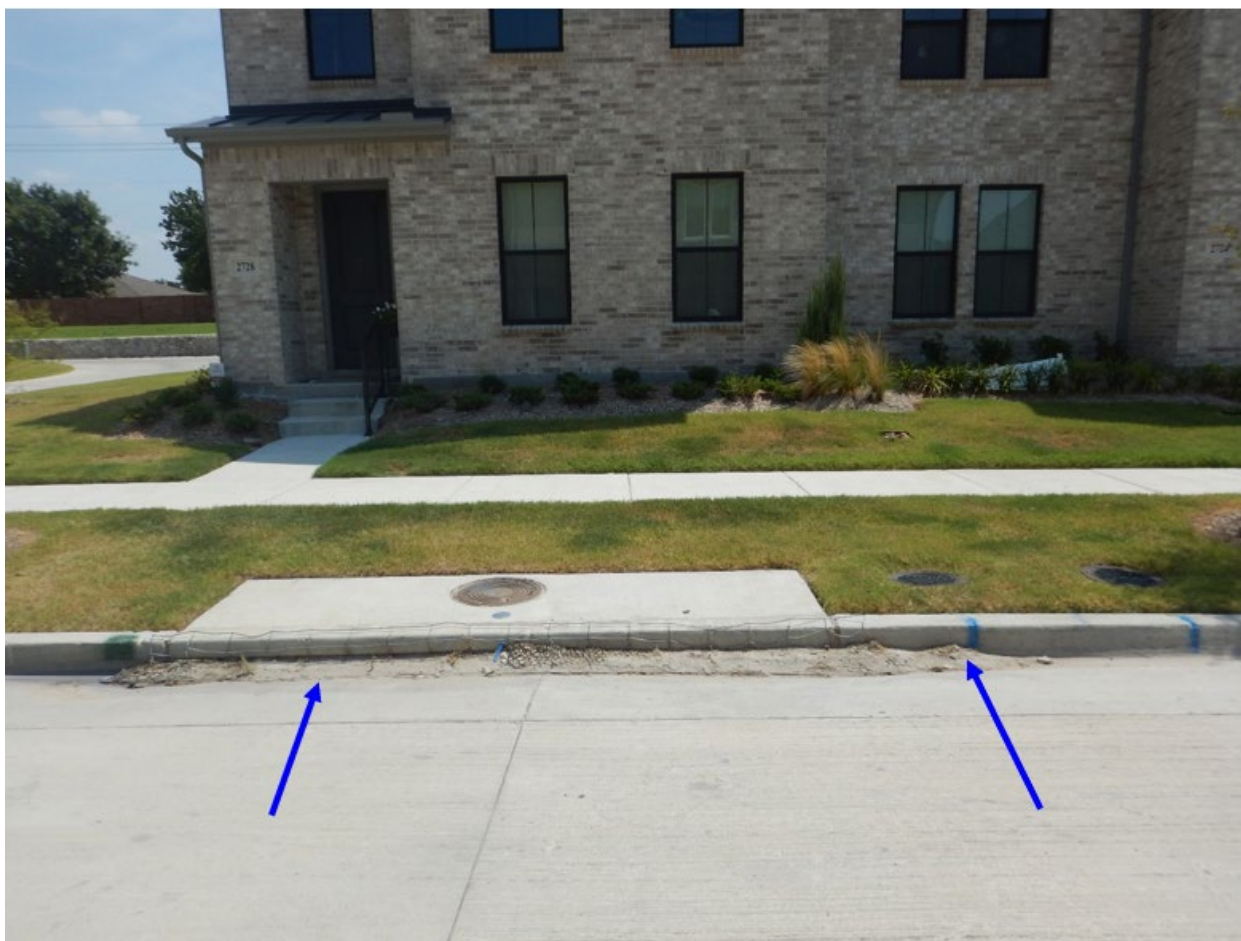
Photo No. 14

Description: View, of inlet protection on Bastrop St., not maintained in an effective operating condition (e.g., inlet protection was completely covered by sediment and there was additional sediment carry over observed in the in the access street (blue arrows).

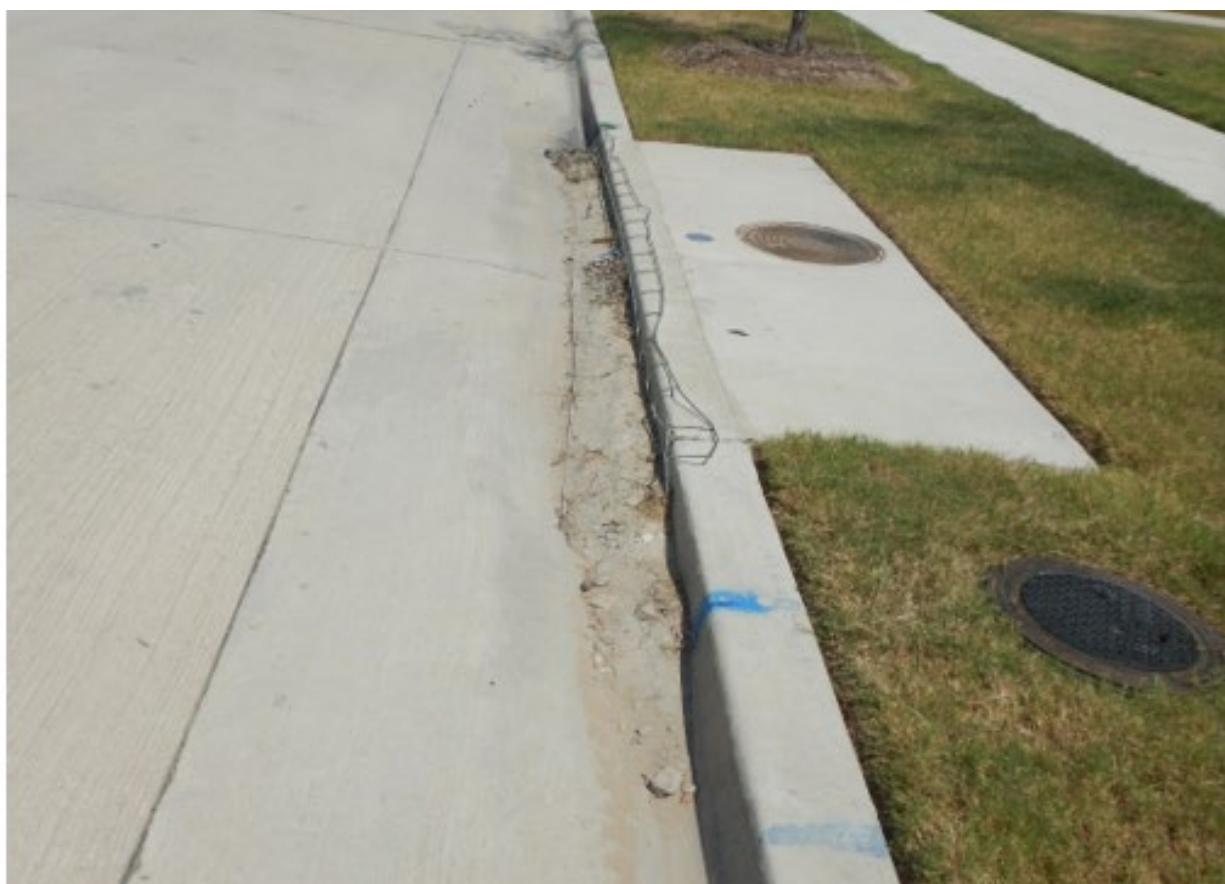
Photo No. 15

Description: An additional view, of inlet protection on Bastrop St., not maintained in an effective operating condition (e.g., inlet protection was completely covered by sediment and there was additional sediment carry over observed in the in the access street.
