### INSPECTION REPORT

| Regulatory Program(s) | NPDES Stormwater/CWA 402 | |
| Company Name: | <b>CB Jeni Homes DFW LLC</b> | |
| Facility Name: | Painted Tree Village District (Townhomes Phase 1) | |

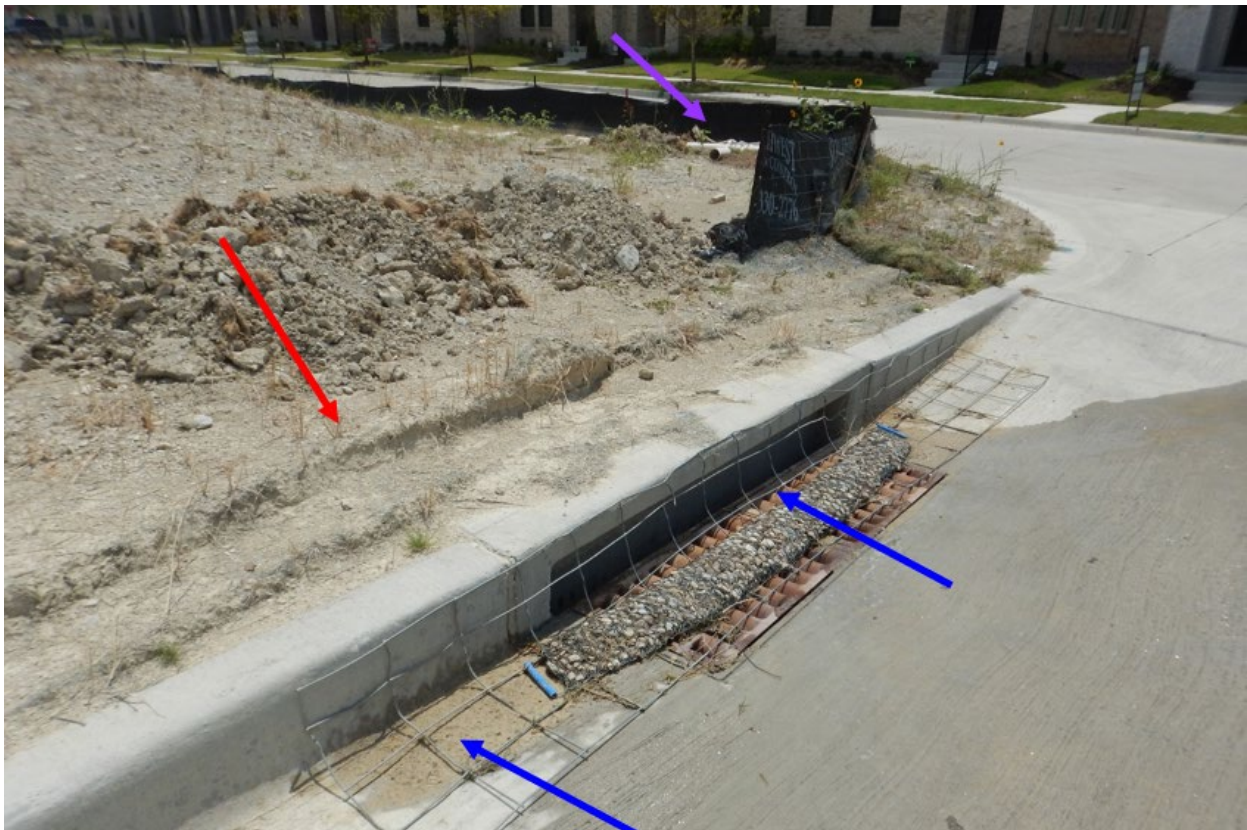
Photo No. 16

- i. Absent or damaged silt fencing and/or erosion blanket(s), and/or accumulated sediment observed in multiple areas (see Appendix 1, Photograph Log, Photo Nos. 2, 5, 6, 9, 10, 13, 16, and 19);

- ii. Sediment carry over into the access street from the construction area (see Appendix 1, Photograph Log, Photo Nos. 2, 3, 6, 14, 15, and 16);
    - iii. Inlet protection was not maintained in an effective operating condition in multiple areas. The inlet protection was full of sediment and/or trash with the presence of sediment leading to the inlet (see Appendix 1, Photograph Log, Photo Nos. 3, 7, 8, 14, 15, 16, and 17);

- v. Trash and/or construction debris observed throughout the construction site (see Appendix 1, Photograph Log, Photo Nos. 16, and 18).

Description: View, of inlet protection identified by blue arrows on an unnamed street and the corner of Bastrop St., not maintained in an effective operating condition (e.g., the inlet protection did not provide adequate/complete coverage of the drainage inlet, and was surrounded by sediment and additional sediment carry over observed in the in the access street); no silt fencing was present immediately over the drainage opening (red arrow). A closer view of the inlet protection is provided in Photo #17. Trash and the construction debris was also observed in the area (purple arrow). A closer view is provided in Photo #18.

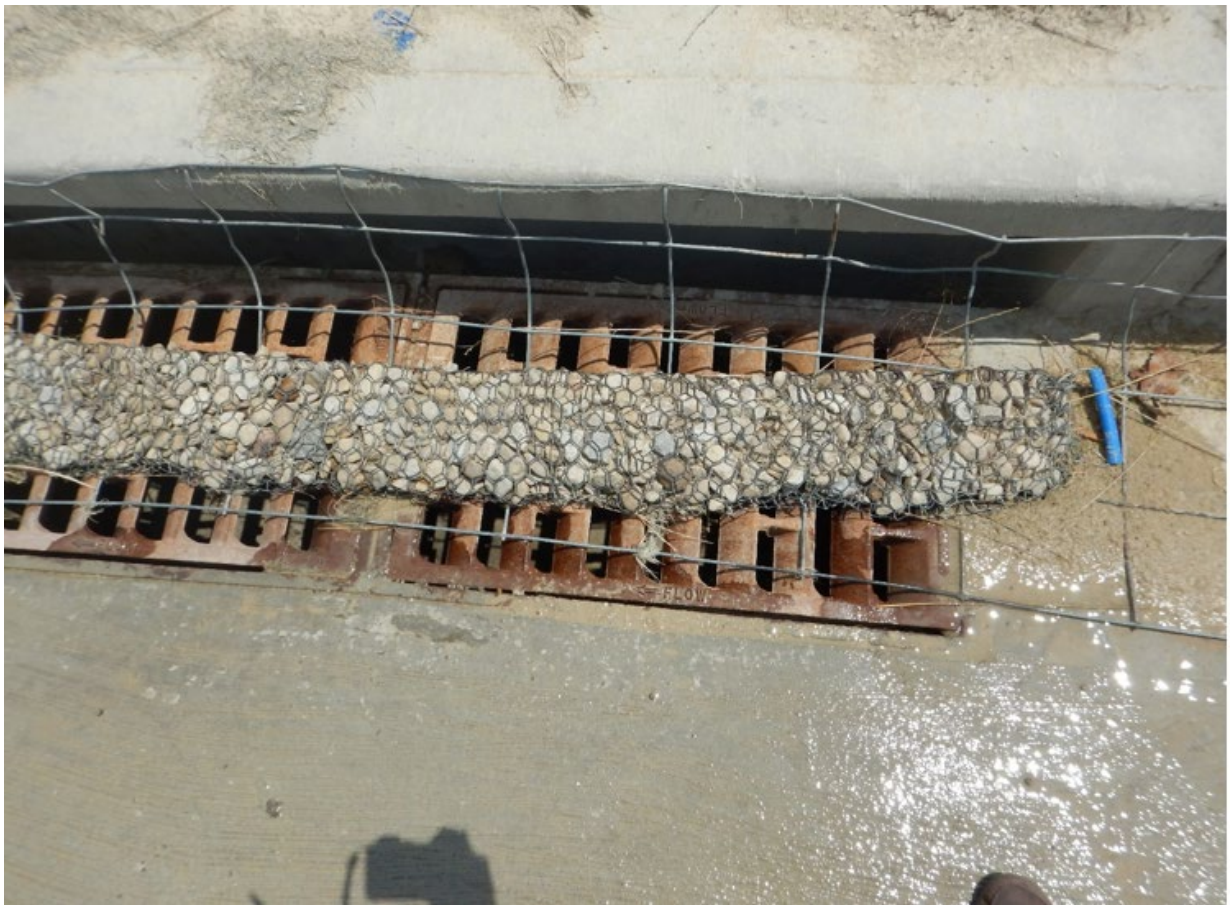
Photo No. 17

Description: Closer view, of inlet protection on Jacaranda Dr. (and the corner of Bastrop St.), not maintained in an effective operating condition.

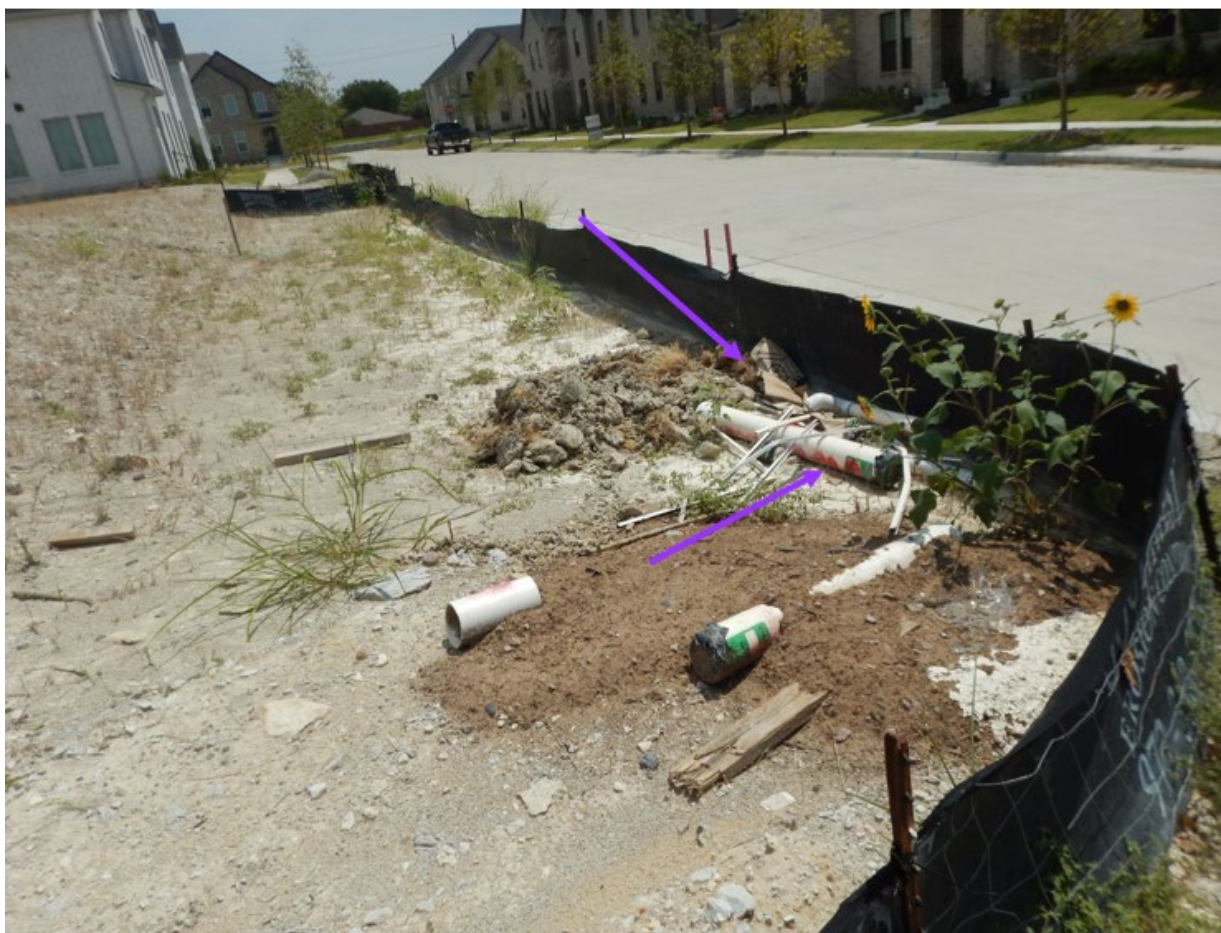
Photo No. 18

Description: Closer view, of trash and construction debris observed at construction site on the corner of Jacaranda Dr. and Bastrop St. (purple arrows).

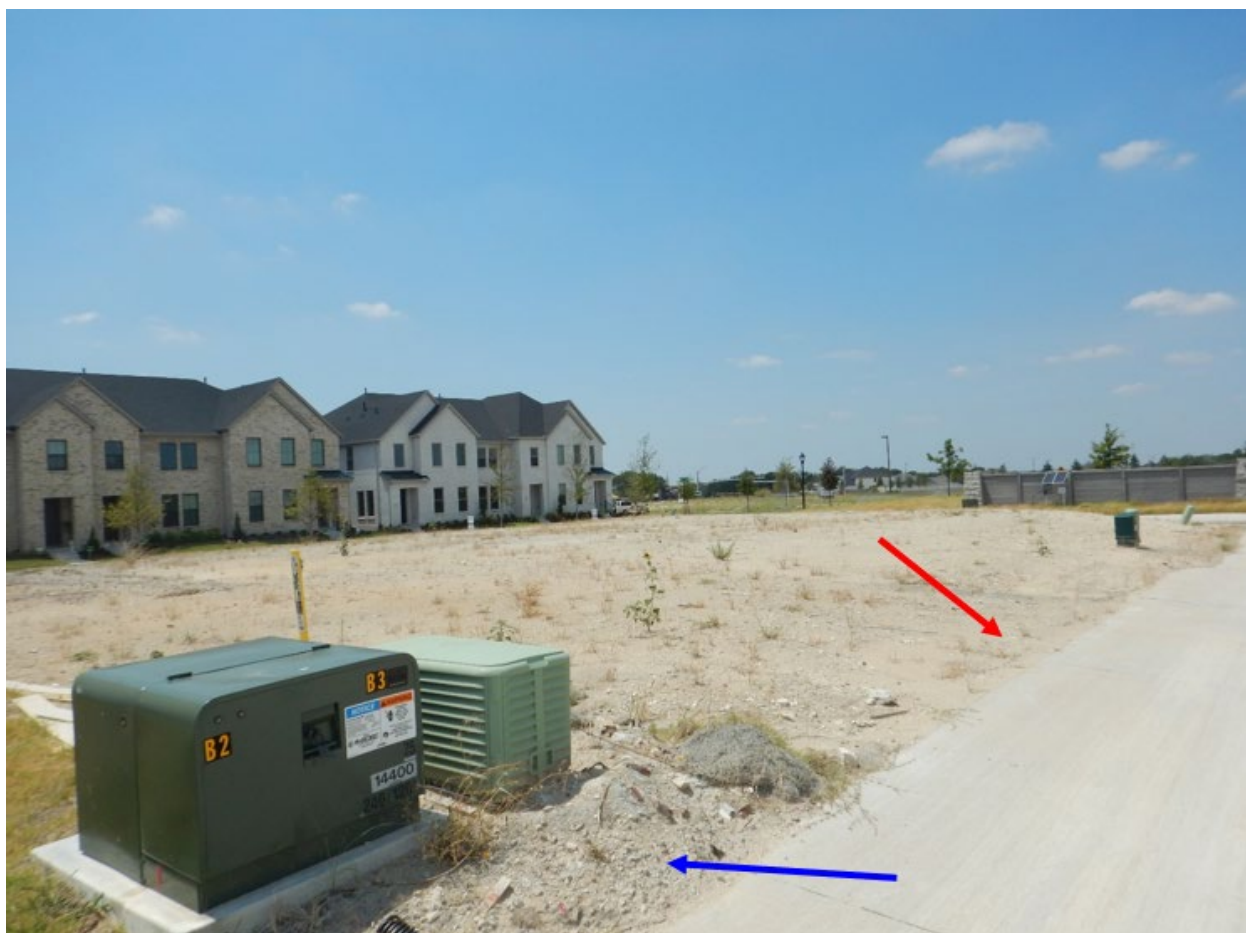
Photo No. 19

Description: View, of construction area, between an unnamed street and Jacaranda Dr. with ineffective BMPs indicated by red and blue arrows (i.e., no silt fencing and accumulated sediment).
