## **RCRA Inspection Report**

### **1) Inspector and Author of Report**

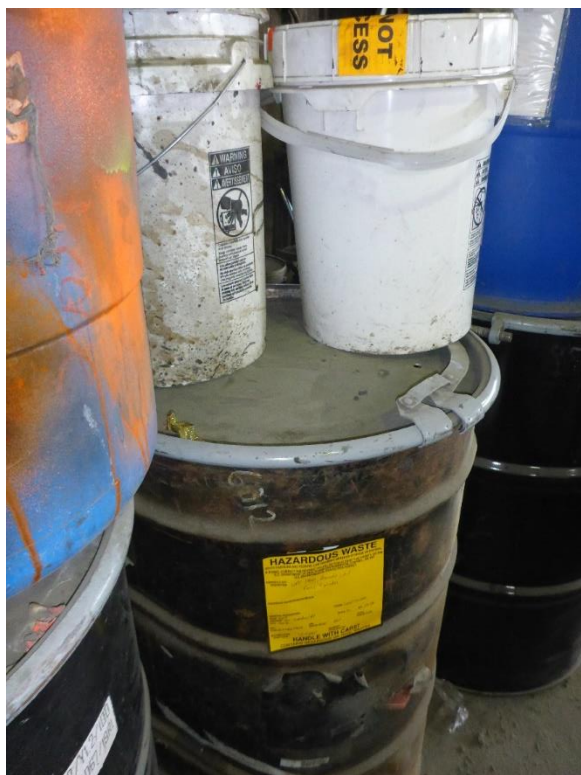
**Photo 1:** 55-gallon drum in SA-6. The drum, which was labeled D001 hazardous waste aerosol can cylinders and marked with an accumulation start date of 04/11/2021, had a small hole in the lid.

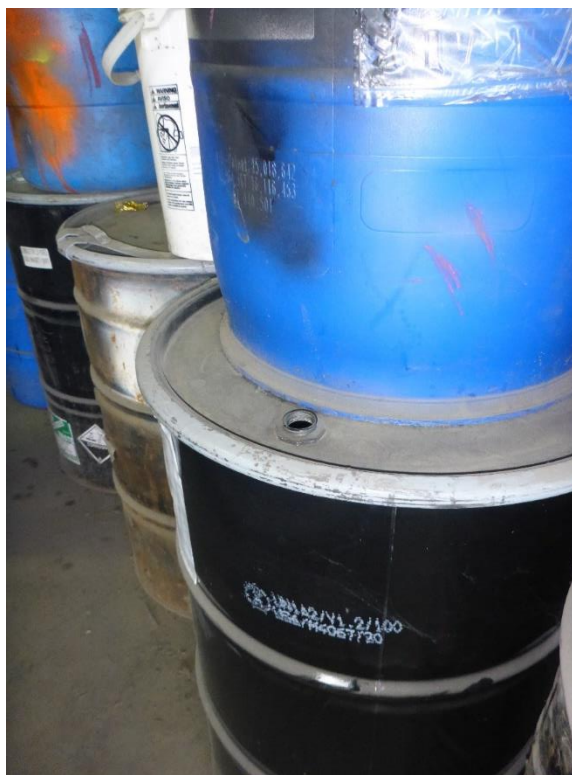
**Photo 2:** 55-gallon drum in SA-6. The drum, which was labeled as D005 / D006 / D007 / D008 hazardous waste paint filters, was missing a bung.

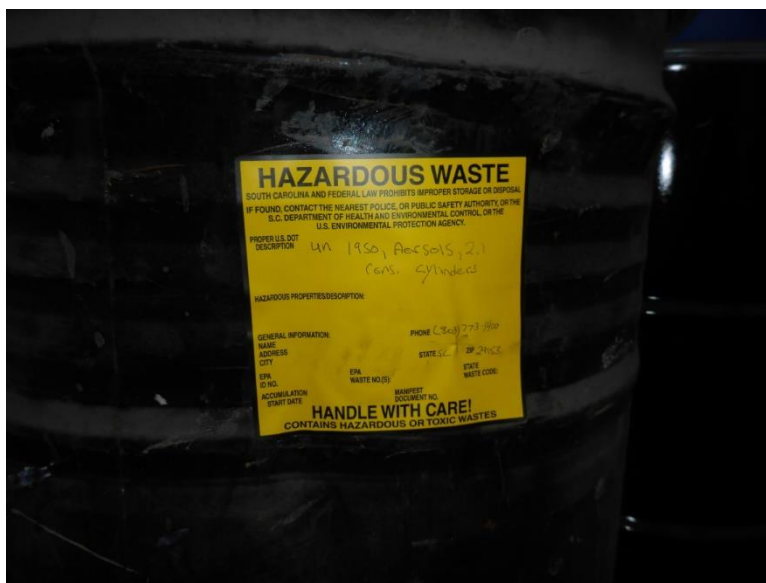
**Photo 3:** 55-gallon drum in SA-6. Drum labeled hazardous waste flammable aerosol can / cylinder, but not labeled with generator information, EPA waste codes, or an accumulation start date.

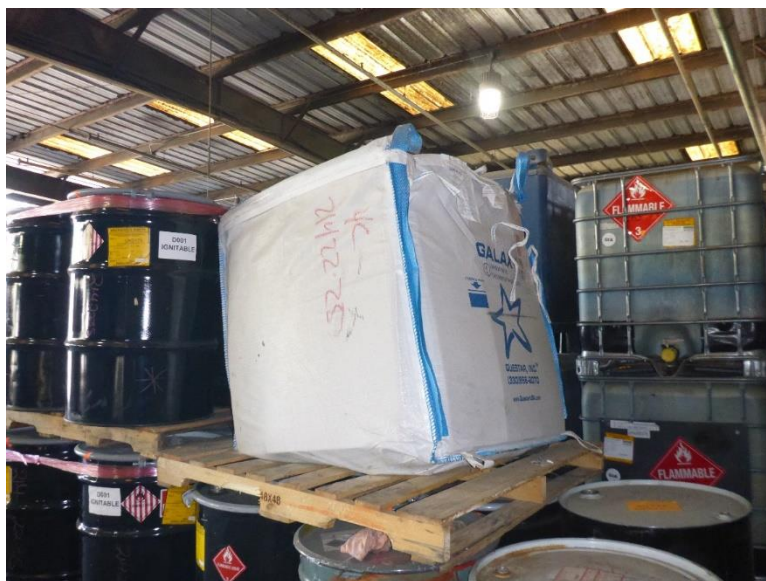
**Photo 4:** Supersack in SA-6, which was marked with the identification number 21-4-22-25, was not labeled with the words hazardous waste.

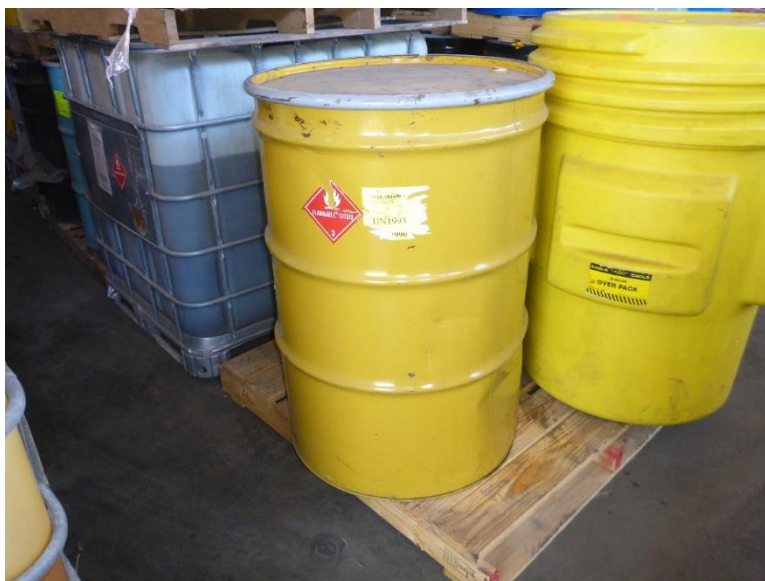
**Photo 5:** Drum in SA-6 with the hazardous waste label scratched off.

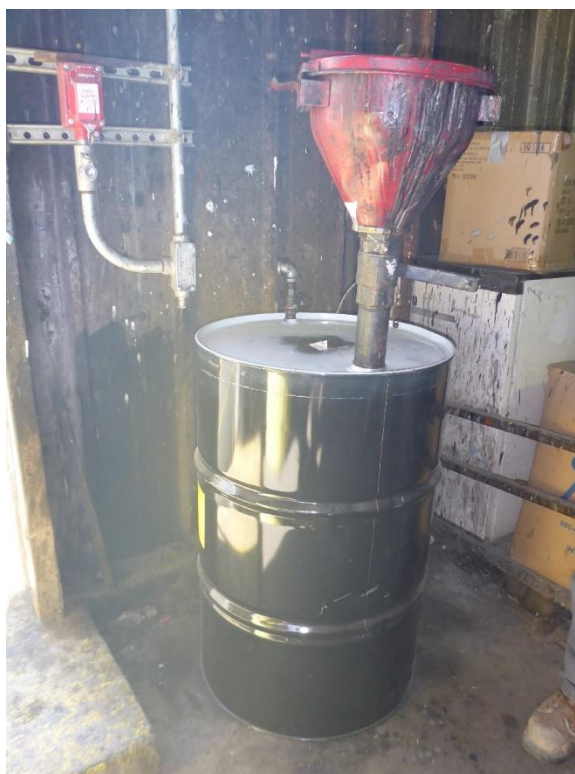
**Photo 6:** One 55-gallon drum in a CAA within SA-6. The drum is used to accumulate and store hazardous waste that is generated at the laboratories. It was equipped with a funnel, labeled as hazardous waste flammable liquid (acetone, xylene), and dated 04/23/2021.

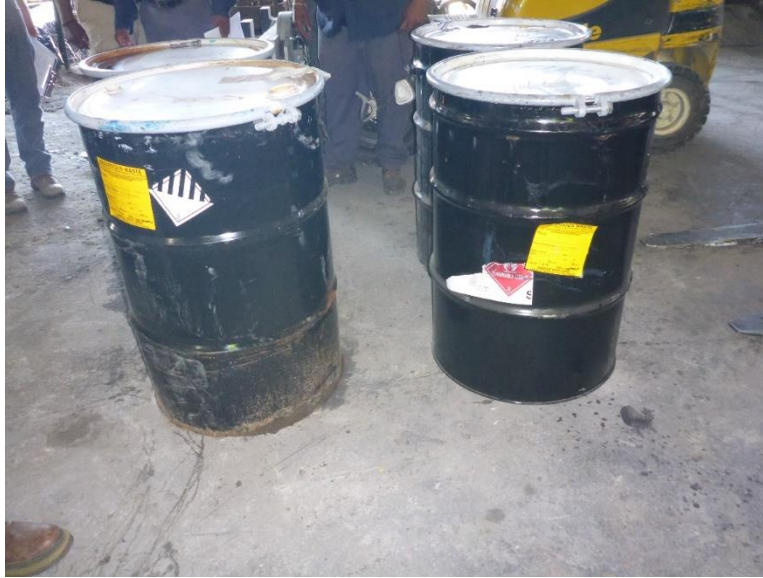
**Photo 7:** Four 55-gallon drums of F005 / F003 / F004 / F001 / F002 / D001 / D006 / D005 hazardous waste solid (xylene / toluene) in SA-5. Each of the containers was identified with a Class 9 DOT hazard placard. One drum had a portion of a flammable hazard placard, which was part of a previous product label which had been torn off, but none of the containers were clearly identified with an indication that the contents are flammable or toxic.

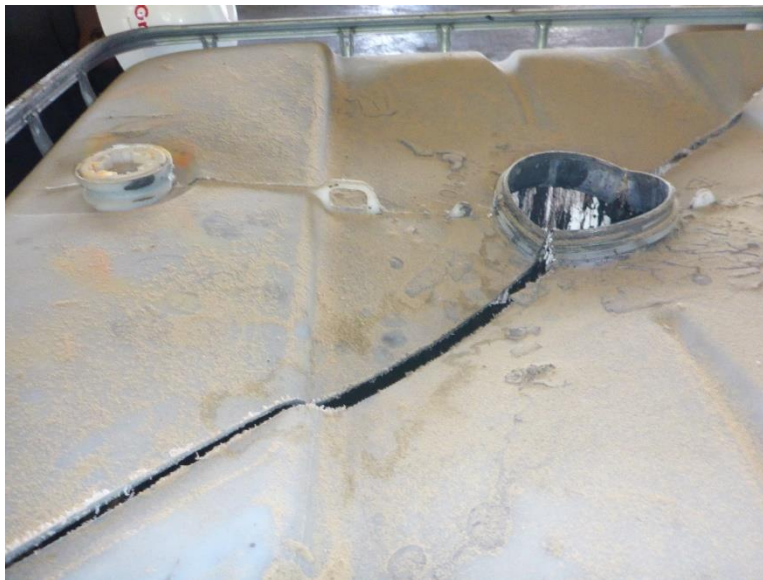
**Photo 8:** One tote of hazardous waste stacked above other waste containers in SA-5. No hazardous waste label was observed on the tote, which was marked with the tracking number 21-2-16-30. The top of the tote had been cut, leaving the container open and in poor condition. The container label, which had fallen inside the tote, indicated that the tote contained D001 / D035 / F003 / F005 hazardous waste flammable liquid (toluene / MEK).

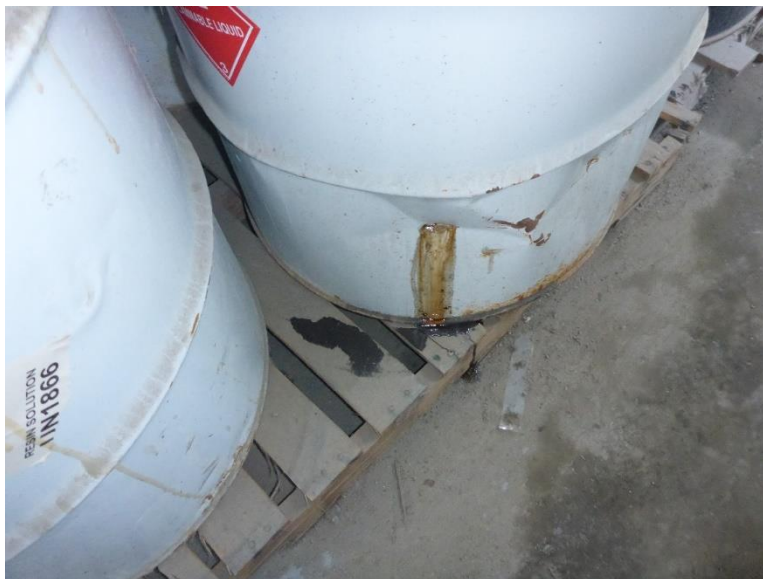
**Photo 9:** Leaking 55-gallon drum in SA-5. Drum was marked with a flammable liquid DOT hazard placard and appeared to be labeled as hazardous waste. The hazardous waste label could not be read, because it was facing away from the aisle and obscured by other containers.

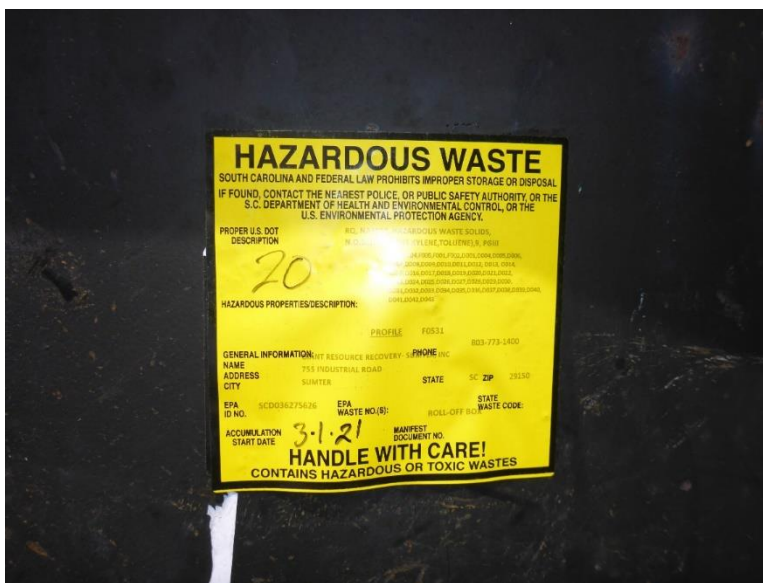
**Photo 10:** Hazardous waste label observed on one of five 40-yard roll-off containers in the CAA.

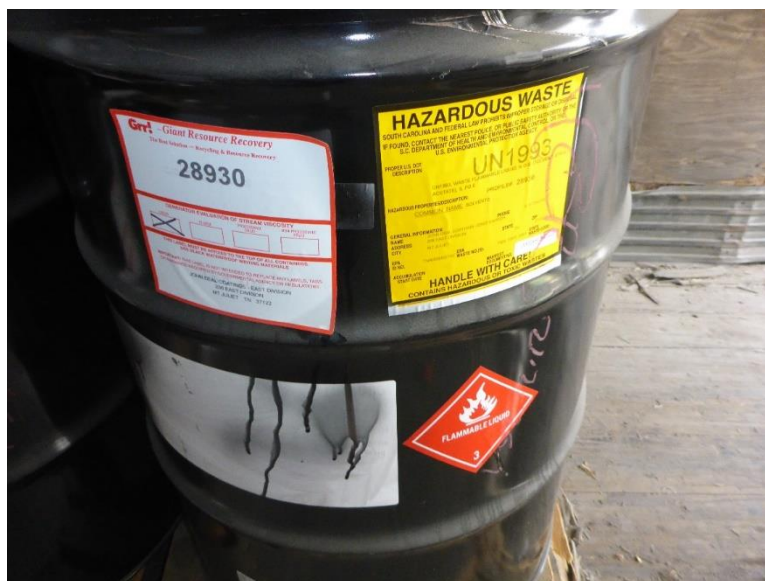
**Photo 11:** Example of one 55-gallon drum observed inside a tractor trailer at the roll-off container CAA.

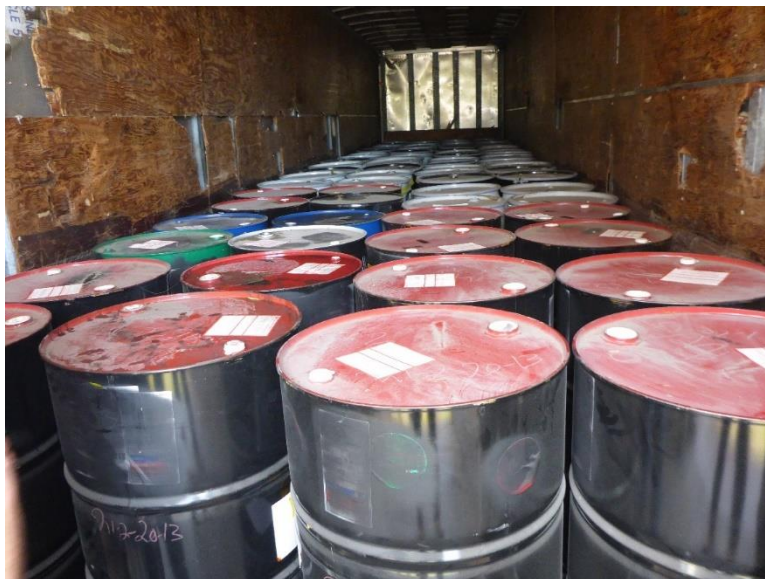
**Photo 12:** First tractor trailer located at the roll-off container CAA. The trailer is full of 55-gallon drums, which were full of hazardous waste generated off-site and received by the facility for treatment, storage and / or disposal.

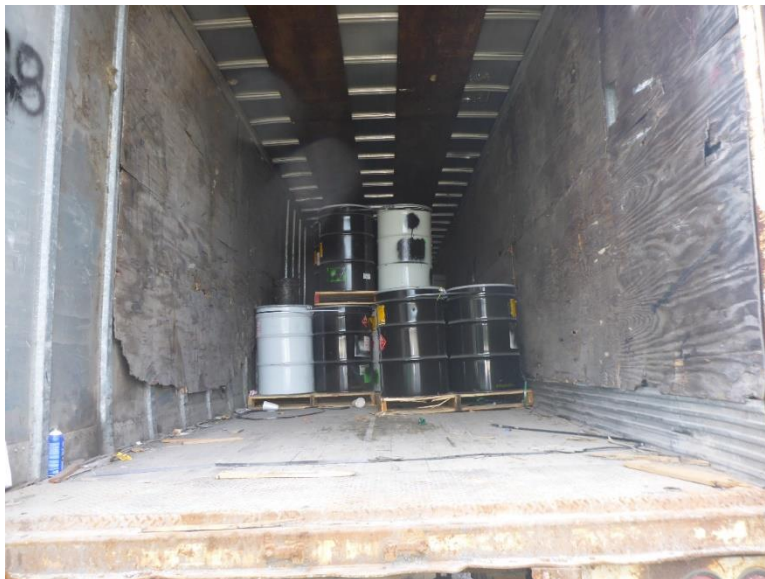
**Photo 13:** Second tractor trailer located at the roll-off container CAA. The trailer is full of 55-gallon drums, which were full of hazardous waste generated off-site and received by the facility for treatment, storage and / or disposal.

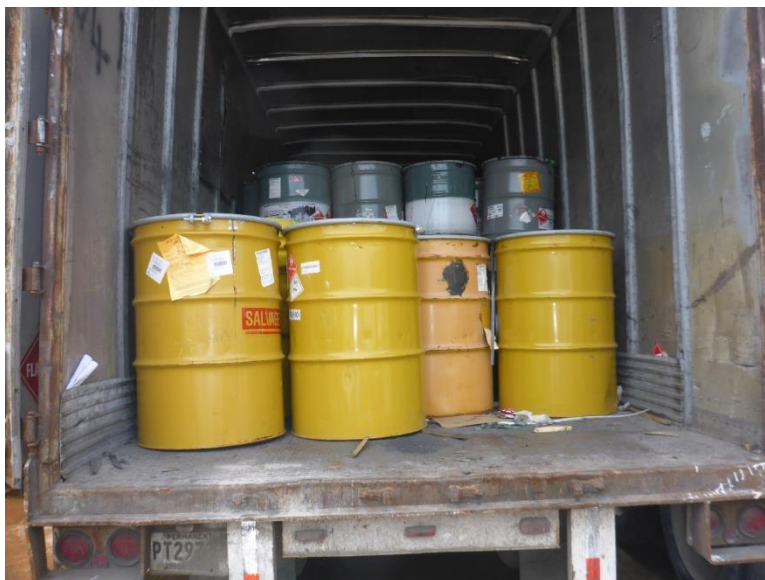
**Photo 14:** Third tractor trailer located at the roll-off container CAA. The trailer is full of 55-gallon drums, which were full of hazardous waste generated off-site and received by the facility for treatment, storage and / or disposal.

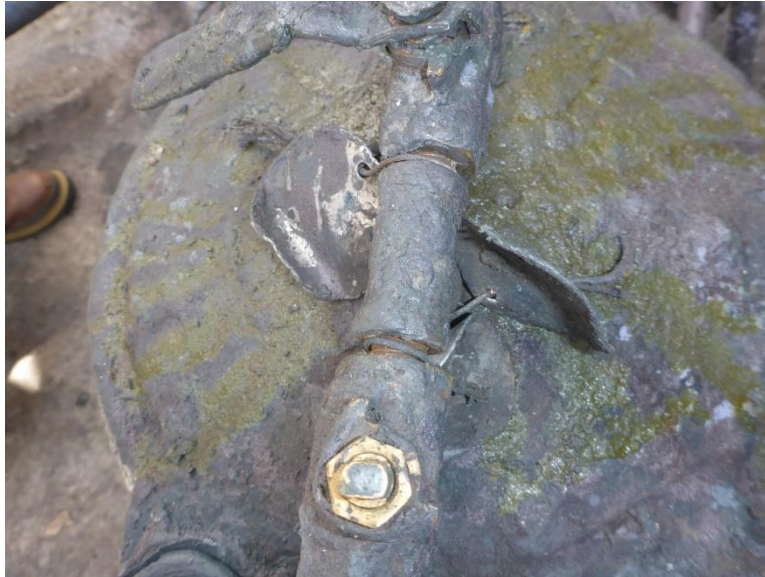
**Photo 15:** Three illegible tags on top of a filter house associated with the BP tank farm in SA-7.

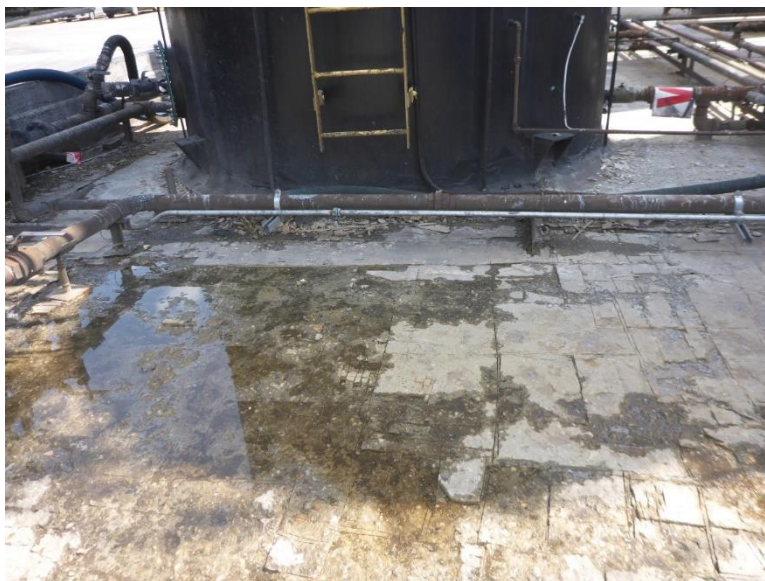
**Photo 17:** Significant cracks, peeled and missing coating in the secondary containment of SA-2.

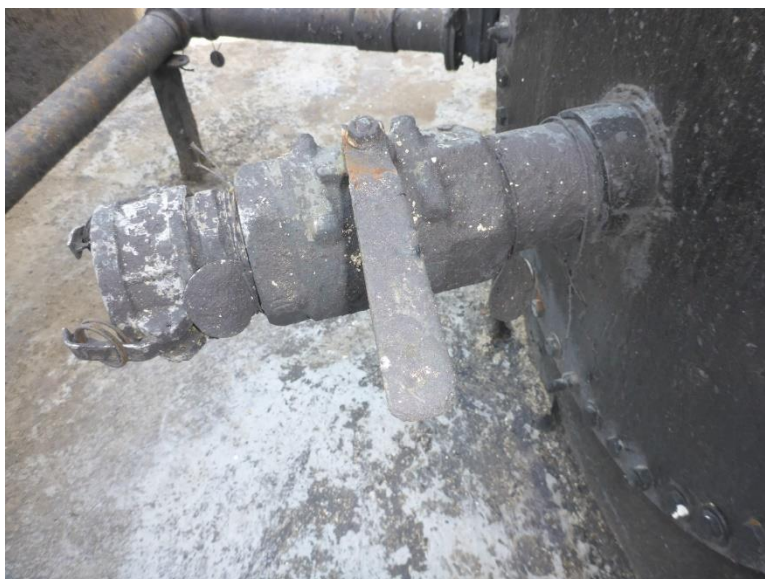
**Photo 18:** Tags associated with Tank 1736B which were not legible.

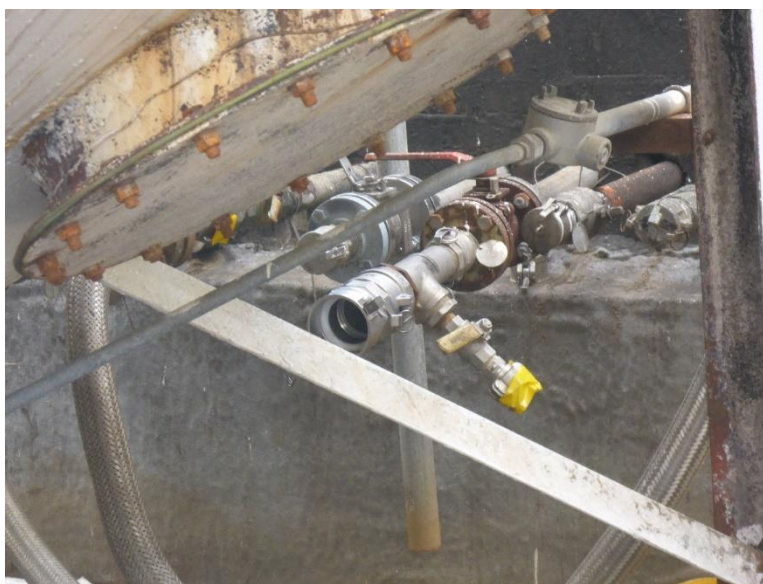
**Photo 20:** Open ended line at the cam-lock fitting that was identified with tag number 572.

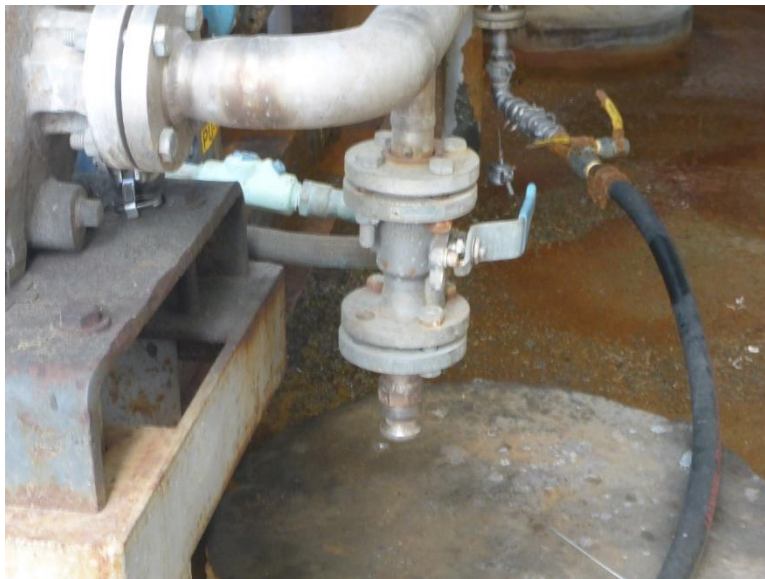
**Photo 23:** Missing bolt on a connection of ancillary equipment associated with the distillation system at T9-A.

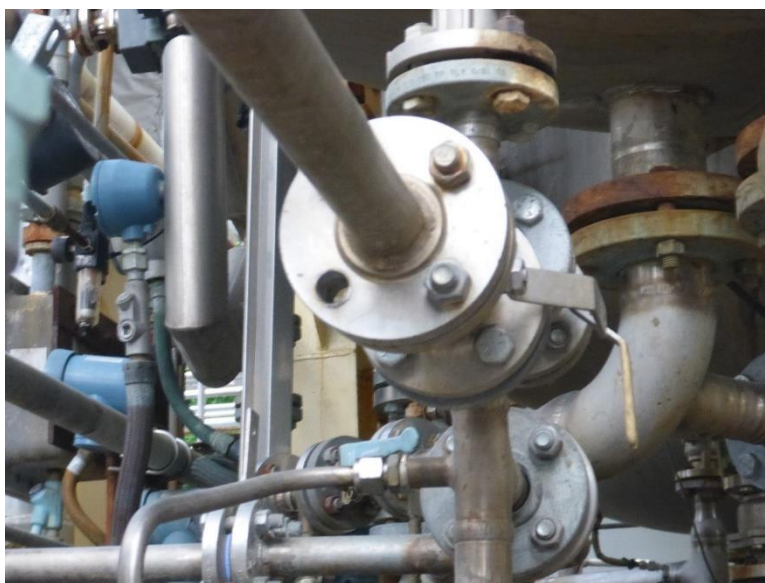
**Photo 24:** Missing bolt on a connection of ancillary equipment associated with the distillation system at T9-A.

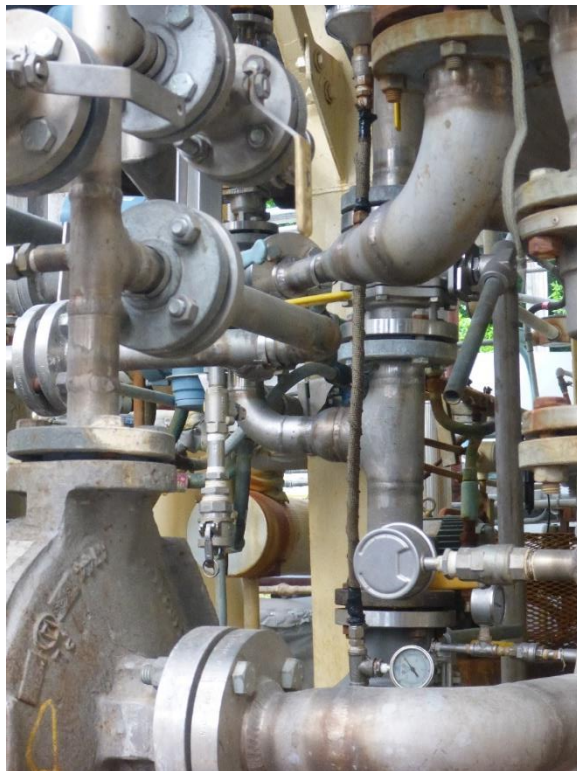
**Photo 25:** No tags on equipment associated with the distillation process.

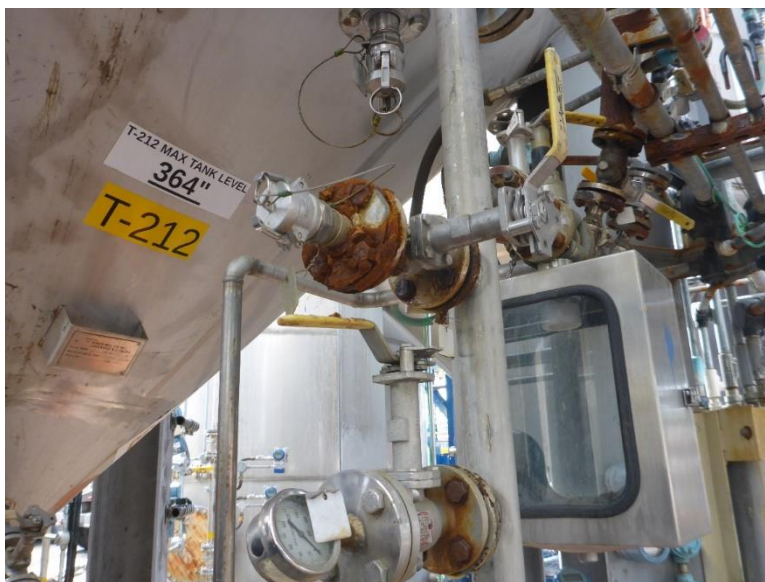
**Photo 26:** Severe corrosion on tags and ancillary equipment associated with Tank 212. Corrosion caused the tags to be illegible.

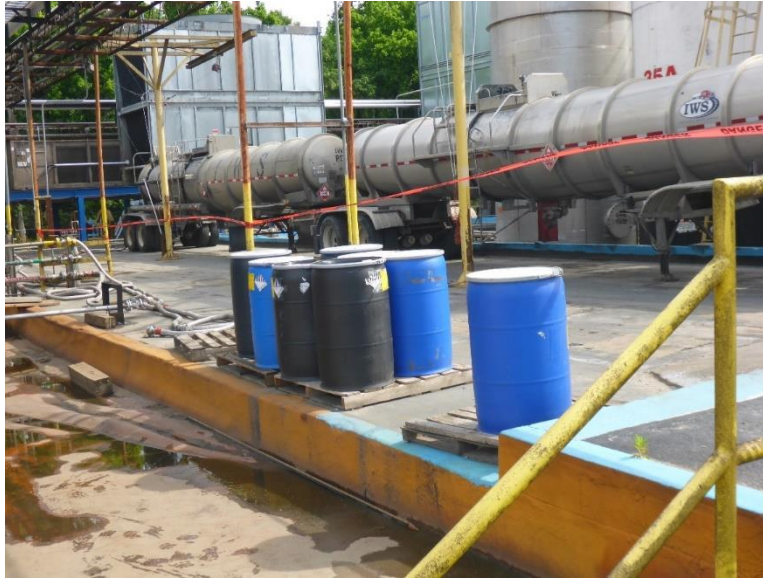
**Photo 27:** Eight 55-gallon drums in the CAA located next to the SA-2 storage pad.
