Clean Water Act Section 404: Site Visit/Case Development

Site Name: Fair Oaks Road Associates

Fair Oaks Road Associates Property (Tax ID: 14-1-68)
Fair Oaks Road, Middletown, NY
(41.5015, -74.4140)

EPA CWA 404 Inspection Photolog
Fair Oaks Road Associates, Inc.
Middletown, Orange County, NY

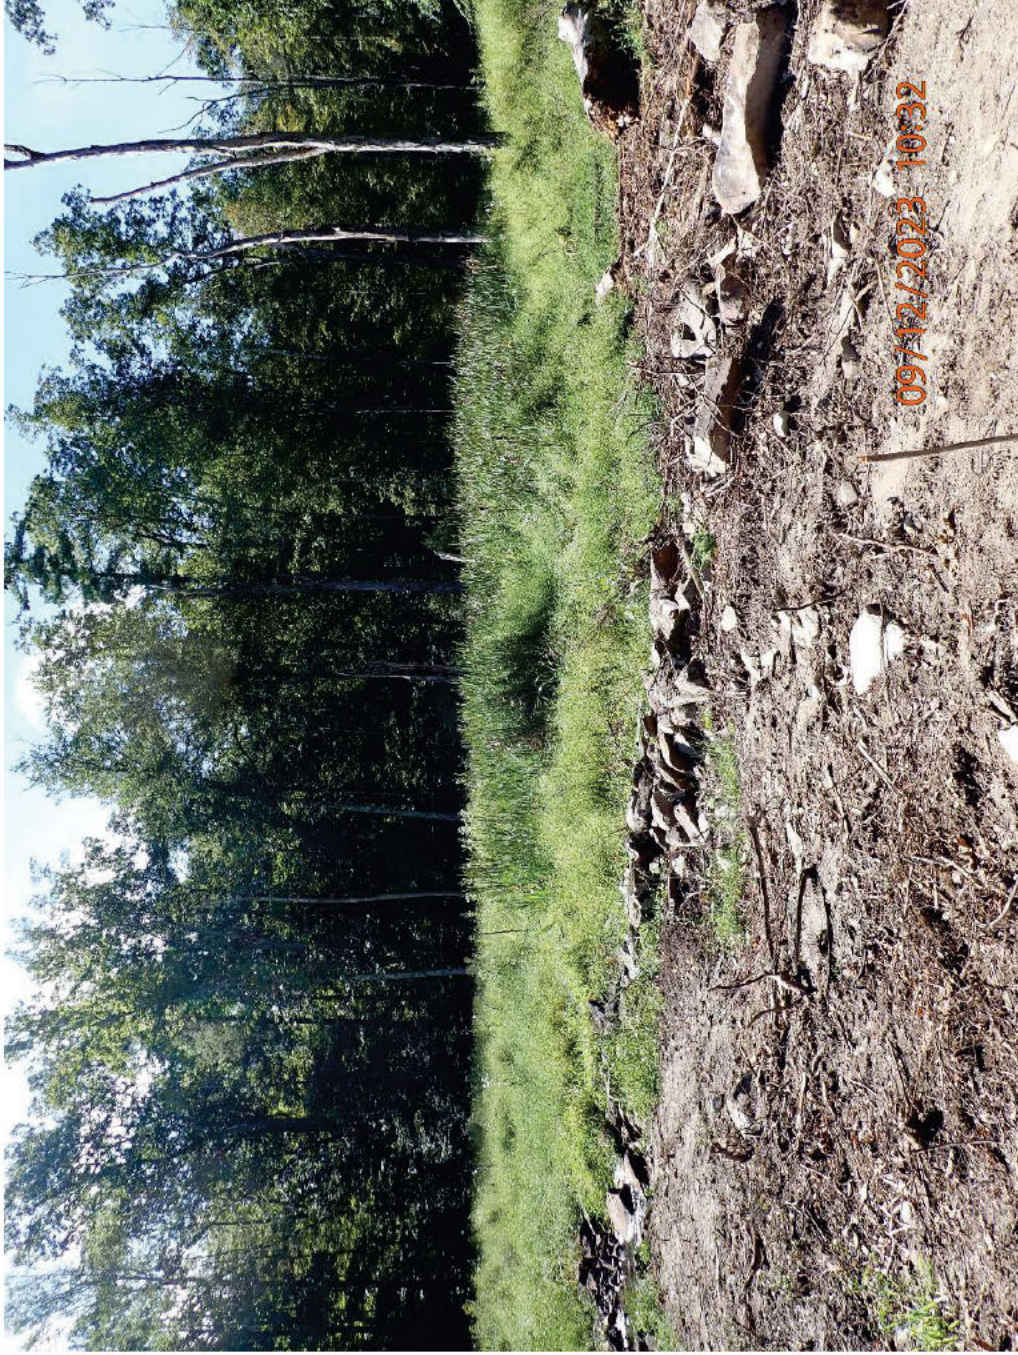
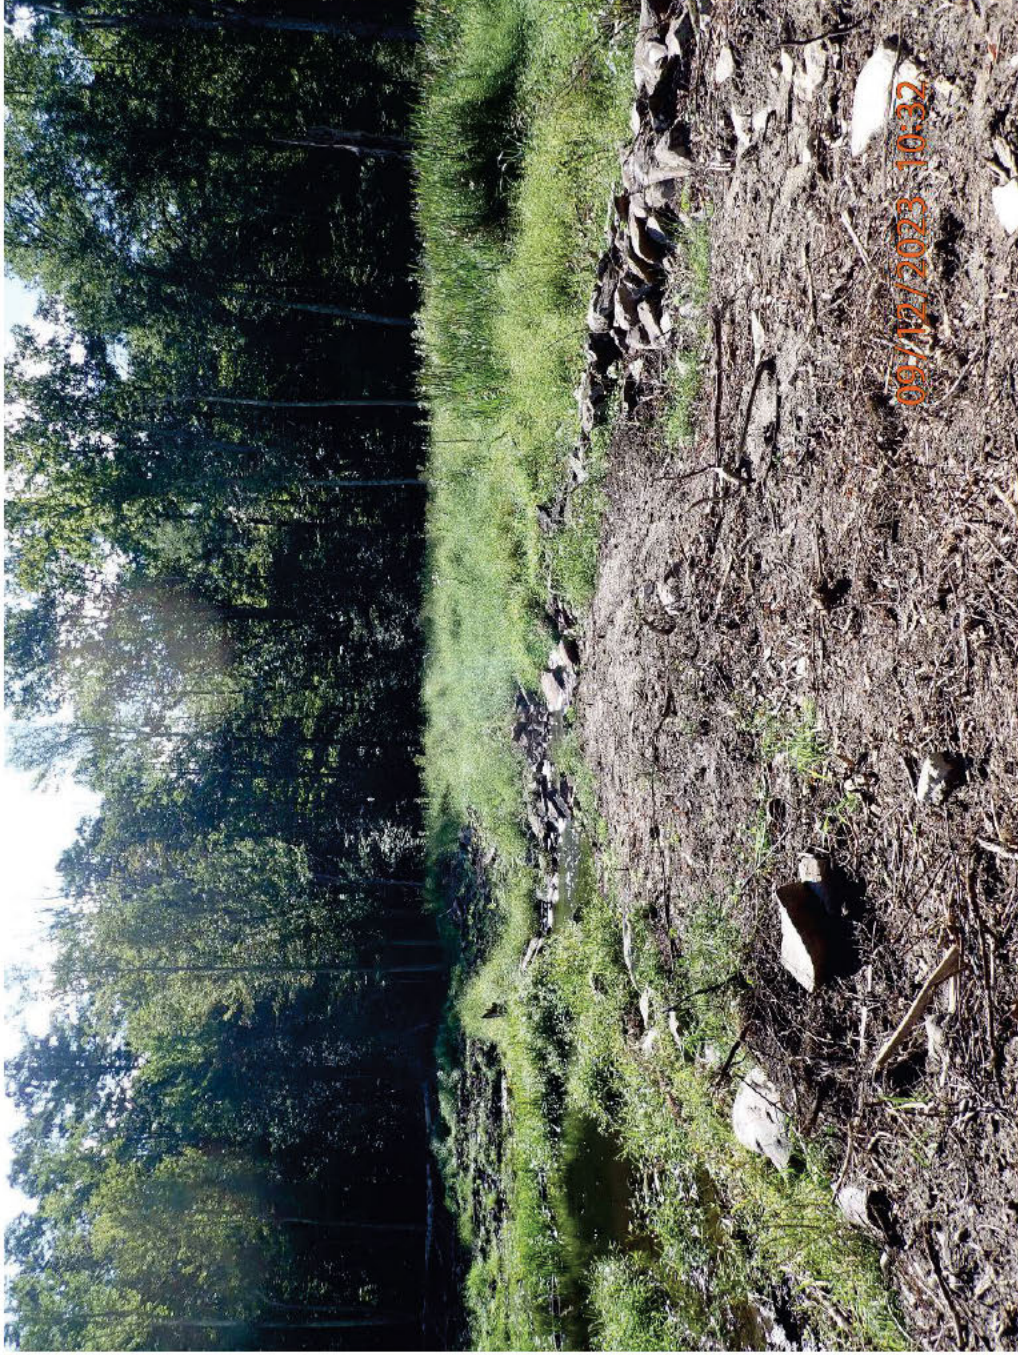
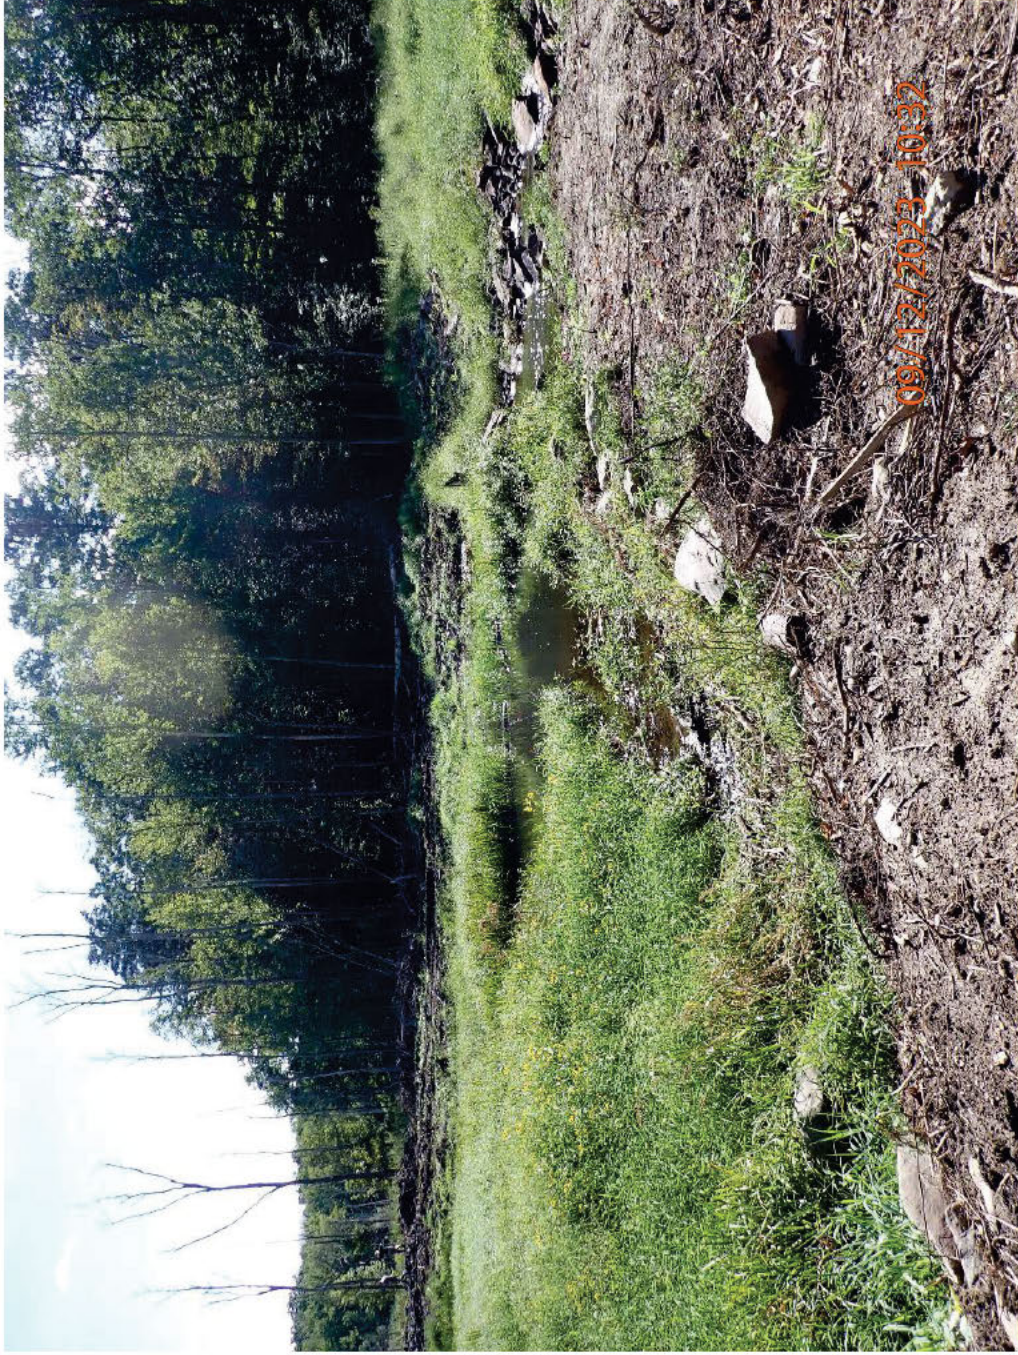
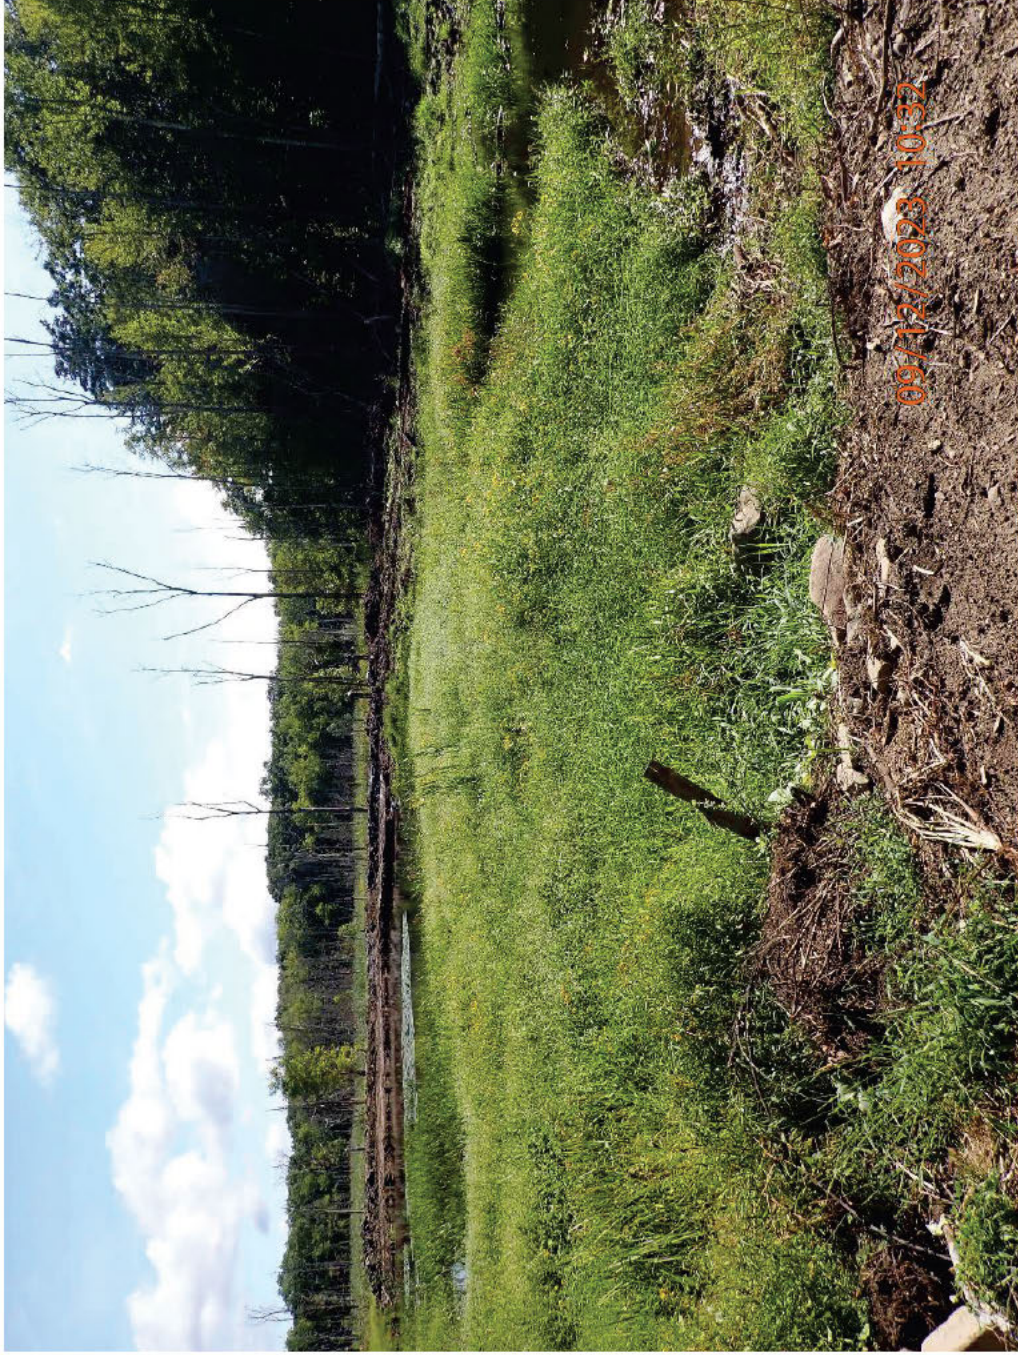
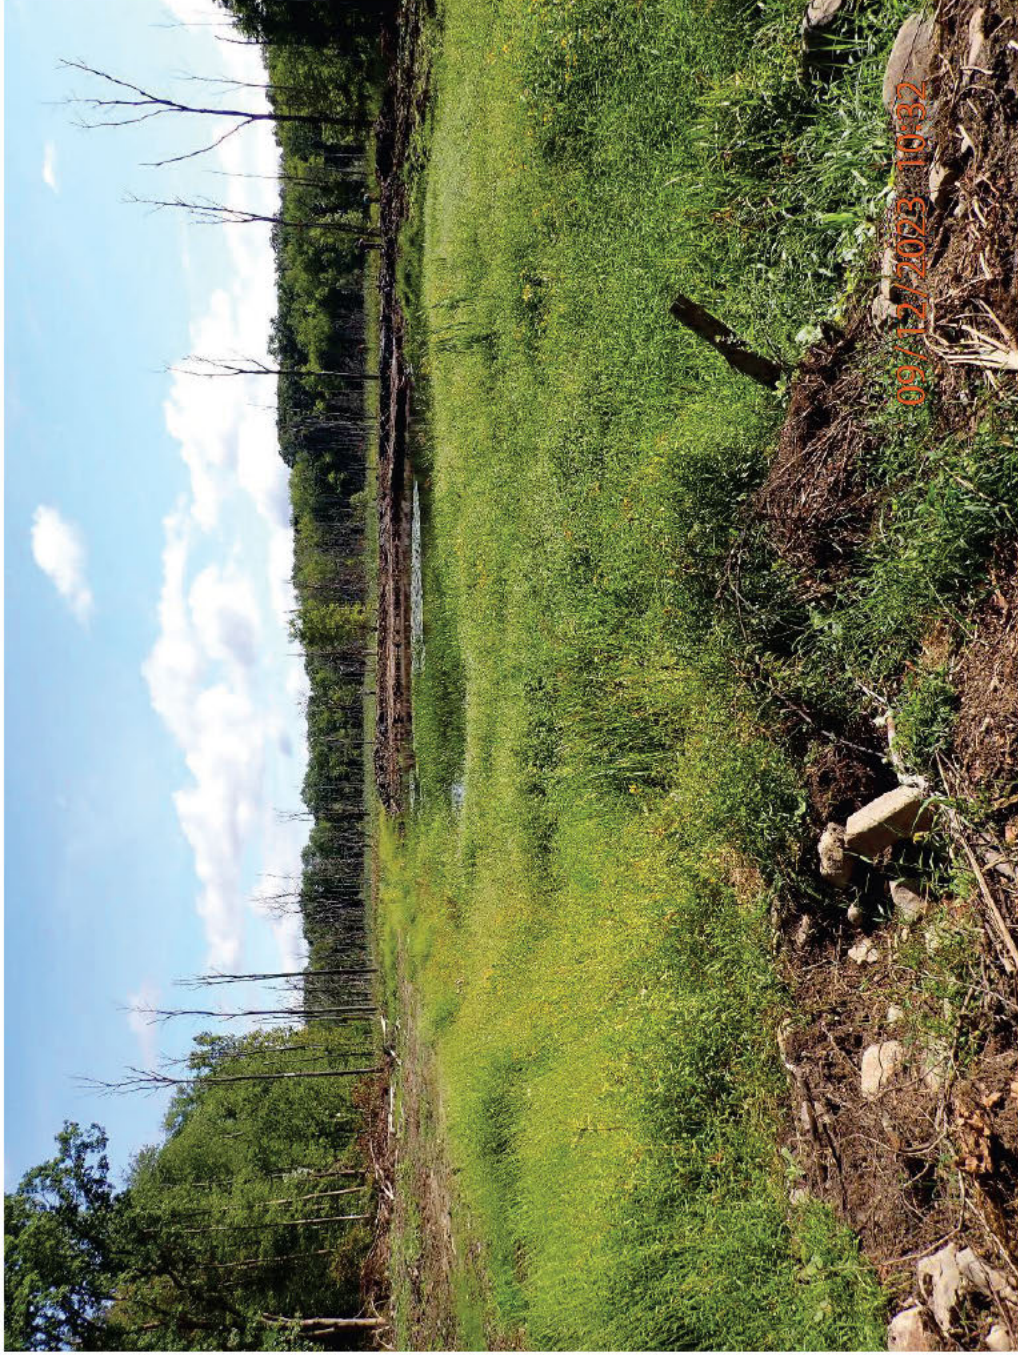
Date: 9/12/2023
Time: 10:32 AM
Photographer: S. Andreescu
Photo ID: 1 – P9120152

(1/5) Panorama of access road to NYS Class "B" Stream

Description:
(2/5) Panorama of access road
to NYS Class "B" Stream

(3/5) Panorama of access road
to NYS Class "B" Stream
Site overview

Description:
(4/5) Panorama of access road
to NYS Class "B" Stream
Site overview

Description:
(5/5) Panorama of access road
to NYS Class "B" Stream
Site overview

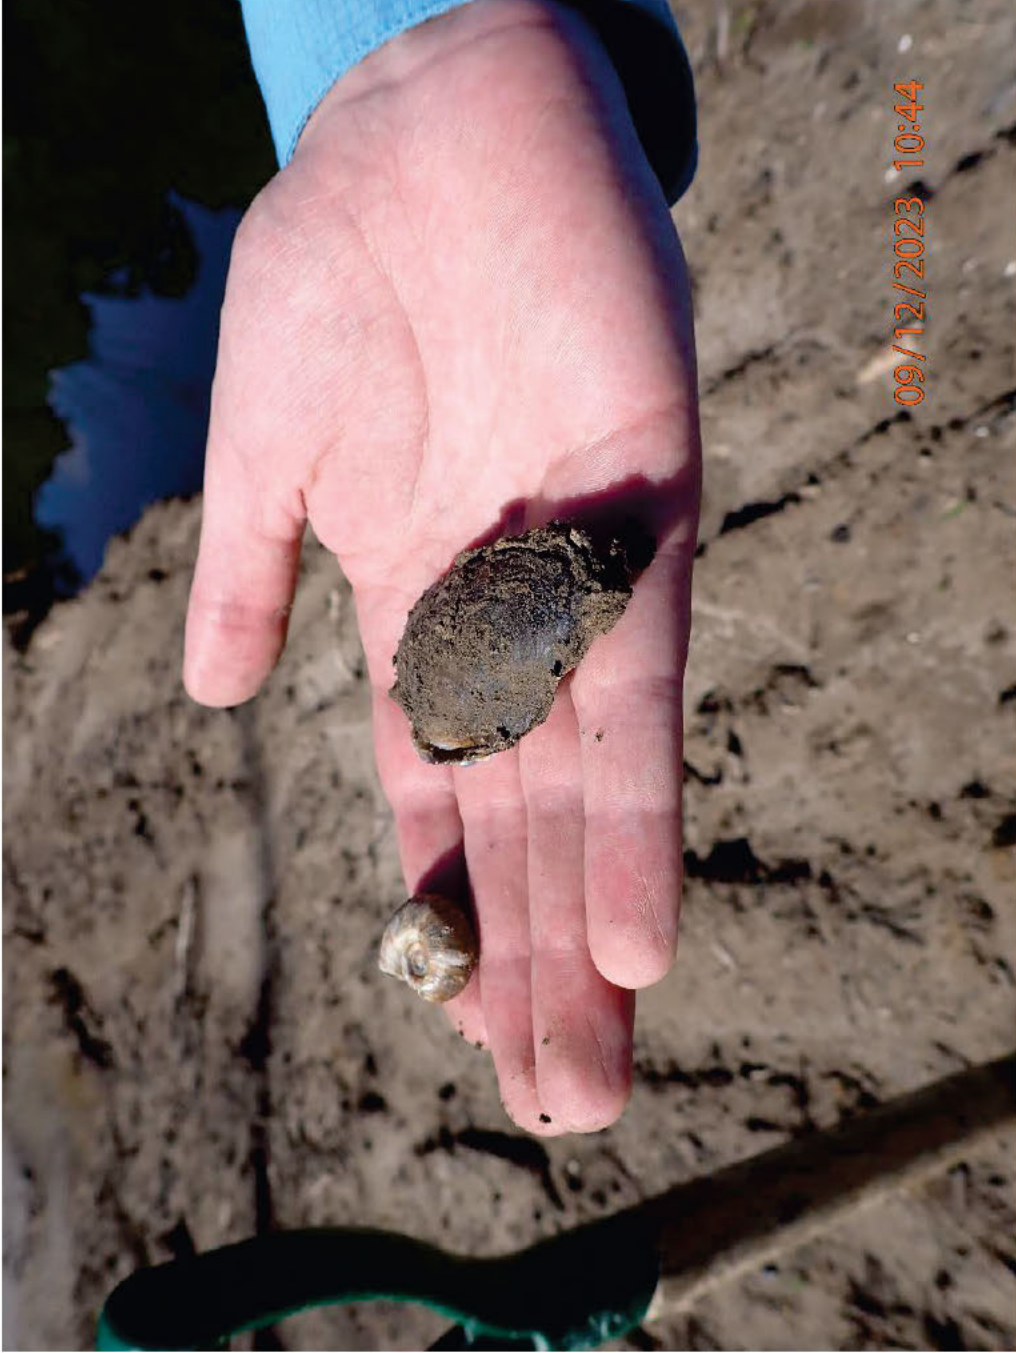
Date: 9/12/2023
Time: 10:44 AM
Photographer: S. Andreescu
Photo ID: 6 – P9120157

Deceased organisms (snail and mussel) found in or around fill material

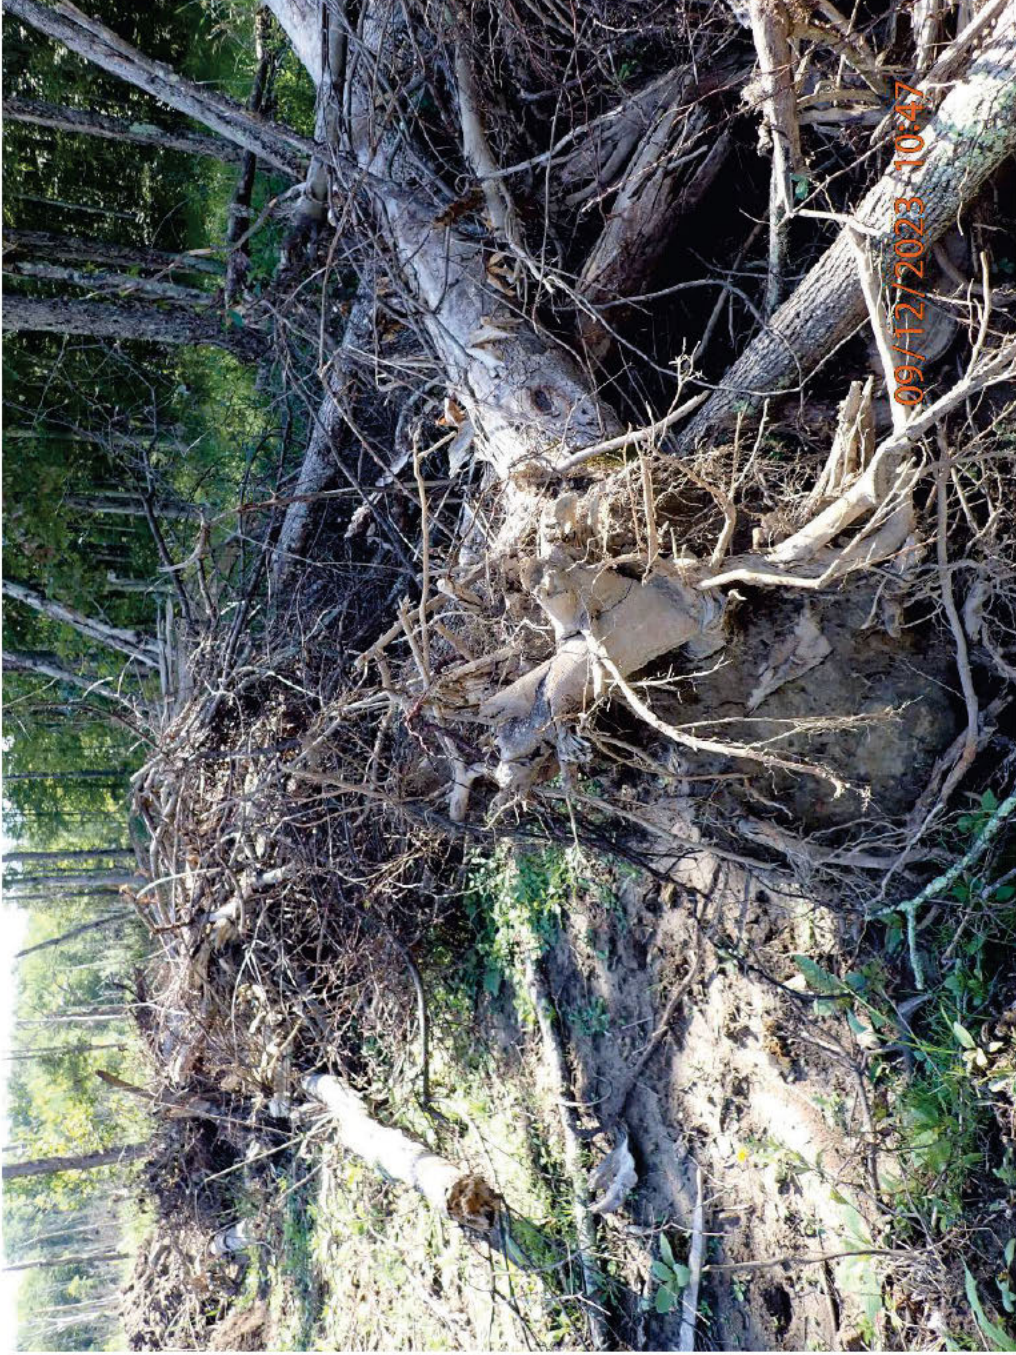
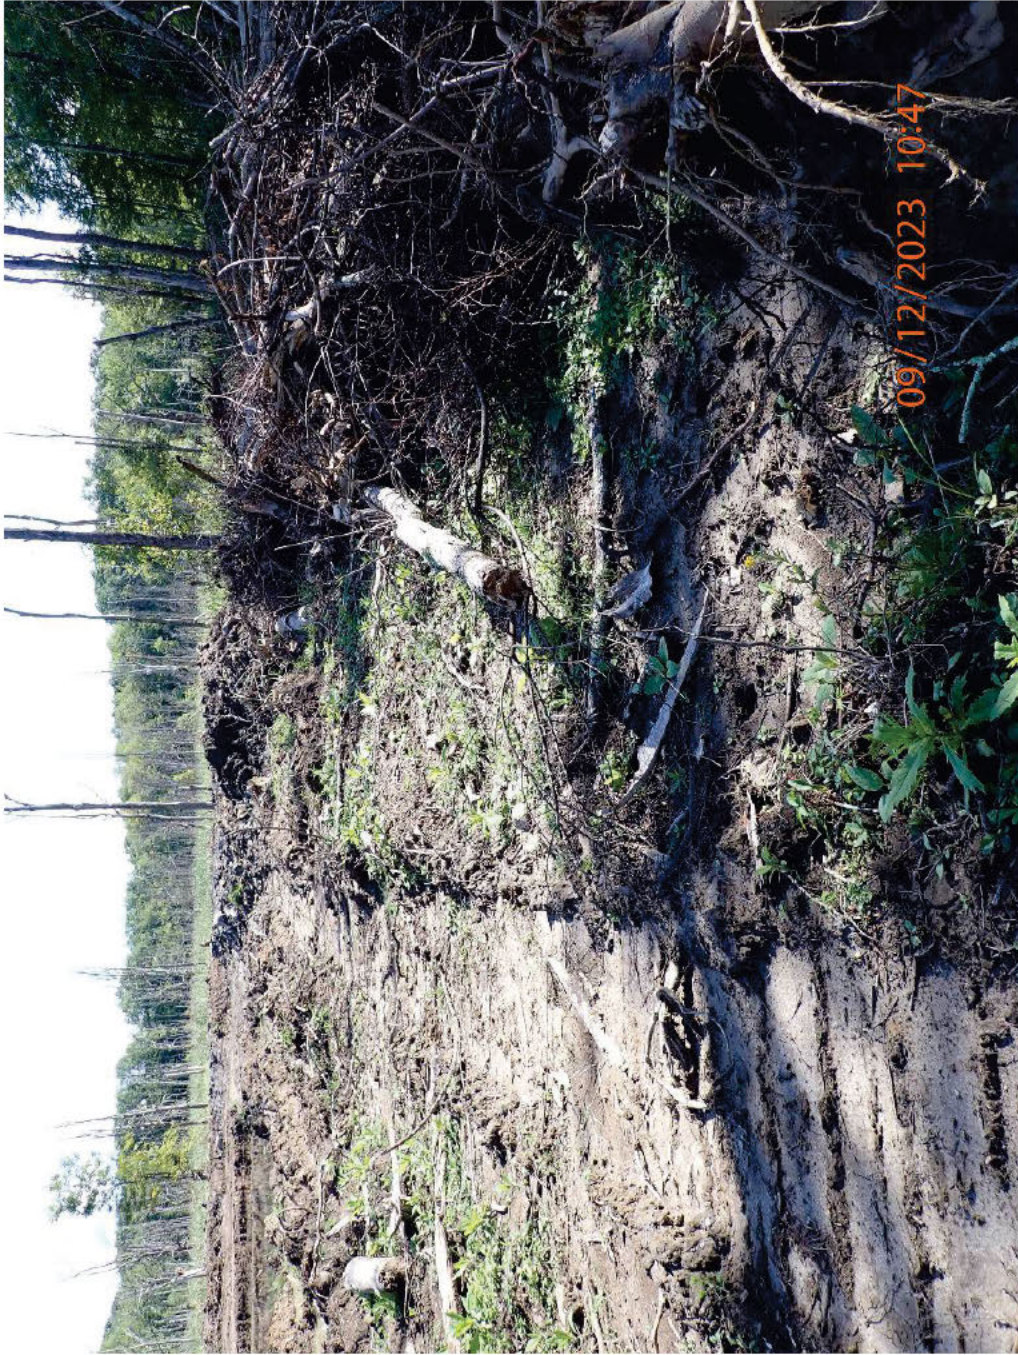
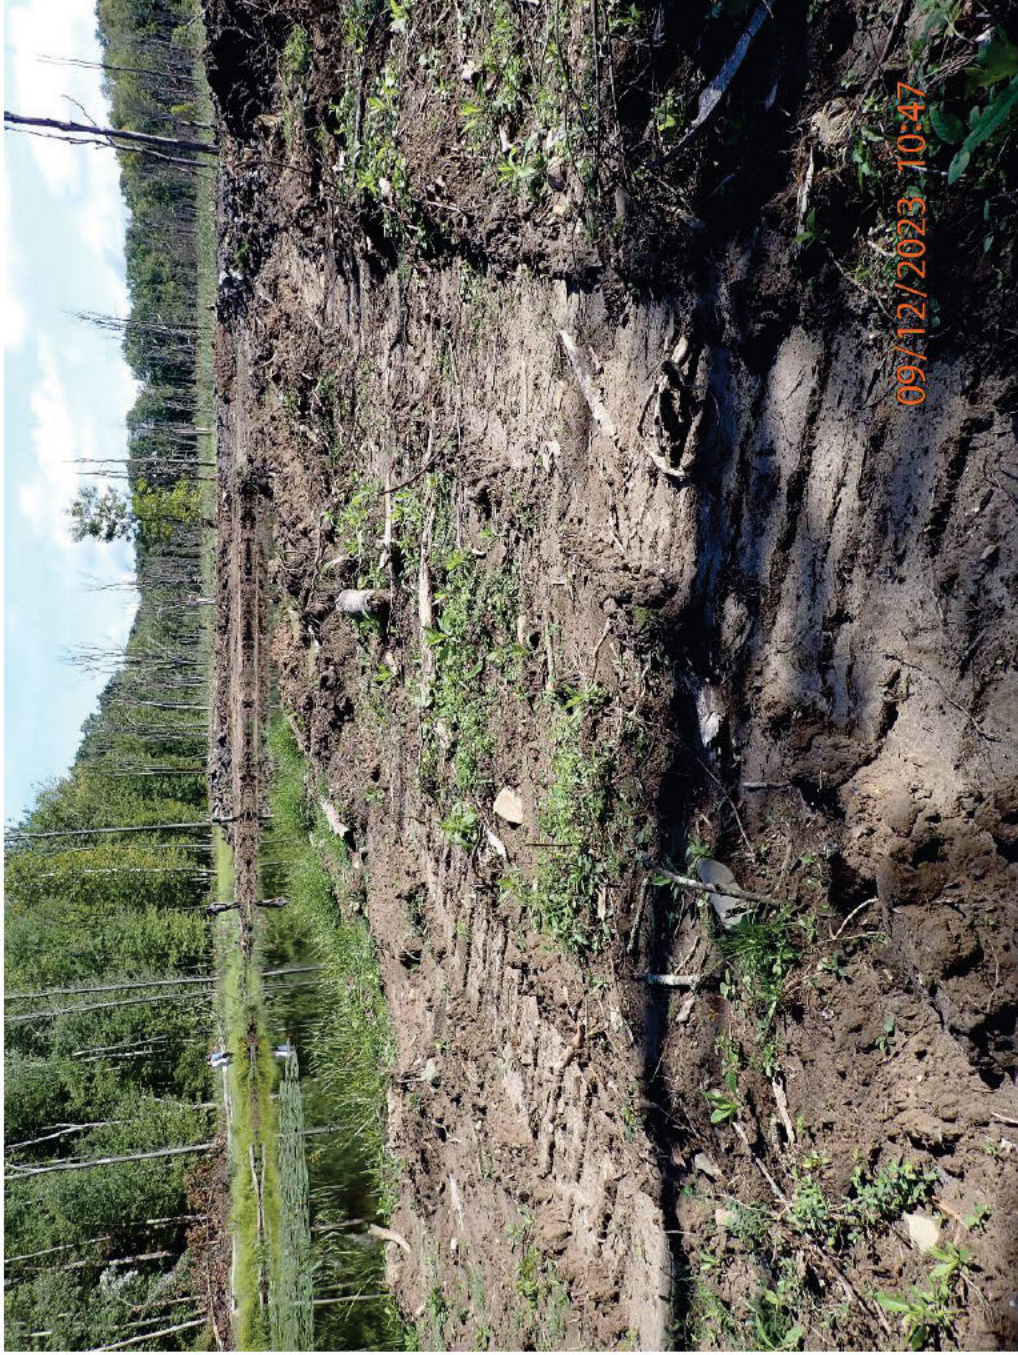
Date: 9/12/2023
Time: 10:47 AM
Photographer: S. Andreescu
Photo ID: 7 – P9120158

Description:
(1/3) Panorama of tree roots
indicative of grubbing activities

Description:
(2/3) Panorama of tree roots
indicative of grubbing activities

Description:
(3/3) Panorama of tree roots
indicative of grubbing activities

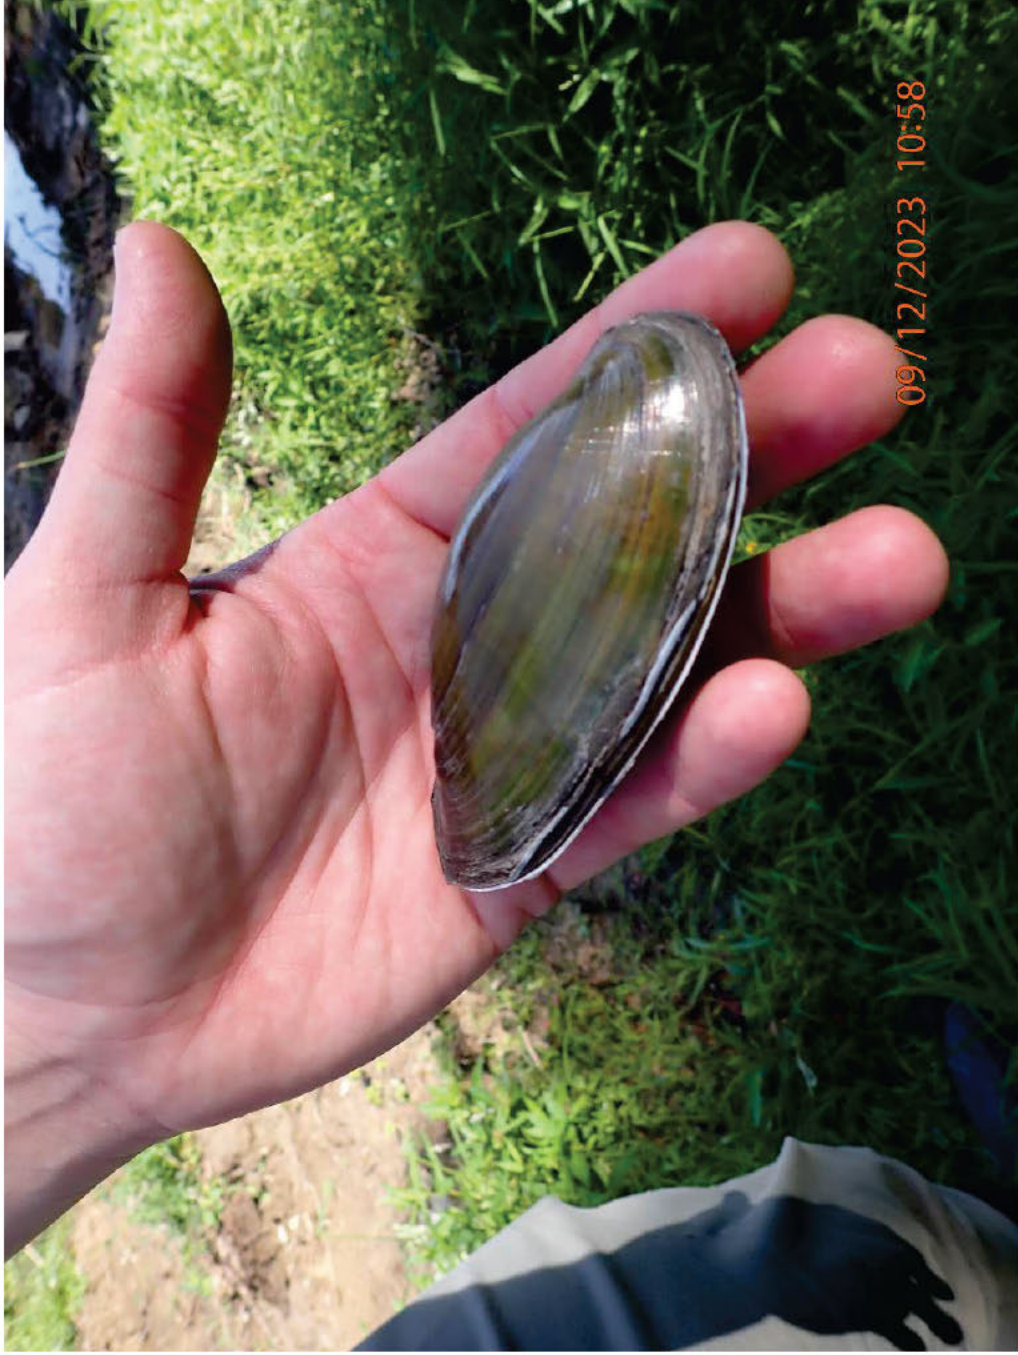
Date: 9/12/2023
Time: 10:58 AM
Photographer: S. Andreescu
Photo ID: 10 – P9120161

Deceased mussel found in or
around fill material

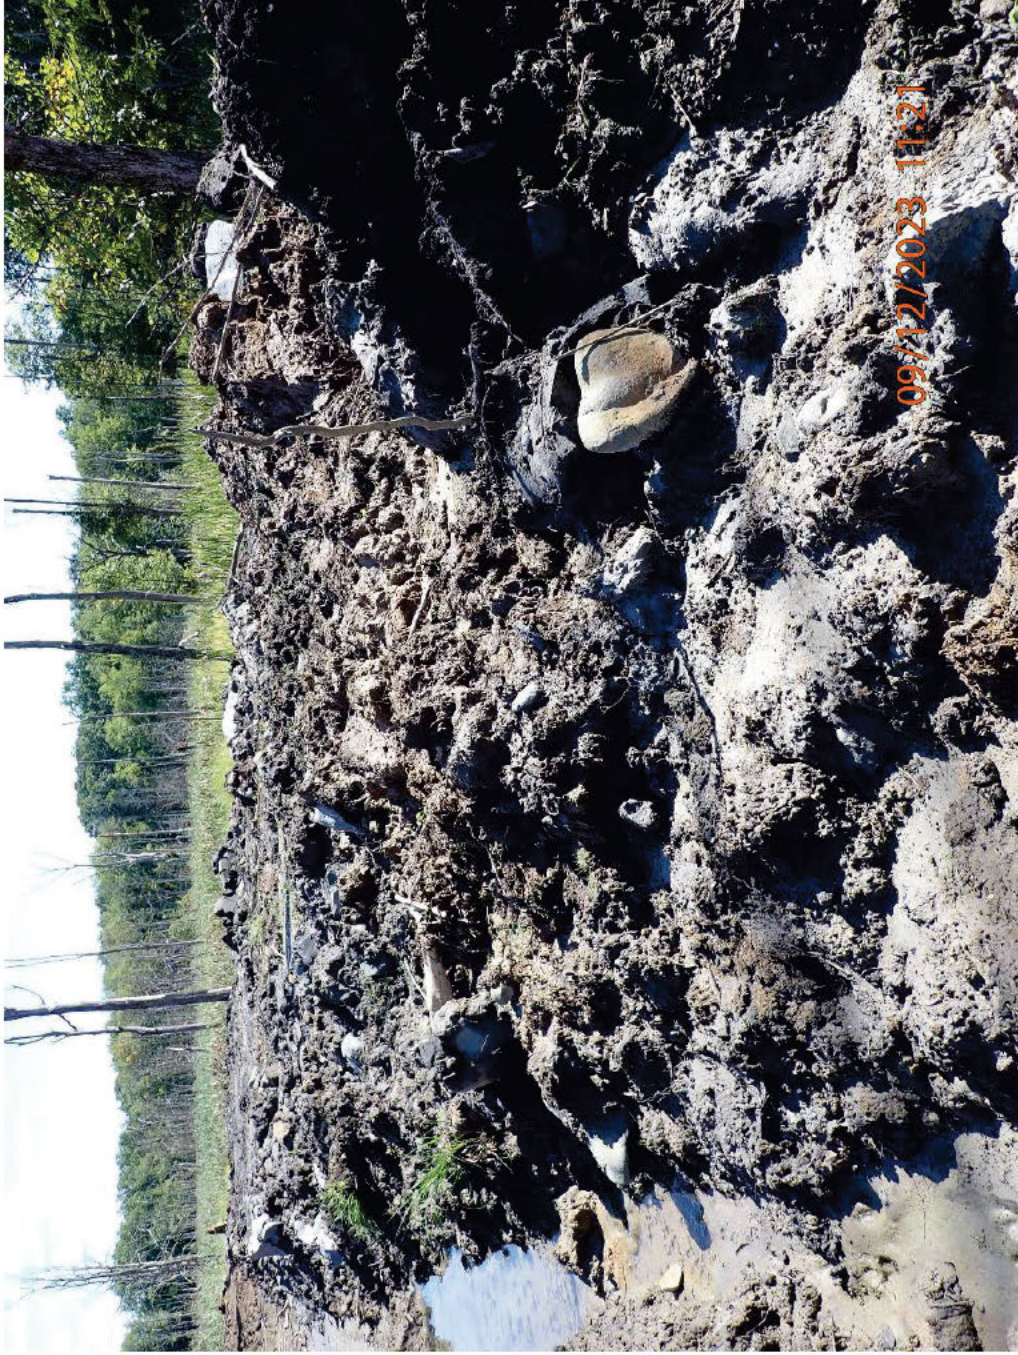
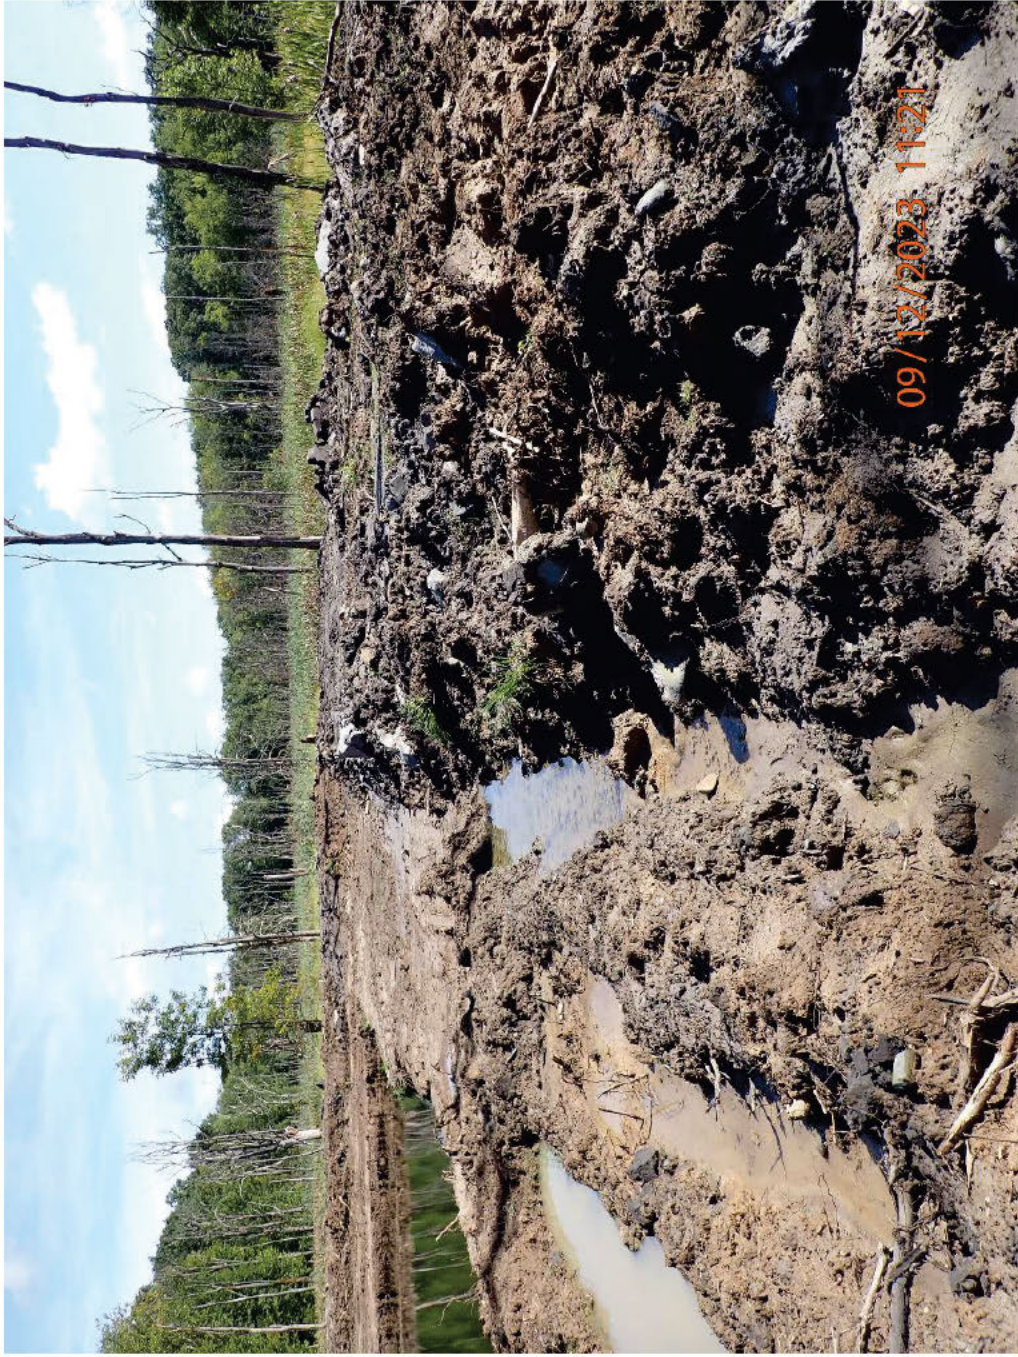
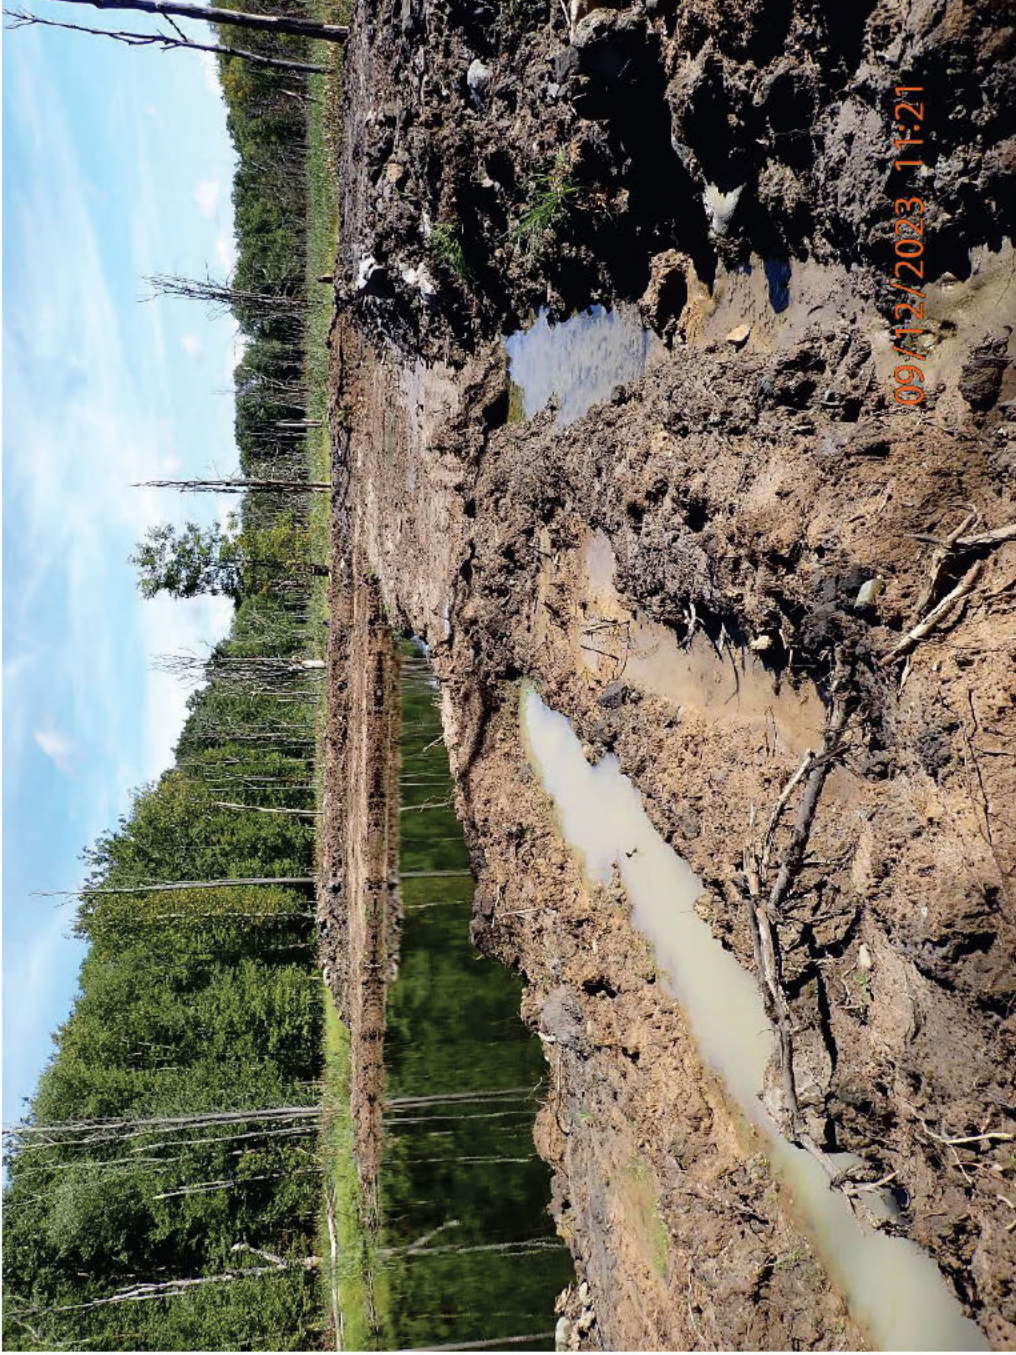
Date: 9/12/2023
Time: 11:21 AM
Photographer: S. Andreescu
Photo ID: 11 – P9120162

The property is undeveloped. A gravel/dirt road off of Fair Oaks Road leads down to the pond.			
Purpose and Need for Discharge of Dredged and/or Fill Material			
Fill material was discharged to potential wetland areas from dredging the in-stream pond and clearing vegetation on the property.

(1/3) Panorama of fill material next to pond

Description:
(2/3) Panorama of fill material next to pond

Description:
(3/3) Panorama of fill material next to pond

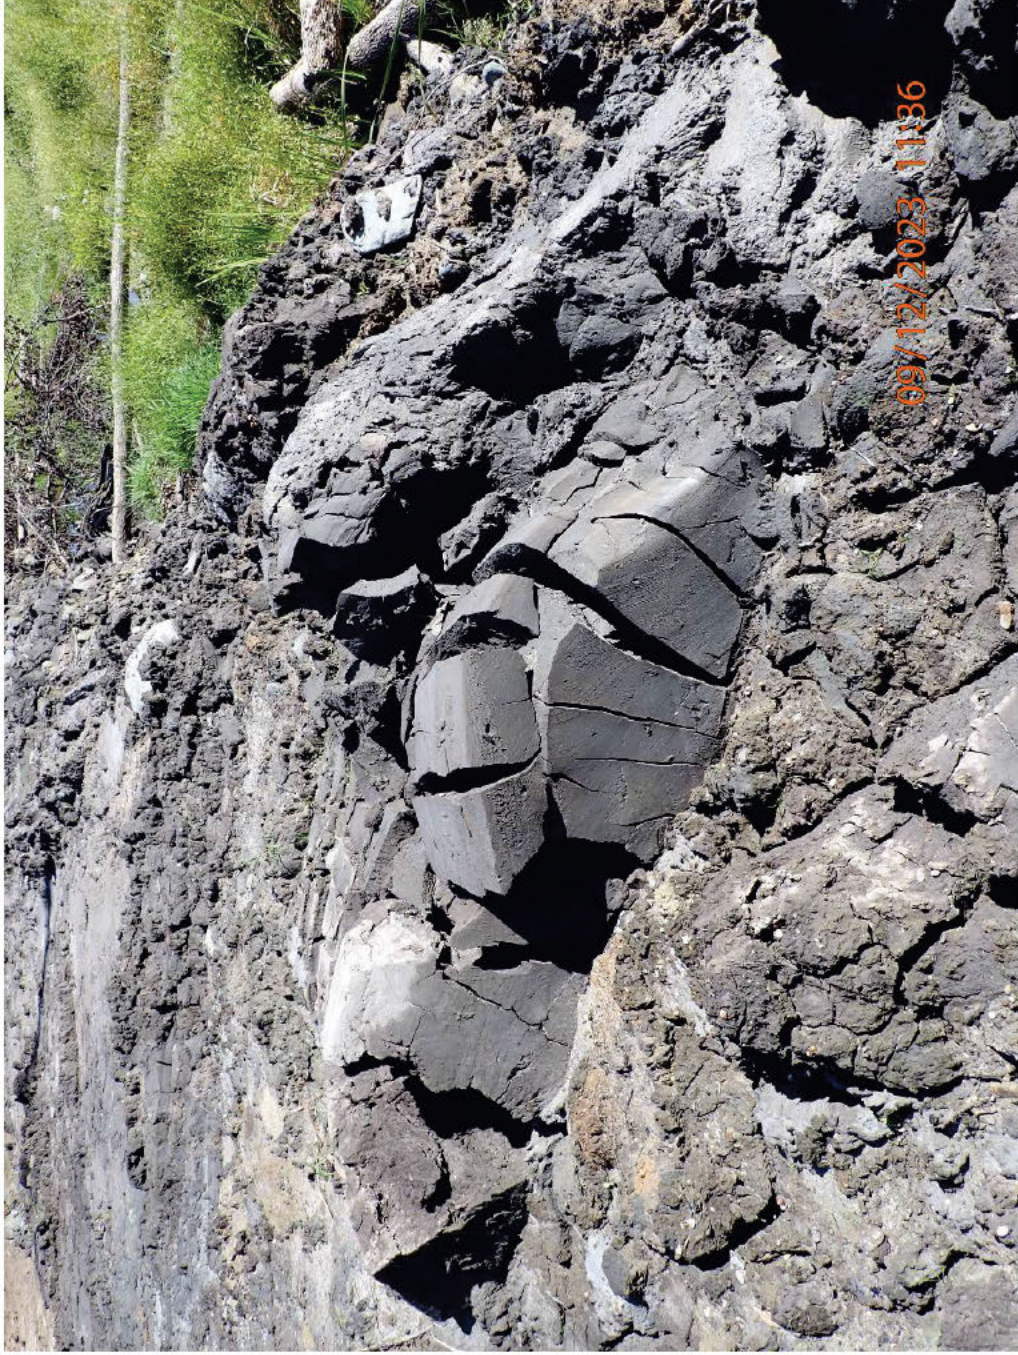
Date: 9/12/2023
Time: 11:36 AM
Photographer: S. Andreescu
Photo ID: 14 – P9120165

Fill material (bucket-shaped)

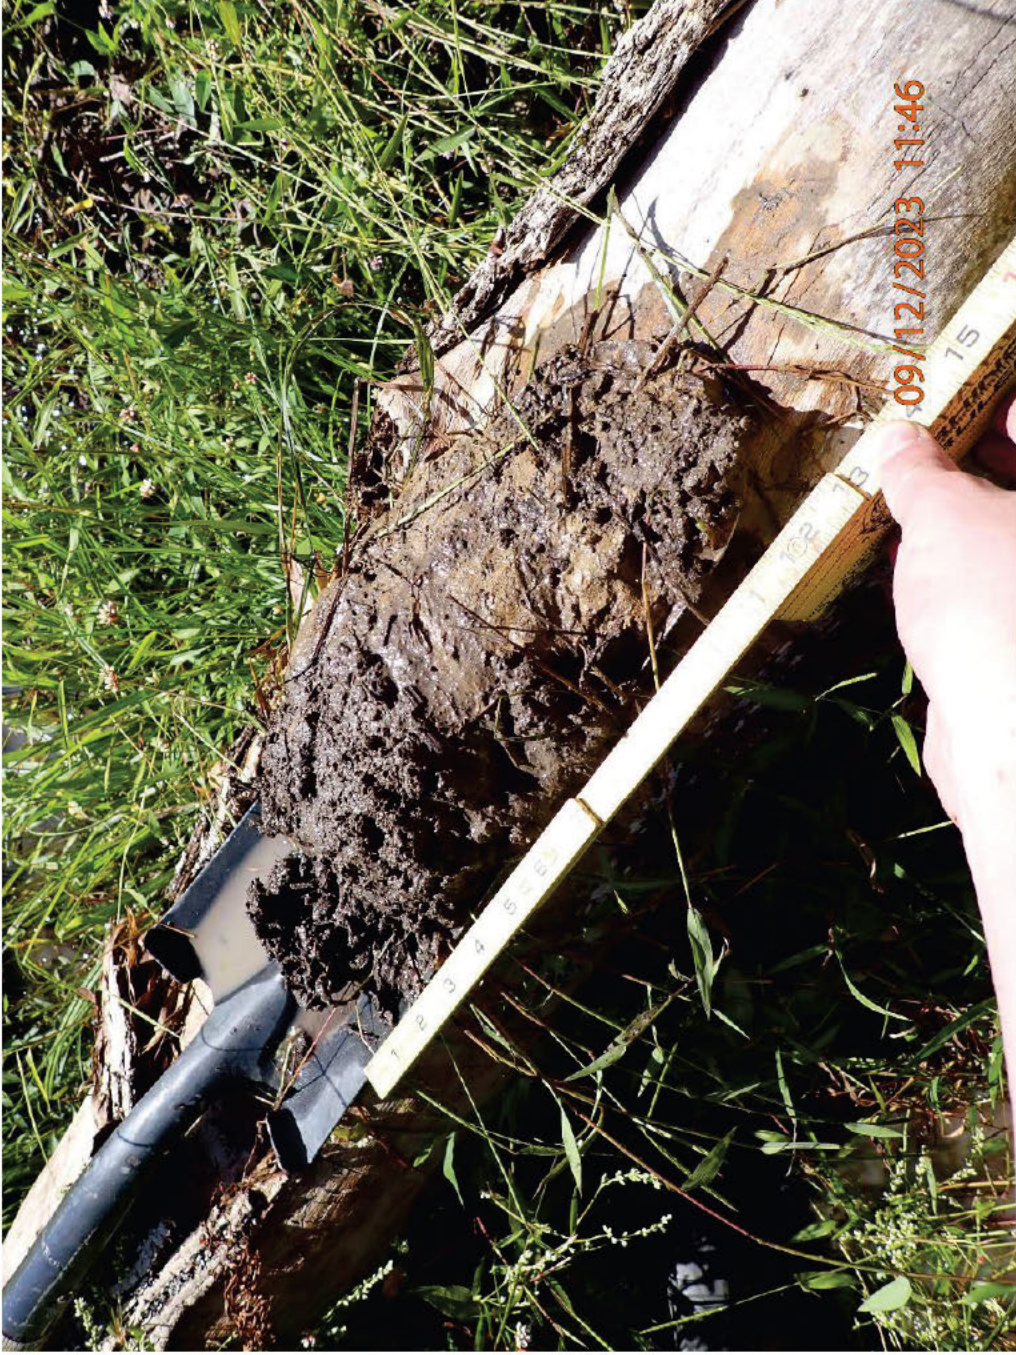
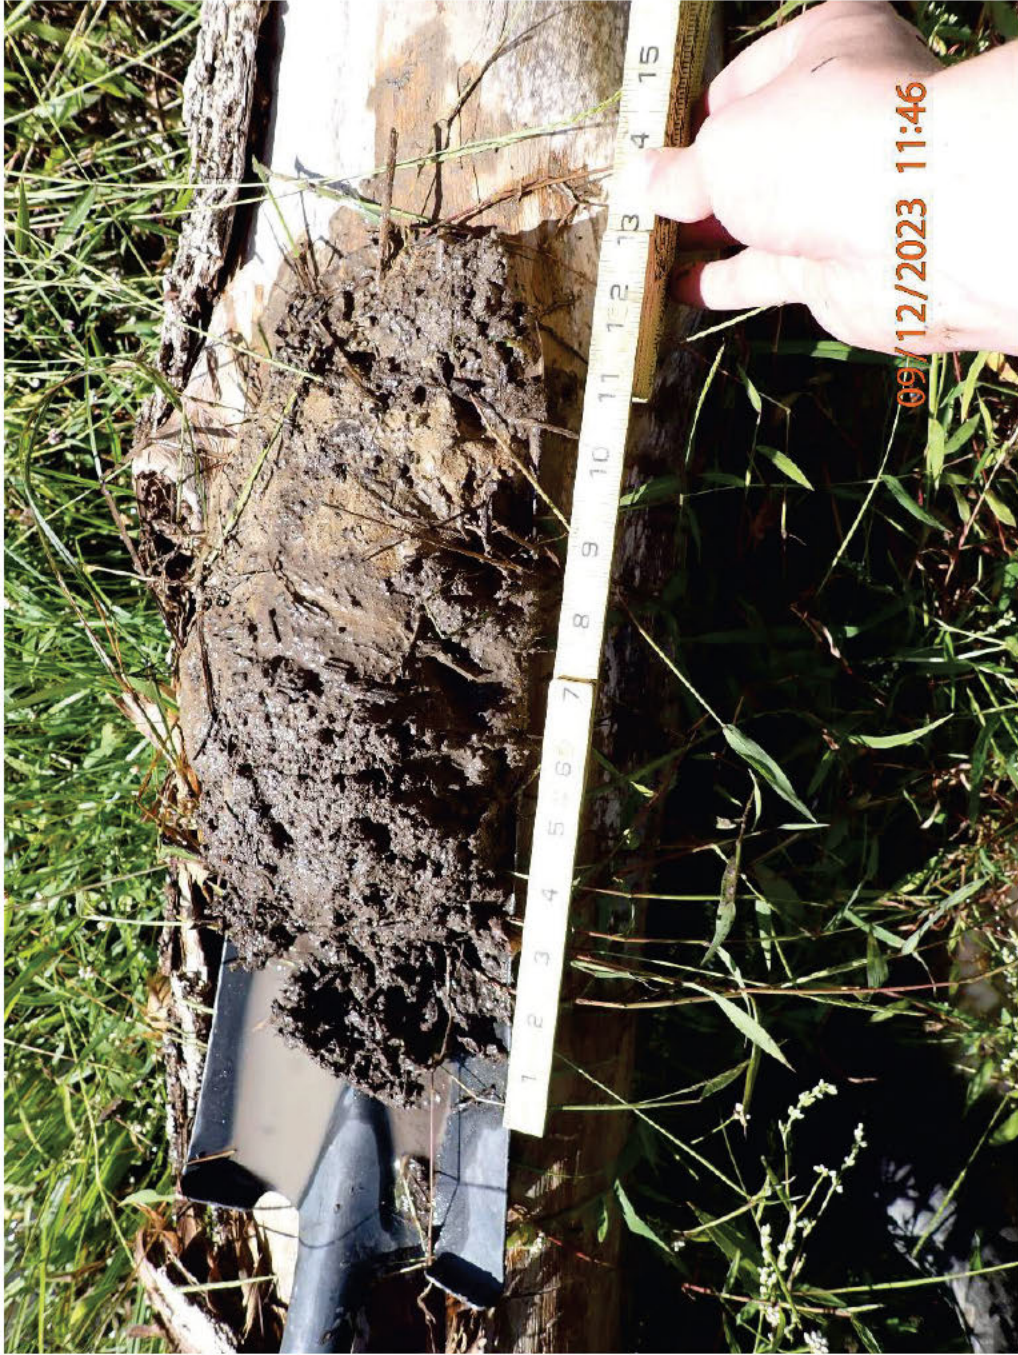
Date: 9/12/2023
Time: 11:46 AM
Photographer: S. Andreescu
Photo ID: 15 – P9120166

Soil sampling location #1 - Soil profile

Remarks: (Explain alternative procedures here or in a separate report.)
 Area adjacent to fill pile
