Clean Water Act Section 404: Site Visit/Case Development

Site Name: Fair Oaks Road Associates

Fair Oaks Road Associates Property (Tax ID: 14-1-68)
Fair Oaks Road, Middletown, NY
(41.5015, -74.4140)

EPA CWA 404 Inspection Photolog
Fair Oaks Road Associates, Inc.
Middletown, Orange County, NY

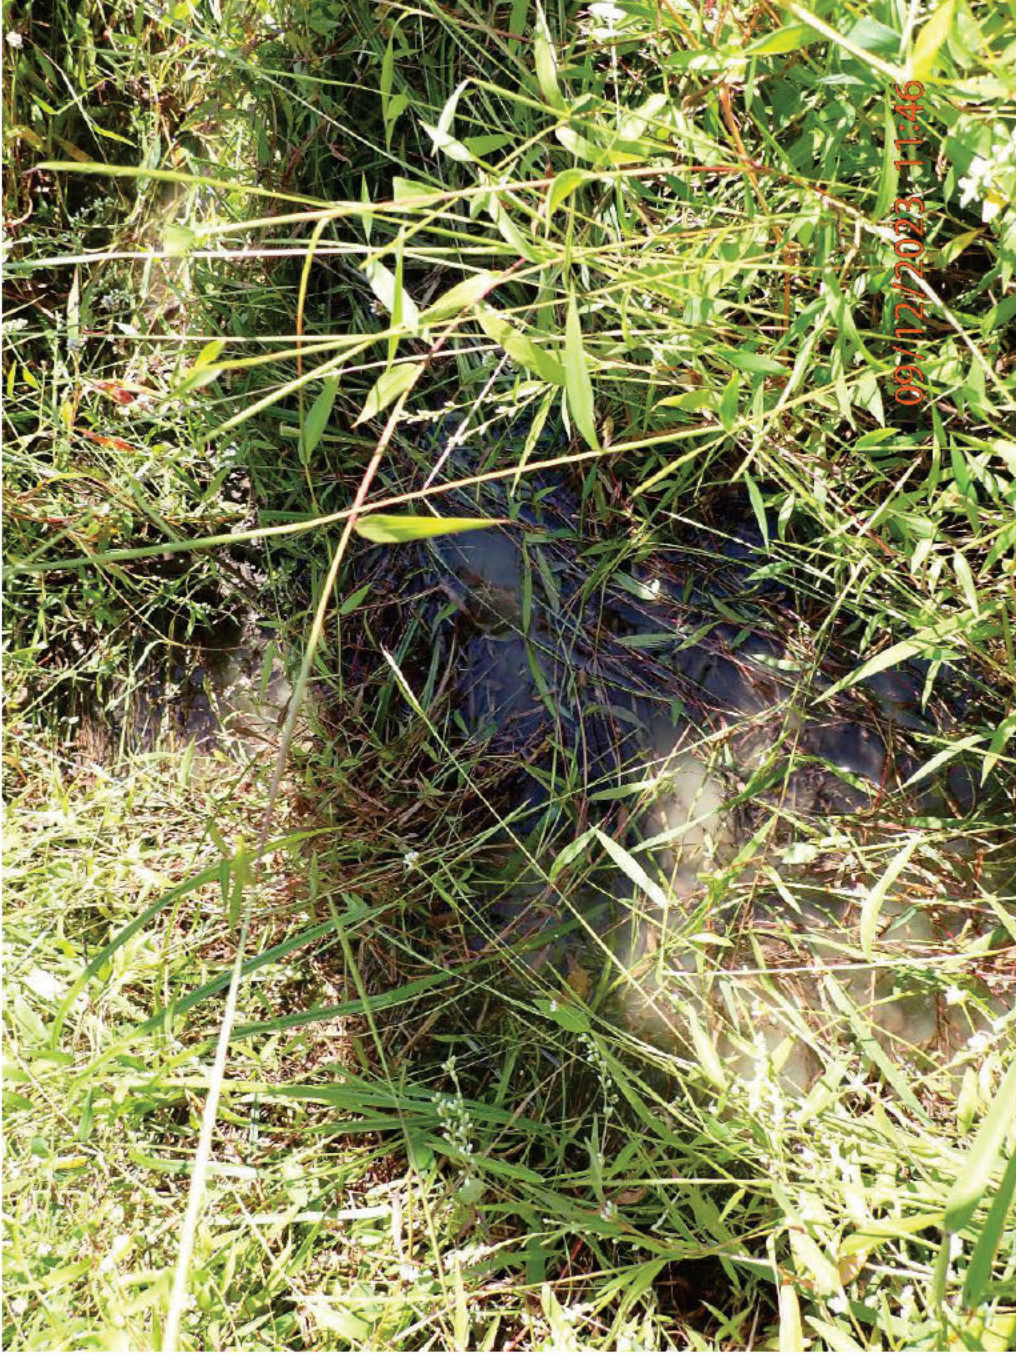
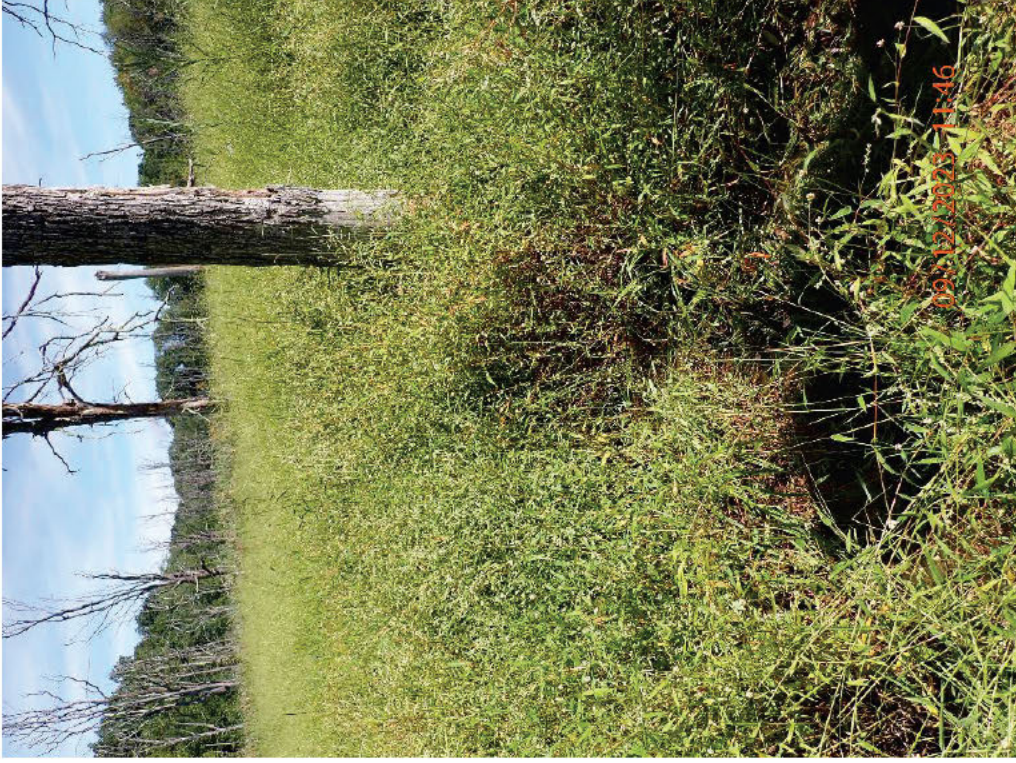
Date: 9/12/2023
Time: 11:46 AM
Photographer: S. Andreescu
Photo ID: 17 – P9120168

Description:
Soil sampling location #1

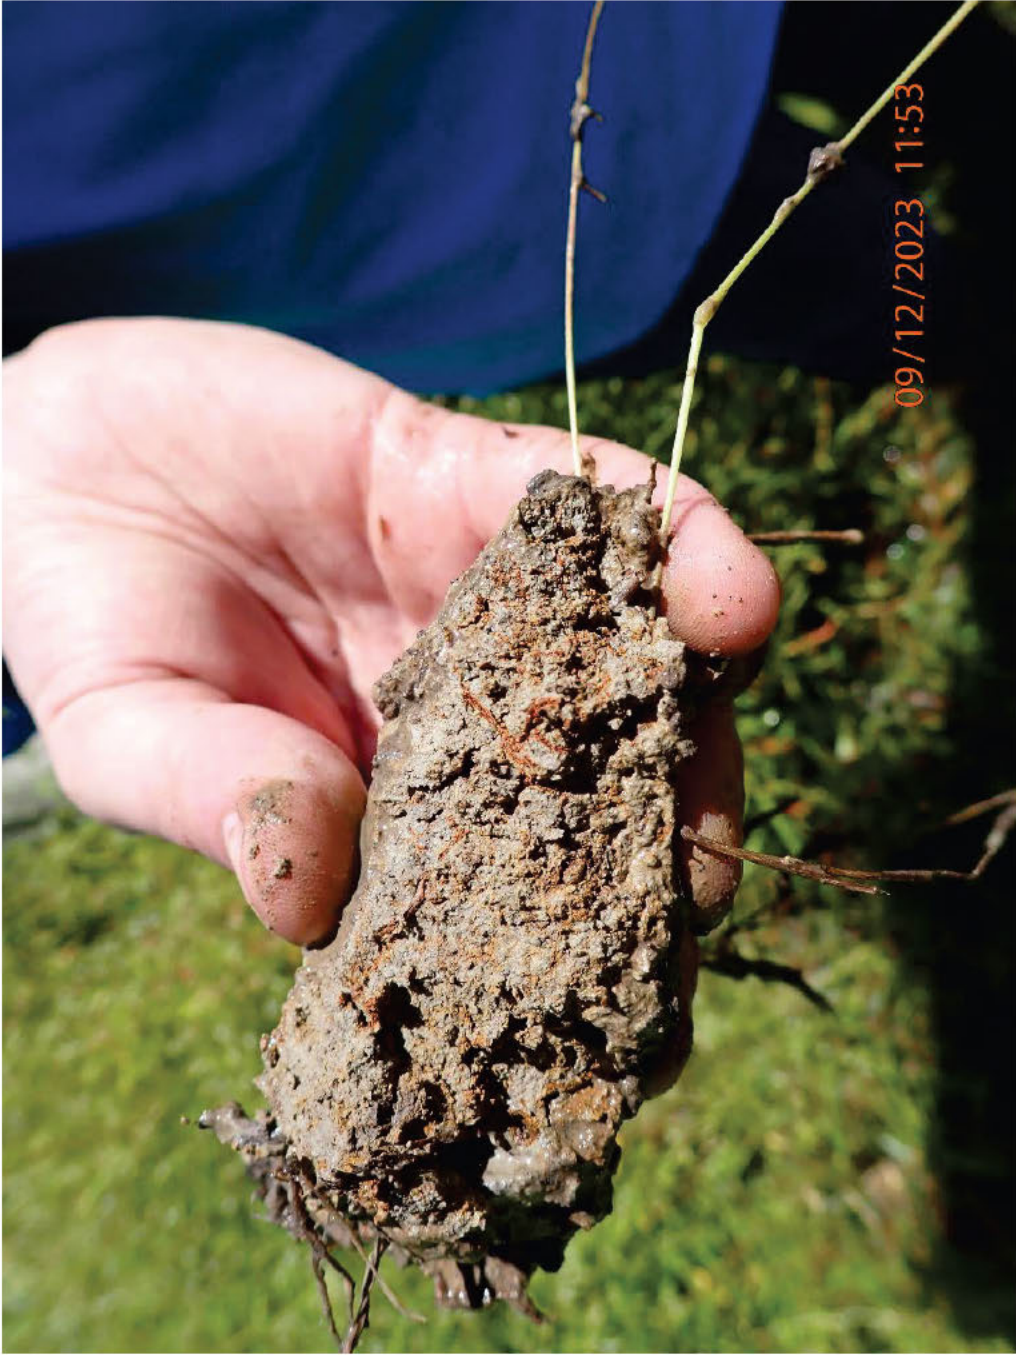
Date: 9/12/2023
Time: 11:53 AM
Photographer: S. Andreescu
Photo ID: 19 – P9120170

Oxidized rhizospheres on living roots (indicator of wetland hydrology)

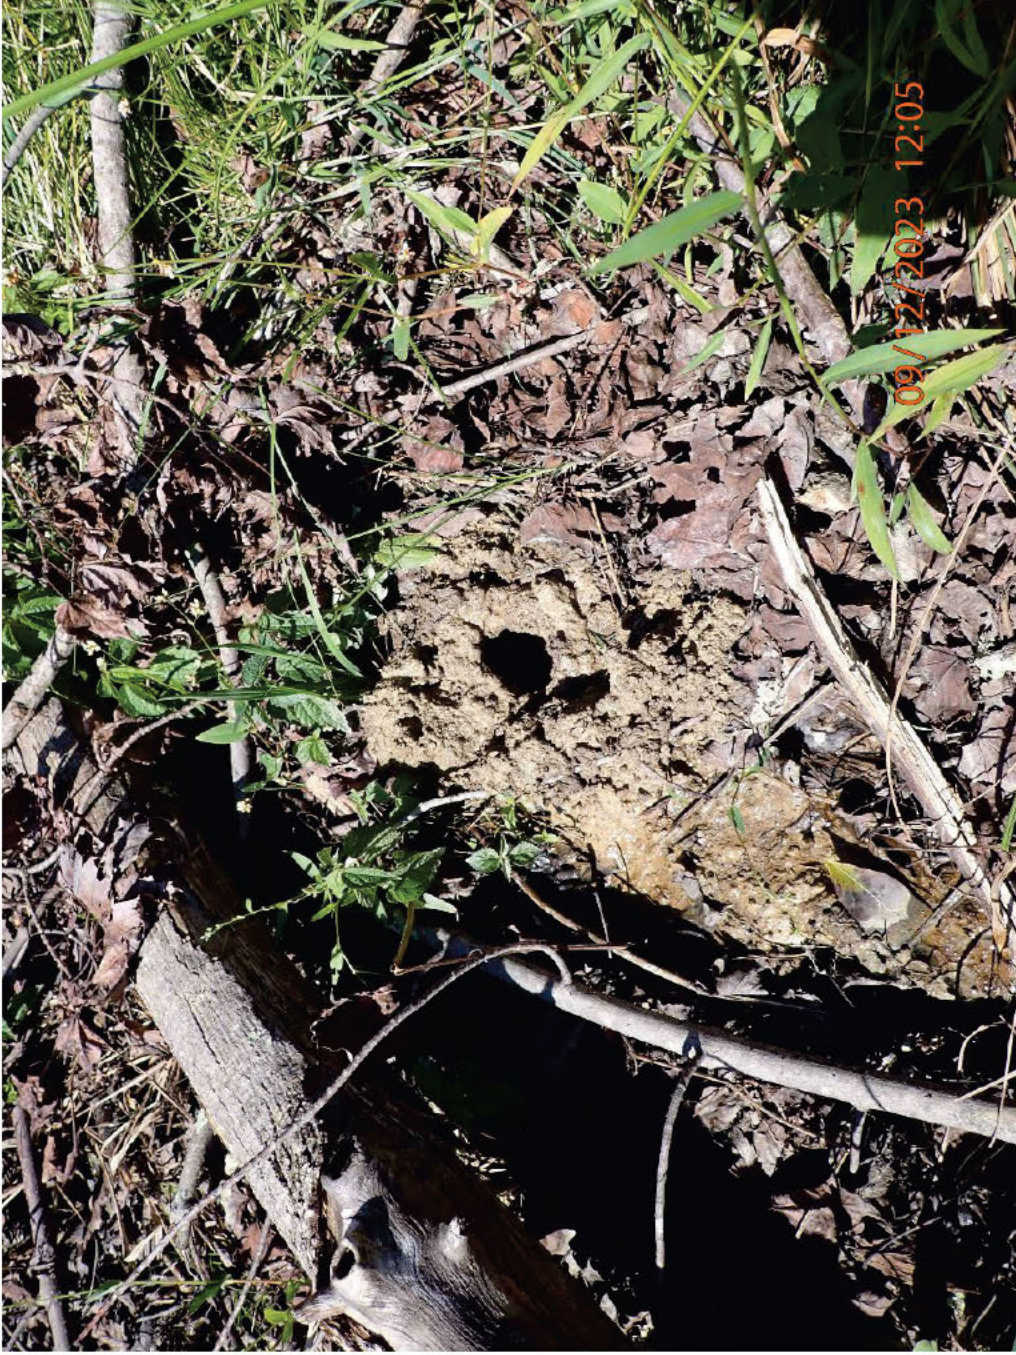
Date: 9/12/2023
Time: 12:05 PM
Photographer: S. Andreescu
Photo ID: 20 – P9120171

Description:
Crayfish burrow in wetland

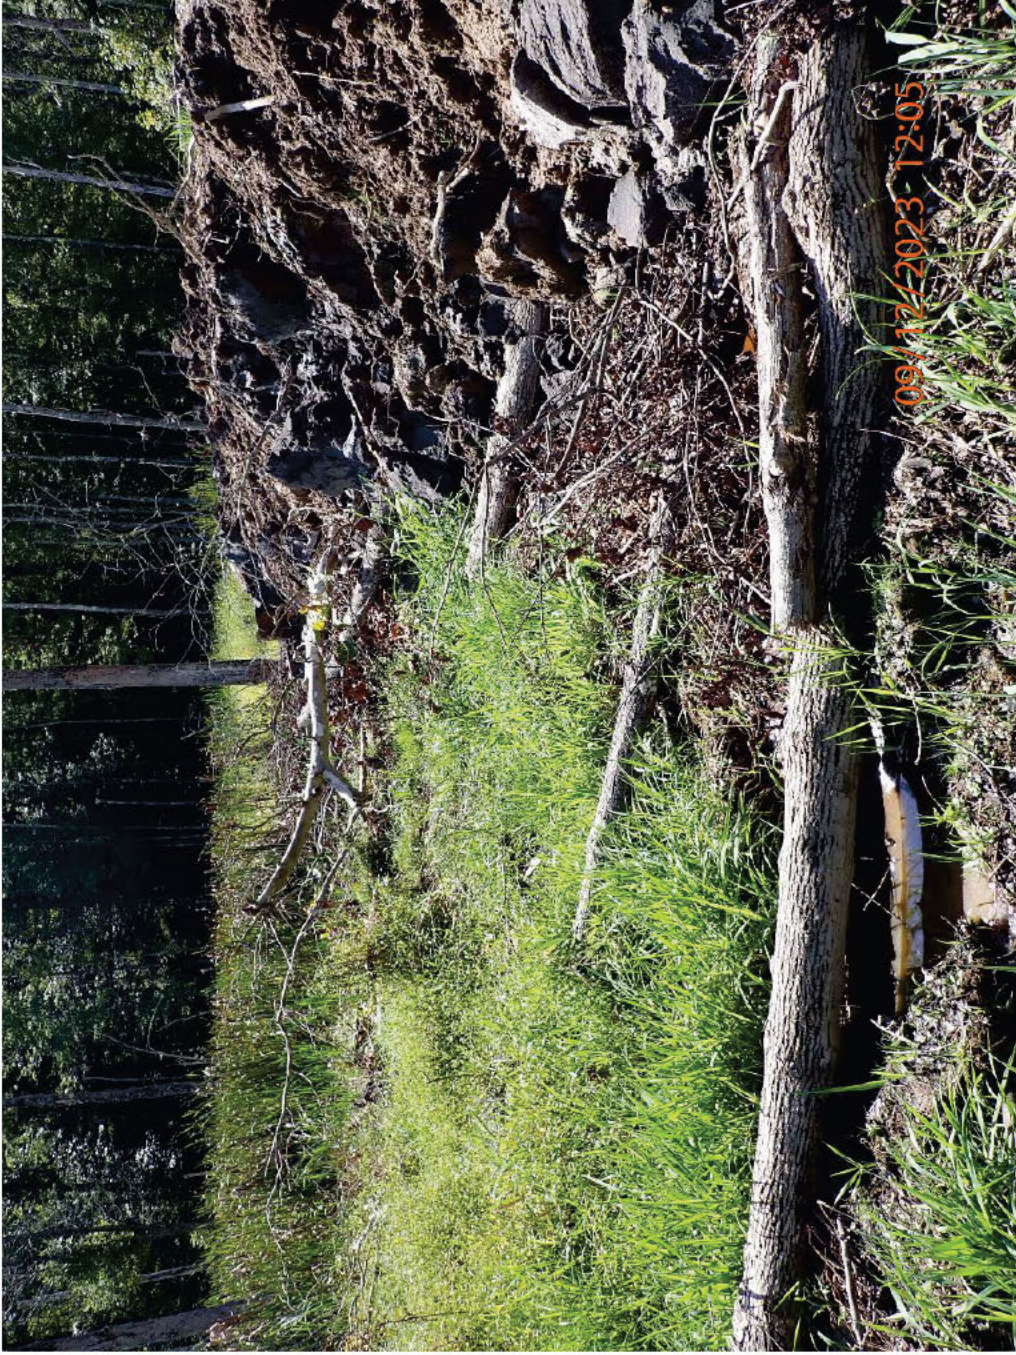
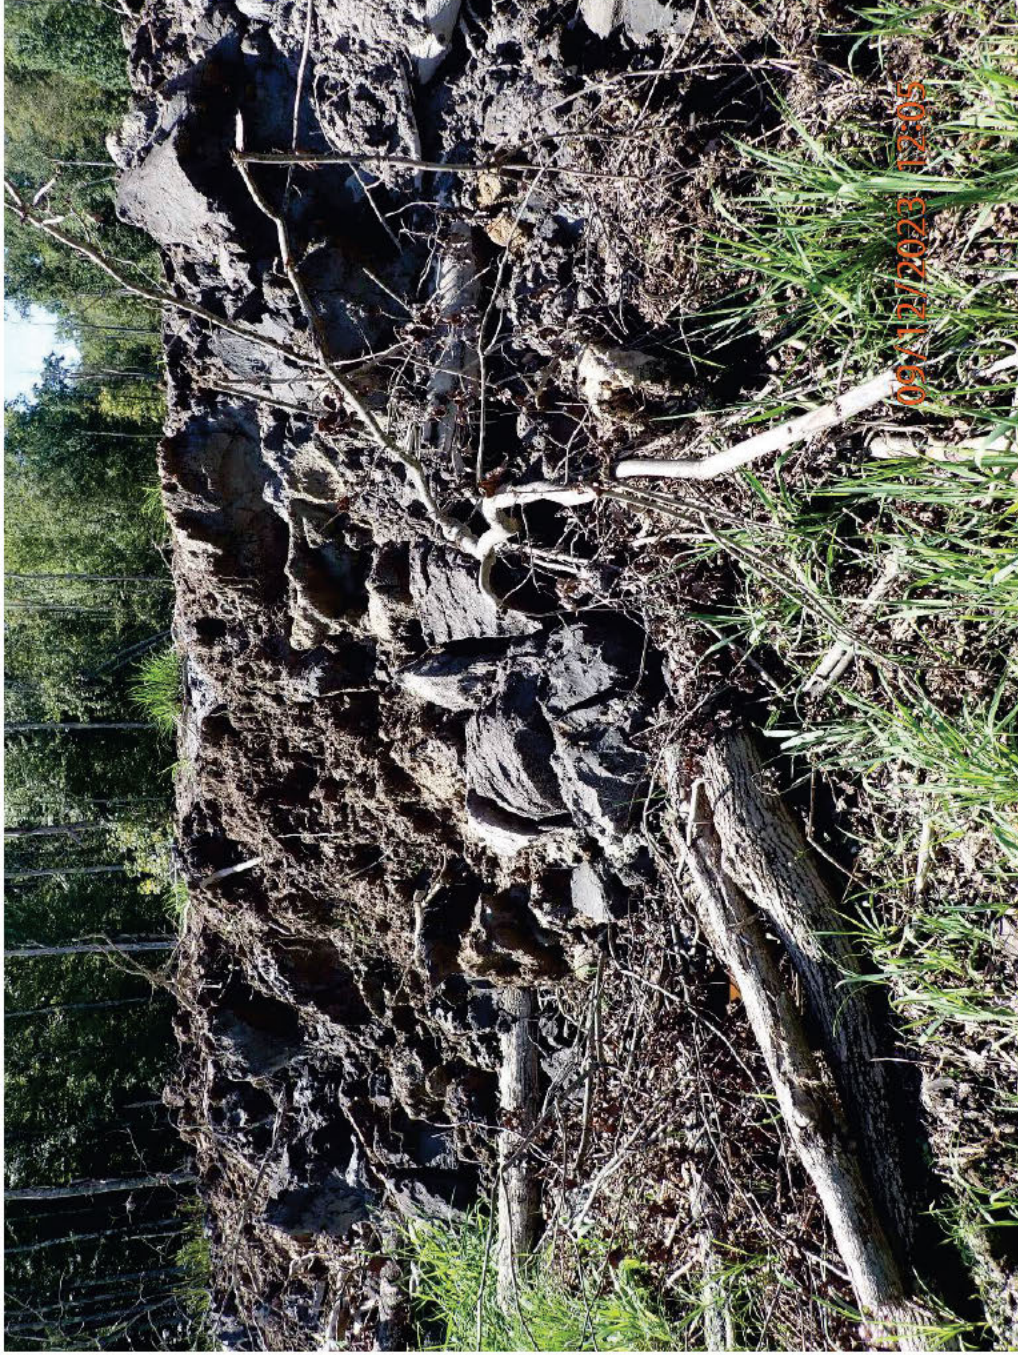
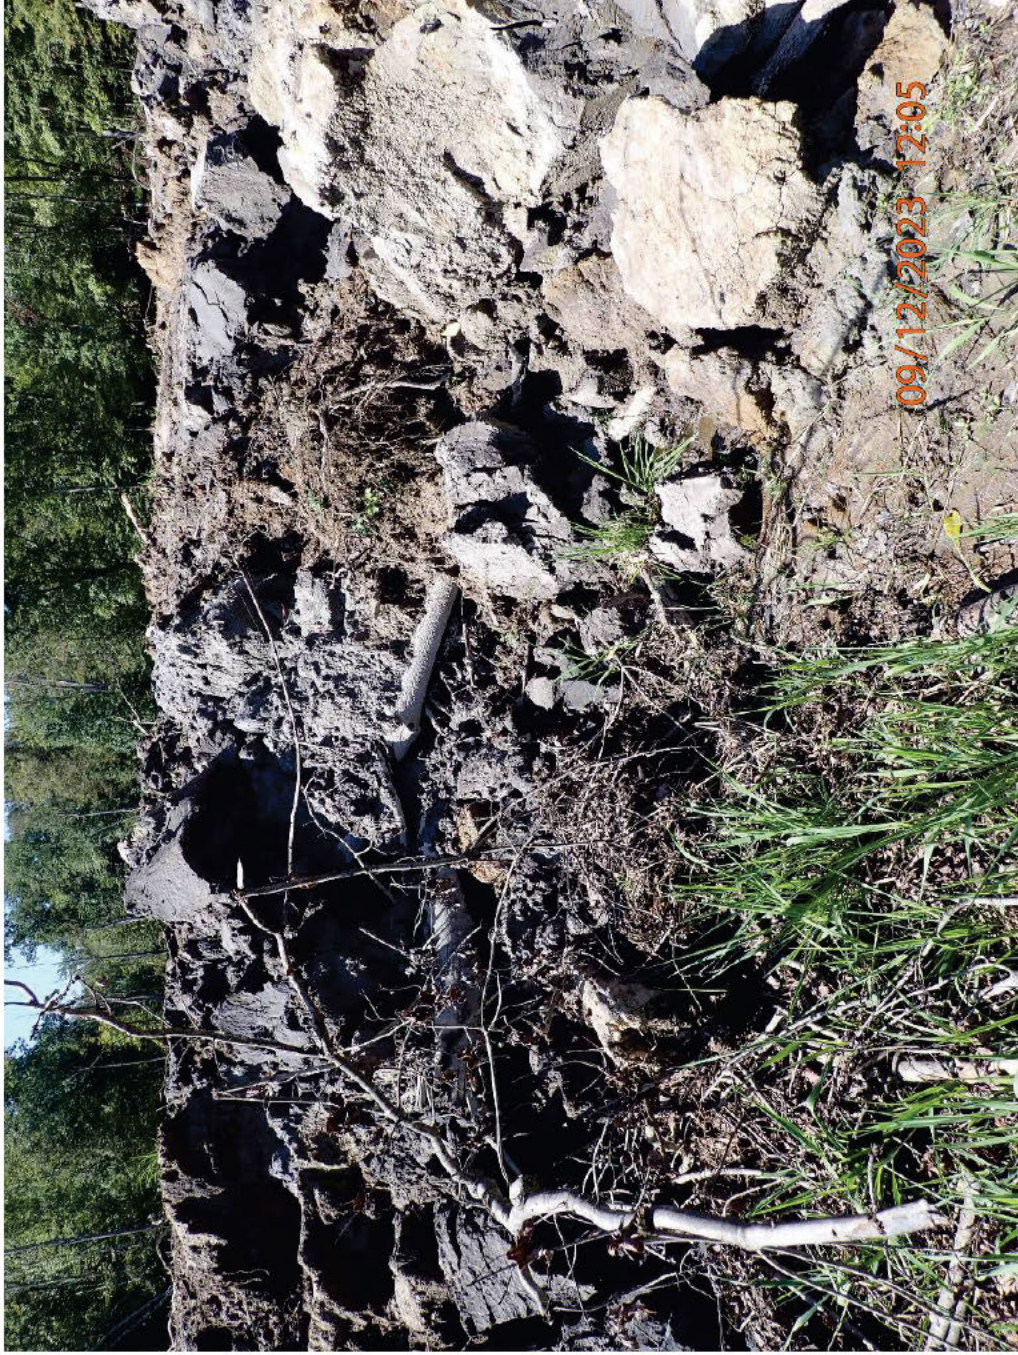
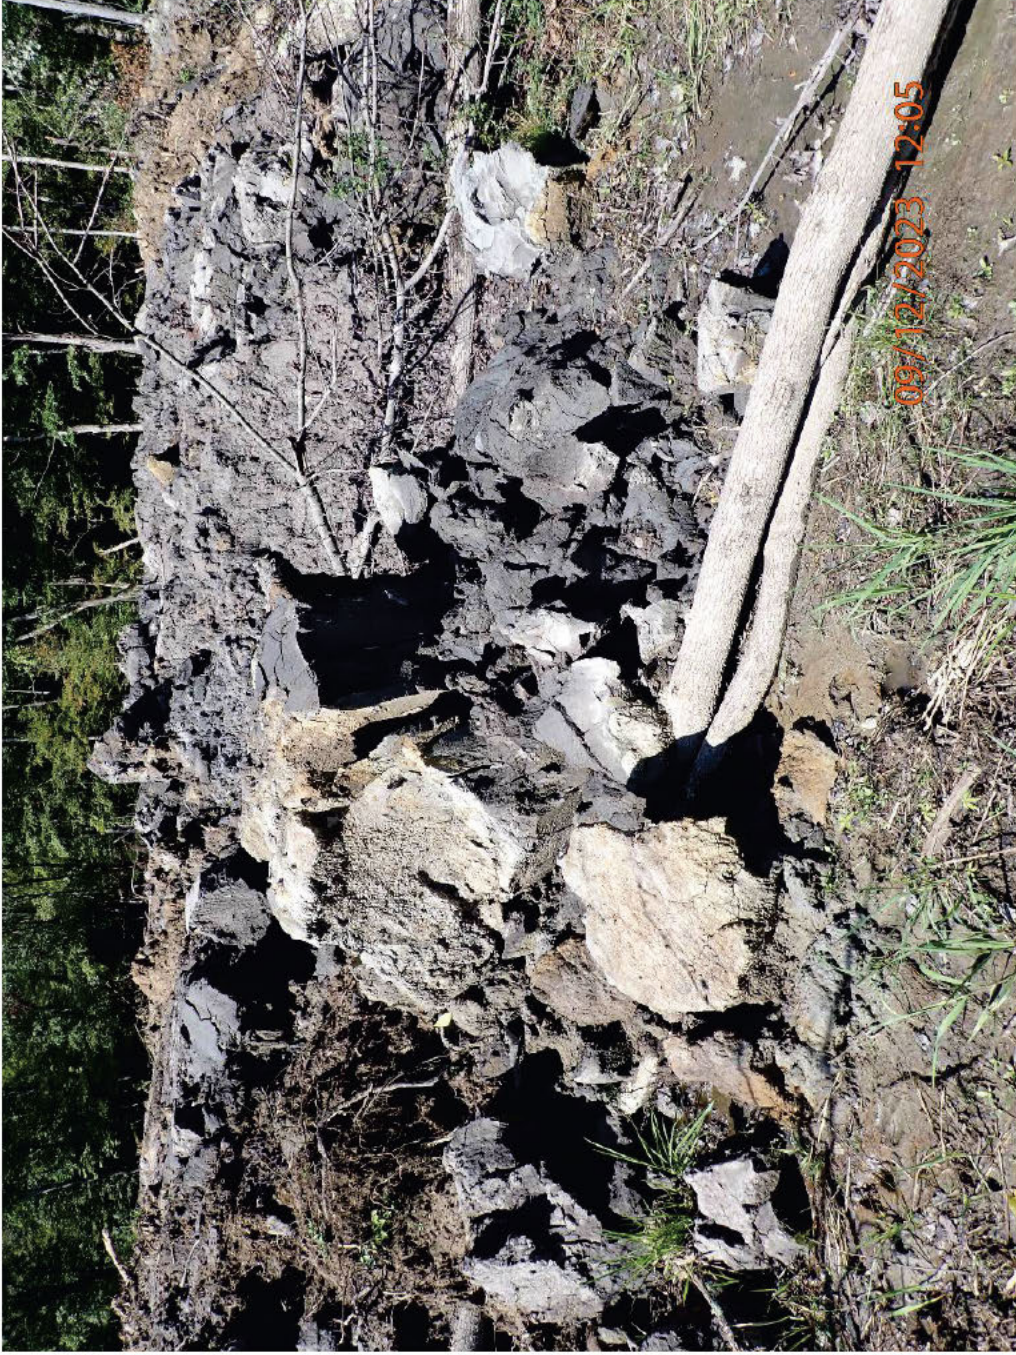
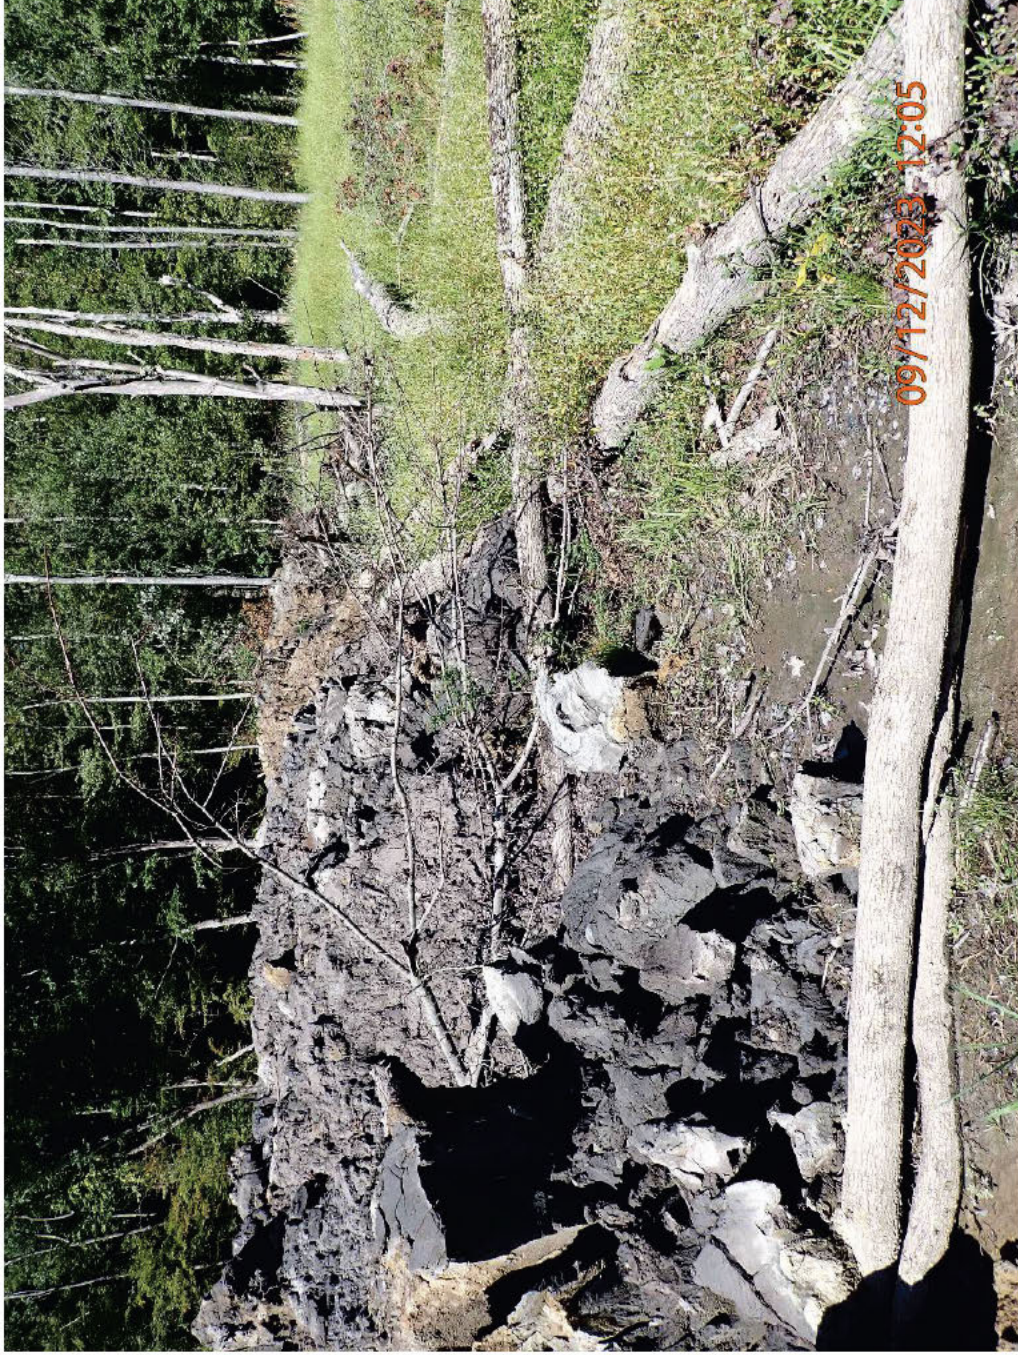
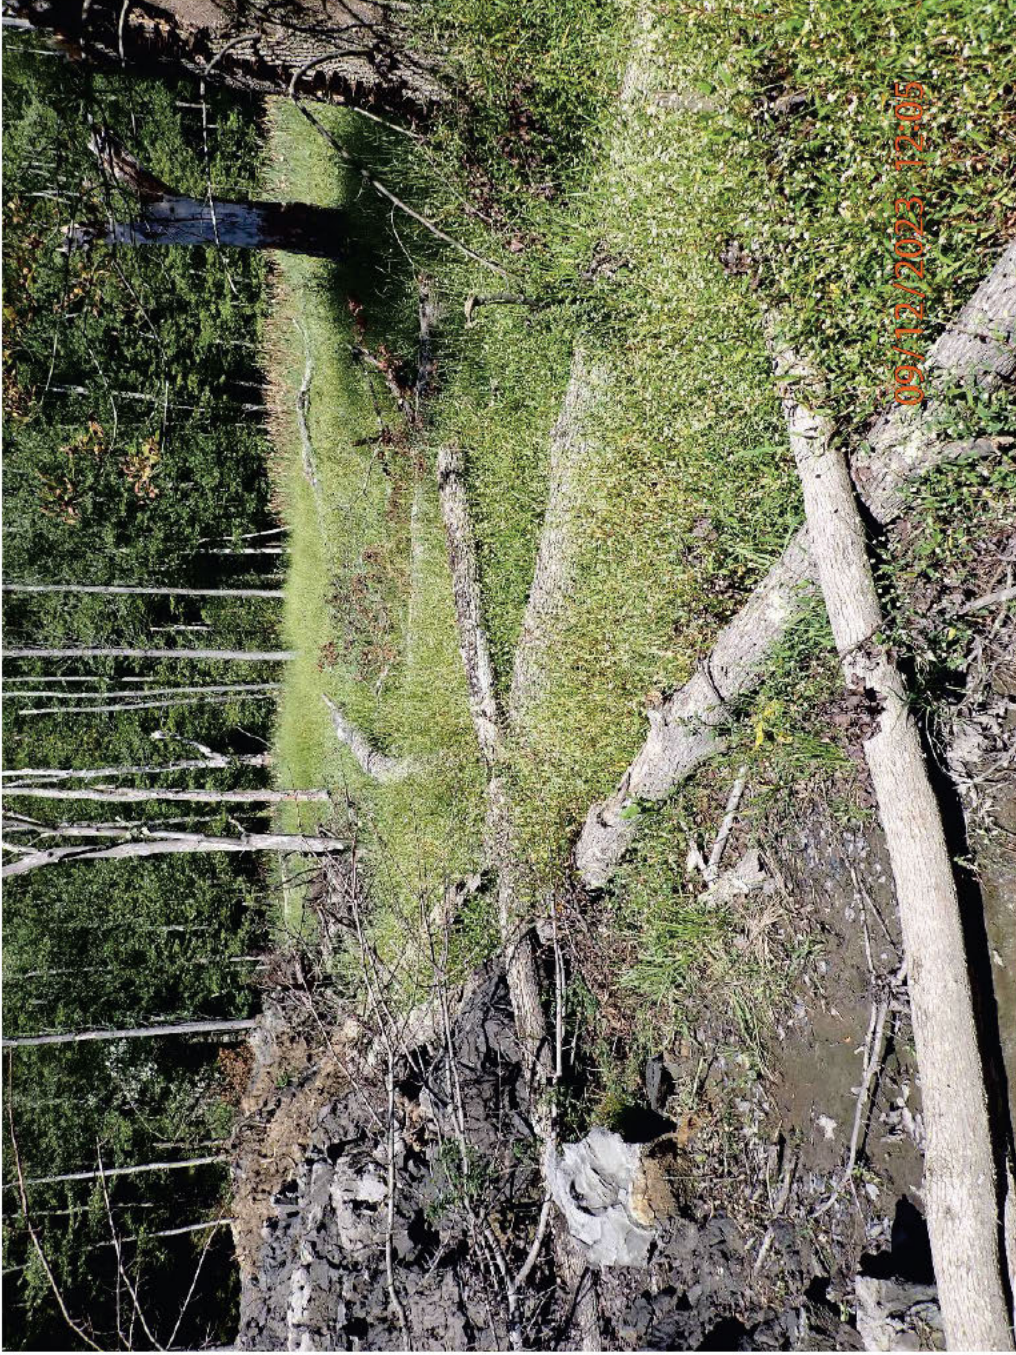
Date: 9/12/2023
Time: 12:05 PM
Photographer: S. Andreescu
Photo ID: 21 – P9120172

(1/6) Panorama of wetland-fill boundary

(2/6) Panorama of wetland-fill boundary

(3/6) Panorama of wetland-fill boundary

(4/6) Panorama of wetland-fill boundary

(5/6) Panorama of wetland-fill boundary

(6/6) Panorama of wetland-fill boundary

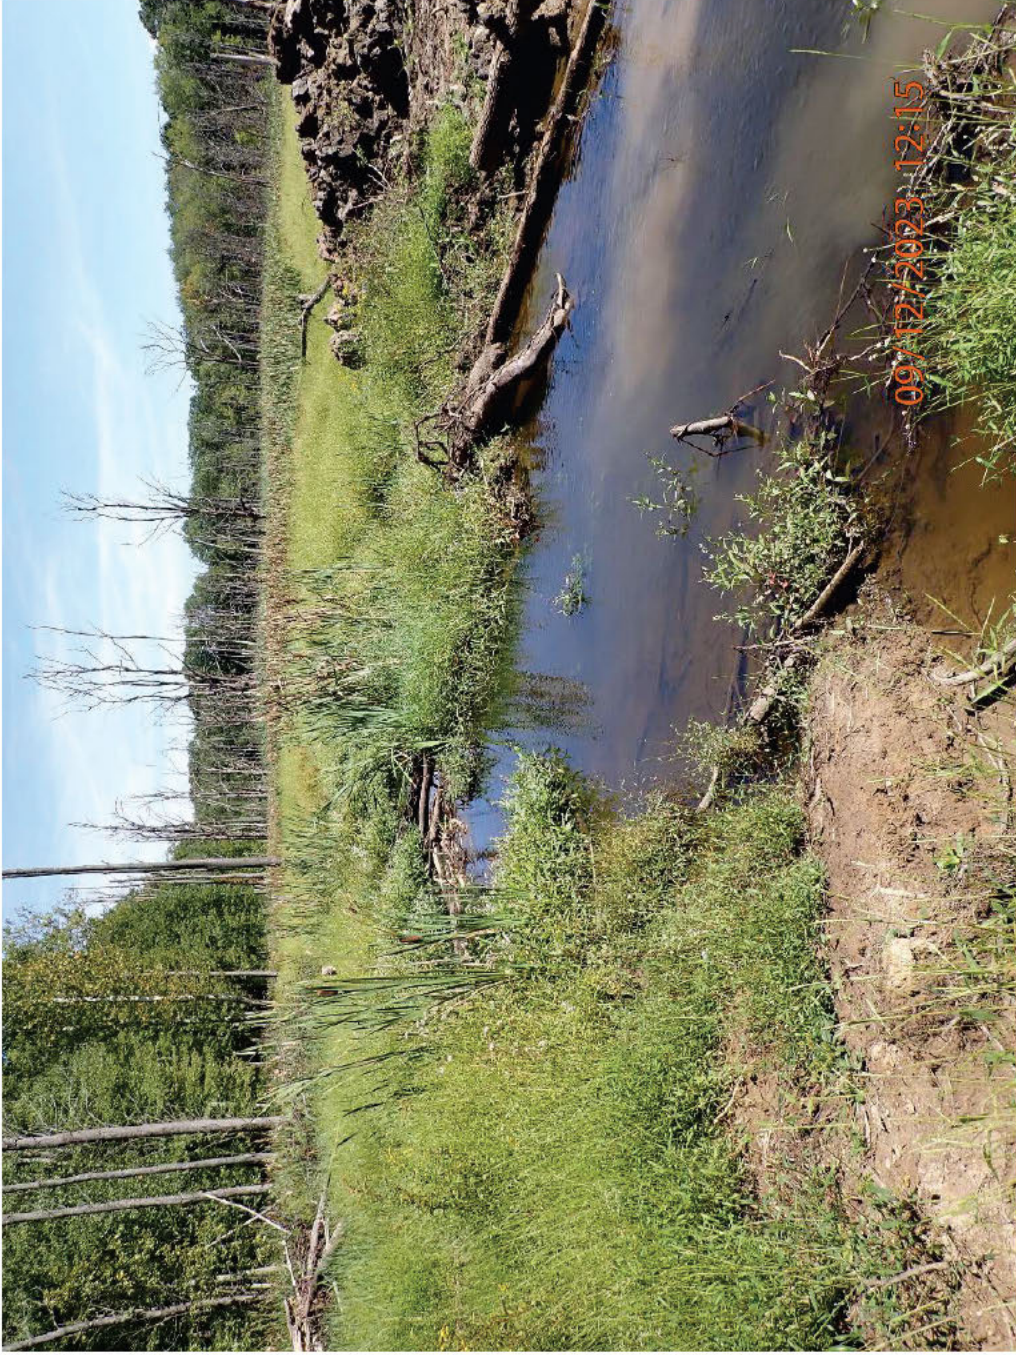
Date: 9/12/2023
Time: 12:15 PM
Photographer: S. Andreescu
Photo ID: 27 – P9120178

Description:
Pond outlet to NYS Class "B"
Stream

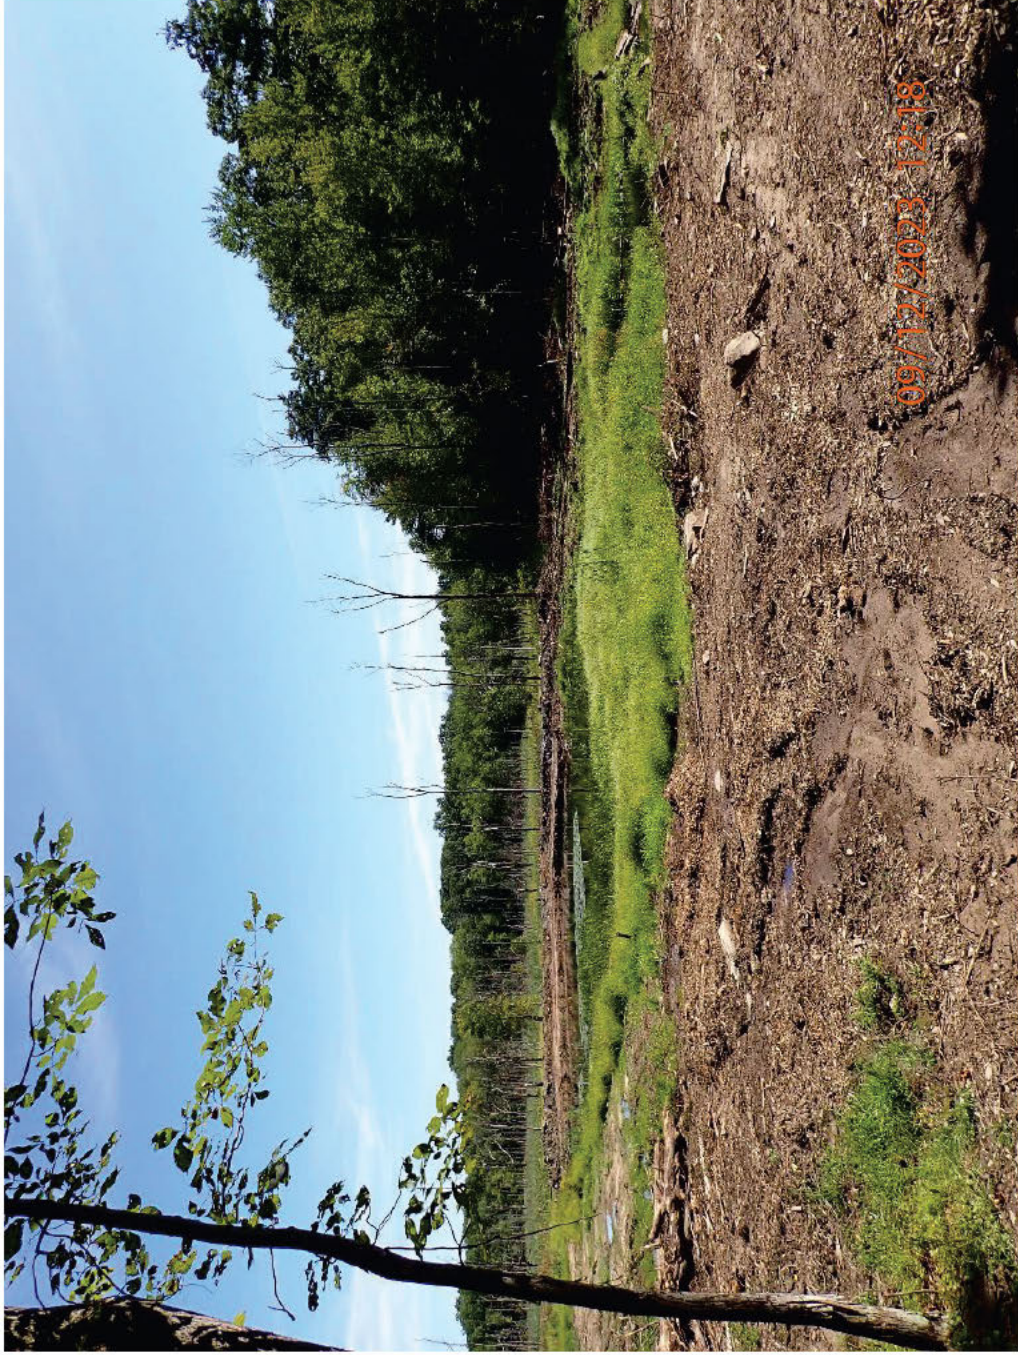
Date: 9/12/2023
Time: 12:18 PM
Photographer: S. Andreescu
Photo ID: 28 – P9120179

Description:
Site overview

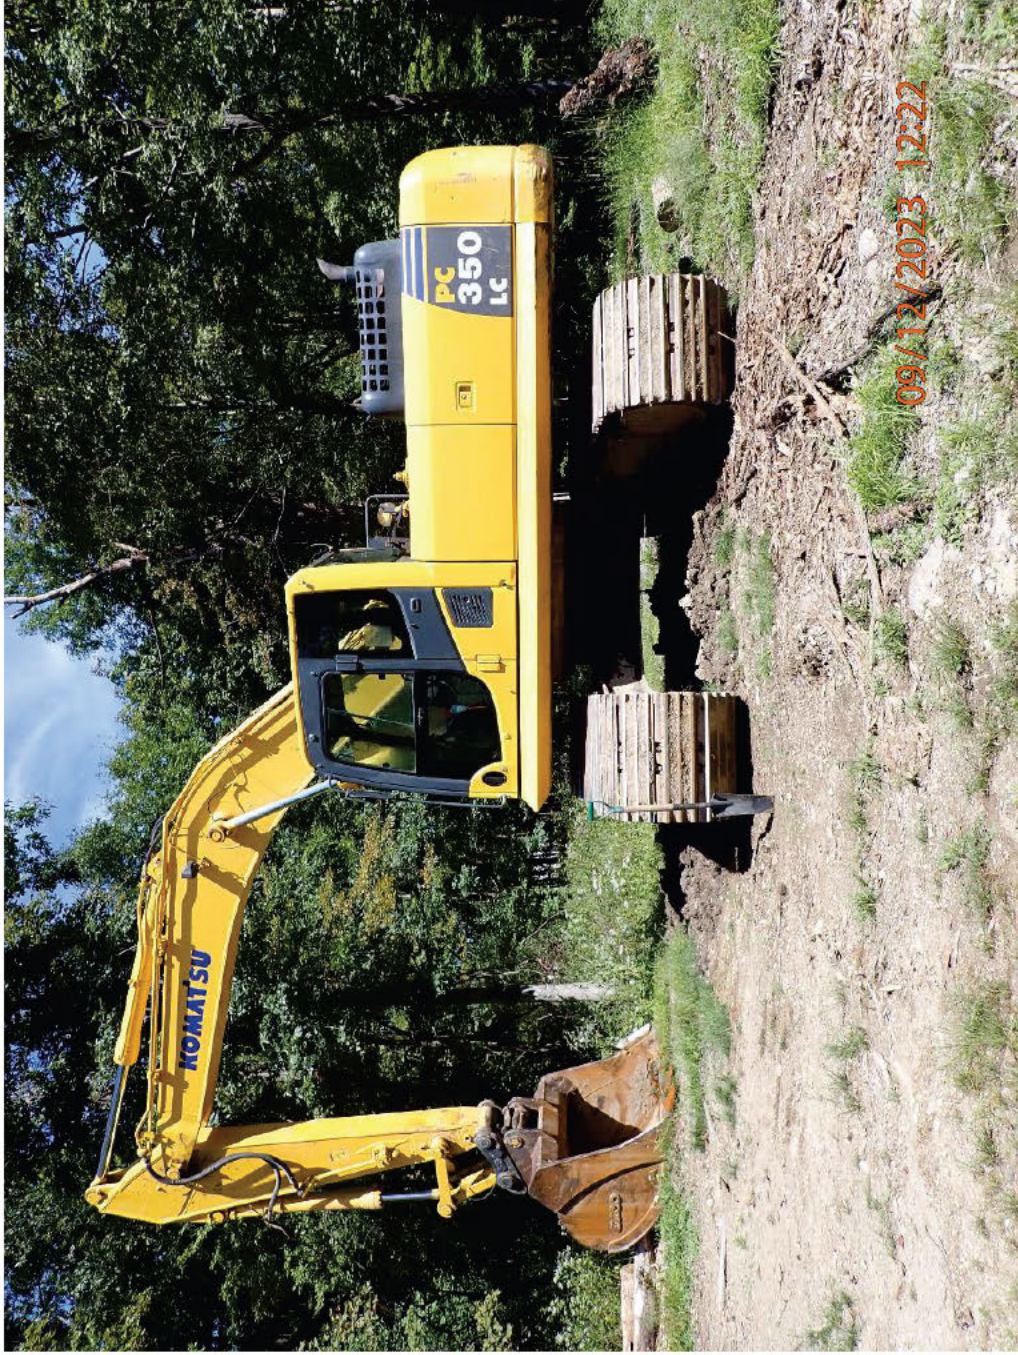
Date: 9/12/2023
Time: 12:22 PM
Photographer: S. Andreescu
Photo ID: 29 – P9120180

Description:
Excavator on property

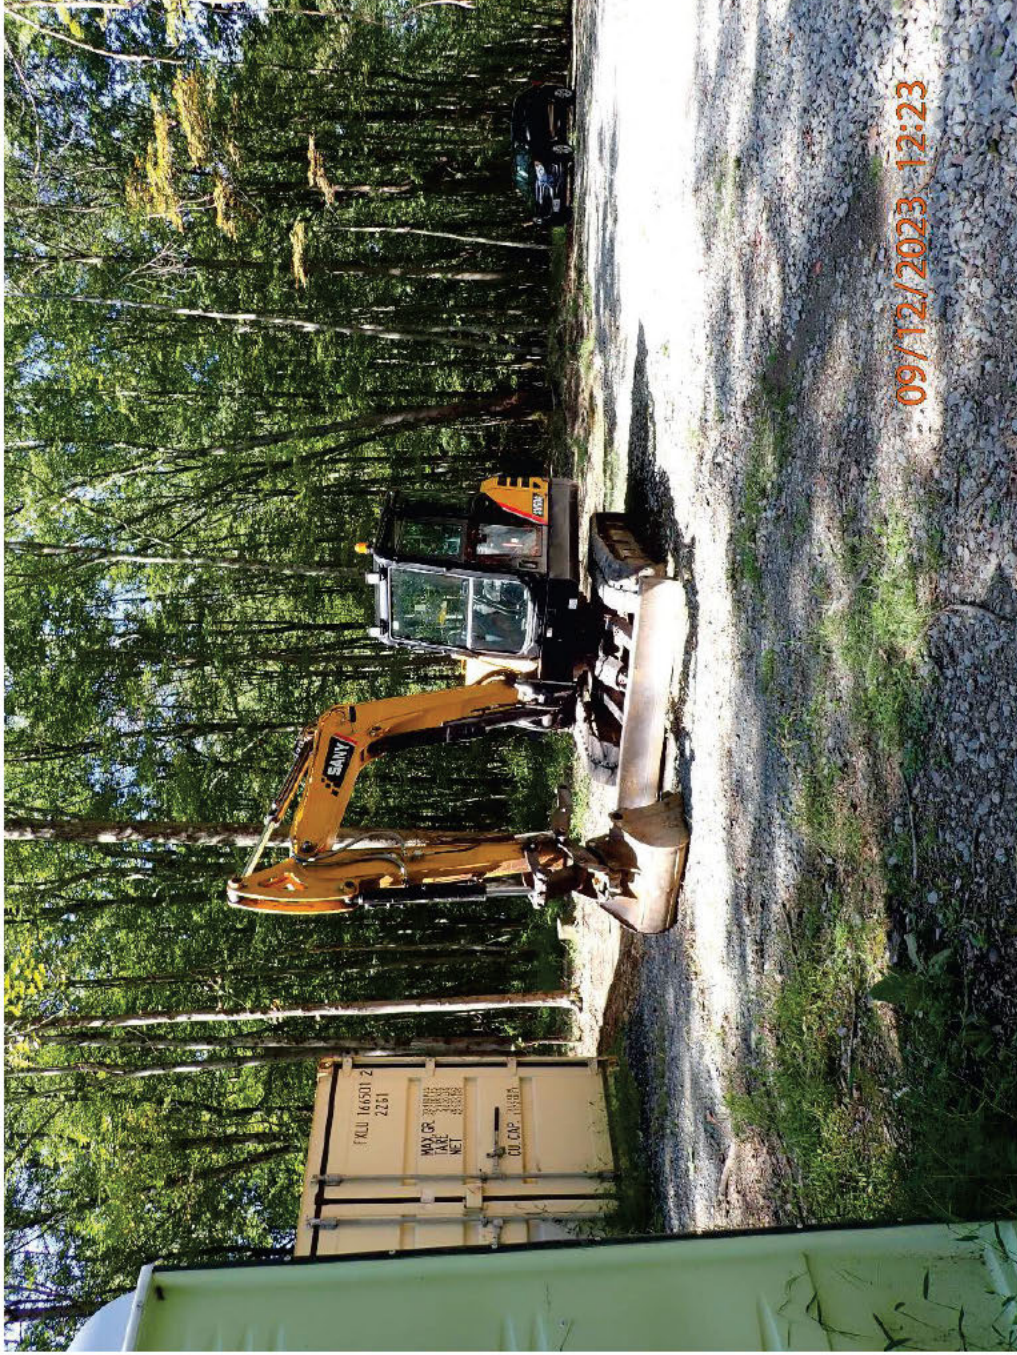
Date: 9/12/2023
Time: 12:23 PM
Photographer: S. Andreescu
Photo ID: 30 – P9120181

Description:
Small excavator on property
