**Region 6 - Enforcement & Compliance Assurance Division**  
**INSPECTION REPORT**

| Regulatory Program(s) | Clean Water Act-National Pollution Discharge Elimination System (Brine) | |
| Company Name: | <b>Calgary Energy, LLC</b> | |
| Facility Name: | <b>Tidal Osage 1 Lease</b> | |

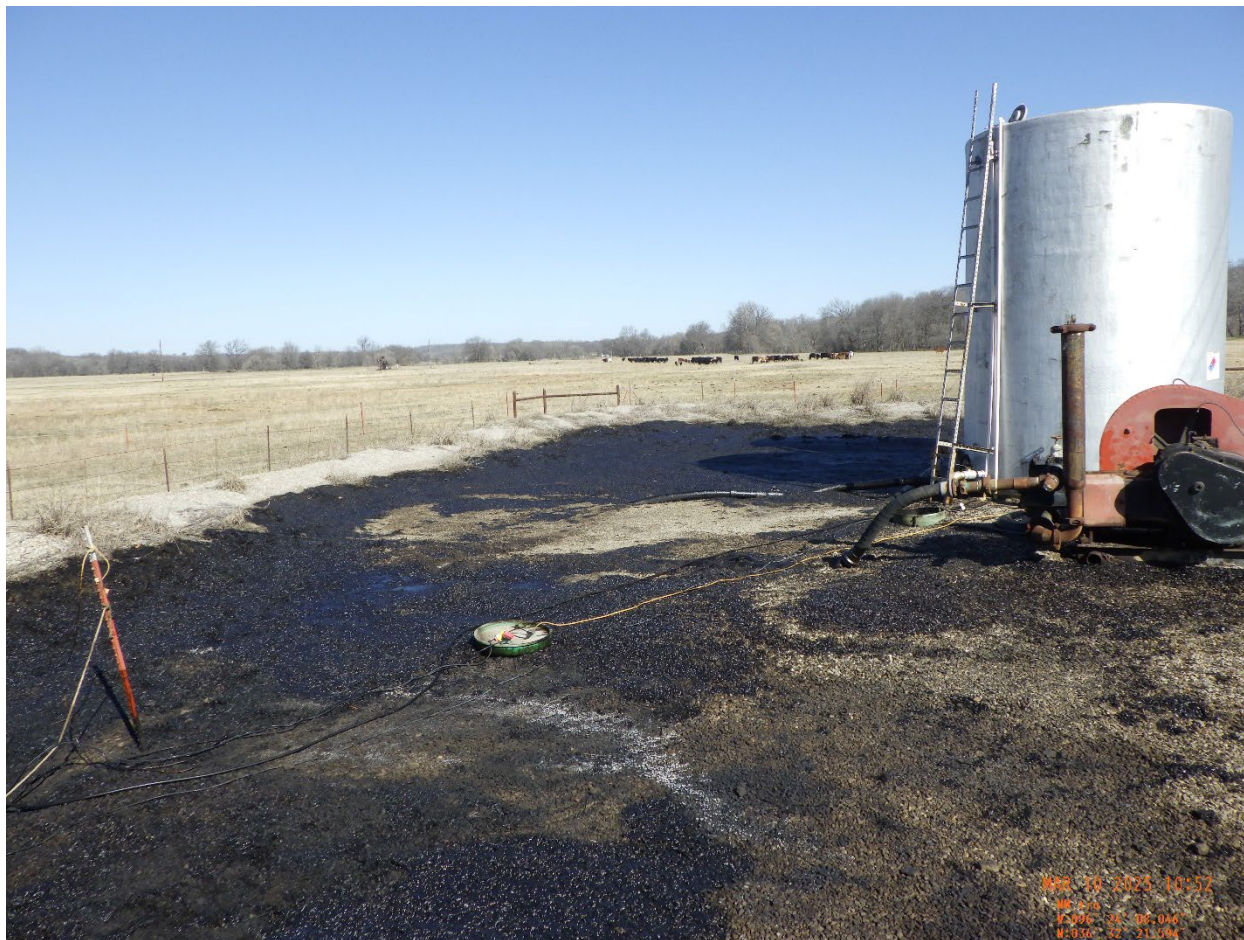
Photo No. 1

I observed the Release Point of the spill, the Tidal Osage 1 lease water station, which can be seen in Appendix 1 (photo log) photo No. 1. At the time of the inspection, the floor of the facility was heavily stained with oil and some free oil was pooled in the lower areas inside the secondary containment. For additional GPS location information and photo metadata, please see Appendix 1 (photo log) attached to this report.

**Description:** This was the floor and secondary containment of the Tidal Osage 1 water station. Oil staining represents the high-water mark which occurred during the spill.

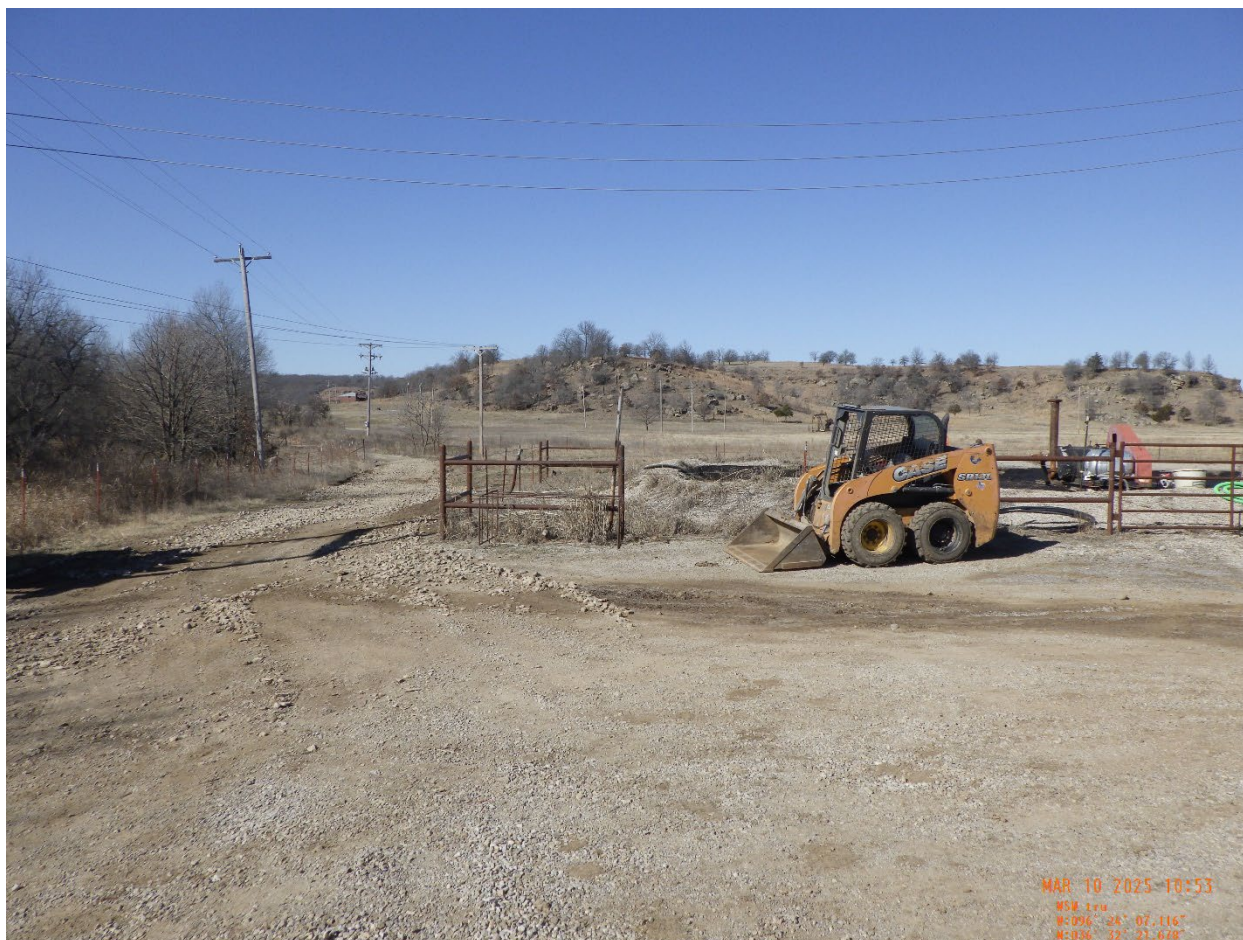
Photo No. 2

I observed a portion of the flowpath along the east and south sides of the facility. Crystallized salt from the released brine was present along the flowpath. Along the base of the south and west containment berm, brine saturated soil indicated the secondary containment was not sufficiently impervious to contain spilled fluids inside the facility. See photos No. 2 & 3.

**Description:** This was a view to the west of the flowpath, from the east side of the Tidal Osage 1 water station, along the south side of the facility. The spill migrated SW along the road until it spilled into Little Hominy Creek

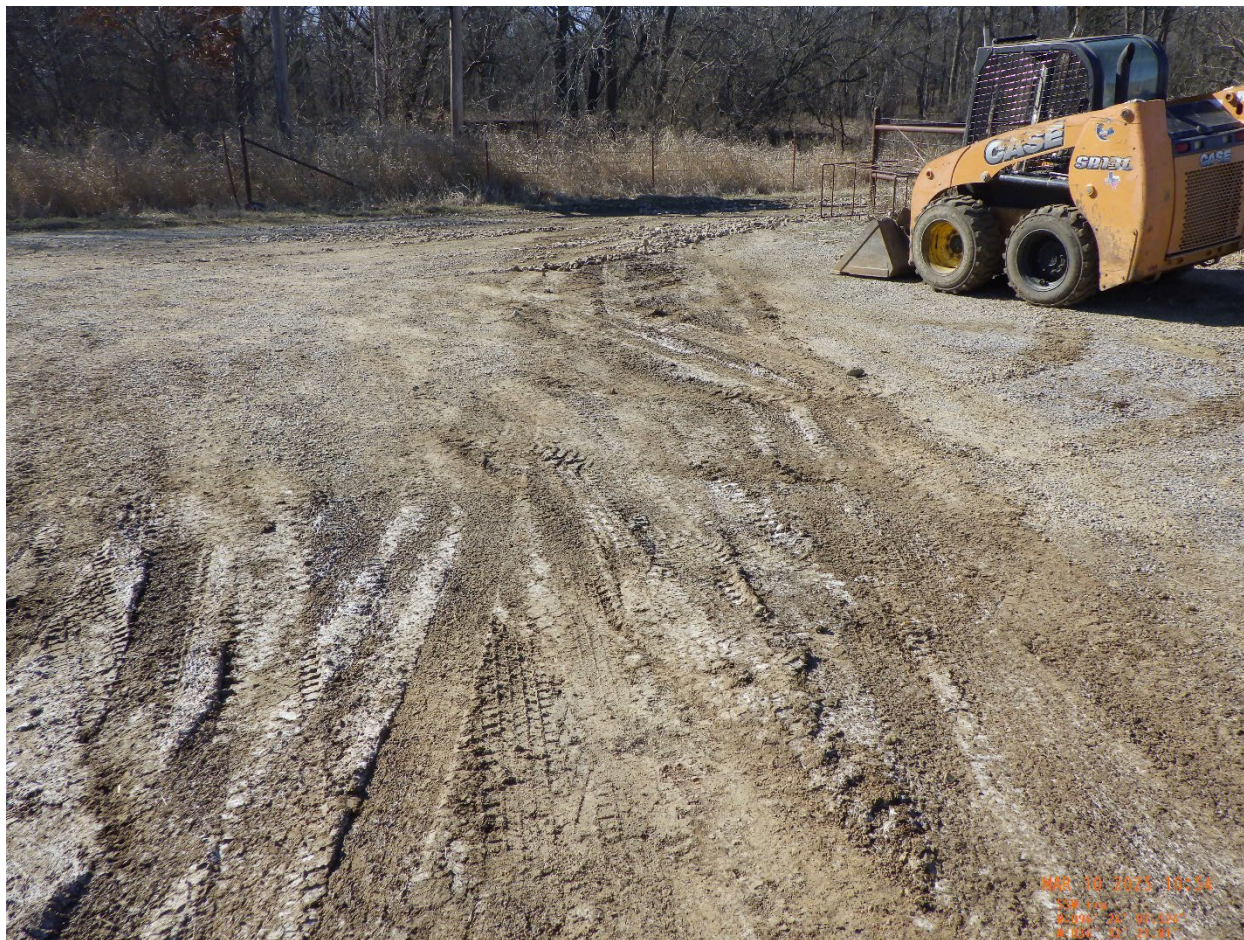
Photo No. 3

**Description:** This was the flowpath from the east side of the Tidal Osage 1 water station. The spill migrated SW along the road until it spilled into Little Hominy Creek. White crystalized salt can be seen along the pictured section of the flowpath.

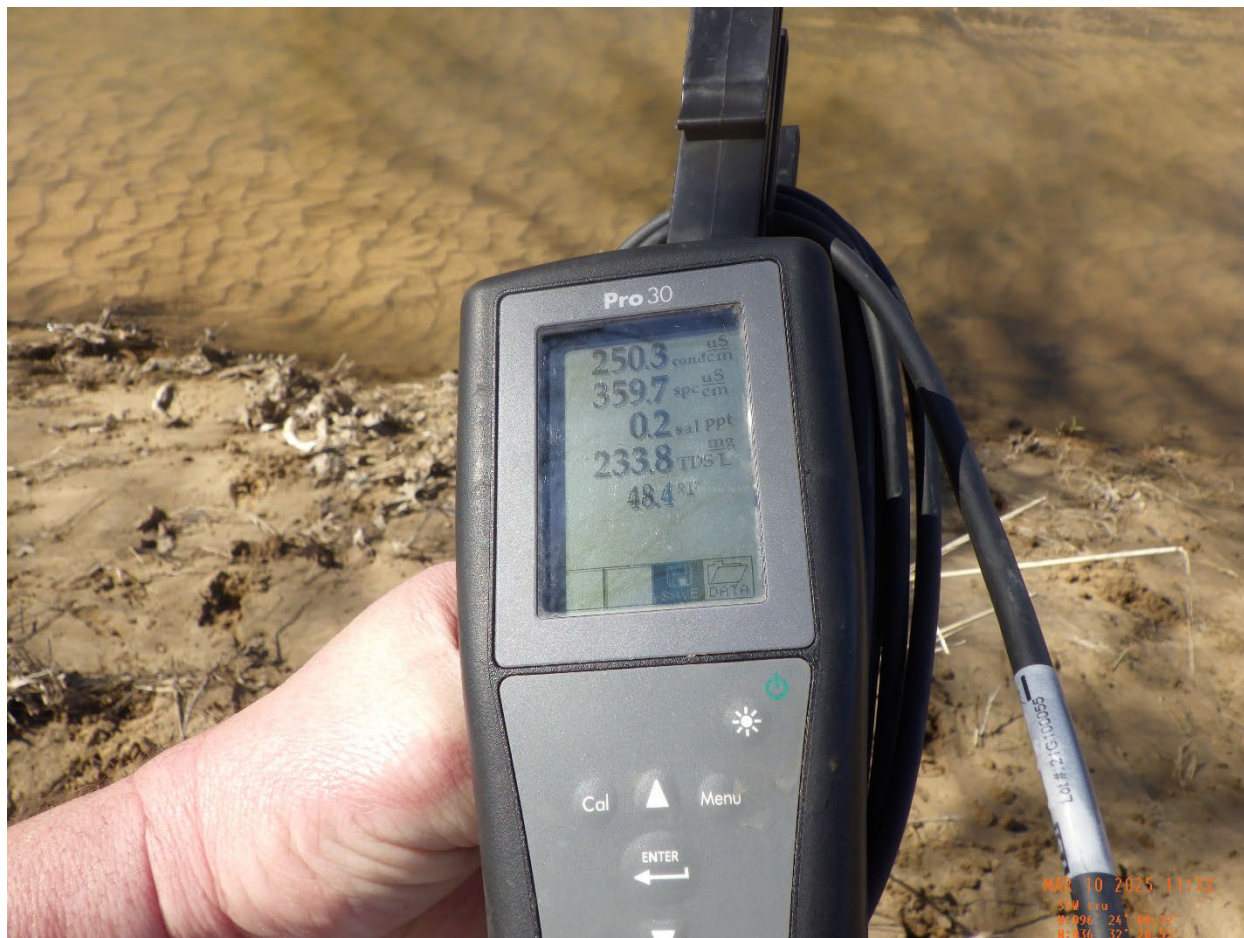
Photo No. 4

I observed a TDS field reading of 233.8 mg/L immediately upstream from the Point of Entry (POE) into Little Hominy Creek. This TDS observation should be used when considering the background TDS levels in the area. See photo No. 4.

**Description:** This was a TDS field reading of 233.8 mg/L observed immediately upstream from the Point of Entry (POE) into Little Hominy Creek. This should be used when considering background TDS levels for Little Hominy Creek.

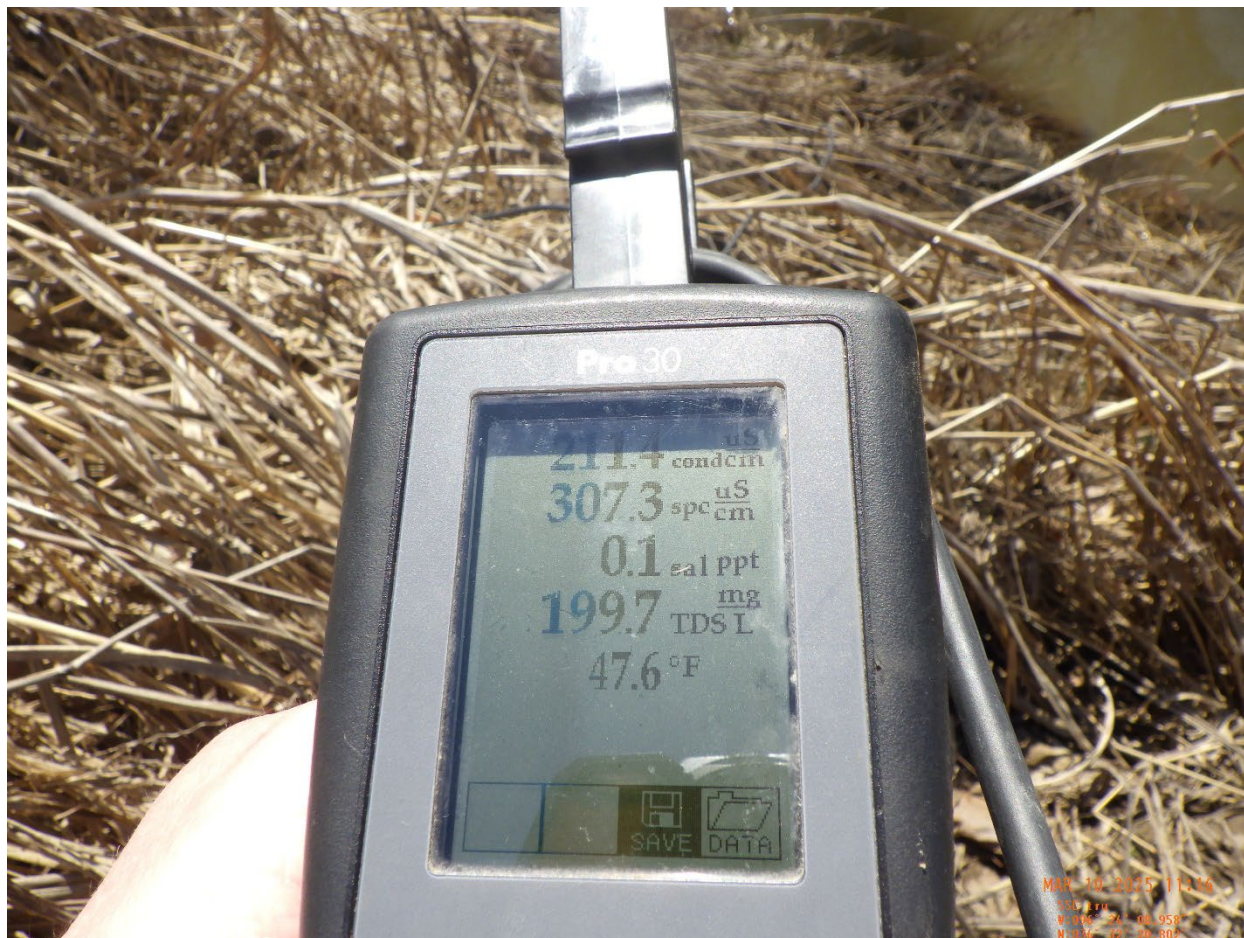
Photo No. 5

At the POE into Little Hominy Creek, I observed a TDS field reading of 199.7 mg/L. Little Hominy Creek had substantial in-stream flow at the time of the inspection. See photo No. 5.

**Description:** This was a TDS field reading of 199.7 mg/L observed at the POE into Little Hominy Creek.

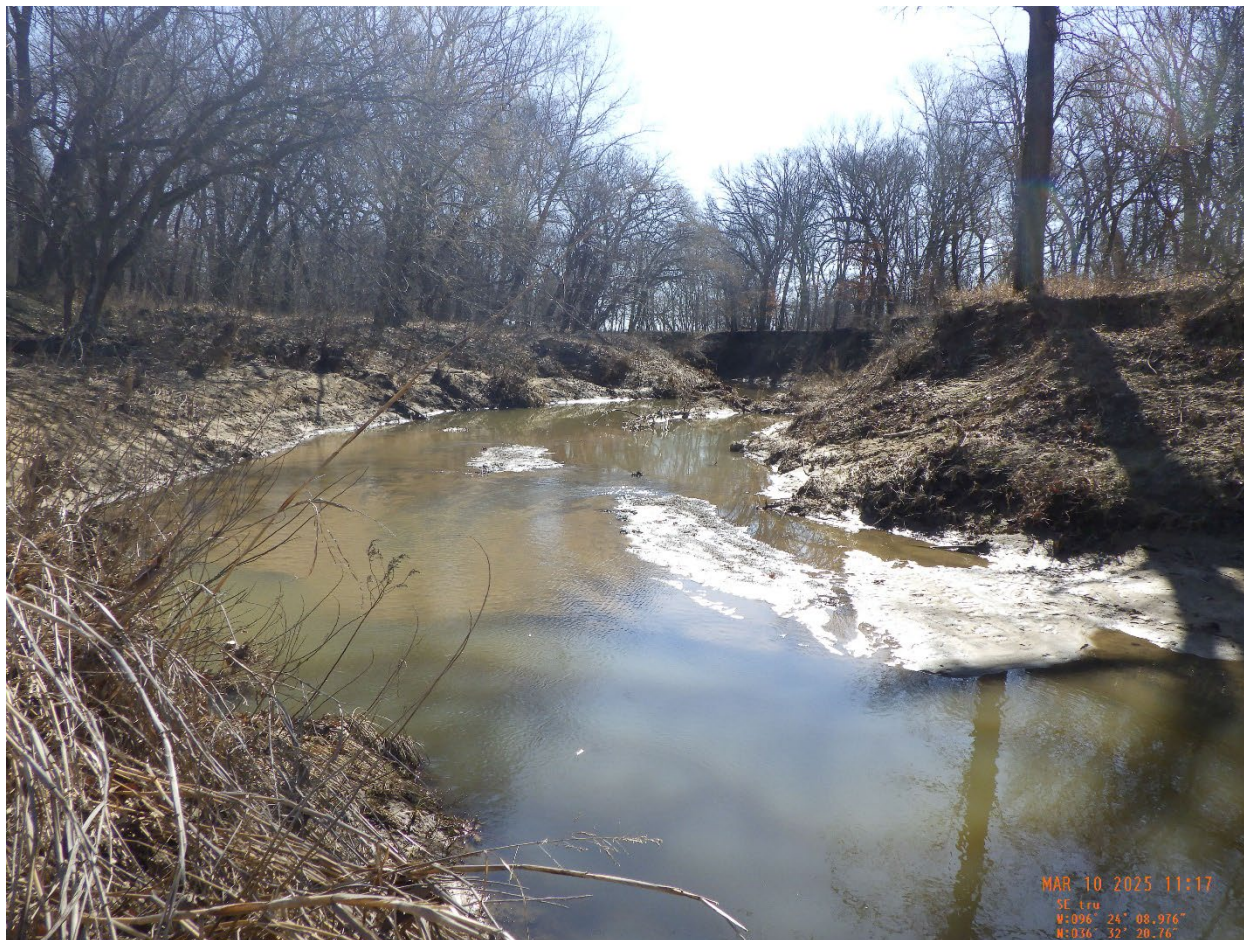
Photo No. 6

From the POE, I observed the upstream (photo No. 6) and downstream (photo No. 7) view of Little Hominy Creek.

**Description:** Standing at the POE with a SE or upstream view of Little Hominy Creek.

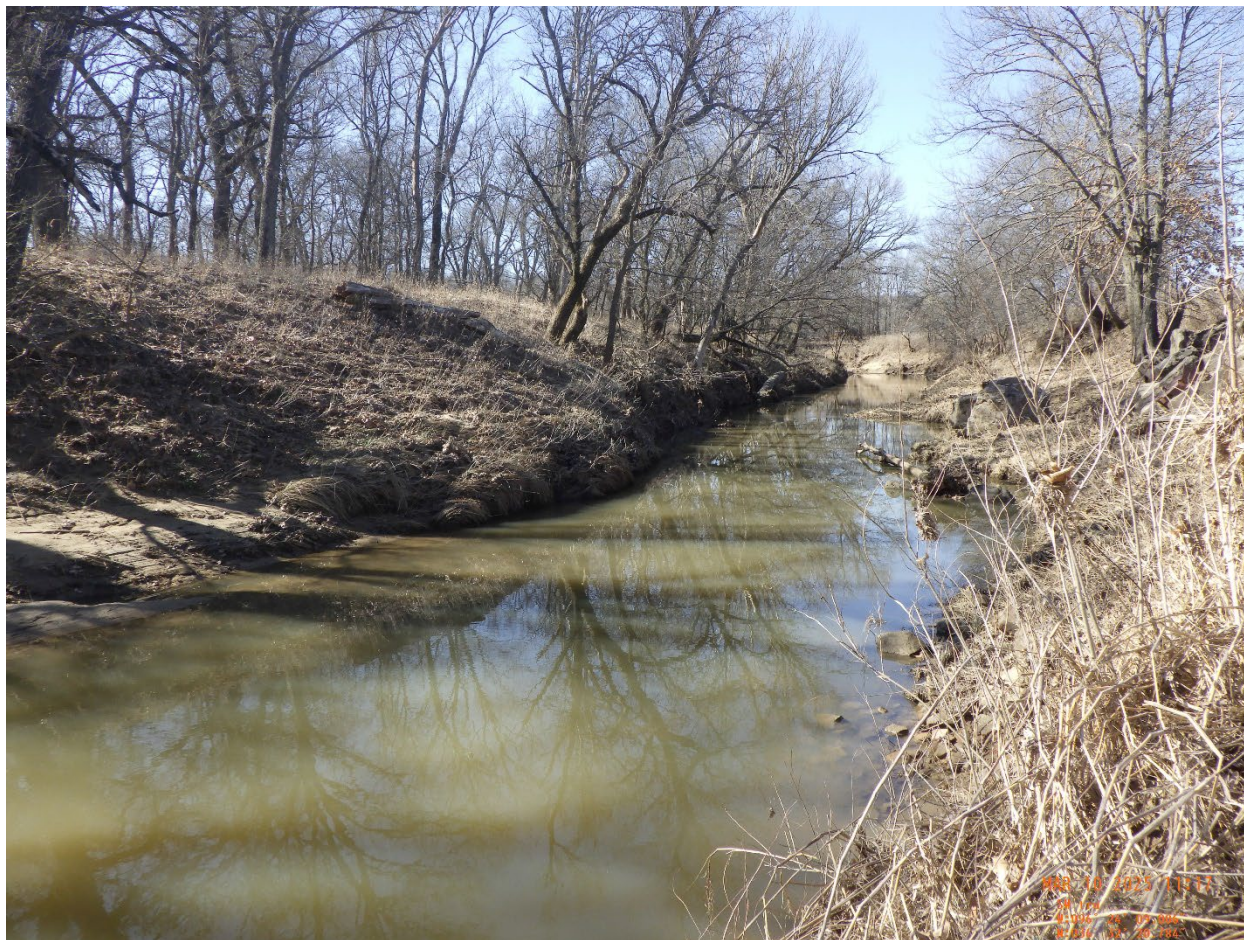
Photo No. 7

**Description:** Standing at the POE with a SW/downstream view of Little Hominy Creek.
