**Region 6 - Enforcement & Compliance Assurance Division**  
**INSPECTION REPORT**

| Inspection Date(s): | 07/31/2025 | |
| Regulatory Program(s) | CWA, NPDES, CAFO | |
| Company Name: | Five States Livestock Auction Inc. | |

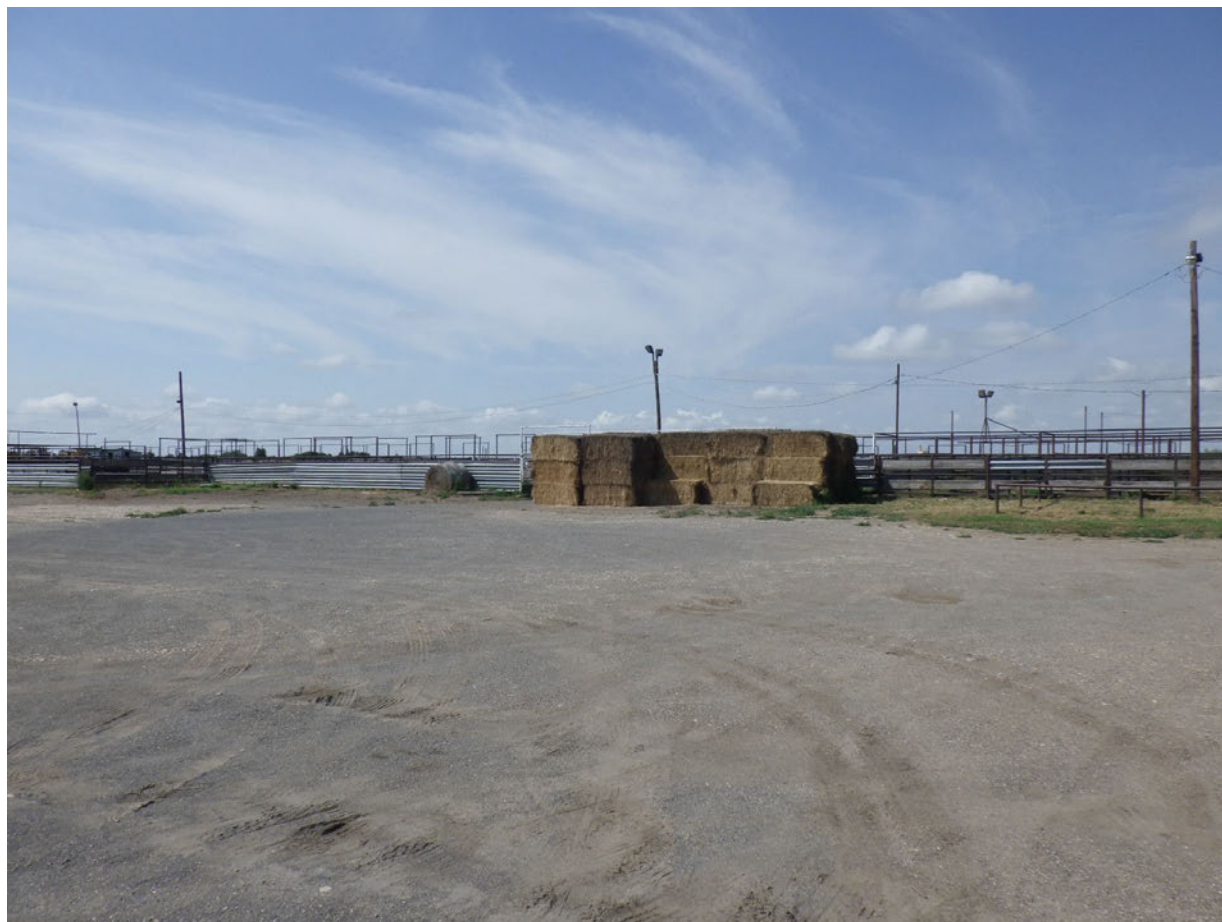
Photo No. 1

The facility uses hay as a feed commodity (Appendix 1, Photo 1).

No mortalities were present on site at the time of the inspection. Hay bales were stored in the open within the drainage channel of the ponding area on the east side of the pens, south of the office (Appendix 1, Photo 1).

| Description: | View to the southeast. Hay storage on east perimeter of pens.<br>(36.4641, -103.1923) |

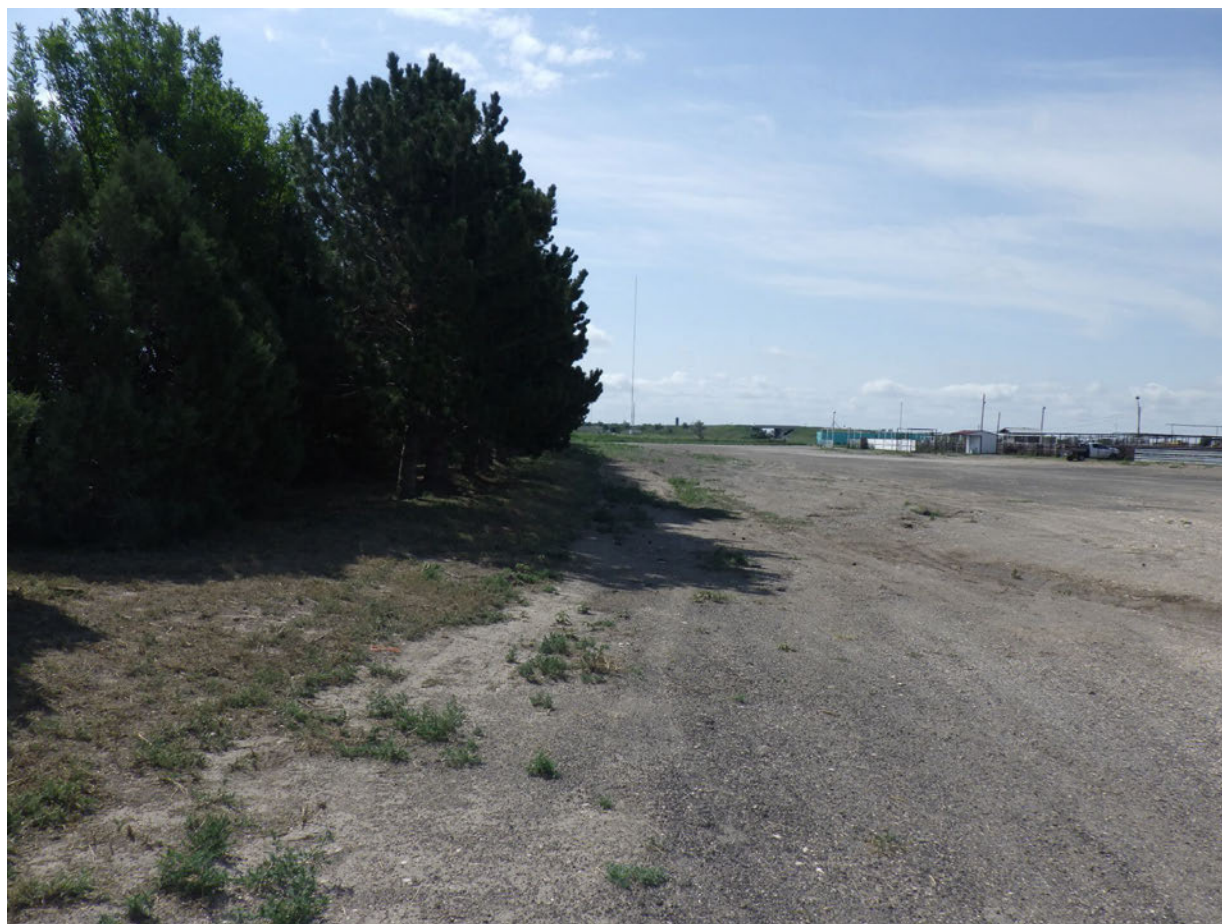
Photo No. 2

The facility borders Lake Hwy/NM-370 on the east perimeter and train tracks on the west perimeter (Appendix 1, Photos 2, 3, & 10; Appendix 2, Photo 1). The raised structures and the facility's grading would channel runoff to the south. During the opening conference, [REDACTED] indicated runoff leaves the property and flows into a ponding area located on the south perimeter of the facility (Appendix 1, Photo 5). He specifically pointed out where the drainage channel flows into this ponding area, which is near the south entrance to the facility off Lake Hwy/NM-370 (Appendix 2, Photo 1).

No signs of runoff were detected leaving the facility after inspecting the perimeter of the pens. (Appendix 1, Photos 2, 3, 9, 10, & 11). During the site tour, inspectors noted the elevation difference between the train tracks and Lake Hwy/NM-370 (Appendix 1, Photos 2, 3, & 10). This elevation difference, along with the grading of the lot, confirmed that runoff will be channeled to the south end of the facility.

| Description: | View to the east. Eastern edge of the facility. Shot of raised area next to NM-370. (36.4643, -103.1920) |

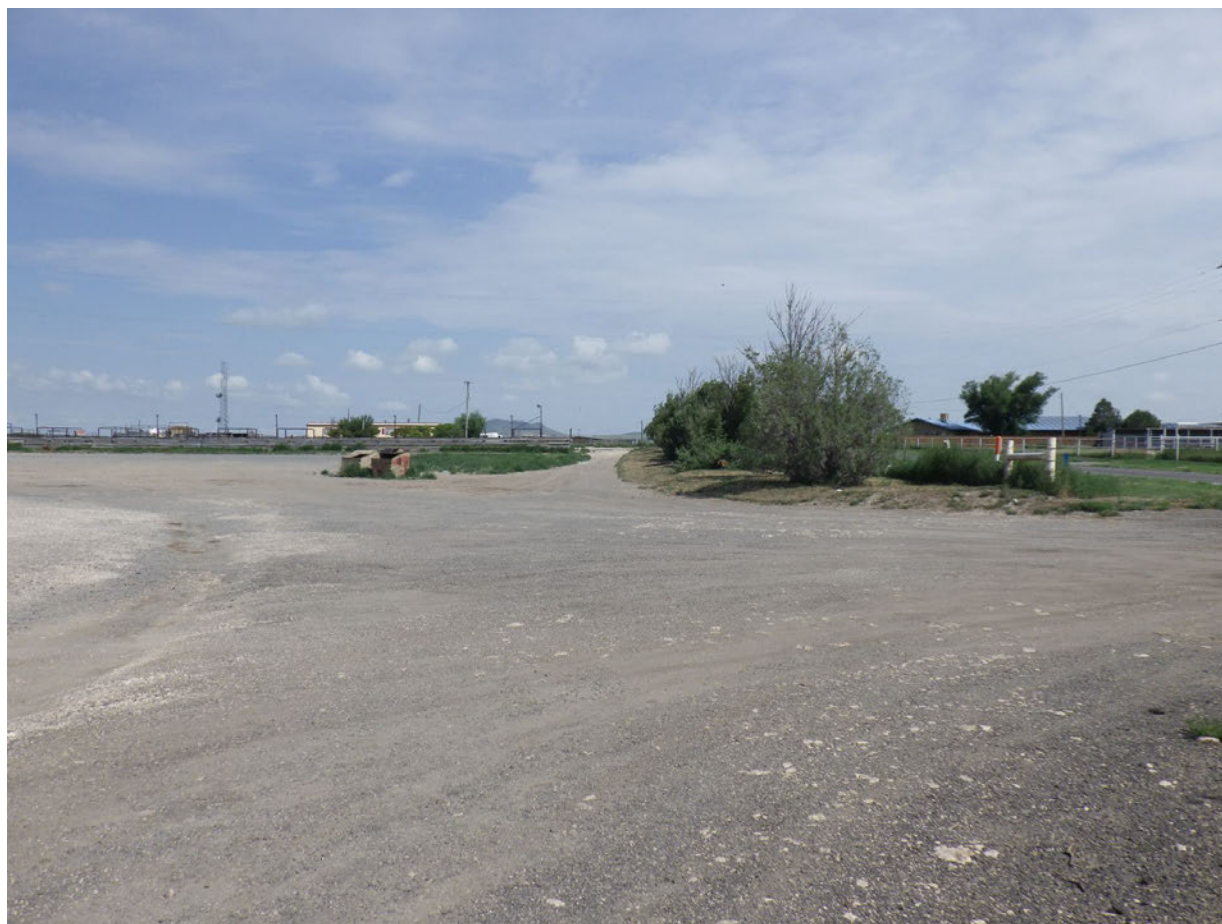
Photo No. 3

| Description: | View to the west. East perimeter of the property. Raised grassy area and entrance to facility from Lake Hwy/NM-370.<br>(36.4643, -103.1920) |

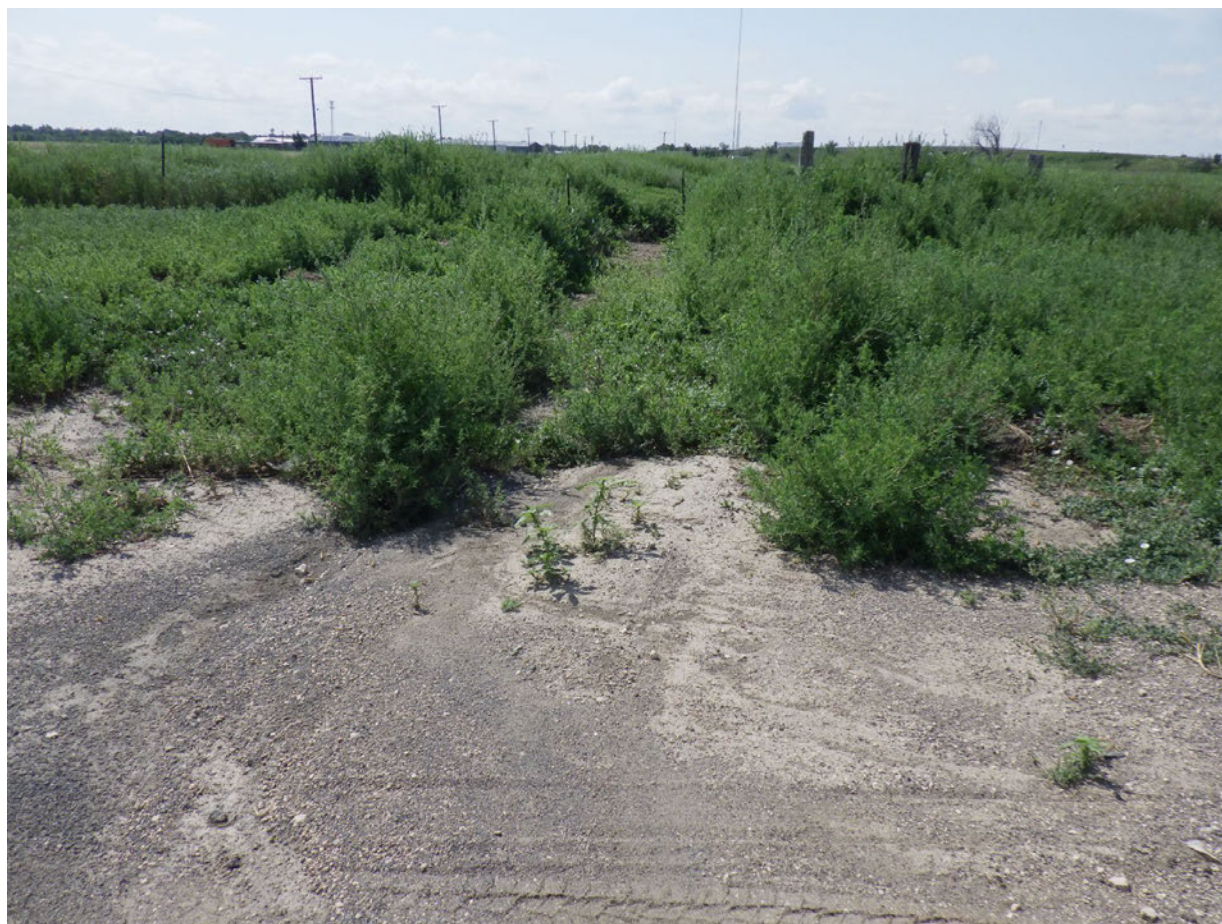
Photo No. 4

The drainage channel on the southeastern corner was also visible and confirmed by [REDACTED] as he drove by (Appendix 1, Photos 4 & 5). Inspectors followed the drainage channel to the ponding area and eventual runoff outfall (Appendix 1, Photos 4, 7, & 8). The ponding area had berms along the perimeter and contained tall vegetation (Appendix 1, Photo 8). The ponding area seems to be utilized as a retention control structure (RCS) for runoff from the facility (See Areas of Concern).

- 1) The facility appears to be utilizing the ponding area to the south of the facility as a Retention Control Structure (RCS) (Appendix 1, Photos 4, 5, 7, & 8; Appendix 2, Photo 1). The primary concern is that the pond has not been certified to demonstrate a liner with a hydraulic conductivity rate of less than  $1 \times 10^{-7}$  cm/sec, which is crucial to prevent groundwater contamination. CWA, Section 301 (33 U.S.C. § 1311): The lack of a synthetic liner in the runoff pond may pose a risk of unauthorized discharge of pollutants, including nutrients and pathogens, in violation of Section 301 of the Clean Water Act, which prohibits the discharge of pollutants into waters of the United States without a permit.

| Description: | View to the southeast. Drainage channel leading to runoff pond on the southeastern end of the property.<br>(36.4626, -103.1910) |

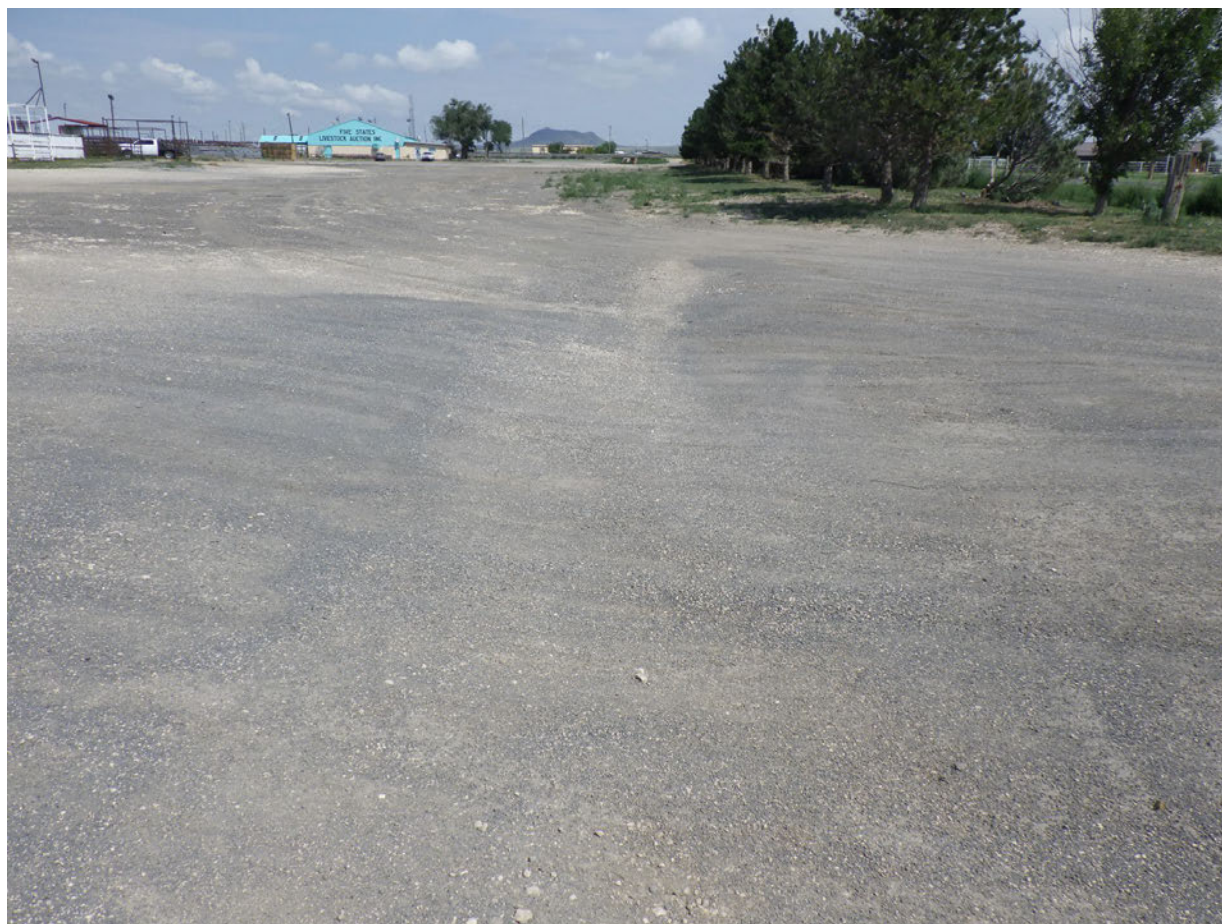
Photo No. 5

| Description: | View to the northwest. Drainage channel that leads to the runoff pond. Facility and pens in background.<br>(36.4626, -103.1910) |

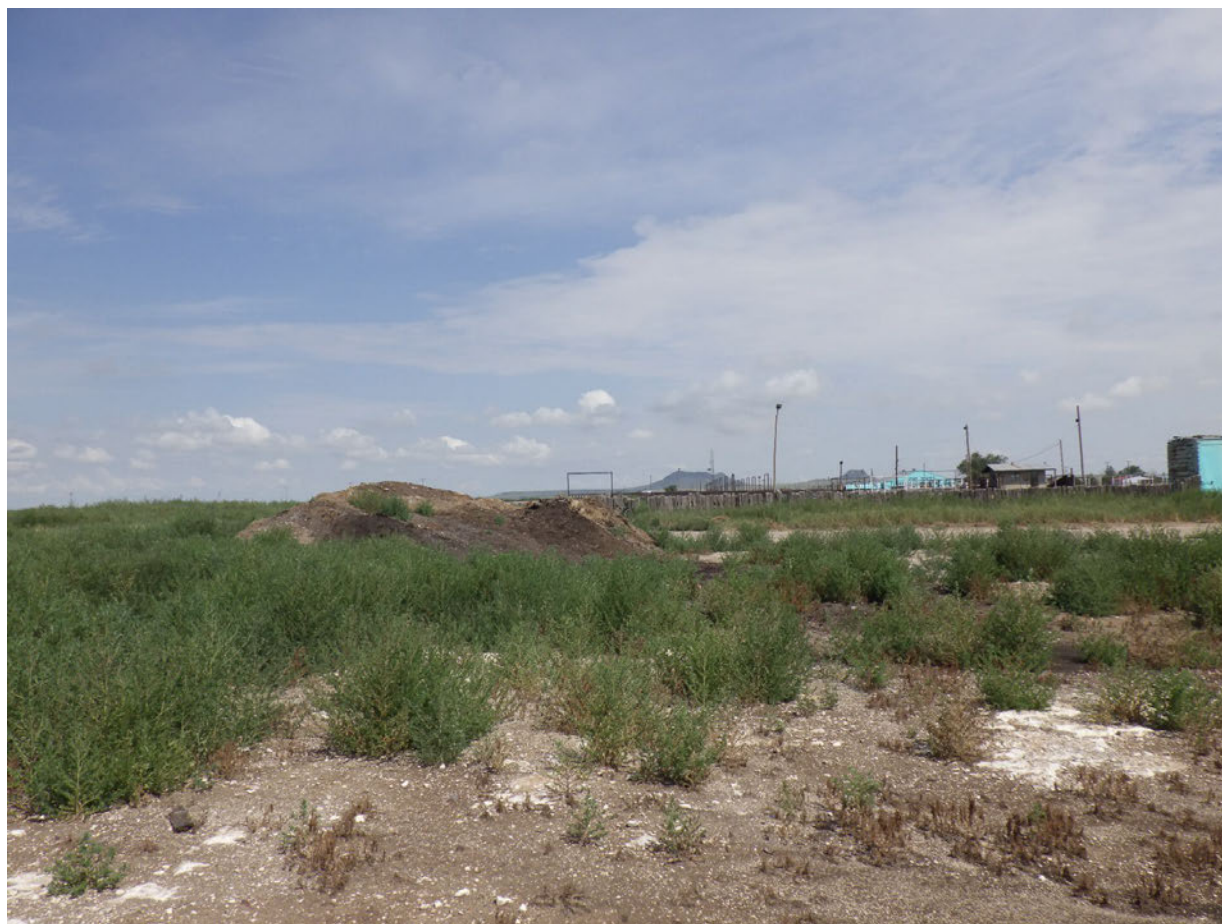
Photo No. 6

Pens are cleaned by scraping with a Bobcat, as needed. Lot scrapings are stockpiled before being distributed and hauled off-site by third-party farmers (Appendix 1, Photo 6).

The open lot pens were clean, with no visible manure piles inside. A manure stockpile was observed outside the pens on the southwest perimeter of the facility (Appendix 1, Photo 6), located within the drainage area leading to the ponding area.

| Description: | View to the west. Manure stockpile on the south end of the property. Within drainage of runoff pond.<br>(36.4619, -103.1913) |

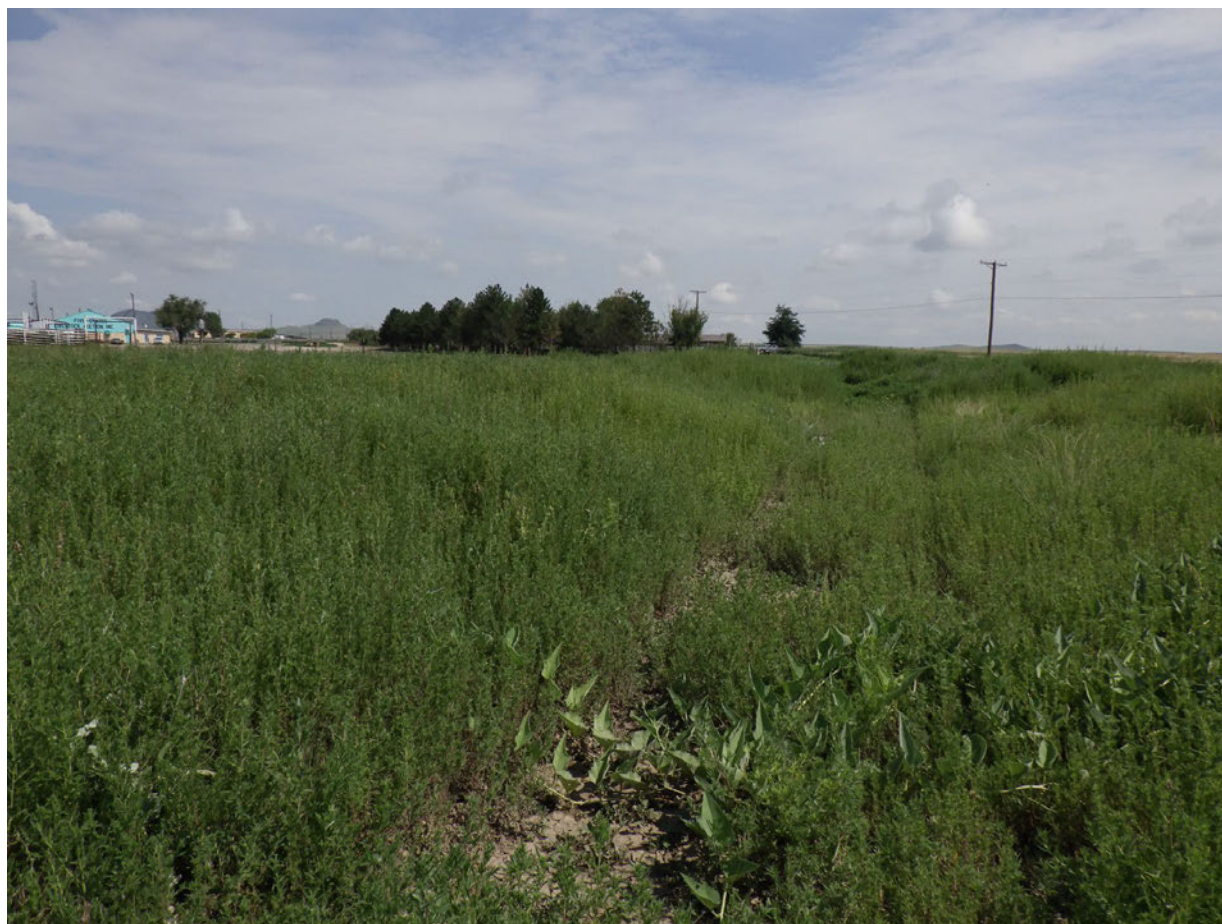
Photo No. 7

| Description: | View to the north. Drainage channel leading to runoff pond in grassy area south of the property. Facility in background.<br>(36.4618, -103.1910) |

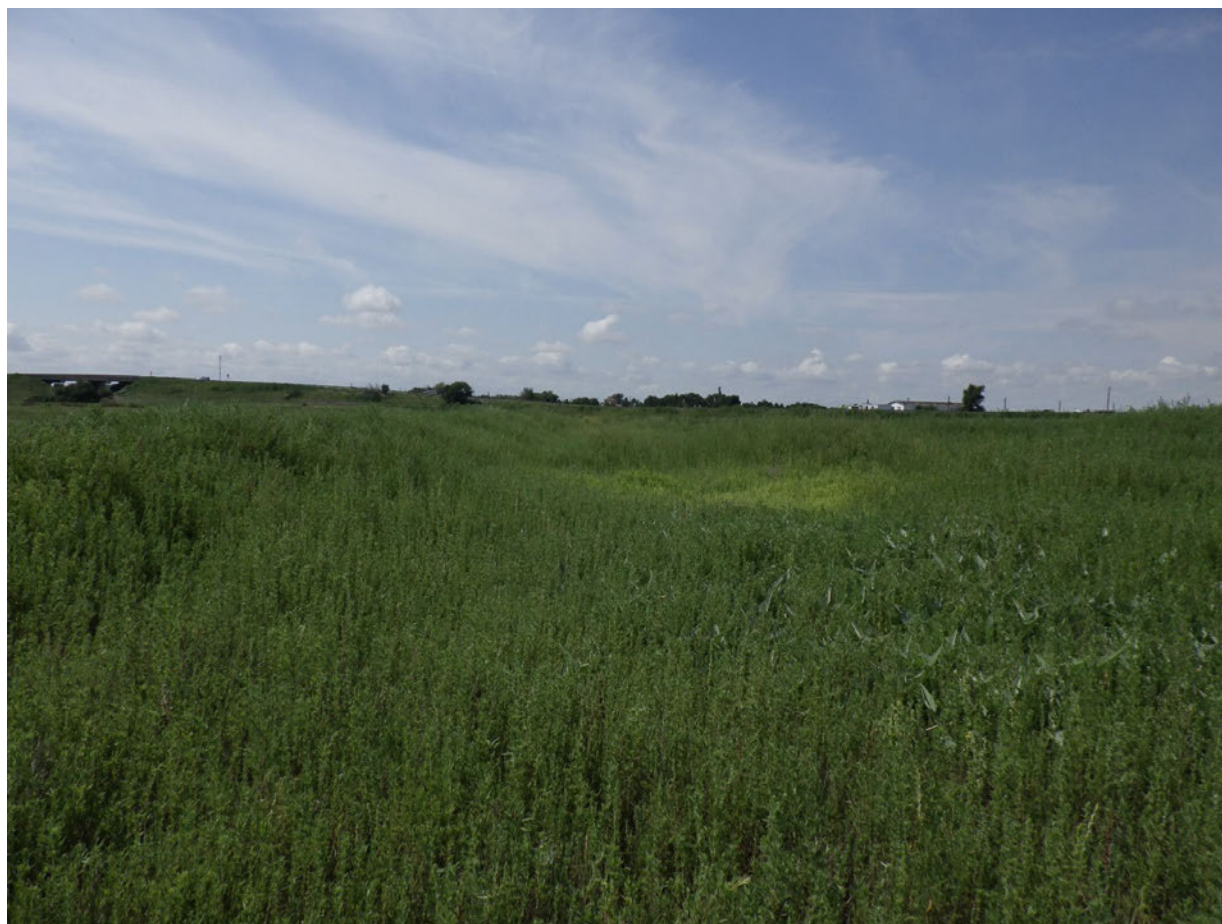
Photo No. 8

| Description: | View to the southwest. Runoff pond in the grassy area south of the property.<br>(36.4613, -103.1912) |

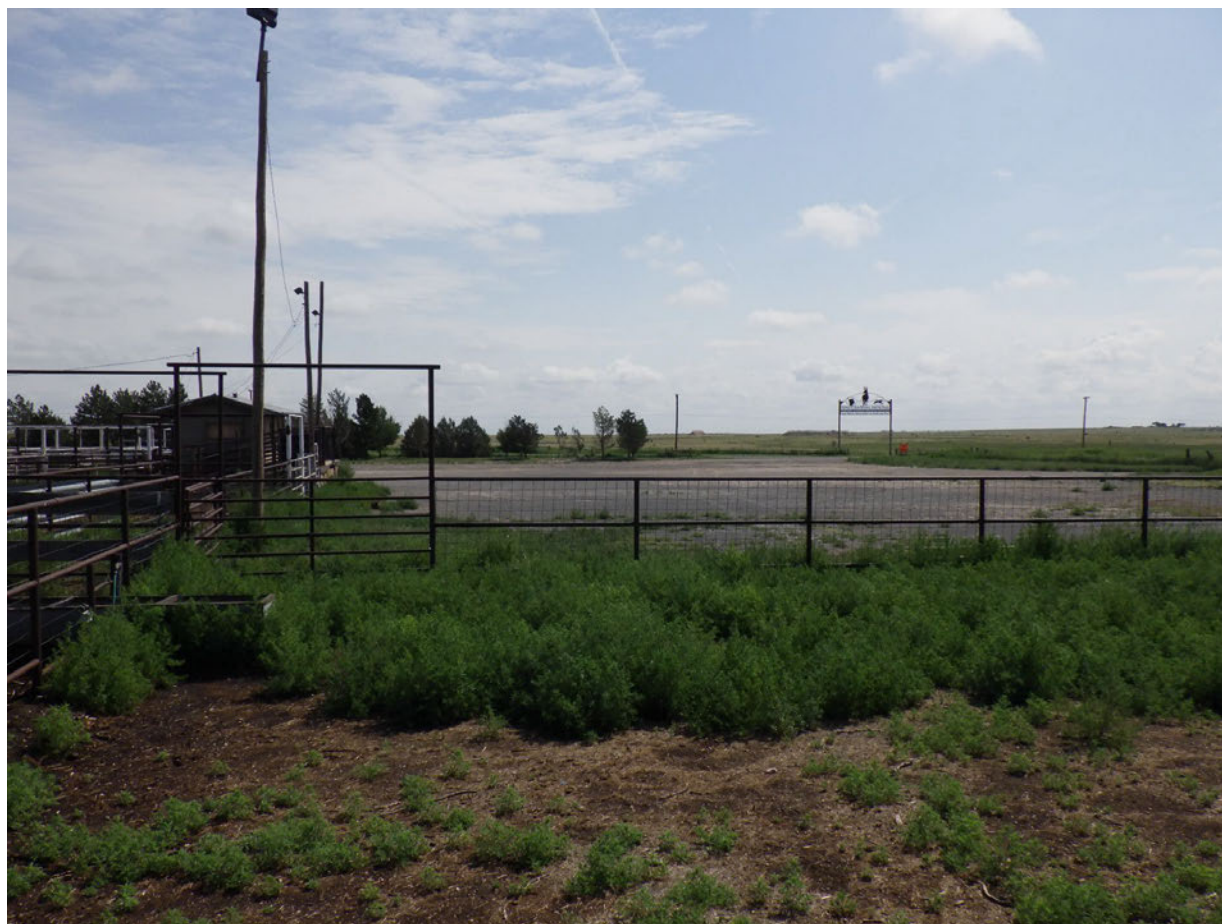
Photo No. 9

| Description: | View to the northeast. Southern perimeter of the pens.<br>(36.4625, -103.1924) |

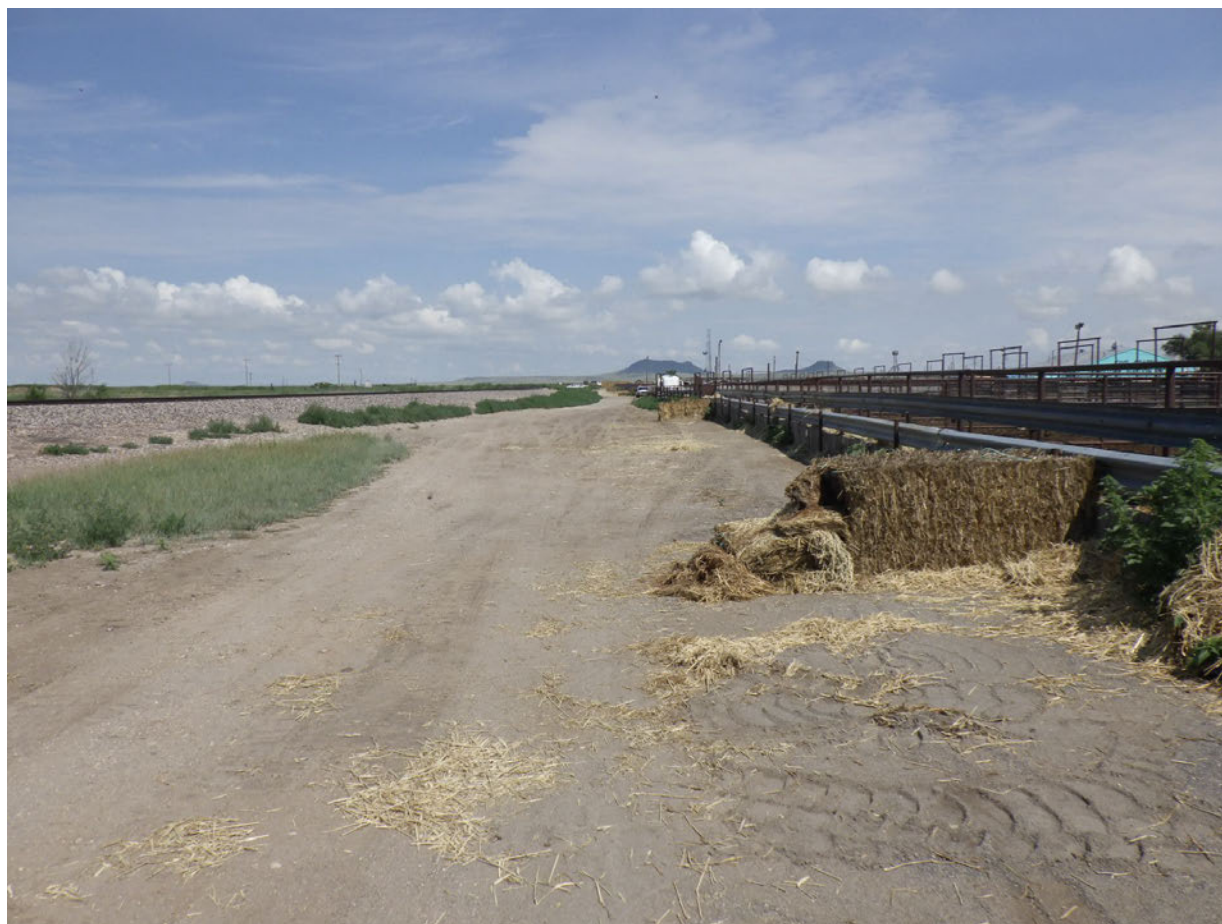
Photo No. 10

| Description: | View to the northwest. West perimeter of the pens. Raised train tracks on the left.<br>(36.4627, -103.1927) |

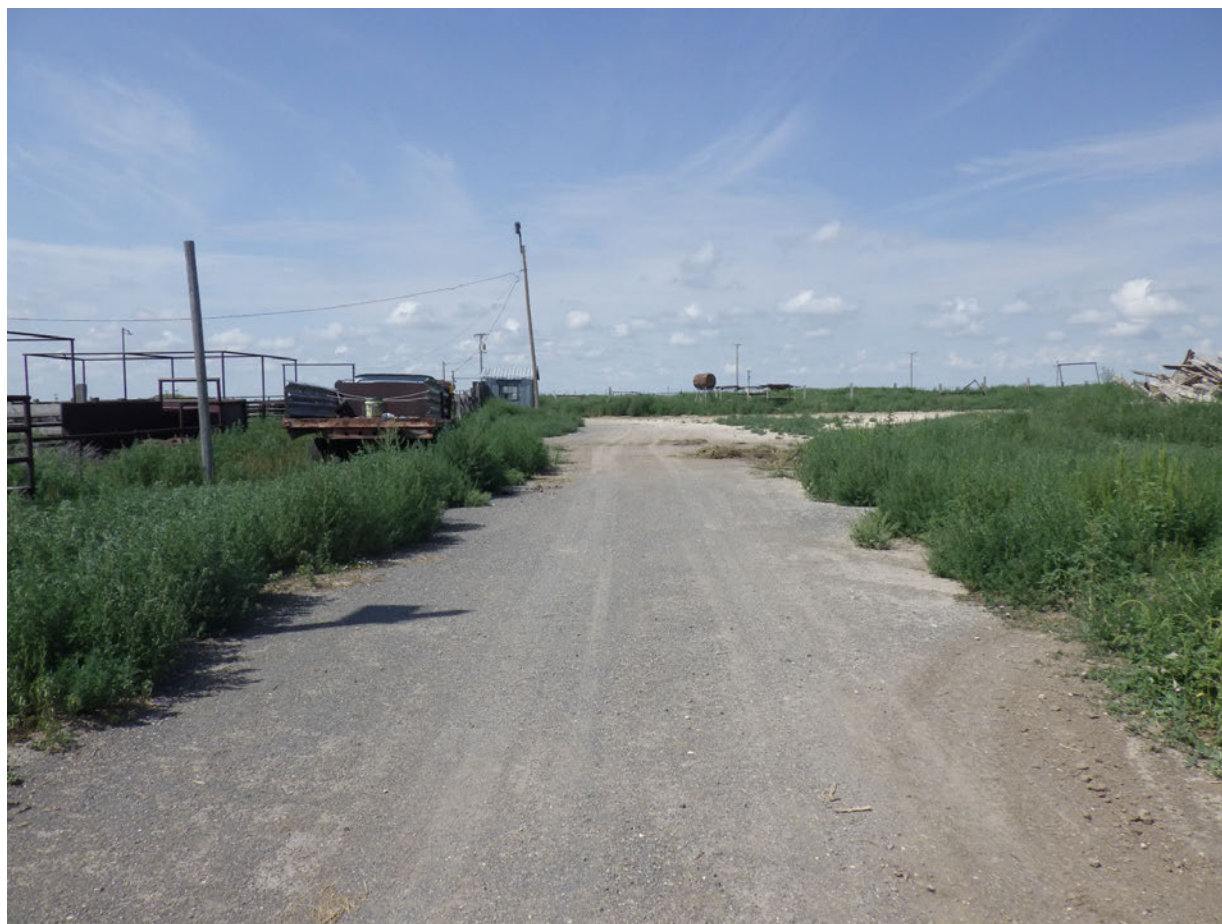
Photo No. 11

| Description: | View to the west. Northern perimeter of the pens.<br>(36.4653, -103.1936) |
