### INSPECTION REPORT

| Inspection Date(s): | 4/3/24 | |
| Company Name: | <b>Nevada Oil, LLC</b> | |
| Facility Name: | <b>Hadley "A" Lease, Wells 1 &amp; 2 Tank Battery</b> | |

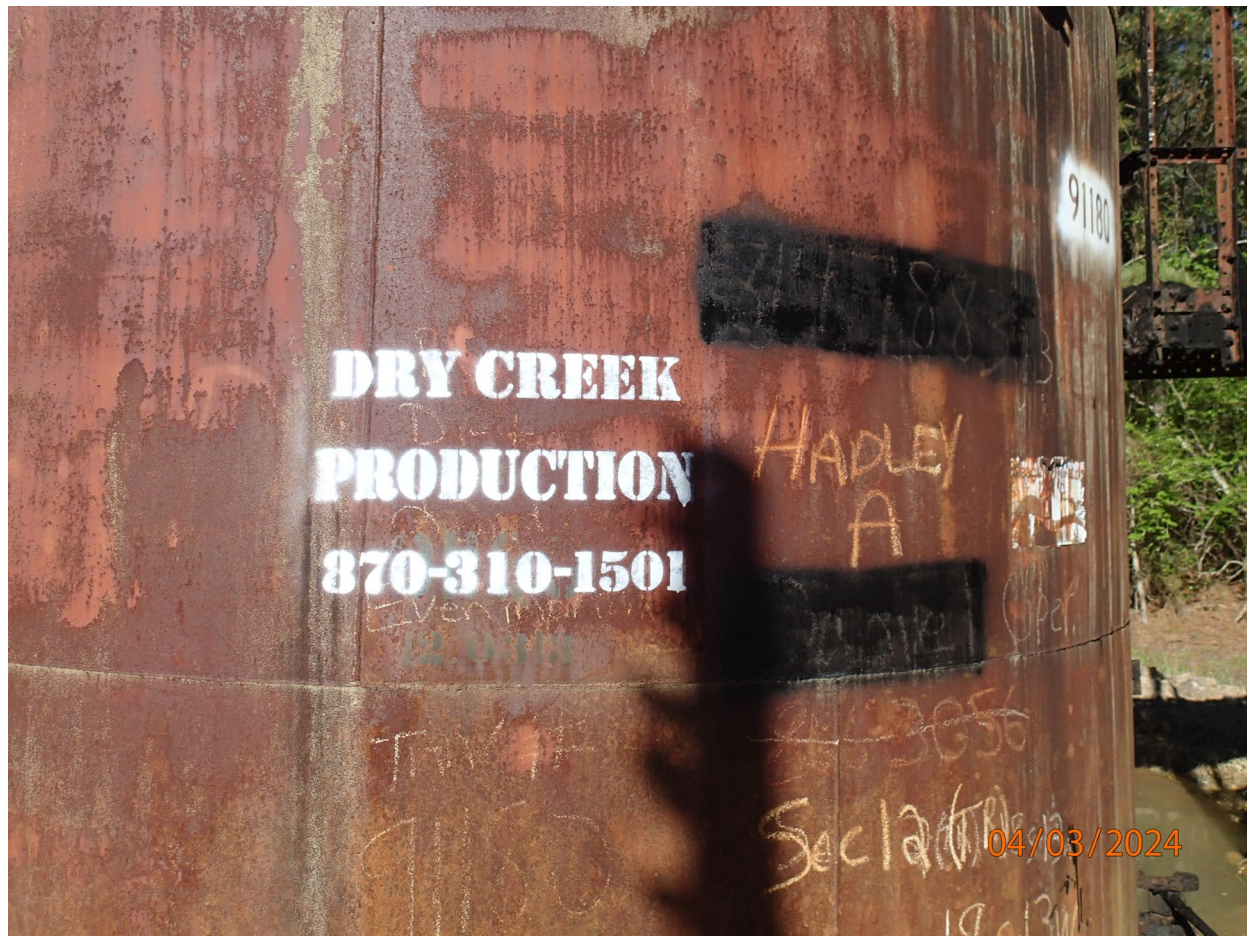
Photo No. 1

Description: Looking E-SE, this photo showed the signage at the facility.

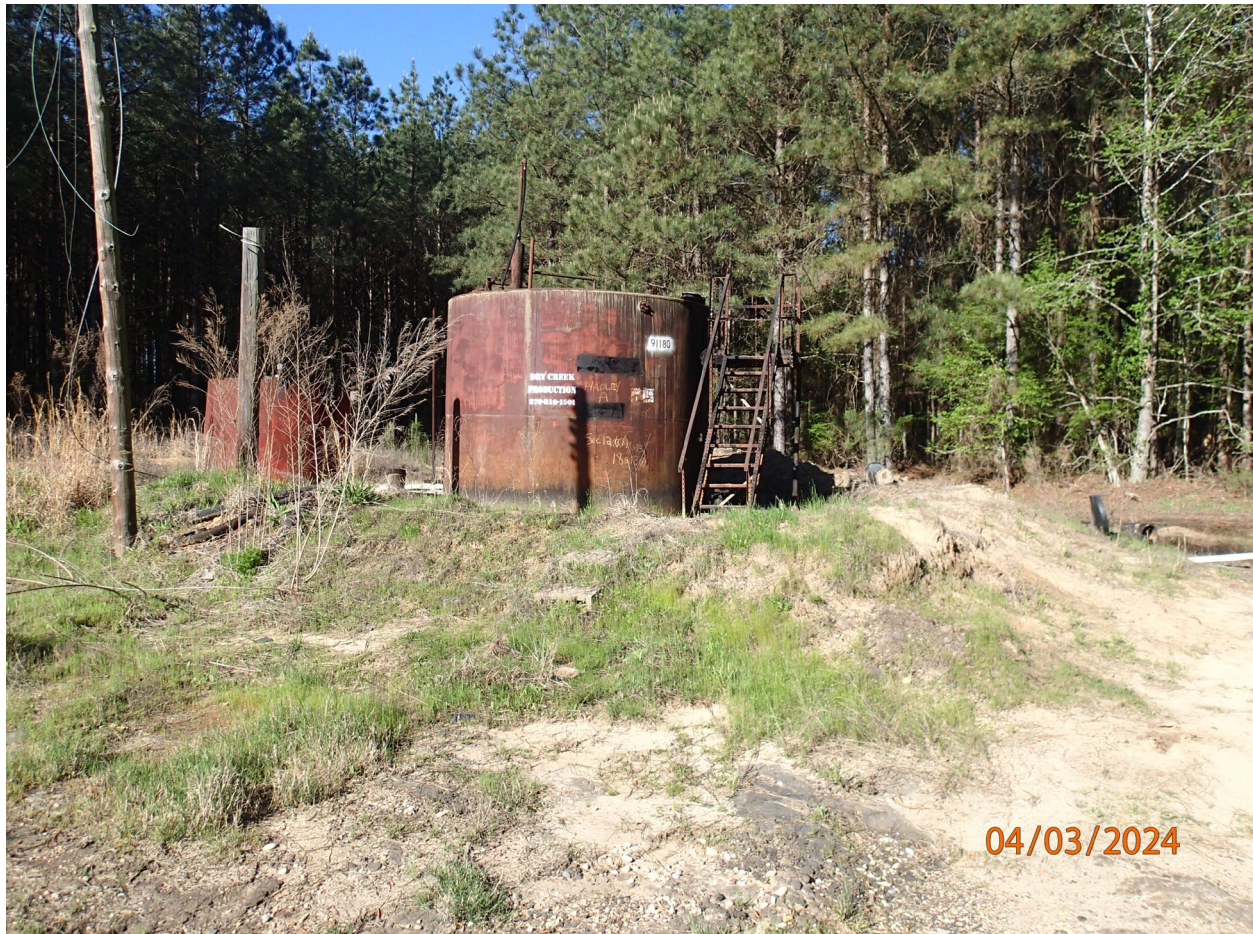
Photo No. 2

**Description:** Looking E-SE, this photo showed the overview of the facility.

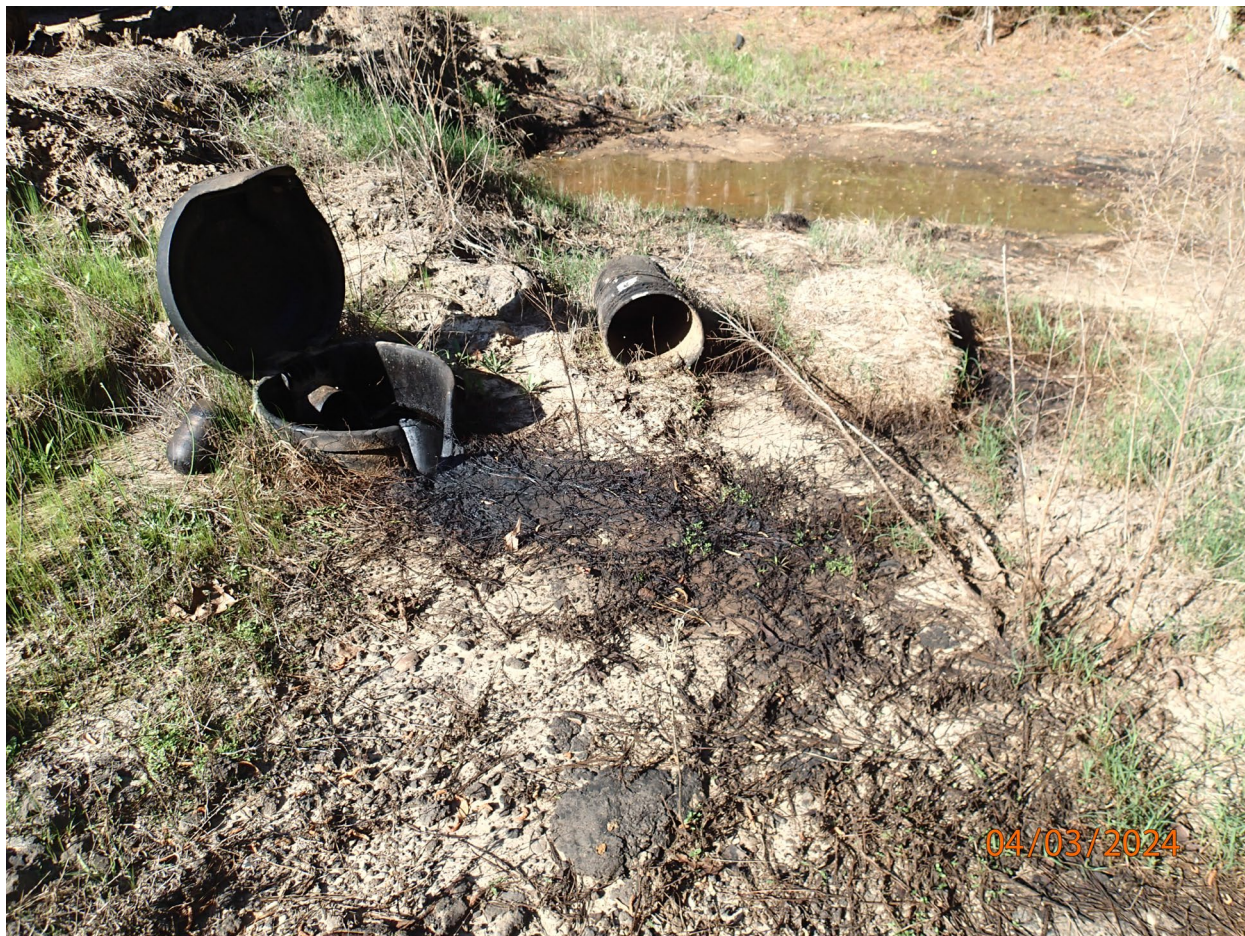
Photo No. 3

I observed a transfer pipe from secondary containment with no cap on the pipe and an open catch bucket; loose oil was observed around the catch bucket; see Photo No. 3.

**Description:** Looking E-SE, this photo showed an open catch bucket at the transfer pipe through secondary containment with loose oil outside on the ground.

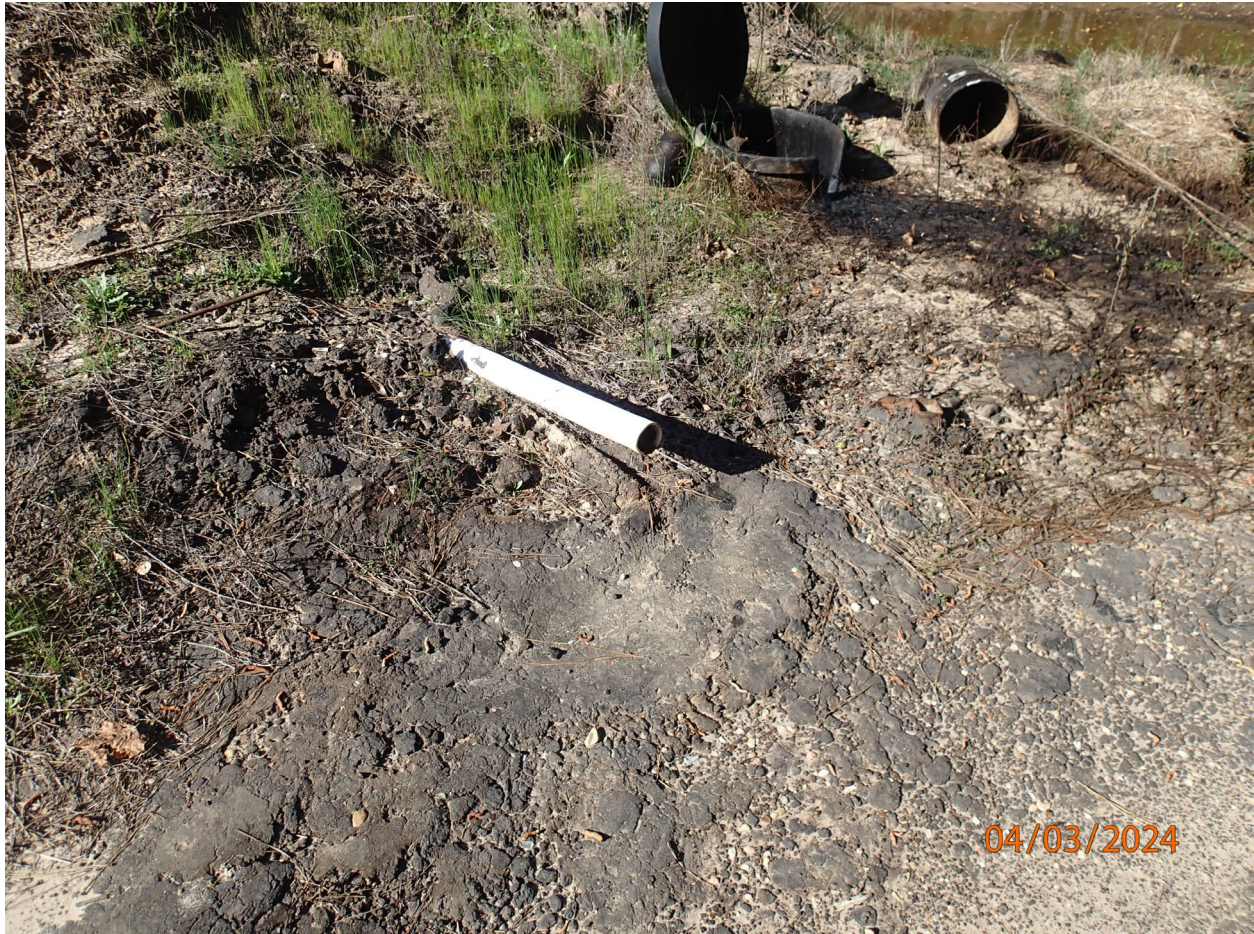
Photo No. 4

I observed a pipe through secondary containment without a shutoff valve or a cap; the purpose of the pipe is unknown; see Photo No. 4.

**Description:** Looking E-SE, this photo showed a pipe through the secondary containment without a cap.

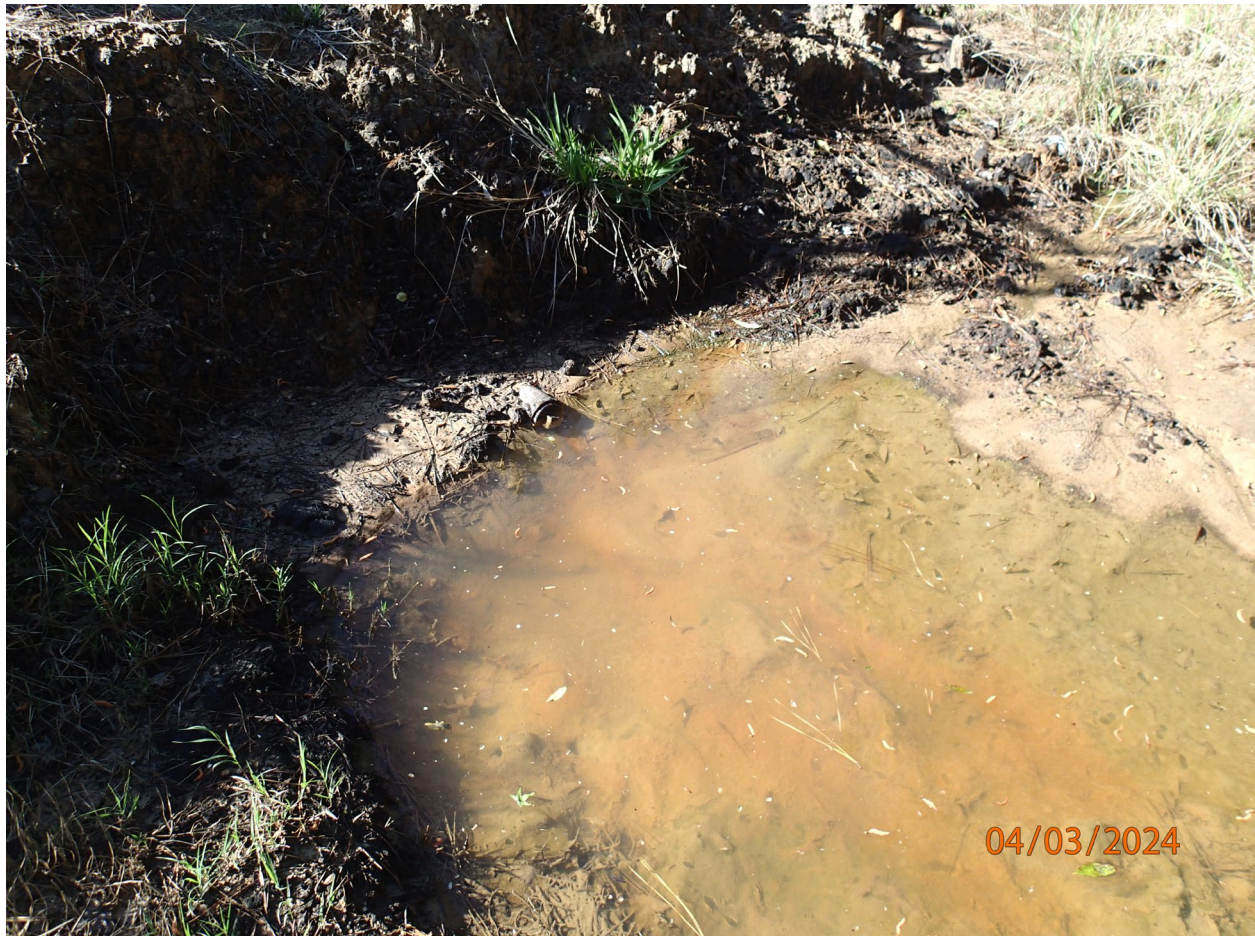
I observed the drainpipe for secondary containment without a shutoff valve or a cap, see Photo No. 5 and No. 6.

**Description:** Looking S-SE, this photo showed the drainpipe for the secondary containment with a cap on the pipe; I noted saltwater staining in the standing water at the drainpipe.

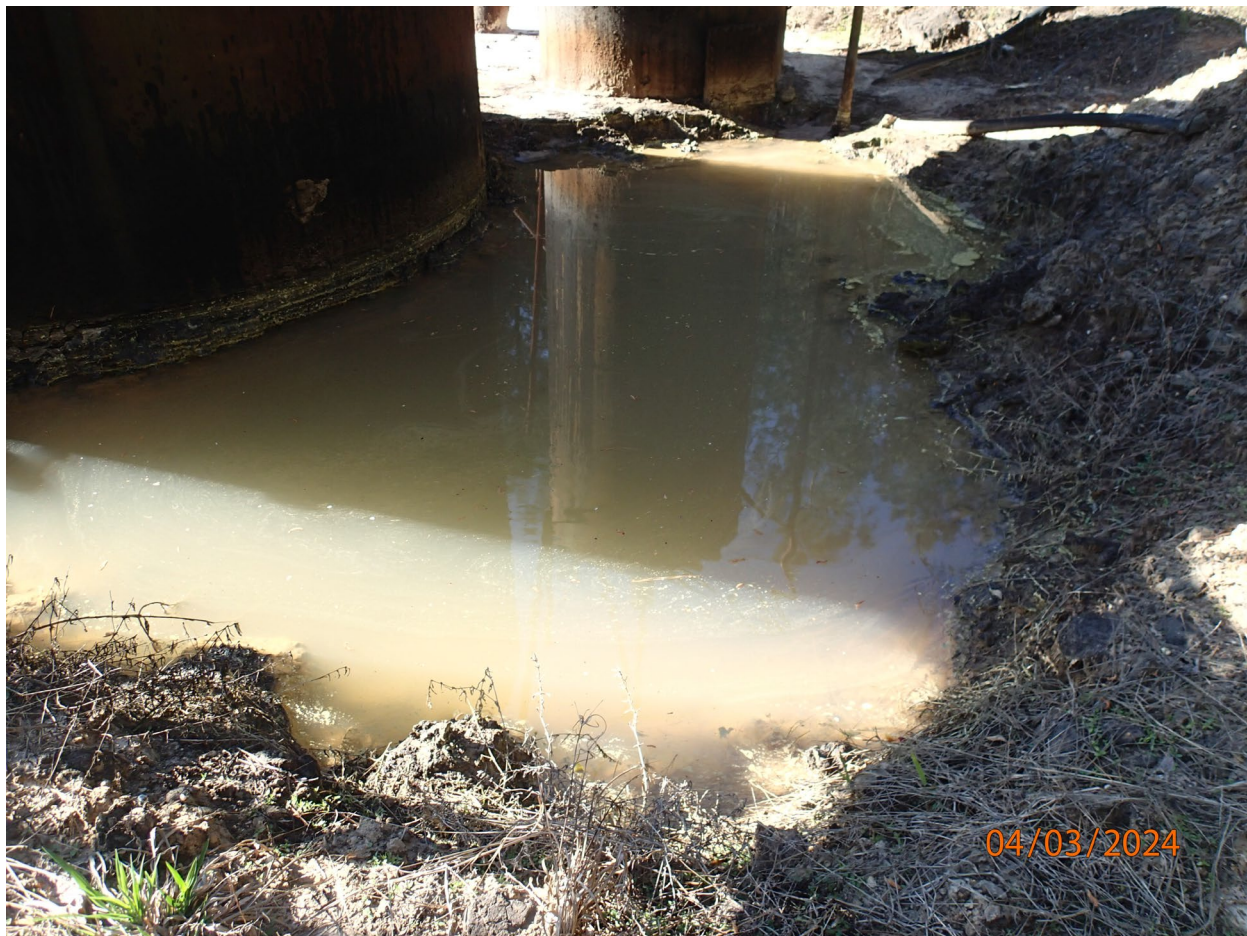
Photo No. 6

**Description:** Looking S, this photo showed standing water inside the secondary containment that would be drained via the drainpipe through the firewall.

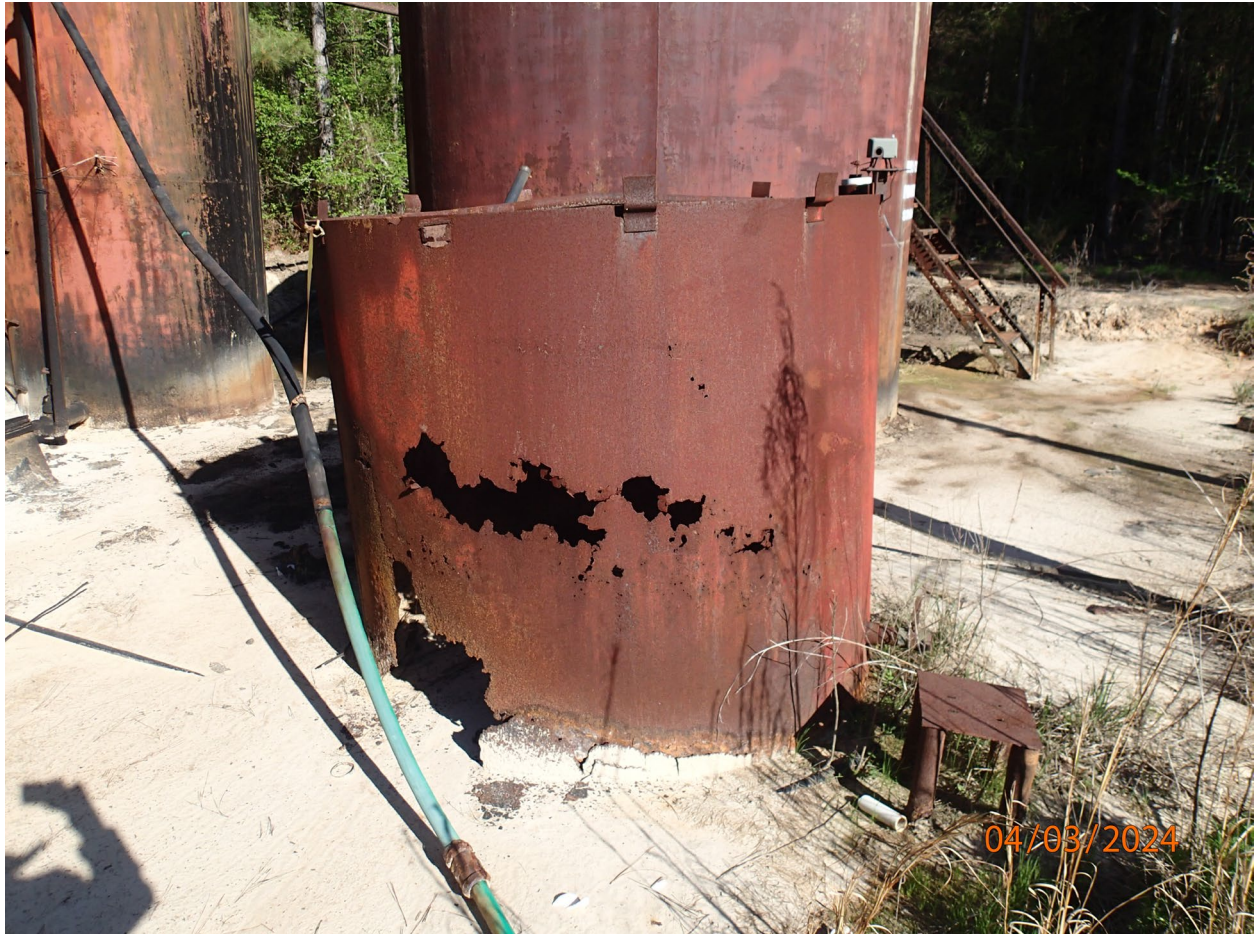
Photo No. 7

I observed the storage tanks to be corroded with one tank with holes in the material; no "out of serve" label on the tank; see Photo No. 7.

**Description:** Looking E-NE, this photo showed a storage tank with numerous holes that is not being utilized and it is not labeled “out of service.”

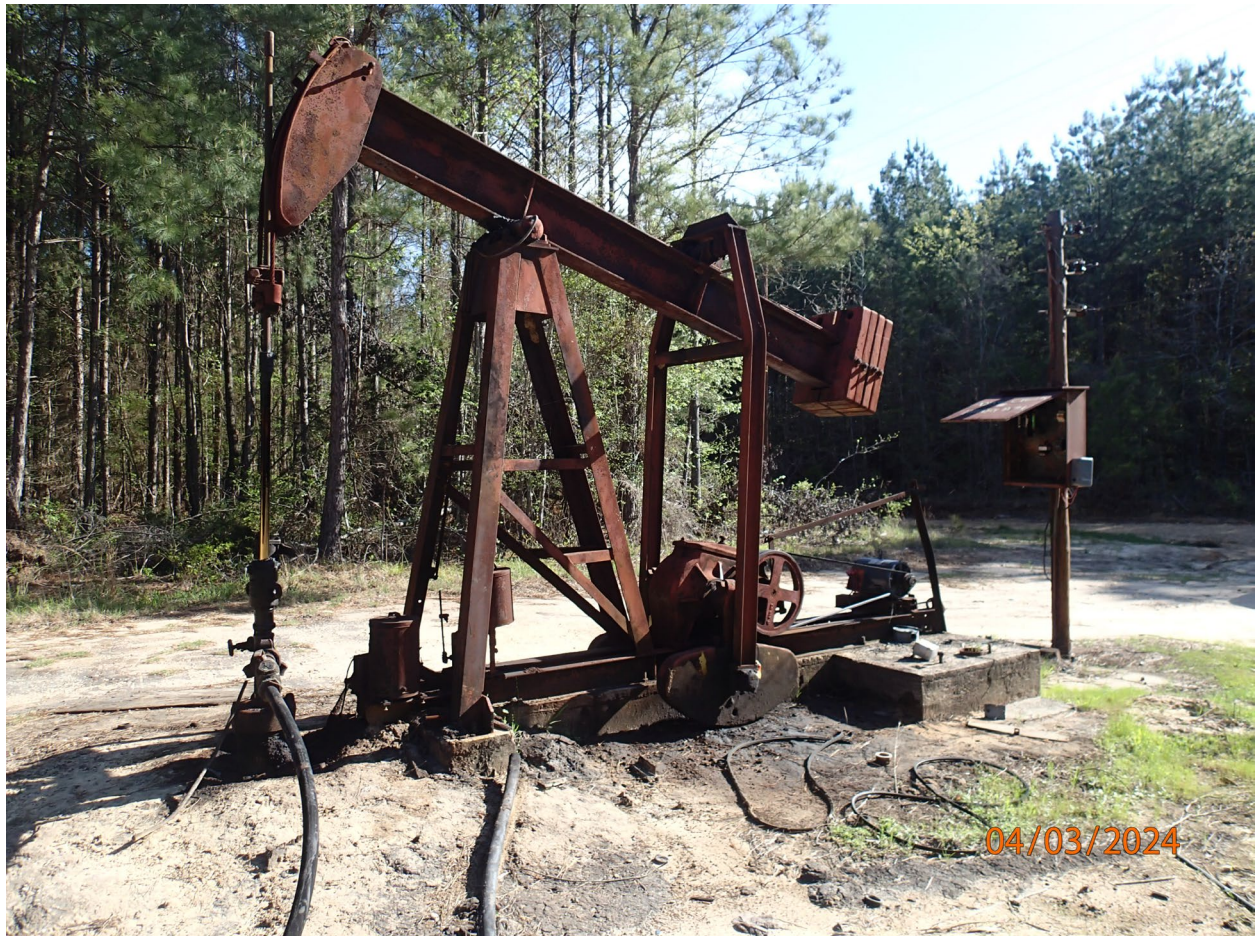
Photo No. 8

I observed the production well located onsite with loose oil around the well, see Photo No. 8.

**Description:** Looking NW, this photo showed a production well onsite with some residual loose oil on the ground.
