## **RCRA Inspection Report**

AAR Landing Gear Services  
9371 NW 100th St  
Medley, Florida 33178

EPA ID # FLD982101933  
NAICS # 336413 – Other Aircraft  
Parts and Auxiliary Equipment  
Manufacturing

January 24, 2024

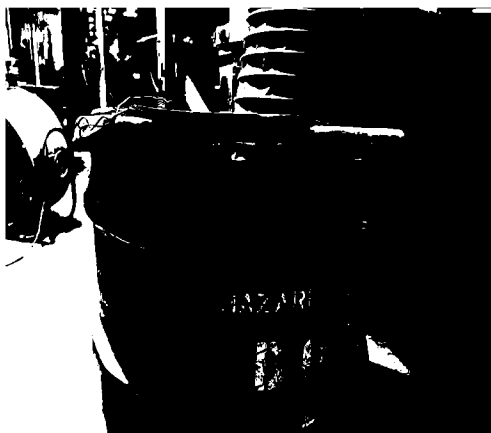
Photo #4 – Blasting Area: opened container, D006 label

One opened (20)-gallon container with D006 content was marked with the words "hazardous waste". However, the container was not marked with the indication of the hazards of the contents. Photos with drums closed and a pictogram consistent with the Occupational Safety and Health Administration Hazard Communication Standard at 29 CFR 1910.1200 received by email on January 31, 2024. Photo #4.

**Pursuant to Fla. Admin. Code Ann. R. 62-730.160(1) [40 C.F.R. §262.15(a)(5)(ii)], which is a condition of the SAA permit exemption, a generator must mark or label its container with the following: (ii) an indication of the hazards of the contents (examples include, but are not limited to, the applicable hazardous waste characteristic(s) (i.e., ignitable, corrosive, reactive, toxic); hazard communication consistent with the Department of Transportation requirements at 49 CFR part 172 subpart E (labeling) or subpart F (placarding); a hazard statement or pictogram consistent with the Occupational Safety and Health Administration Hazard Communication Standard at 29 CFR 1910.1200; or a chemical hazard label consistent with the National Fire Protection Association code 704).**

**Pursuant to Fla. Admin. Code Ann. R. 62-730.160(1) [40 C.F.R. § 262.15(a)(4)], which is a condition of the SAA permit exemption, a container holding hazardous waste must be closed at all times during accumulation, except: (i) When adding, removing, or consolidating waste; or (ii) when temporary venting of a container is necessary.**

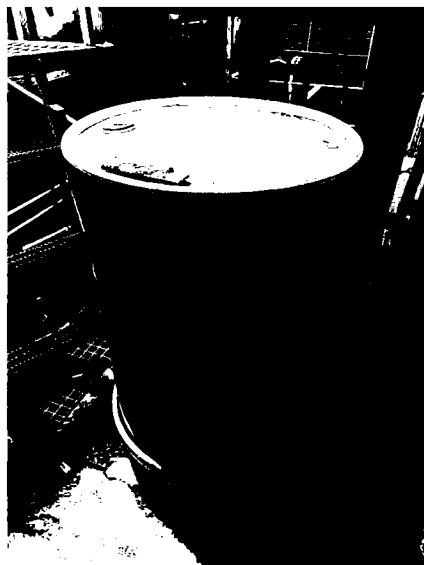
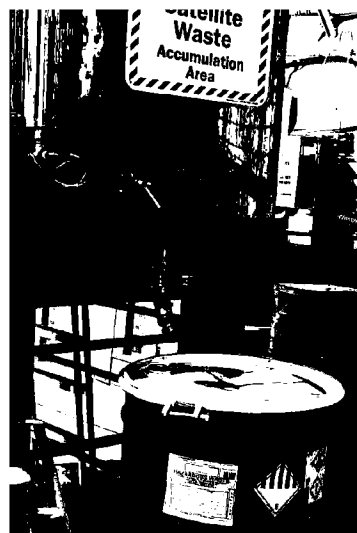
Photo #5 – Vapor Degreaser: Container without label

The vapor degreaser process uses perchloroethylene (perc) to remove any waxy residue on parts before plating. Maintenance to the tank is performed every six months. One closed (55)-gallon container was observed in this area without a label. Photos with drums closed and a pictogram consistent with the Occupational Safety and Health Administration Hazard Communication Standard at 29 CFR 1910.1200, was received by email on January 31, 2024. Photo #5.

**Pursuant to Fla. Admin. Code Ann. R. 62-730.160(1) [40 C.F.R. §262.15(a)(5)(i)(ii)], which is a condition of the SAA permit exemption, a generator must mark or label its container with the following: (i) the words "Hazardous Waste", and (ii) an indication of the hazards of the contents (examples include, but are not limited to, the applicable hazardous waste characteristic(s) (i.e., ignitable, corrosive, reactive, toxic); hazard communication consistent with the Department of Transportation requirements at 49 CFR part 172 subpart E (labeling) or subpart F (placarding); a hazard statement or pictogram consistent with the Occupational Safety and Health Administration Hazard Communication Standard at 29 CFR 1910.1200; or a**

**chemical hazard label consistent with the National Fire Protection Association code 704).**

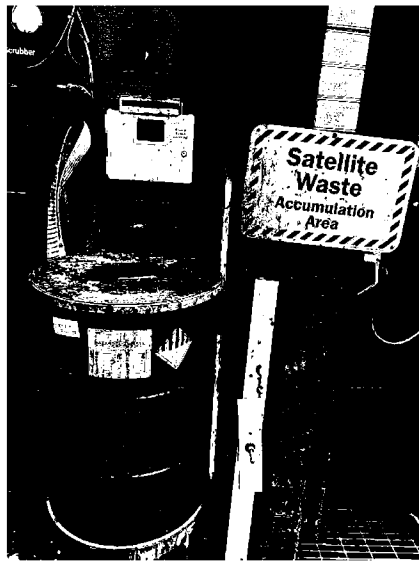
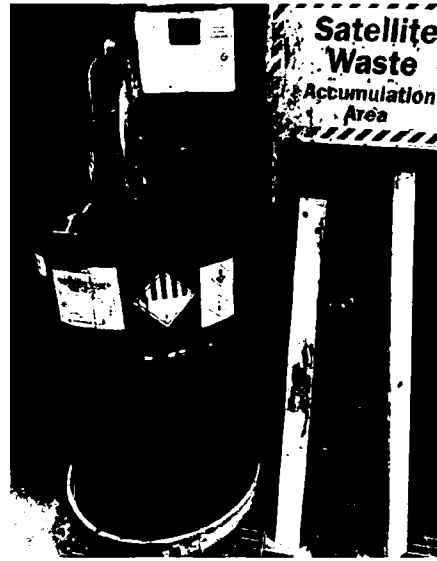
Photo #7 – Plating Area: container labeled with the Class 9 (miscellaneous)

It was observed that these containers were not labeled or marked with the appropriate hazard indicator. Instead, it was labeled with the Class 9 (miscellaneous) Department of Transportation (DOT) label. Photos with drum closed and a pictogram consistent with the Occupational Safety and Health Administration Hazard Communication Standard at 29 CFR 1910.1200, was received by email on January 31, 2024. Photo #7.

**Pursuant to Fla. Admin. Code Ann. R. 62-730.160(1) [40 C.F.R. §262.15(a)(5)(i)(ii)], which is a condition of the SAA permit exemption, a generator must mark or label its container with the following: (i) the words “Hazardous Waste”, and (ii) an indication of the hazards of the contents (examples include, but are not limited to, the applicable hazardous waste characteristic(s) (i.e., ignitable, corrosive, reactive, toxic); hazard communication consistent with the Department of Transportation requirements at 49 CFR part 172 subpart E (labeling) or subpart F (placarding); a hazard statement or pictogram consistent with the Occupational Safety and Health Administration Hazard Communication Standard at 29 CFR 1910.1200; or a chemical hazard label consistent with the National Fire Protection Association code 704).**

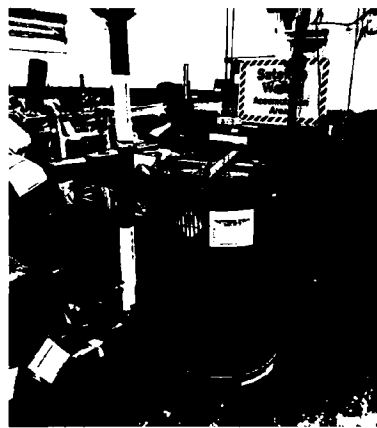
Photo #9 – ICR Disposition Inspection

One (55)-gallon container with dirty rags was observed to be opened (not properly closed), marked with the words "hazardous waste", and with the indication of the hazard of the contents (flammable solid, MPK toluene). Photos with drums properly labeled were received by email on January 31, 2024. Photo #9.

**Pursuant to Fla. Admin. Code Ann. R. 62-730.160(1) [40 C.F.R. § 262.15(a)(4)], which is a condition of the SAA permit exemption, a container holding hazardous waste must be closed at all times during accumulation, except: (i) When adding, removing, or consolidating waste; or (ii) when temporary venting of a container is necessary.**

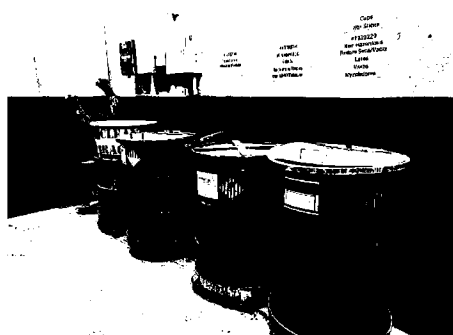
Photo #11 – Paint Prep/Paint Shop: Container with Class 9 label

One (55)-gallon container with paint filters was observed to be closed, marked with the words “hazardous waste”. It was observed that the container was not labeled or marked with the appropriate hazard indicator. Instead, it was labeled with the Class 9 (miscellaneous) Department of Transportation (DOT) label. Photos with drums properly labeled were received by email on January 31, 2024. Photo #11.

**Pursuant to Fla. Admin. Code Ann. R. 62-730.160(1) [40 C.F.R. §262.15(a)(5)(ii)], which is a condition of the SAA permit exemption, a generator must mark or label its container with the following: (ii) an indication of the hazards of the contents (examples include, but are not limited to, the applicable hazardous waste characteristic(s) (i.e., ignitable, corrosive, reactive, toxic); hazard communication consistent with the Department of Transportation requirements at 49 CFR part 172 subpart E (labeling) or subpart F (placarding); a hazard statement or pictogram consistent with the Occupational Safety and Health Administration Hazard Communication Standard at 29 CFR 1910.1200; or a chemical hazard label consistent with the National Fire Protection Association code 704).**

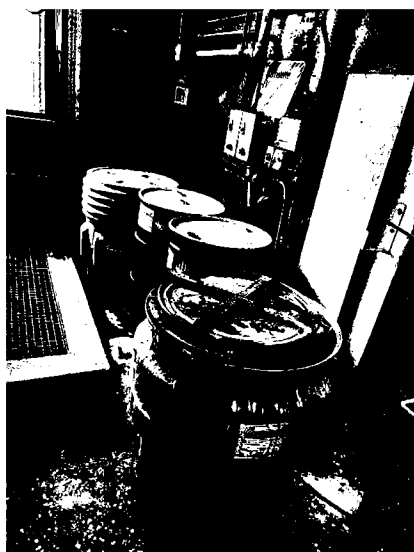
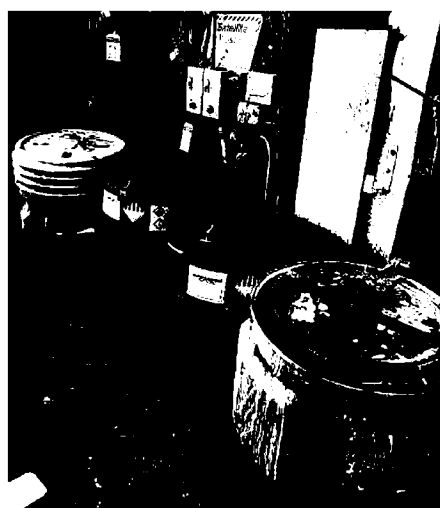
Photo #12 – Small Parts Shop:

Three (55)-gallon containers (flammable, MPK toluene with high sludge, paint filters, and cadmium/chrome/plating/b and H debris) were observed and marked with the words “hazardous waste”. Two of these containers were not properly closed, and not labeled or marked with the appropriate hazard indicator. Instead, the containers were labeled with the Class 9 (miscellaneous) Department of Transportation (DOT) label. One container was not marked with the indication of hazard of the contents. Photos with drums properly labeled were received by email on January 31, 2024. Photo #12.

**Pursuant to Fla. Admin. Code Ann. R. 62-730.160(1) [40 C.F.R. § 262.15(a)(4)], which is a condition of the SAA permit exemption, a container holding hazardous waste must be closed at all times during accumulation, except: (i) When adding, removing, or consolidating waste; or (ii) when temporary venting of a container is necessary.**

**Pursuant to Fla. Admin. Code Ann. R. 62-730.160(1) [40 C.F.R. §262.15(a)(5)(ii)], which is a condition of the SAA permit exemption, a generator must mark or label its container with the**

**following: (ii) an indication of the hazards of the contents (examples include, but are not limited to, the applicable hazardous waste characteristic(s) (i.e., ignitable, corrosive, reactive, toxic); hazard communication consistent with the Department of Transportation requirements at 49 CFR part 172 subpart E (labeling) or subpart F (placarding); a hazard statement or pictogram consistent with the Occupational Safety and Health Administration Hazard Communication Standard at 29 CFR 1910.1200; or a chemical hazard label consistent with the National Fire Protection Association code 704).**

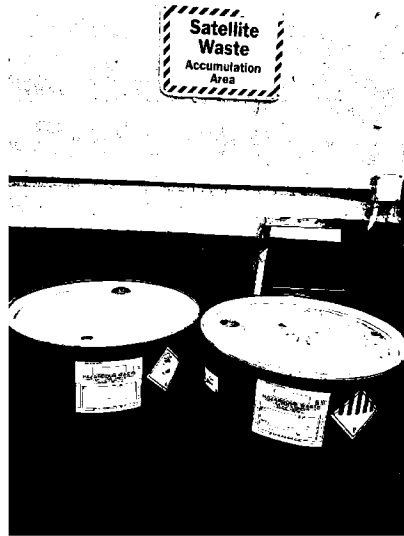
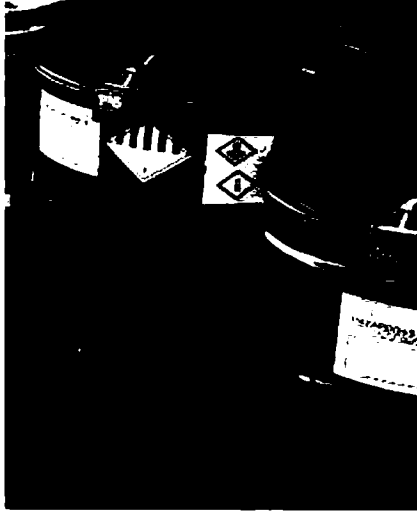
Photo #13 – Aluminum-Titanium Shop

One closed (55)-gallon container with "bead blast plastic media" was marked with the words "hazardous waste"; however, it was marked with the incorrect indication of hazard of the contents. It was labeled with the Class 9 (miscellaneous) Department of Transportation (DOT) label. Photos with drums properly labeled were received by email on January 31, 2024. Photo #13.

**Pursuant to Fla. Admin. Code Ann. R. 62-730.160(1) [40 C.F.R. §262.15(a)(5)(ii)], which is a condition of the SAA permit exemption, a generator must mark or label its container with the following: (ii) an indication of the hazards of the contents (examples include, but are not limited to, the applicable hazardous waste characteristic(s) (i.e., ignitable, corrosive, reactive, toxic); hazard communication consistent with the Department of Transportation requirements at 49 CFR part 172 subpart E (labeling) or subpart F (placarding); a hazard statement or pictogram consistent with the Occupational Safety and Health Administration Hazard Communication Standard at 29 CFR 1910.1200; or a chemical hazard label consistent with the National Fire Protection Association code 704).**

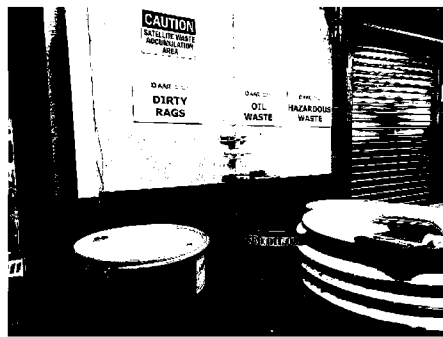
Photo #15 – Military Assembly

One opened (55)-gallon container with dirty rags marked with the words “hazardous waste”,

and with the indication of hazard of the contents (flammable solid, MPK toluene). Photos with drums properly closed and labeled were received by email on January 31, 2024. Photo #15.

**Pursuant to Fla. Admin. Code Ann. R. 62-730.160(1) [40 C.F.R. § 262.15(a)(4)], which is a condition of the SAA permit exemption, a container holding hazardous waste must be closed at all times during accumulation, except: (i) When adding, removing, or consolidating waste; or (ii) when temporary venting of a container is necessary.**

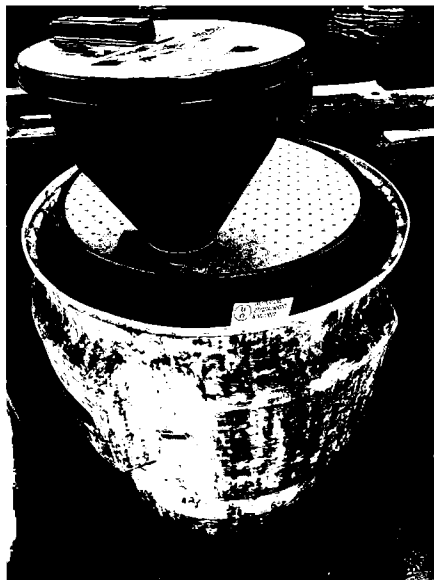
Photo #16 – Disassembly: Used Oil Container

One (55)-gallon container was observed with a closed funnel, used to store used oil. The container was not marked with the words “Used Oil” (Photo #16). It was labeled the same day.

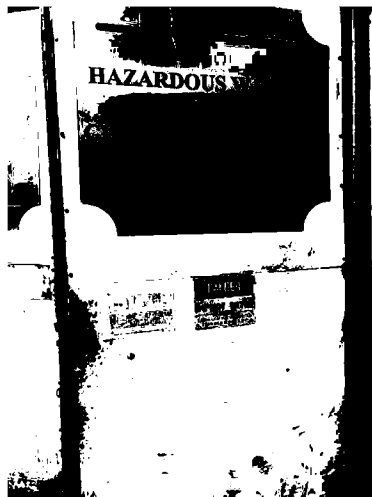
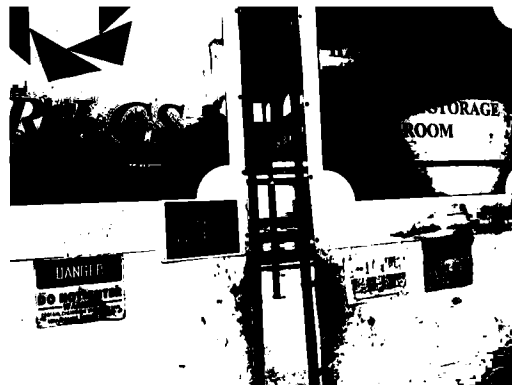
Photo #18 – 90 day CAA

The inspectors visited the 90 day CAA located inside the building. The area was identified with a sign that read “Hazardous Waste” and “Chemical Storage Room” at the entrance. This room is also used to store raw material. However, the “No Smoking Sign” was missing in the CAA. There was no adequate aisle space between sections. Approximately, twenty-eight (28) containers with “Used Oil” or hazardous waste material were observed in this area. The containers were observed closed, labeled, and dated. The accumulation starting date ranged from November 2023 to December 2023. Photos were received by email on January 31, 2024 showing the “No Smoking Sign and aisle space between containers. Photos # 18 to #22.

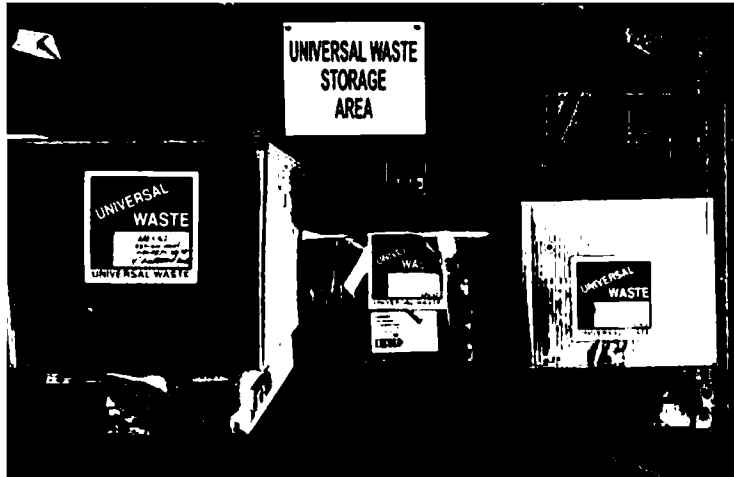
The facility generates universal waste lamps that are stored at another AAR Landing building. The inspectors did not visit the area, but a photo was received by email on February 8, 2024. Photo #23.

Photo #23 – Universal Waste Lamps
