**SUBJECT:** CLEAN AIR ACT INSPECTION REPORT  
Kraton Polymers U.S. LLC

**Facility Name:** Kraton Polymers U.S. LLC

## **Flare VISR Test Report**

**Facility: Kraton Polymers U.S. LLC**

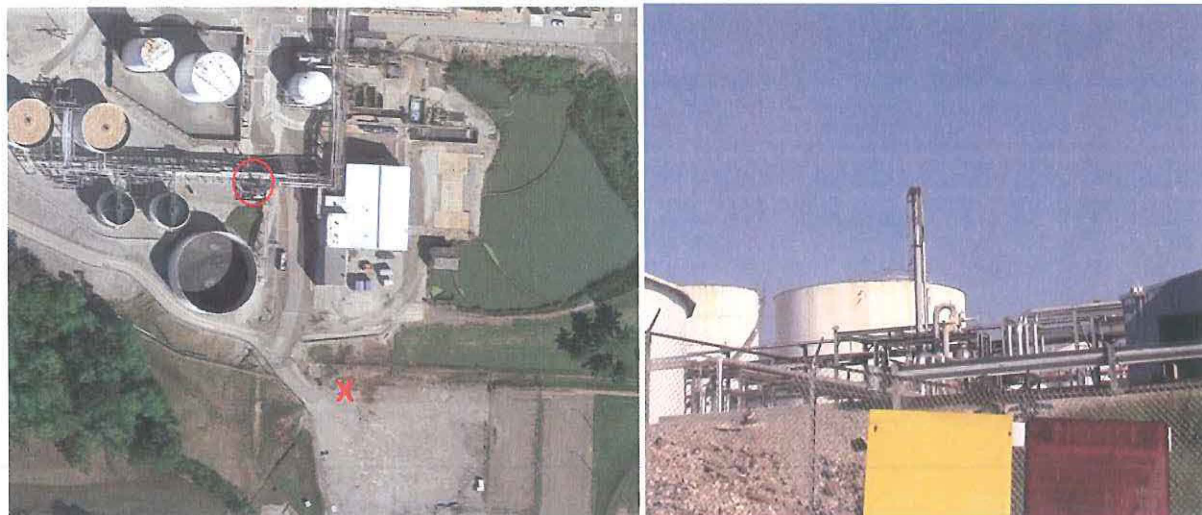
Figure 1. South flare. A steam assisted flare.  
Left: Google map with a red circle indicating the location of the flare and a red "X" indicating the location of the VISR instrument. Distance: 276 ft.  
Right: A photo of the flare taken during the test.

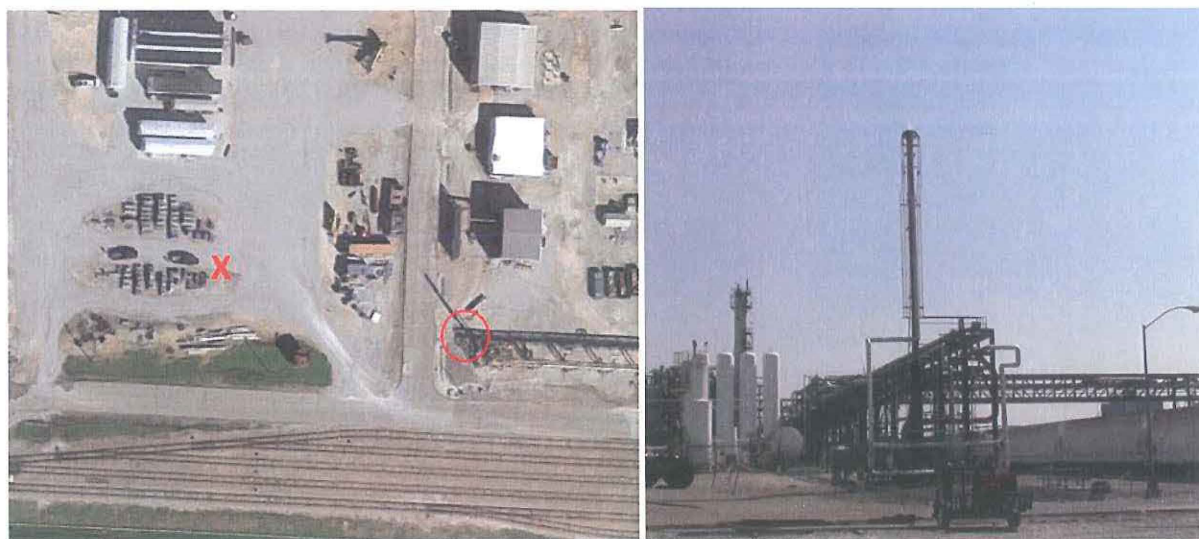
Figure 2. North flare. A steam assisted flare.  
Left: Google map with a red circle indicating the location of the flare and a red "X" indicating the location of the VISR instrument. Distance: 180 ft.  
Right: A photo of the flare taken during the test.

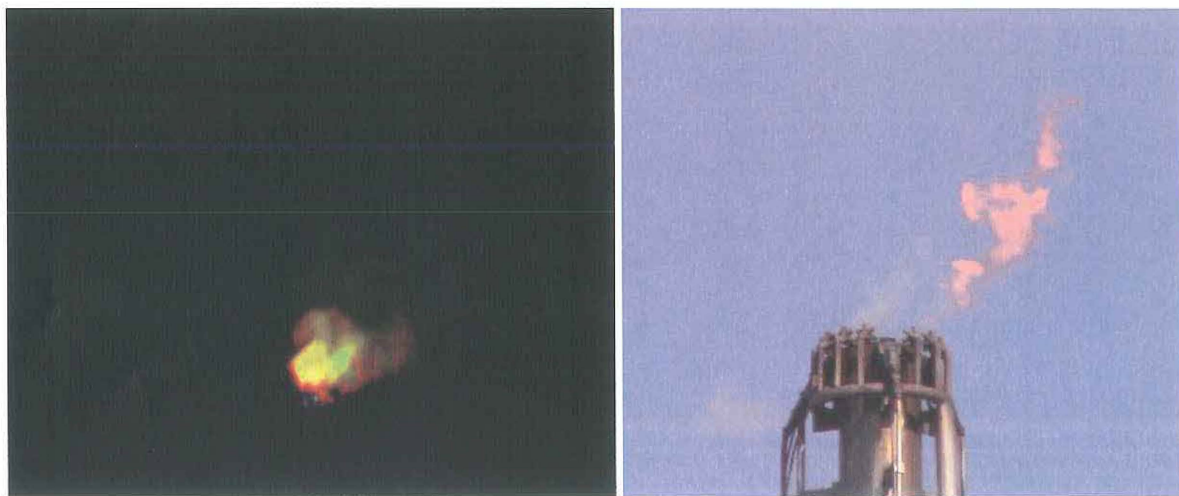
Figure 6. South Flare.  
Left: A representative composite spectral image generated by VISR instrument. Red color represents  $\text{CO}_2$ ; green color represents hydrocarbon; and blue or bluish white color represents aerosol (e.g., soot) or hot solid object (e.g., the shield for pilots).  
Right: A representative image in visible spectrum.
