## RCRA Inspection Report

Century Aluminum of South Carolina Inc.  
Mount Holly Plant  
3375 Highway 52  
Goose Creek, South Carolina 29445

June 26, 2024, at 9:00 a.m.

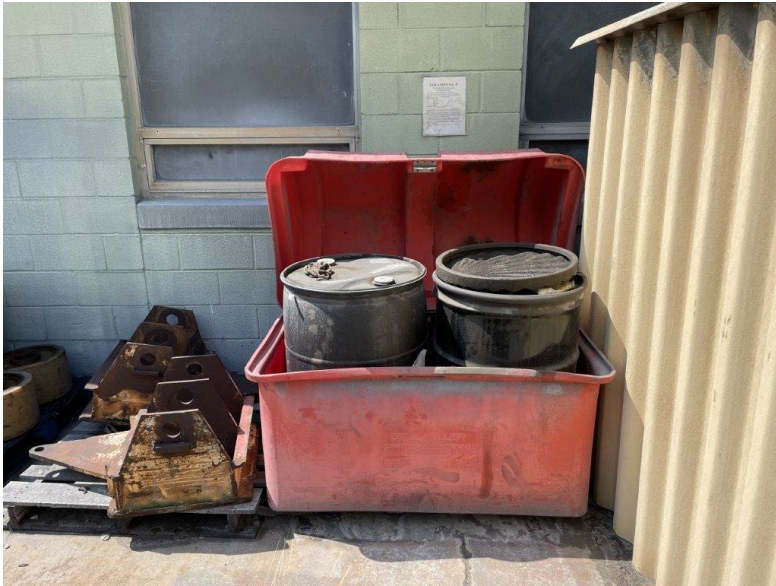
Photograph 1: SA-1, Two unlabeled Used Oil Containers.

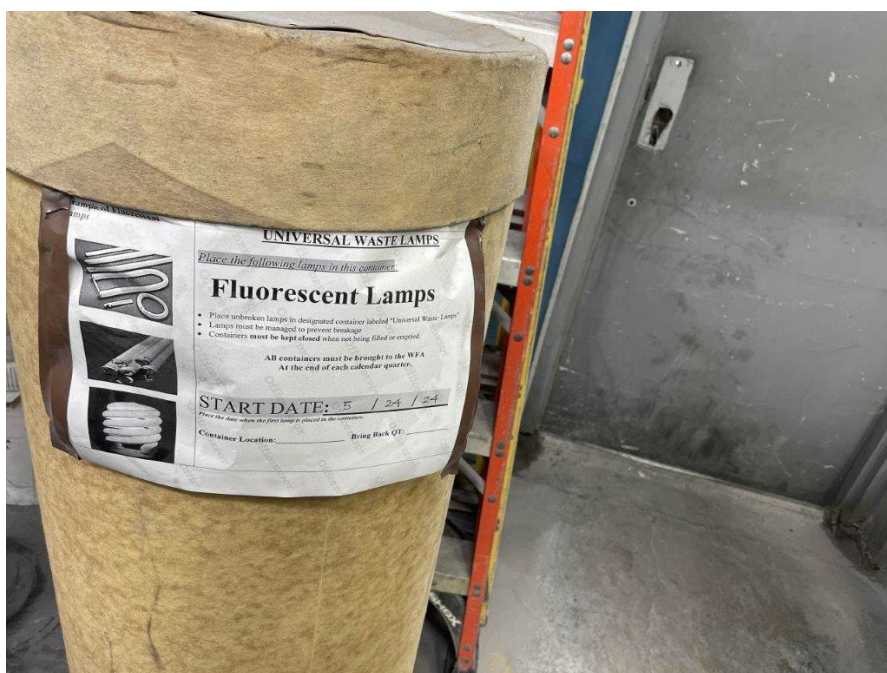
Photograph 4: Label on the UW Lamp Container.

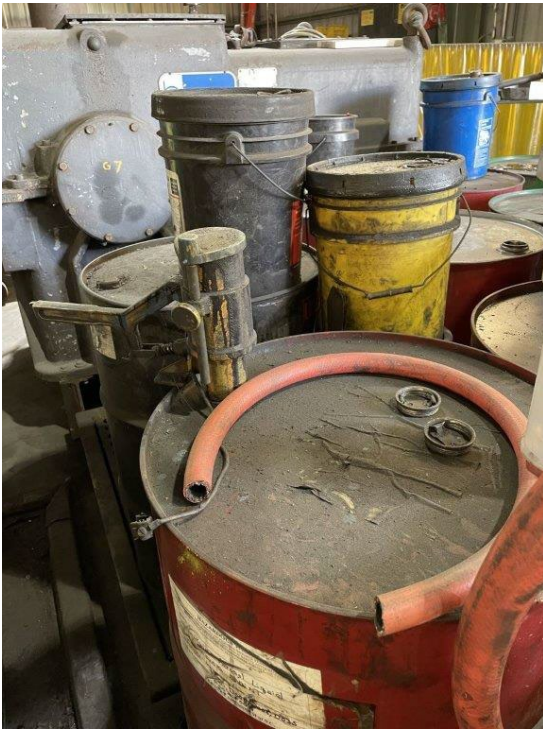
Photograph 7: SA-2, Building 270, Top of the Aerosol Puncturing SAA container.

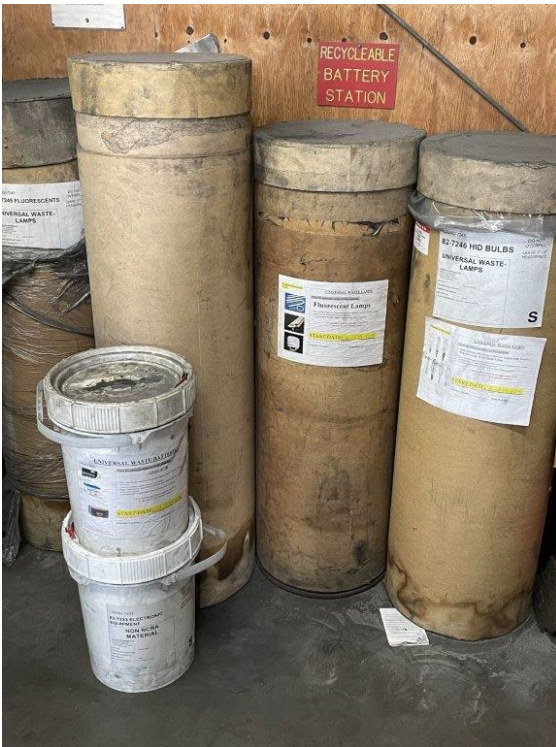
Photograph 8: UW Containers, 5-foot UW Lamp Container is not labeled.

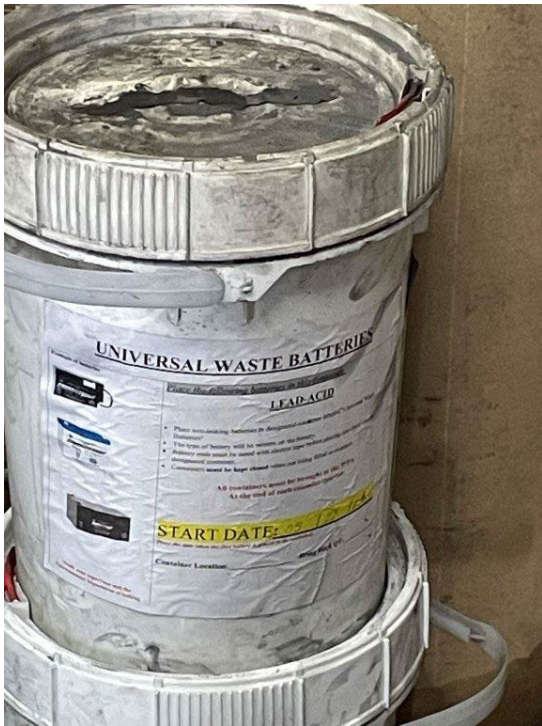
Photograph 9: SA-2A, UW Battery Containers, Containers Labeled and Dated.

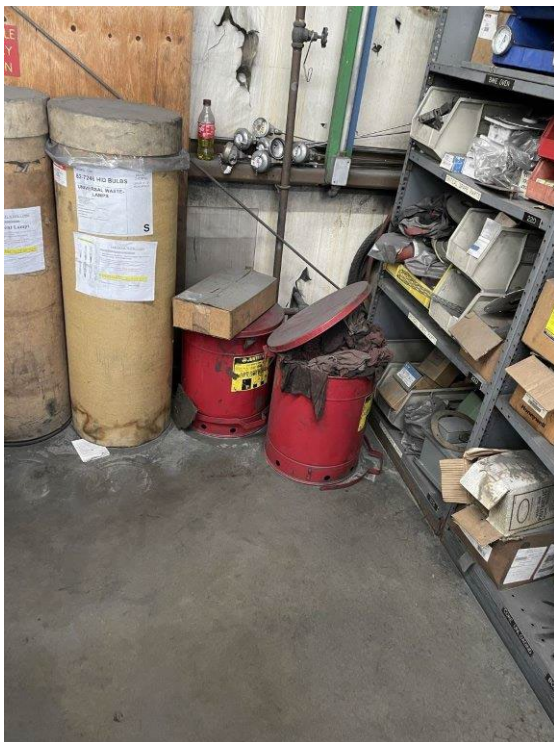
Photograph 10: SA-2A, Two 4-foot UW Lamp Containers near oily rag containers.

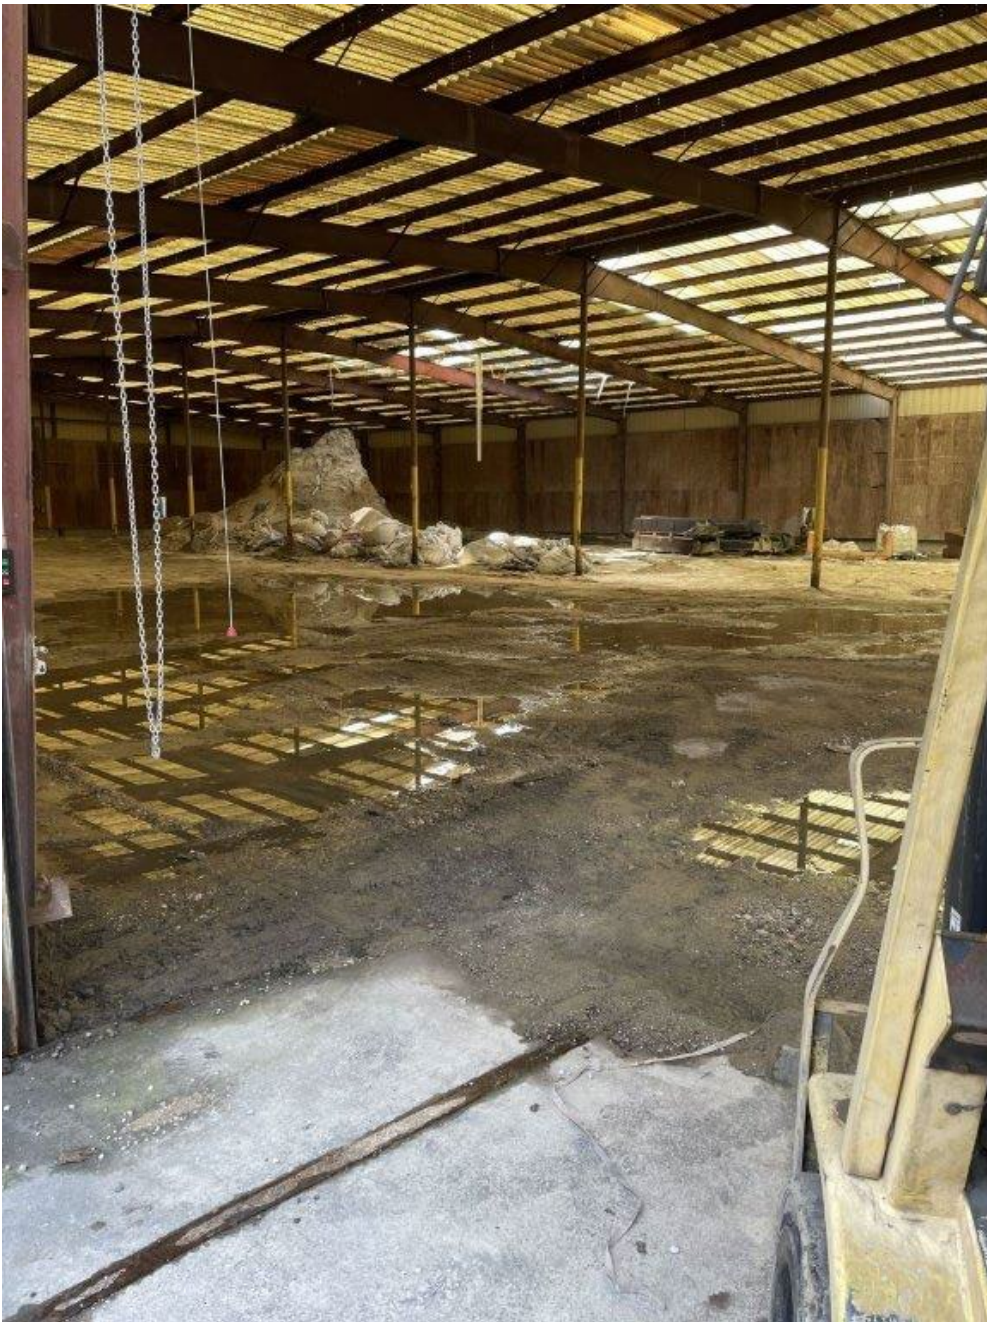
The inspection team next went to the CAA for containers by Building 139 (Container CAA). The inspectors observed that Building 139 had large hole(s) in the roof, the floor was coated with a clear liquid, powdery material was scattered across the floor, and there was a large pile of a powdery material in one area of the building. Due to safety concerns related to issues with the building's roof and the material and liquid in the building, the inspection team decided not to enter Building 139. The inspectors conservatively estimated that the waste pile of powdery material (also referred to "Waste Bath" by Century Aluminum staff) was approximately 30 feet high by 40 feet by 40 feet wide at the base. The inspectors observed that clear liquid covered approximately half of the visible floor area (Photograph 11). The inspectors observed, approximately a dozen supersacks near the waste bath pile, and near the liquid covering the floor. The super sacks near the pile were in poor condition. There were numerous super sacks stored at the rear of the building that appeared to be in better condition than the ones near the waste bath pile (Photograph 12). The waste bath pile, and the super sacks adjacent to the waste bath pile, appeared to be abandoned, and/or discarded, and did not appear to be being managed as a product. At the time of the inspection, a manager was contacted, who informed the inspectors that the material in the pile, and the supersacks, had been in the building for approximately 4 to 5 years.

Photograph 11: Building 139, Pile of Bath Salts Material and Supersacks of Crushed Bath Material Containing Cryolite. Maintenance issues are visible with the roof and clear liquid is covering a significant portion, approximately half, of the visible floor.

Due to the free liquids on the floor and the status of the roof, a review of Building 139's maintenance status and materials management is recommended.

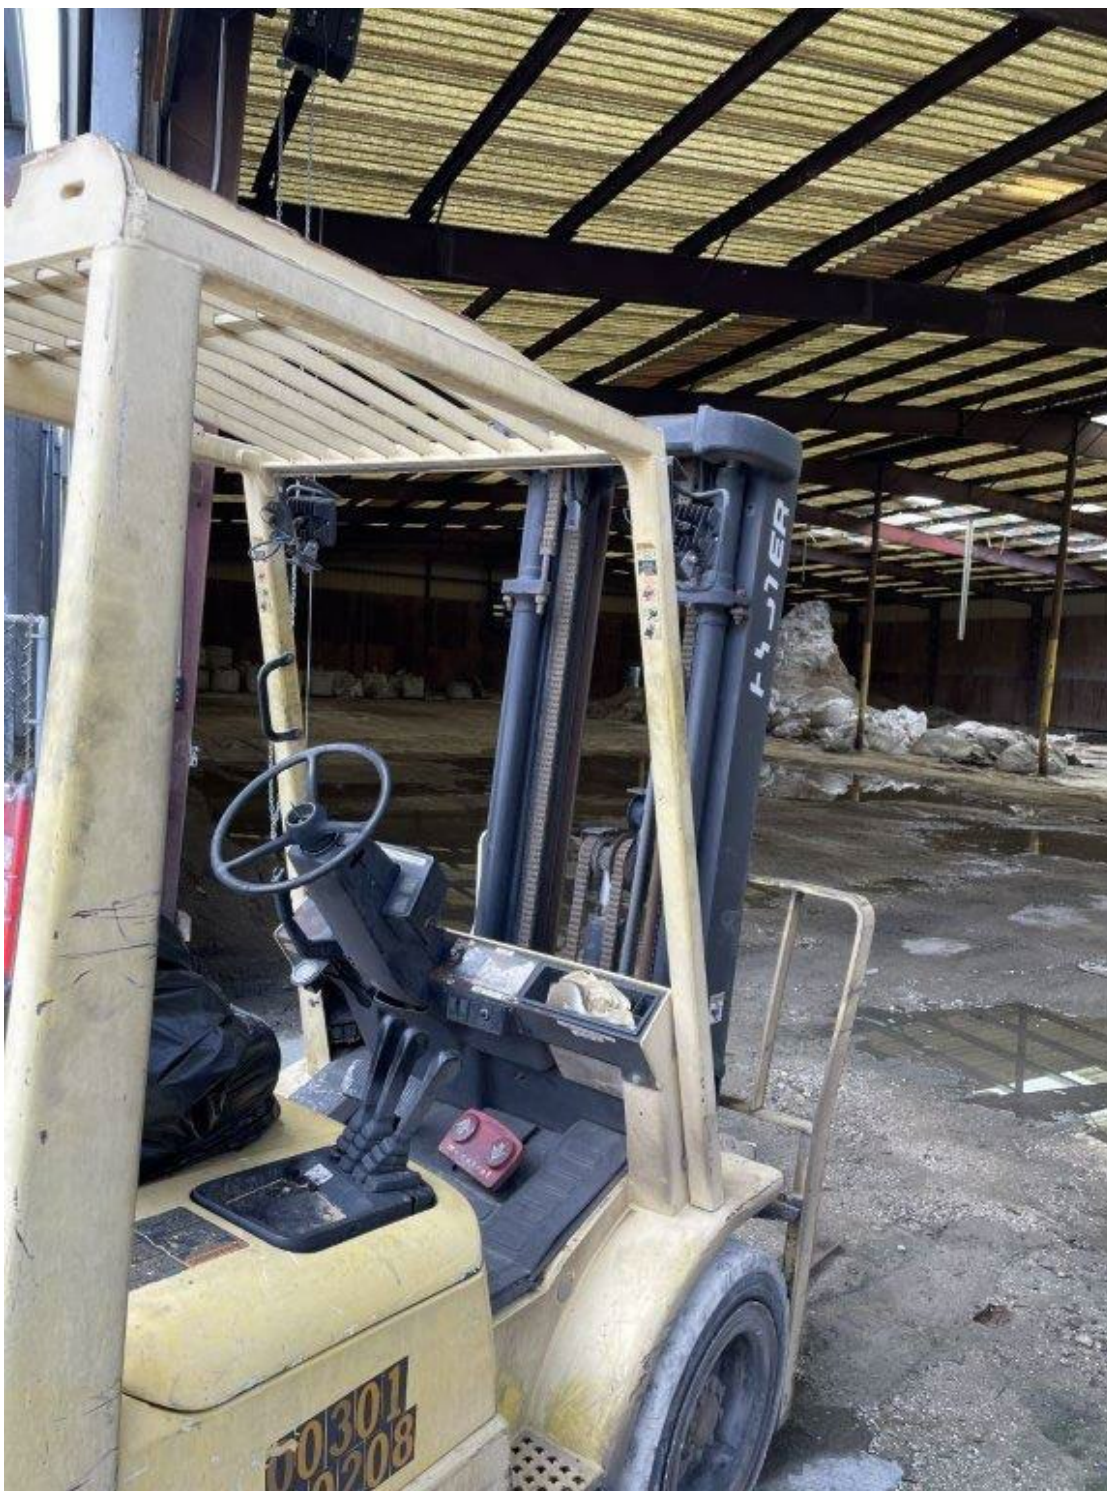
Photograph 12: Building 139, Second view of the pile of Bath Salts Material and Supersacks of Crushed Bath Material Containing Cryolite. More super sacks are visible along the rear of the building to the left.

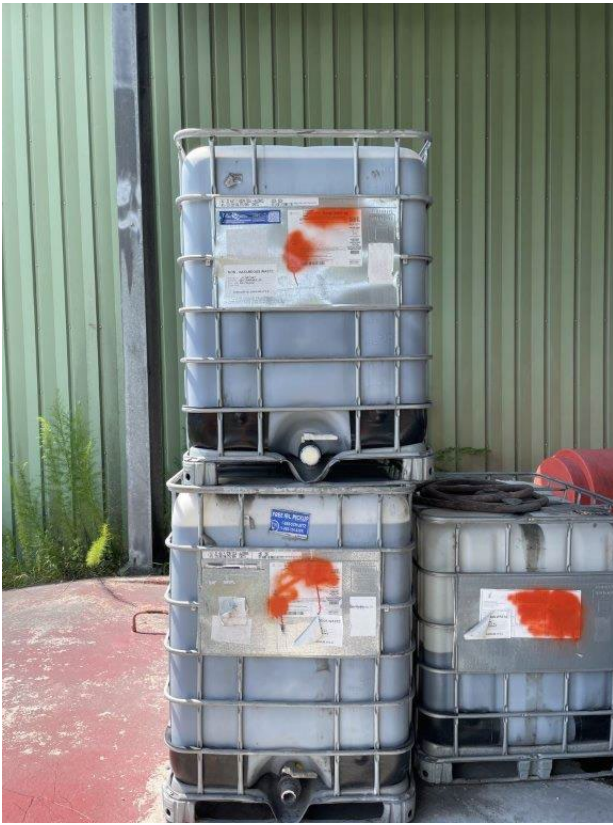
Photograph 13: CAA, Three 300-gallon tote-tanks of Non-Pumpable Oil Material.

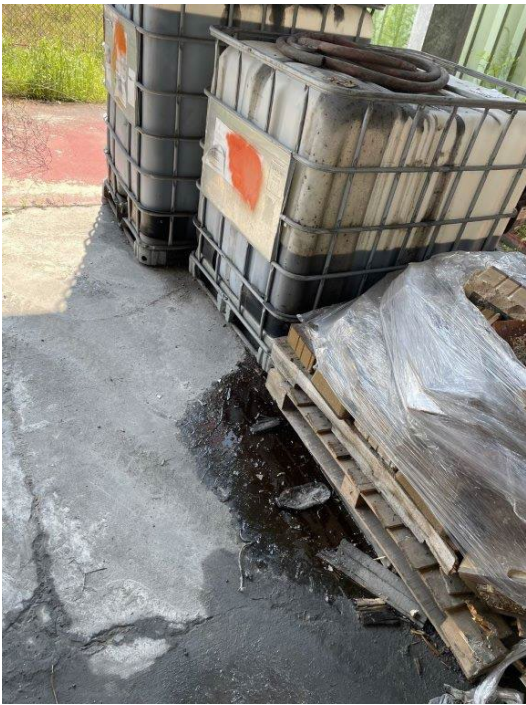
The Container CAA adjacent to Building 139, was surrounded by a chain link fence that was 8 feet tall in places and 5 feet tall in other places and was under a roof. The CAA had a "no smoking" sign, a spill kit, fire extinguisher, and an eye wash and safety shower. There were three 300-gallon tote tanks that were labeled as non-hazardous waste containing non-pumpable oil from maintenance activities. Two of the tote tanks were full and one was half full. The tote tanks were not labeled as used oil but were labeled as "Non-Pumpable Oil" and being managed as a non-hazardous waste (Photographs 13-14). At the time of the inspection, the inspectors observed a leak of a black liquid that appeared to be a used oil leak originating from under one of the tote tanks (Photograph 15). Because the tote tanks still contained some portion of free-flowing used oil they are required to also be labeled as used oil.

Photograph 15: Used oil release in the CAA area.

**Pursuant to S.C. Code Ann. Regs. 61-107.279(d) [40 C.F.R. § 279.22(d)], generators of used oil upon discovery of a release of used oil must stop the release, contain the released used oil, clean up the used oil, and make any necessary repairs or replacements to the container or**

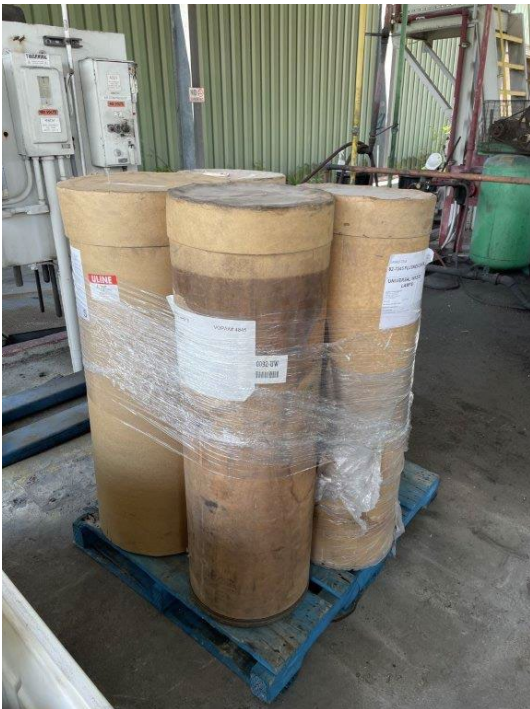
Universal waste was stored in the Container CAA. There were four 4-foot tube containers of universal waste lamps that were closed but the containers were missing the accumulation dates (Photograph 16). There was also a 3-foot container of universal waste lamps labeled and dated March 28, 2024.

Photograph 16: 4-Foot UW Lamp containers that are closed and labeled but not dated.

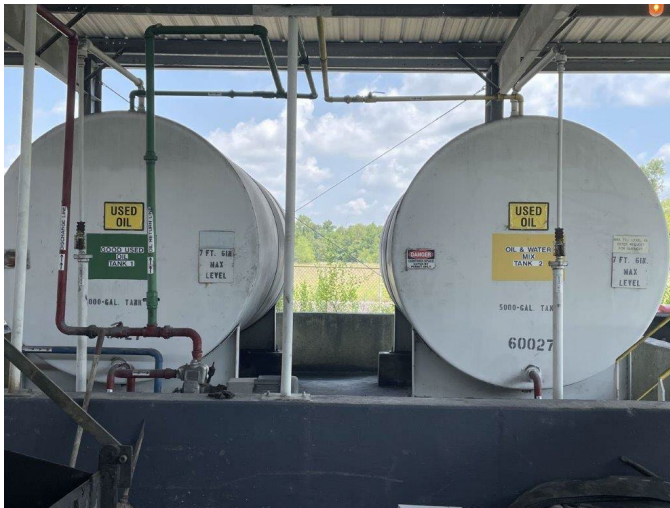
At the time of the inspection, the inspectors observed that the Container CAA had a 5,000 gallon Used Oil tank that was labeled as “Used Oil” (Photograph 17). A metal container for collecting used oil from the used oil pumps’ operations, was present but was not closed or labeled as “Used Oil” (Photograph 18).

Photograph 17: Two 5,000-gallon used oil tanks that are labeled as used oil.

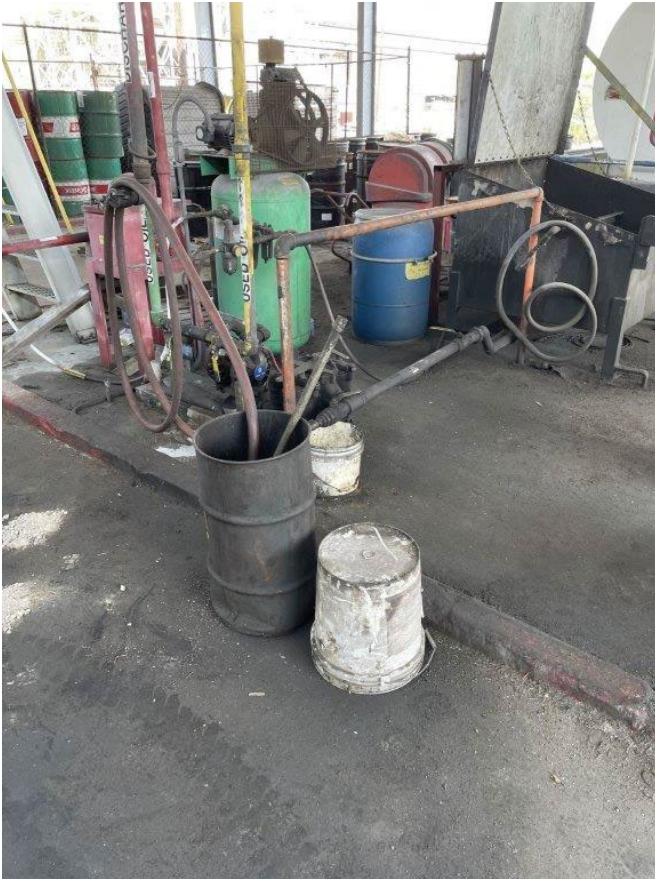
Photograph 18: Used oil container for pump operations that is not closed or labeled.

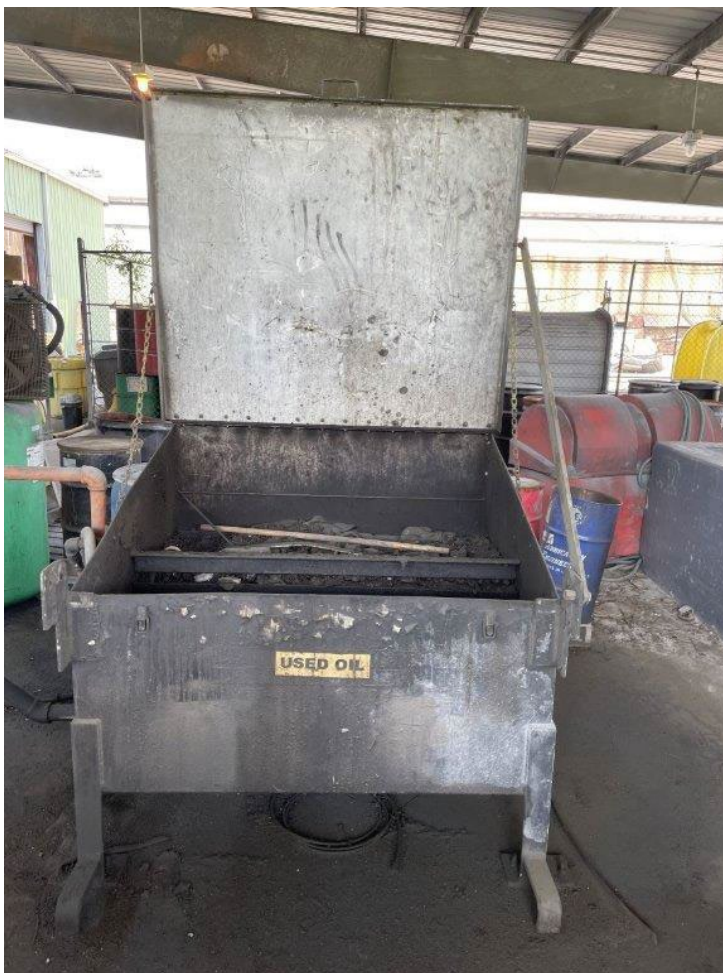
Photograph 19: Used oil draining device.

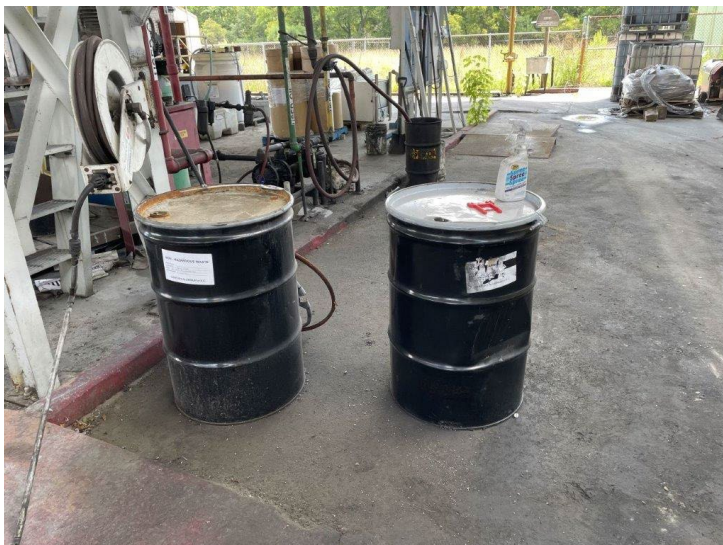
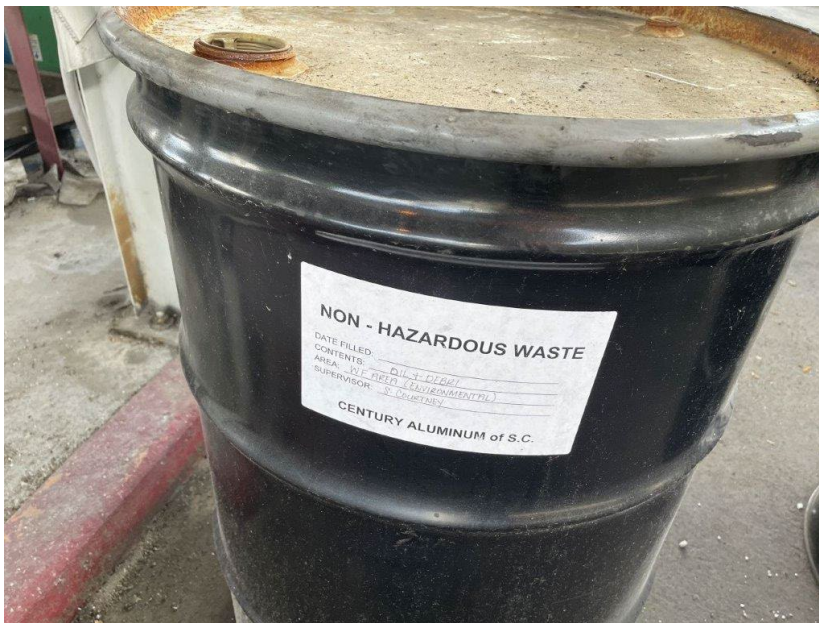
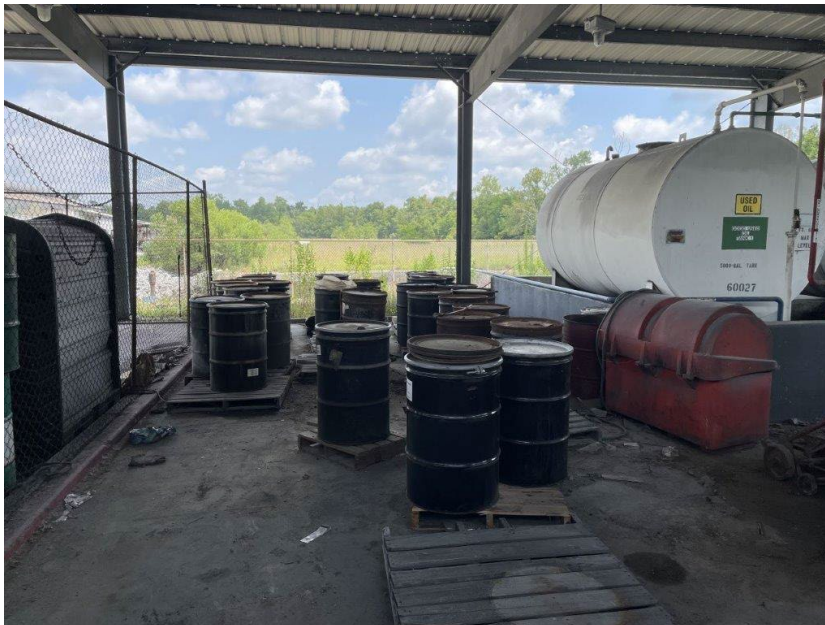
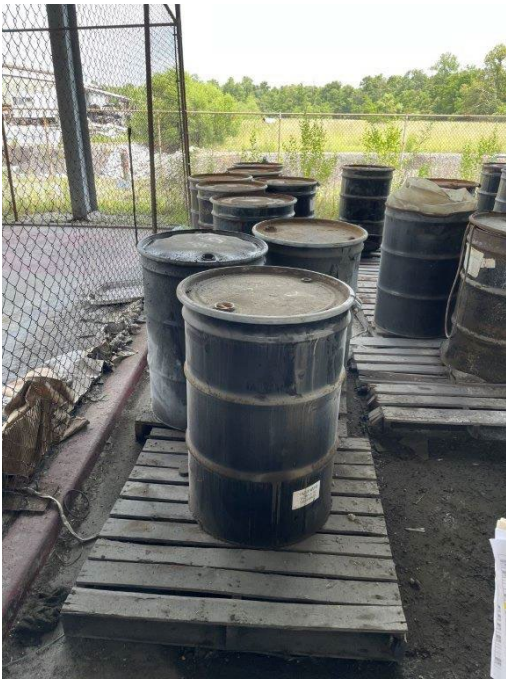
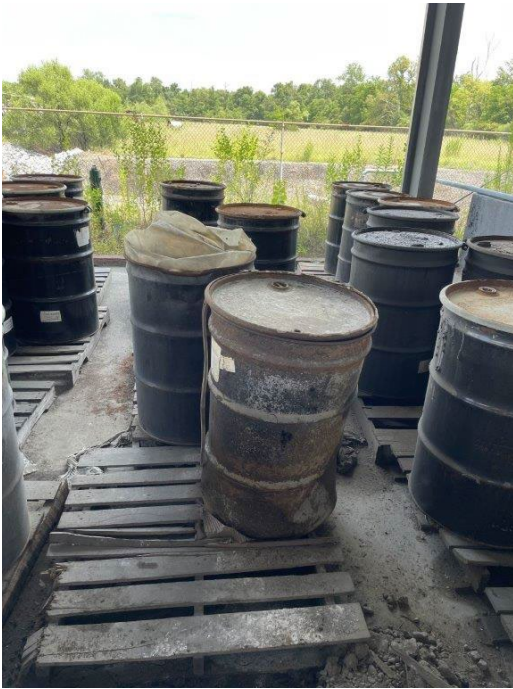
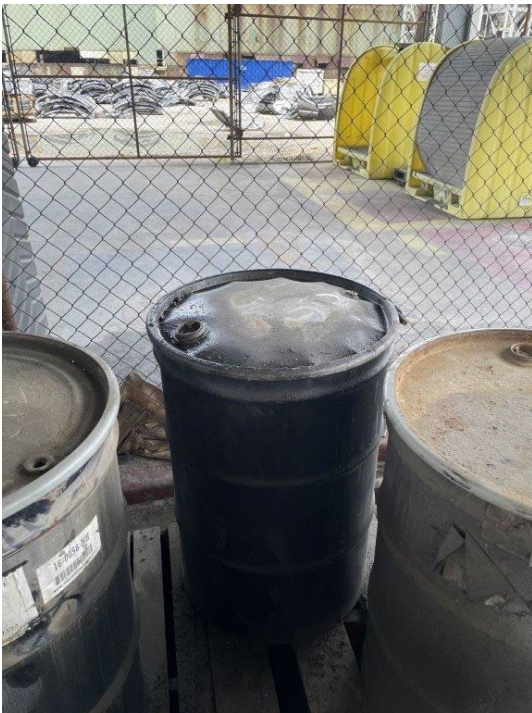
At the time of the inspection, the inspectors observed 30 metal 55-gallon containers of materials that the facility staff stated was non-hazardous waste from clean-ups. There were two metal 55-gallon containers of “Used Oil debris” and 28 metal 55-gallon containers of oily grease debris and oily soil that were being managed as non-hazardous waste. Several of the containers appeared to be in poor condition, including one container that appeared to be significantly bulging due to excessive internal pressures (Photographs 20-25).

Photograph 20: Two 55-gallon containers of oil debris.

Photograph 21: Label on 55-gallon container of oily debris.

Photograph 22: Containers of Oil & Grease debris.

Photograph 23: Containers of Oil & Grease debris.

Photograph 24: Damaged container of oil & grease debris.

Photograph 25: Oil and grease debris drum that is significantly bulging at the top of the container.

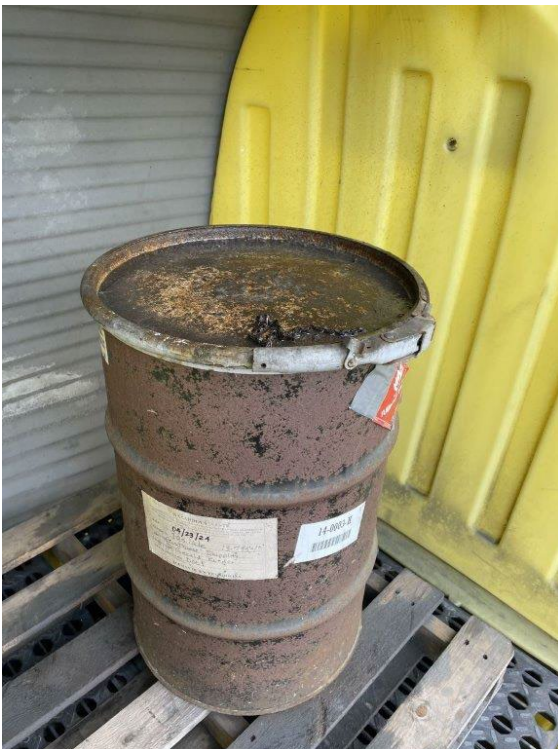
The facility representatives informed inspectors that the facility had shipped its hazardous waste from the Container CAA on Tuesday, June 25, 2024. At the time of the inspection, the inspectors observed one metal 30-gallon container of ignitable (D001) hazardous waste dated April 23, 2024, remaining in the CAA. The other containers had been shipped. This container was in poor condition as evidenced by being completely coated in rust (Photographs 26-27).

Photograph 26: 30-gallon Metal hazardous waste container that has a significant amount of rusted area.

Photograph 27: Label on the 30-gallon HW container.

**Pursuant to S.C. Code Ann. Regs. 61-79.262.17(a)(1)(ii) [40 C.F.R. § 262.17(a)(1)(ii)], which is a condition of the LQG permit exemption, if a container holding hazardous waste is not in good condition, or if it begins to leak, the LQG must immediately transfer the waste to a container that is in good condition or manage the waste in some other way that complies with the exemption requirements.**

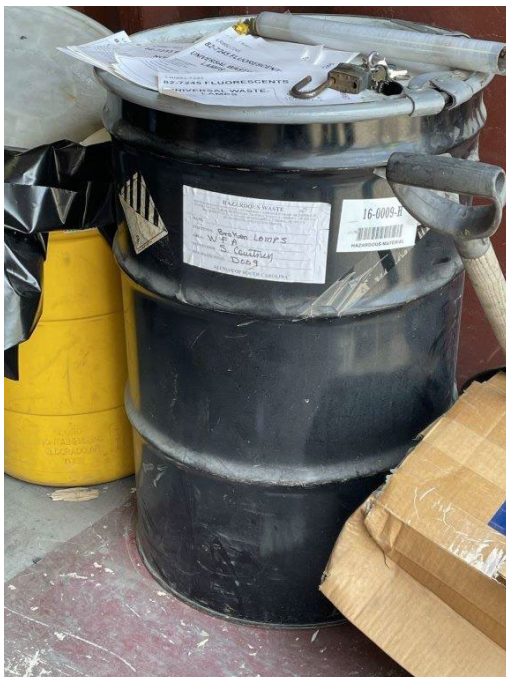
The inspectors observed a Universal Waste Connex adjacent to the Container CAA. Inside the Connex, the inspectors observed a metal 55-gallon container of broken lamps being managed as toxic (D009) hazardous waste. This container was being utilized for broken universal waste lamps. The container was labeled as containing hazardous waste and had a Class 9 DOT label, but was not properly marked or labeled with an indication of the hazard of its contents (Photograph 28).

Photograph 28: 55-gallon HW Container of broken lamps that requires a hazard marking.

**Pursuant to S.C. Code Ann. Regs. 61-79.262.15(a)(5)(ii) [40 C.F.R. § 262.15(a)(5)(ii)], which is a condition of the LQG permit exemption, a generator must mark or label its container with the following: (ii) An indication of the hazards of the contents (examples include, but are not limited to, the applicable hazardous waste characteristic(s) (*i.e.*, ignitable, corrosive, reactive, toxic); hazard communication consistent with the Department of Transportation requirements at 49 CFR part 172 subpart E (labeling) or subpart F (placarding); a hazard statement or pictogram consistent with the Occupational Safety and Health Administration Hazard Communication Standard at 29 C.F.R. § 1910.1200; or a chemical hazard label consistent with the National Fire Protection Association code 704).**

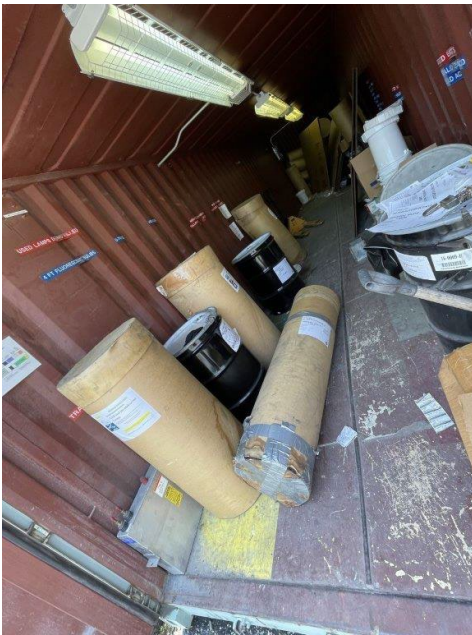
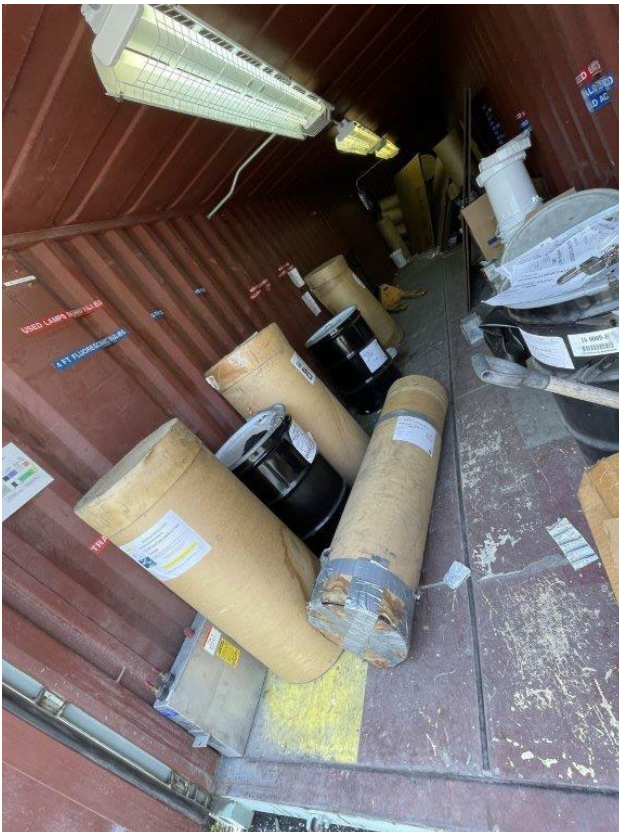
At the time of the inspection, the inspector observed a 6-foot container and two other universal lamp containers in the Connex that were open (Photographs 29-30).

Photograph 29: Connex container for UW. Three UW lamp containers are not fully closed.

Photograph 30: Connex container for UW. Three UW lamp containers are not fully closed.

**Pursuant to S.C. Code Ann. Regs. 61-79.273.13(d)(1) [40 C.F.R. § 273.13(d)(1)], a small quantity handler of universal waste must contain any lamp in containers or packages that are structurally sound, adequate to prevent breakage, and compatible with the contents of the lamps. Such containers and packages must remain closed and must lack evidence of leakage, spillage or damage that could cause leakage under reasonably foreseeable conditions.**

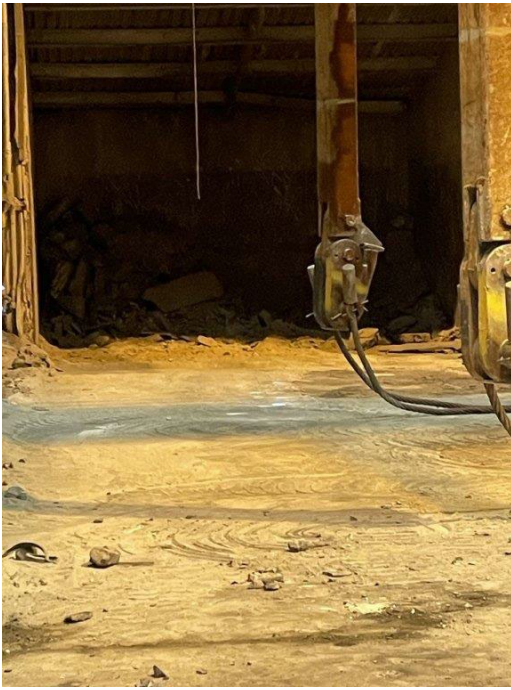
Photograph 31: Building 138 interior.

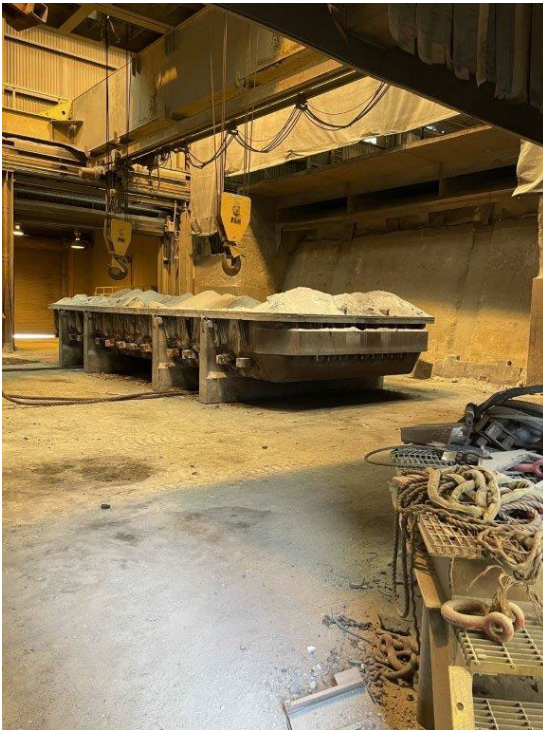
Photograph 32: Building 138, Pot repair and cleaning area.

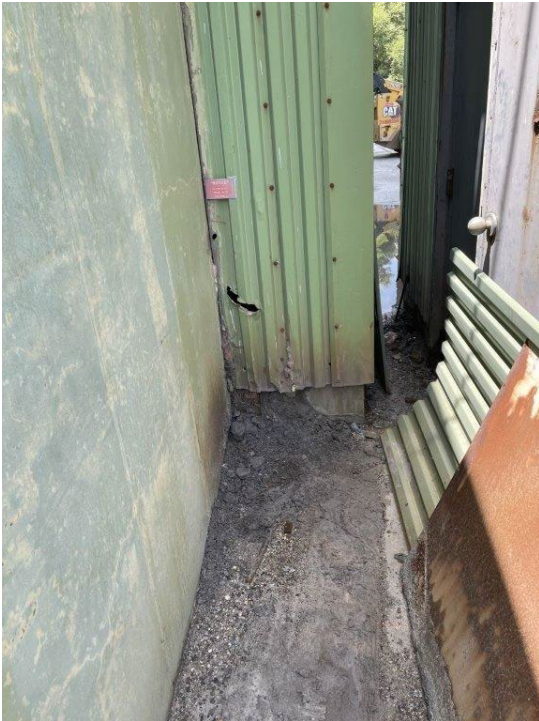
- a small hole in the wall and loose metal siding on Building 138, that had led to a release of hazardous waste (K088) to the environment in the area immediately adjacent to the hole and loose siding (Photograph 36);
- the roll-up vehicle door on Building 138 would not close due to a buildup of hazardous waste (K088) at the edges of the door, and hazardous waste (K088) appeared to be escaping to the environment through the gap created by the improperly maintained roll-up vehicle door;
- the metal siding near the roll-up vehicle door was bent and damaged, which appeared to have resulted in a gap, allowing the release of hazardous waste (K088) to the environment immediately outside of Building 138 (Photographs 37-38); and
- the emergency contact information was not posted on the exterior of Building 138.

Photograph 36: Small hole in the wall of Building 138 and loose siding near the building's foundation. A small release of K088 hazardous waste is shown.

**Pursuant to S.C. Code Ann. Regs. 61-79.262.17(a)(4) [40 C.F.R. § 262.17(a)(4)], which incorporates S.C. Code Ann. Regs. 61-79.265.1101(c)(1) [40 C.F.R. § 265.1101(c)(1)], and is a condition of the LQG Permit Exemption, owners or operators of all containment buildings must: (1) Use controls and practices to ensure containment of the hazardous waste within the unit; and, at a minimum: (i) Maintain the primary barrier to be free of significant cracks, gaps, corrosion, or other deterioration that could cause hazardous waste to be released from the primary barrier; (ii) Maintain the level of the stored/treated hazardous waste within the containment walls of the unit so that the height of any containment wall is not exceeded; (iii) Take measures to prevent the tracking of hazardous waste out of the unit by personnel or by equipment used in handling the waste. An area must be designated to decontaminate equipment and any rinsate must be collected and properly managed; and (iv) Take measures to control fugitive dust emissions such that any openings (doors, windows, vents, cracks, etc.) exhibit no visible emissions. In addition, all associated particulate collection devices (e.g., fabric filter, electrostatic precipitator) must be operated and maintained with sound air pollution control practices. This state of no visible emissions must be maintained effectively**

Pursuant to S.C. Code Ann. Regs. 61-79.262.17(a)(4) [40 C.F.R. § 262.17(a)(4)], which incorporates S.C. Code Ann. Regs. 61-79.265.1101(c)(3) [40 C.F.R. § 265.1101(c)(3)], throughout the active life of the containment building, if the owner or operator detects a condition that could lead to or has caused a release of hazardous waste, the owner or operator must repair the condition promptly, in accordance with the following procedures: (i) Upon detection of a condition that has led to a release of hazardous waste (e.g., upon detection of leakage from the primary barrier) the owner or operator must: (A) Enter a record of the discovery in the facility operating record; (B) Immediately remove the portion of the containment building affected by the condition from service; (C) Determine what steps must be taken to repair the containment building, remove any leakage from the secondary collection system, and establish a schedule for accomplishing the cleanup and repairs; and (D) Within 7 days after the discovery of the condition, notify the Department (SCDES) of the condition, and within 14 working days, provide a written notice to SCDES with a description of the steps taken to repair the containment building, and the schedule for accomplishing the work.

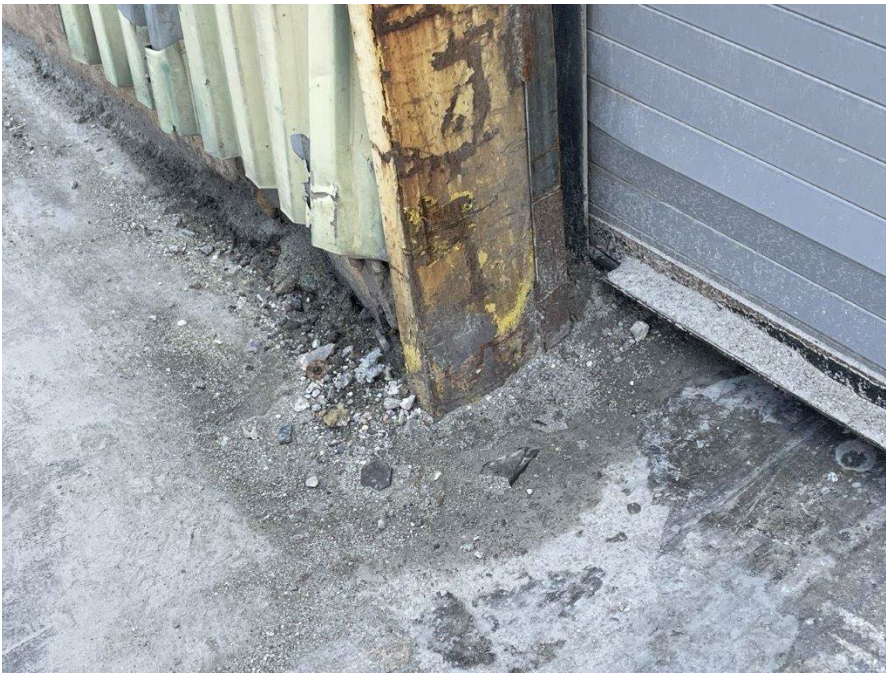
Photograph 37: Building 138, loose siding with a small release of K088 hazardous waste.

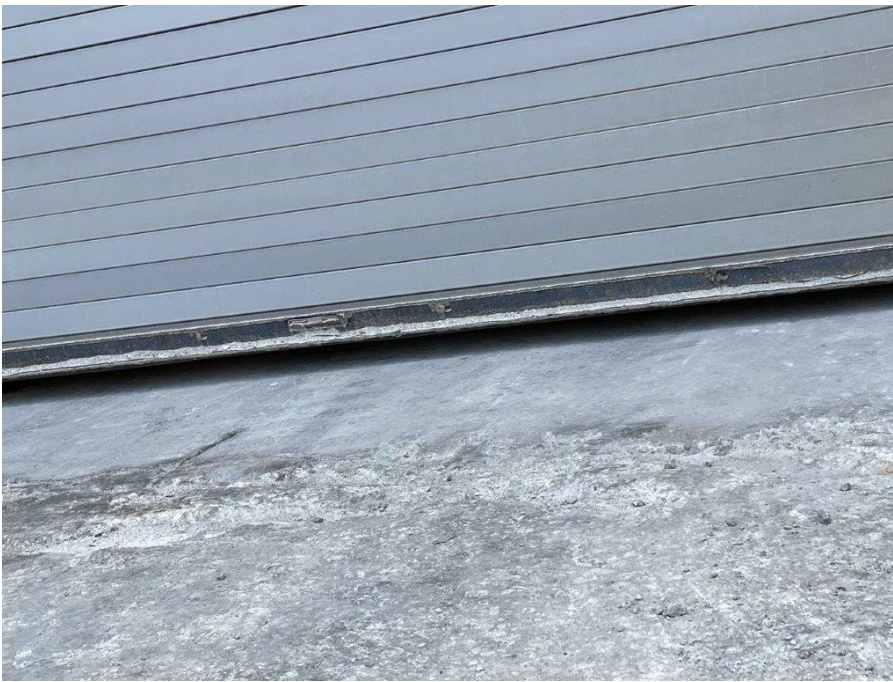
Photograph 38: Roll-up vehicle door on Building 138 will not close due to a build-up of K088 hazardous waste at the sides of the door.

at all times during normal operating conditions, including when vehicles and personnel are entering and exiting the unit.

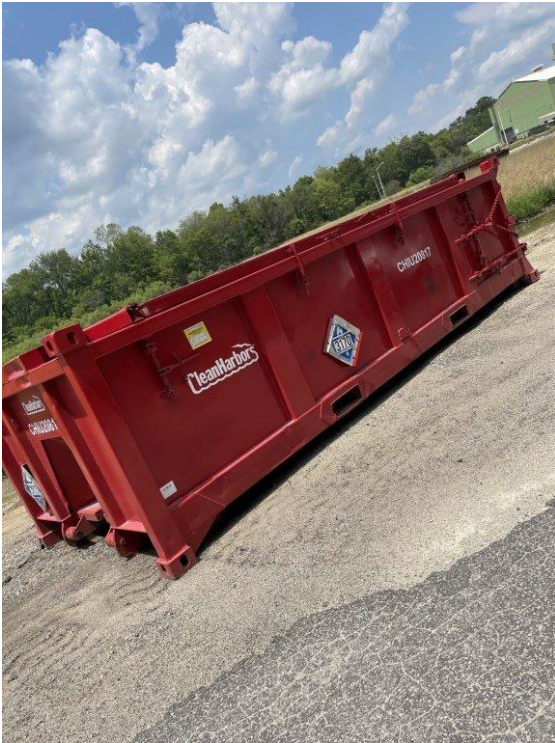
The inspectors inspected the CAA Roll-off containers for K088 hazardous waste. These five 20-yard metal containers were closed and properly labeled and marked. However, the containers are over 200 yards from Building 138 and this distance precludes this area from being classified as part of Building 138 CAA (Photograph 39). This area is required to be a separate CAA.

Photograph 39: HW Roll-off container of K088 Hazardous waste. The containers are closed, labeled And marked but are over 200 yards away from the Building 138 CAA.

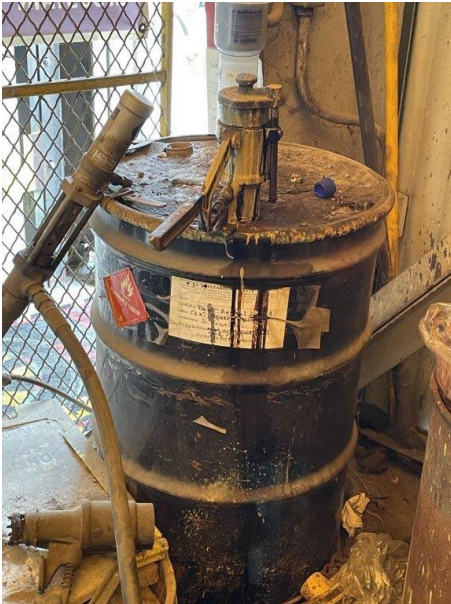
SAA SA-19D was inspected. This SAA is in the maintenance area for the cast house area. This SAA had an aerosol can puncturing device on top of a 55-gallon metal container. The 55-gallon metal container was labeled as hazardous waste and had an appropriate hazard marking (Photograph 40).

Photograph 40: SA-19D HW SAA Container
