**Region 6 - Enforcement & Compliance Assurance Division**  
**INSPECTION REPORT**

| Inspection Date(s): | 04/17/2025 | |
| Company Name: | <b>C12: Arkansas Oil, LLC</b> | |
| Facility Name: | <b>Midway Smackover Unit Tract #3 Tank Battery</b> | |

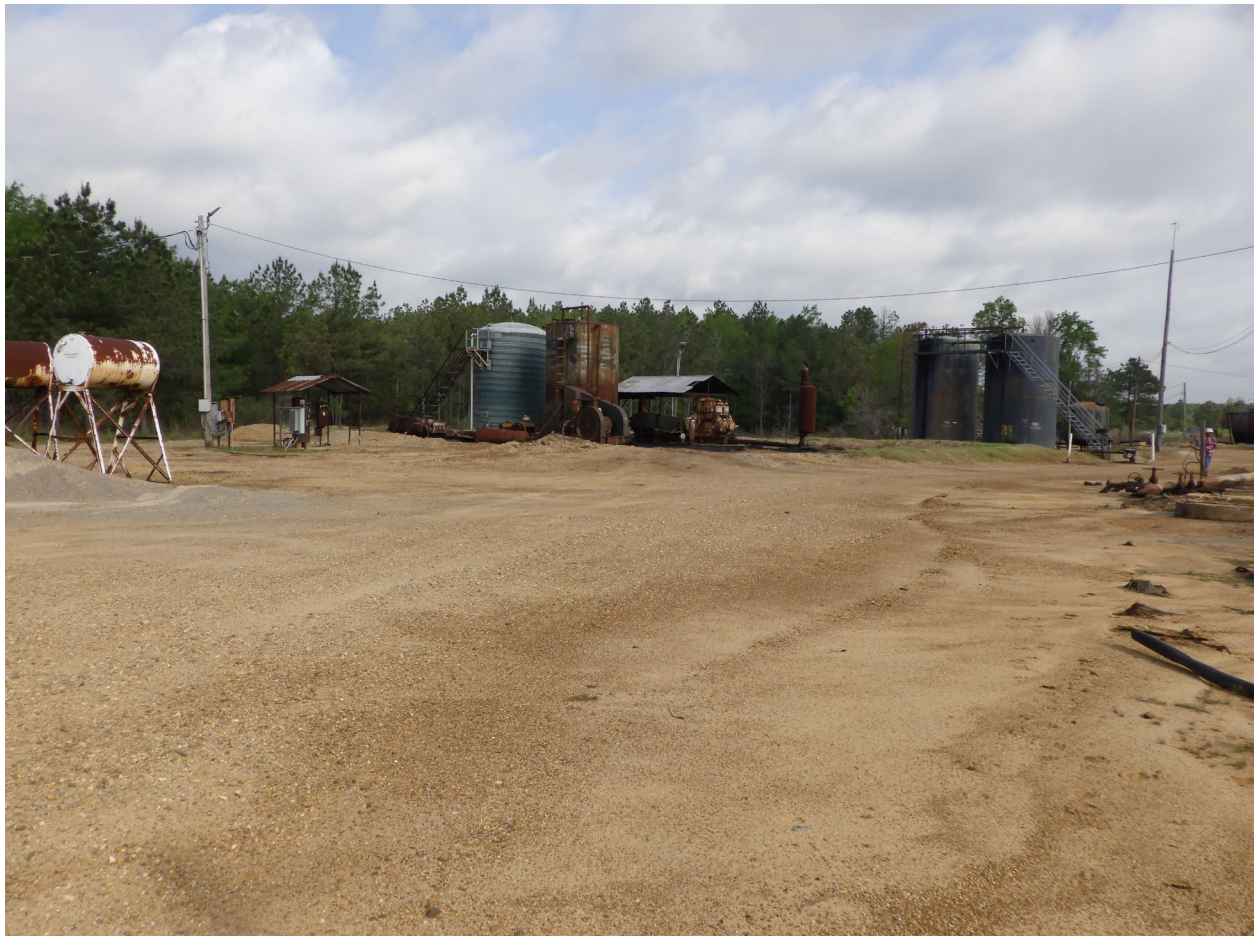
Photo No. 1

**Description:** Looking NW, this photo shows an overview of the C12: Arkansas Oil, LLC – Midway Smackover Unit Tract #3 Tank Battery ("facility").

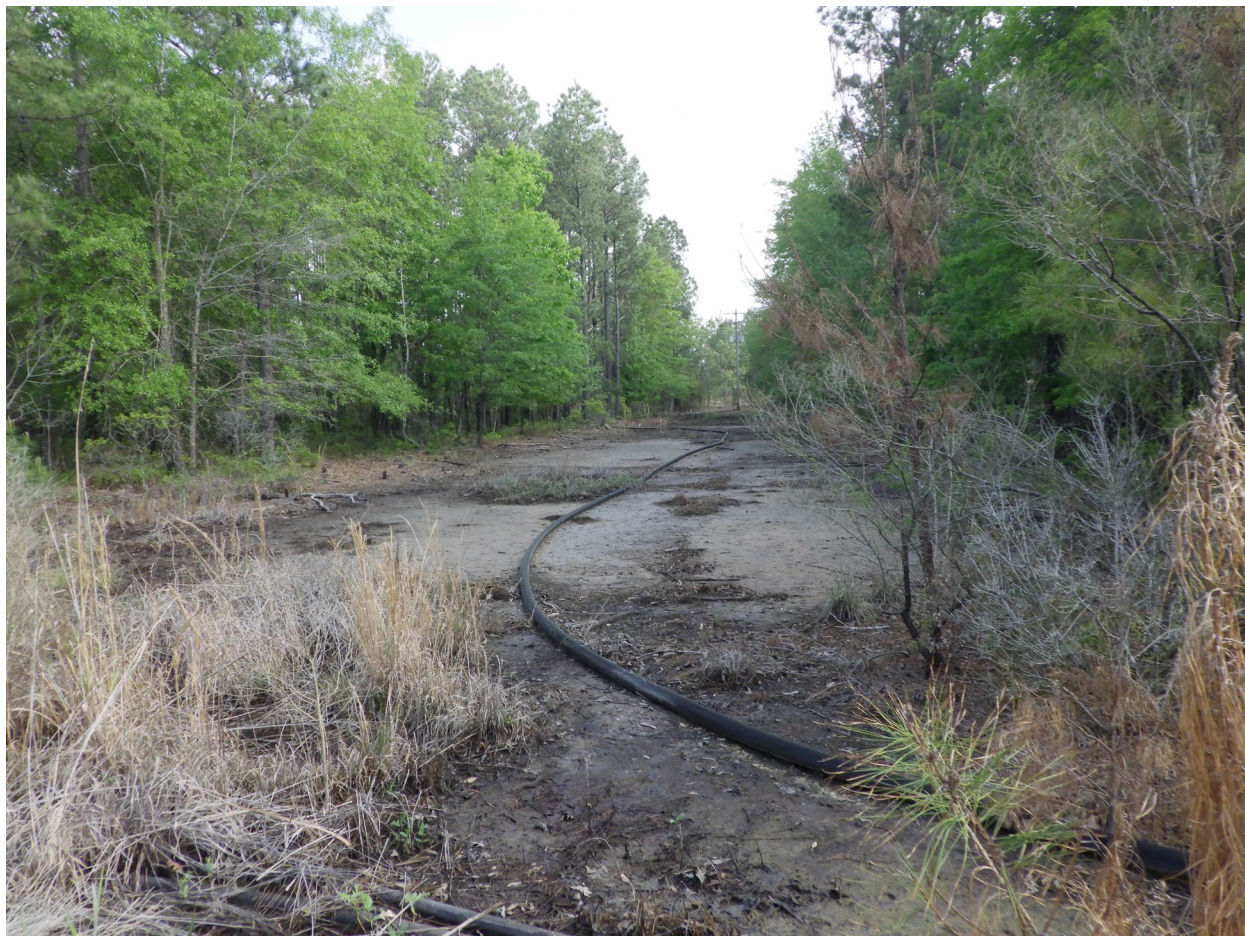
Photo No. 2

**Description:** Looking NNW, this photo shows flowlines placed within a utility right of way and along a lease road.

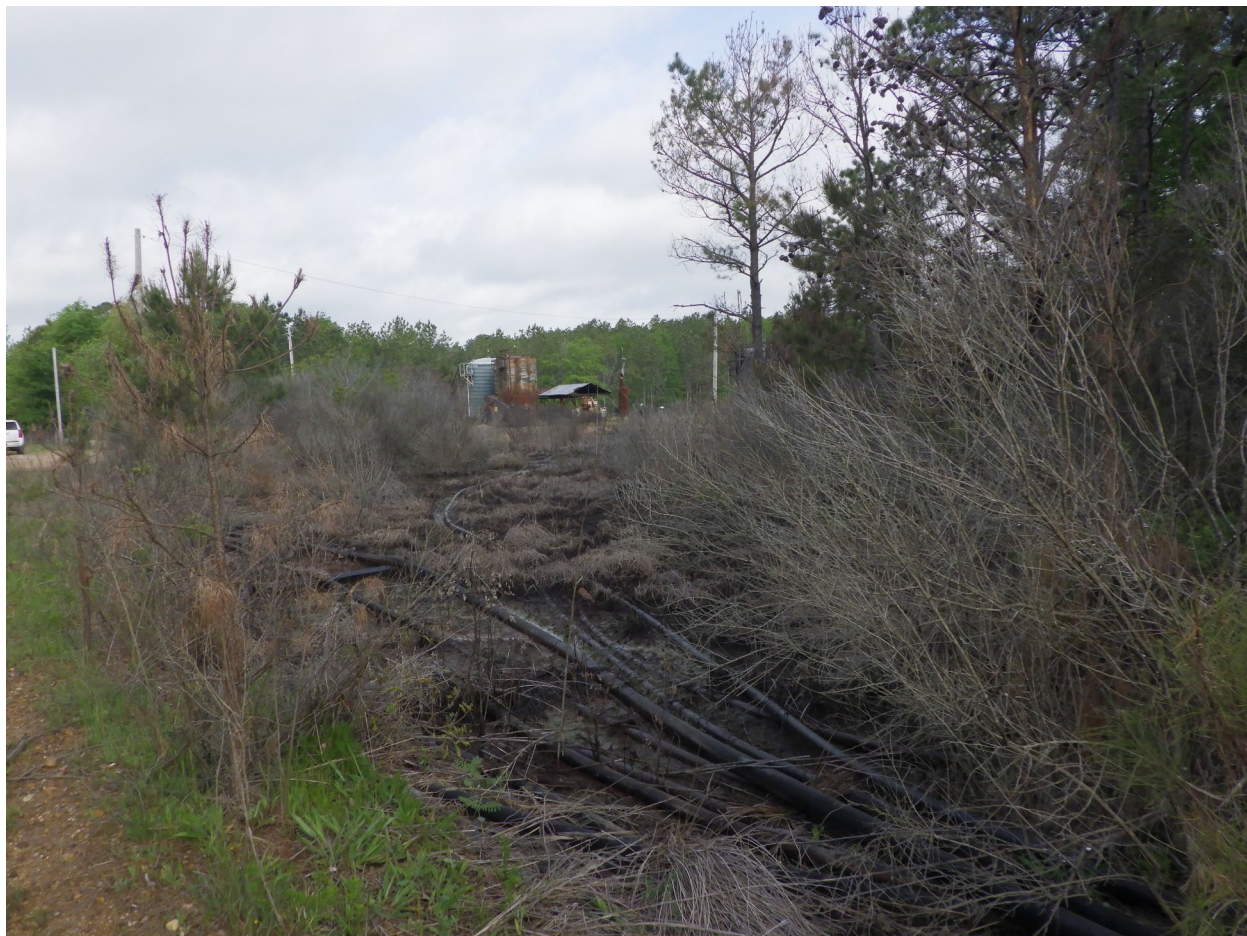
Photo No. 3

**Description:** Looking WNW, this photo shows the flowlines from Photo No. 2 directed to the facility for storage and disposal.

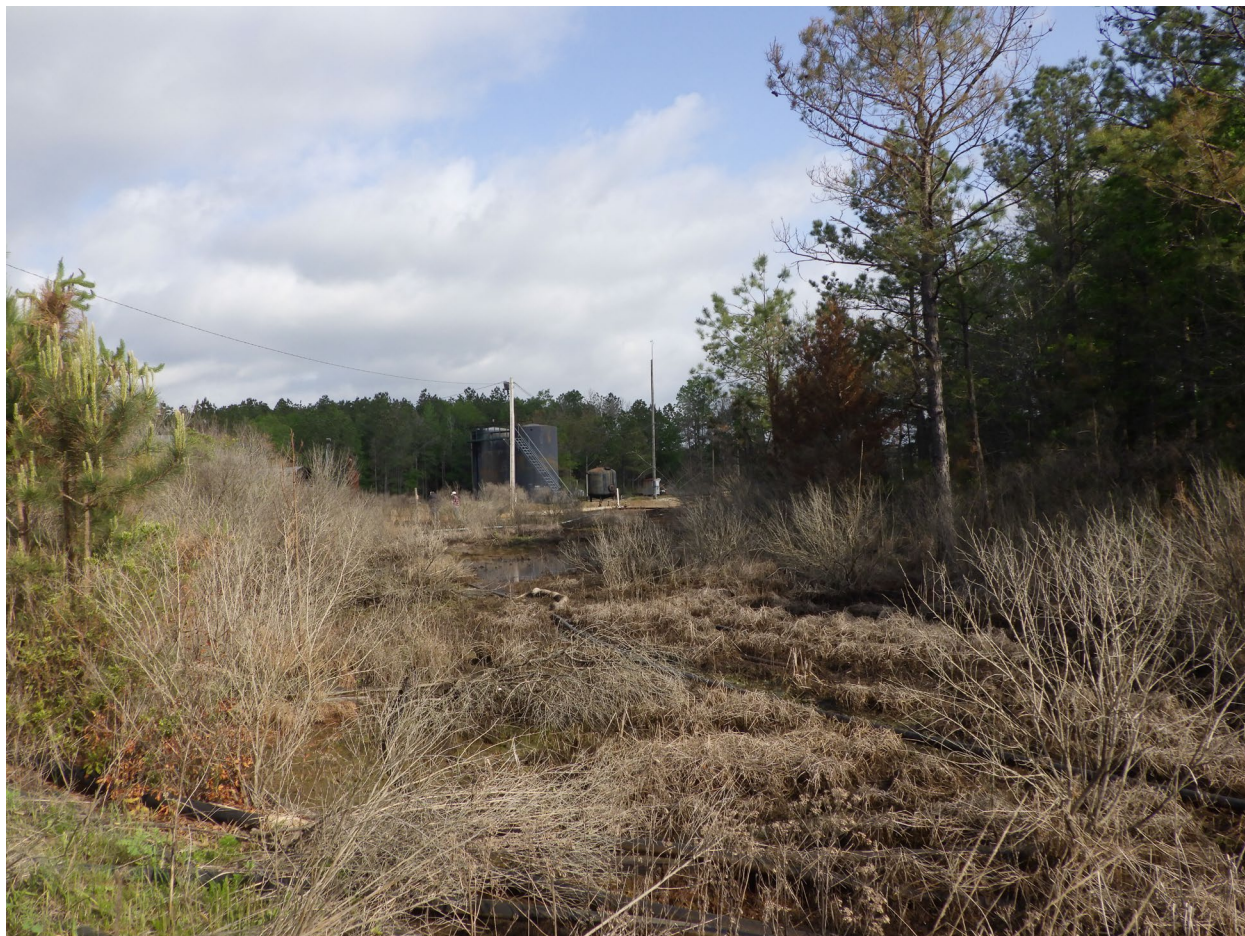
Photo No. 4

**Description:** Looking NW, this photo shows flowlines and dead vegetation within a wetland adjacent to the facility.

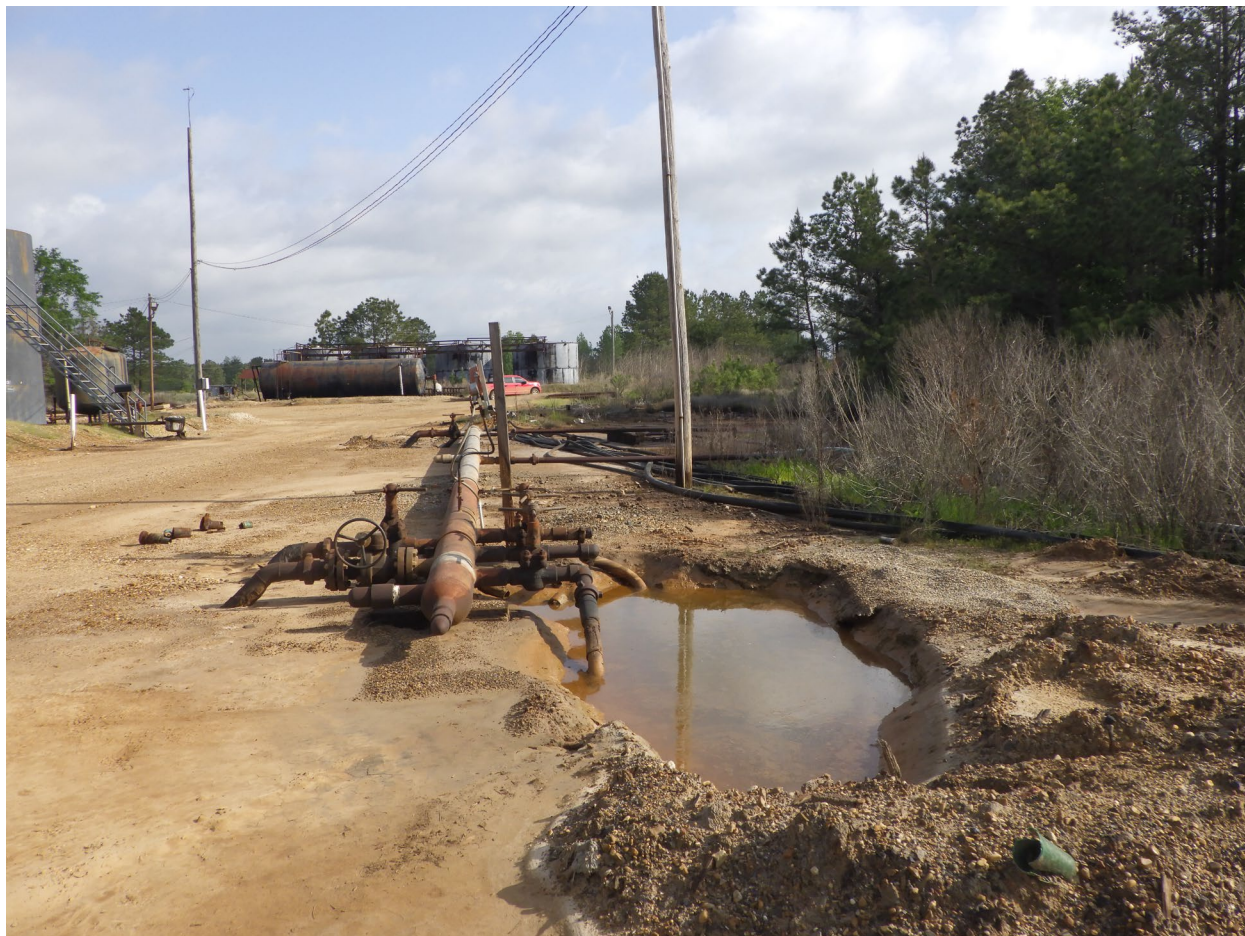
Photo No. 5

**Description:** Looking N, this photo shows a distribution dump setup for flowlines adjacent to the wetland in Photo No. 4.

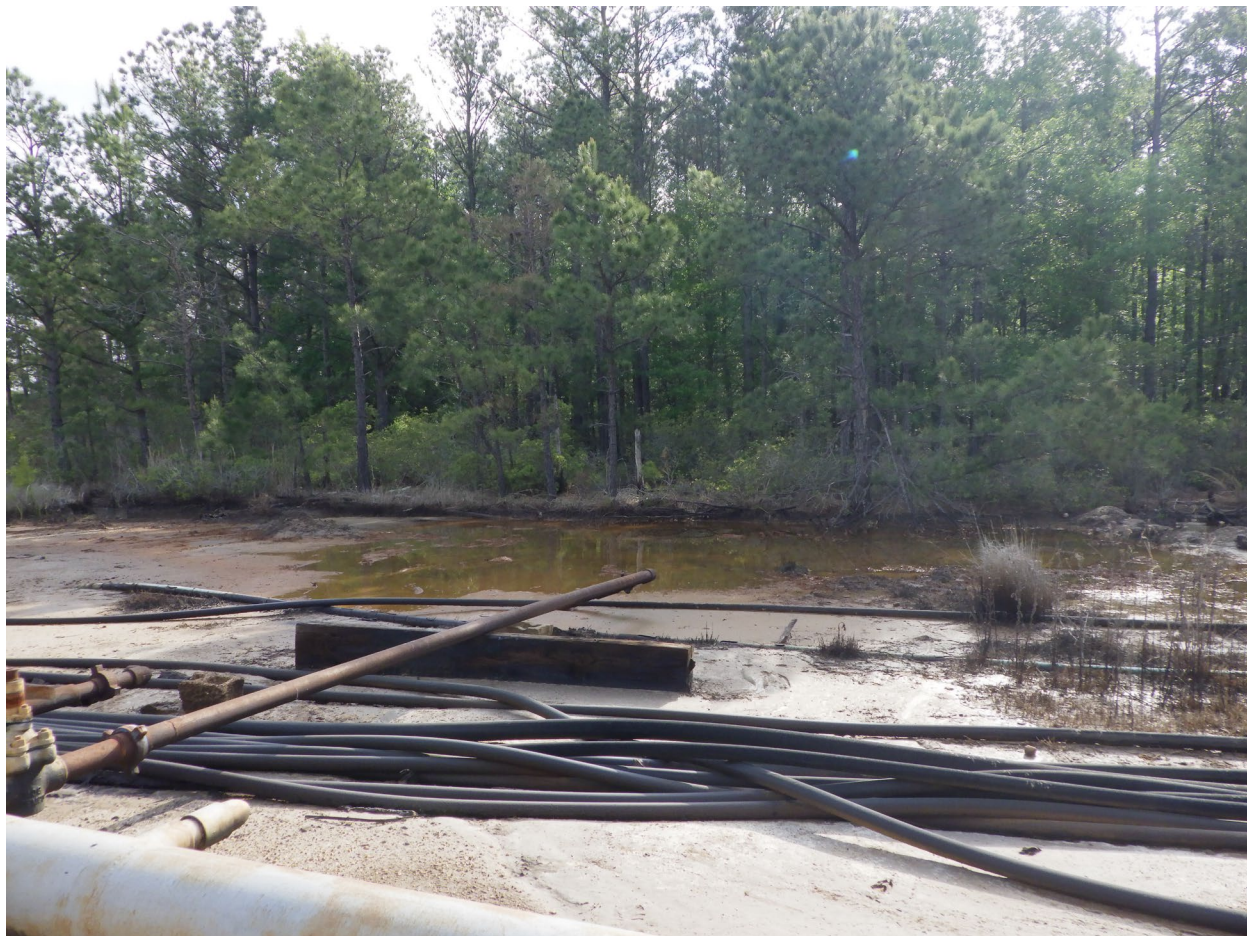
Photo No. 6

**Description:** Looking ENE, this photo shows the wetland adjacent to the flowline distribution setup from Photo No. 5.

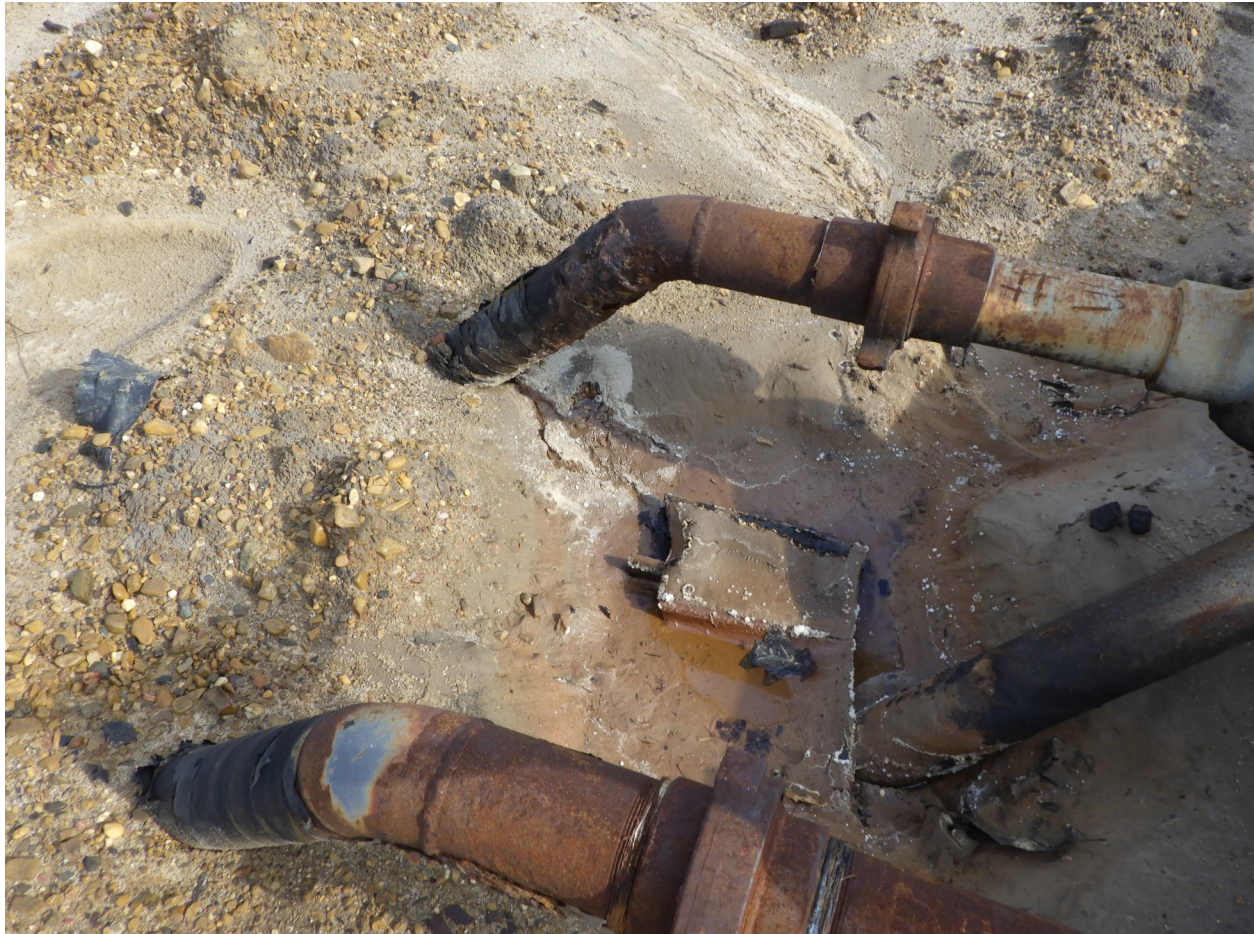
Photo No. 7

- An active saltwater leak from a pipe joint at the flowline collection system (Photos No. 7 and No. 8),
- Storage tanks not in use without proper labeling (Photo No. 11),

**Description:** Looking WNW, this photo shows an active leak from one flowline connection with saltwater staining and crystals on the ground.

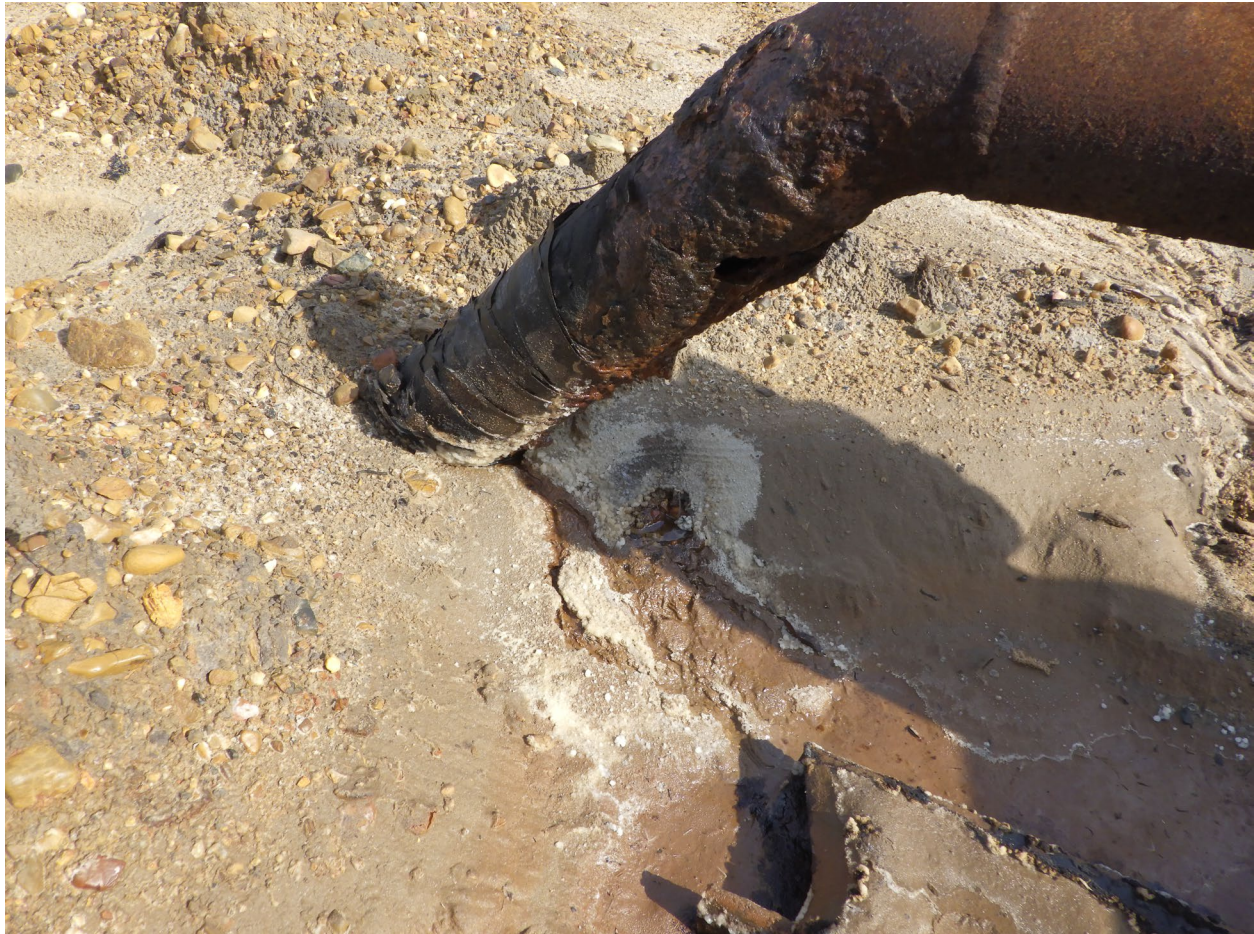
Photo No. 8

**Description:** Looking W, this photo shows a closeup of the active leak from the flowline connection in Photo No. 7.

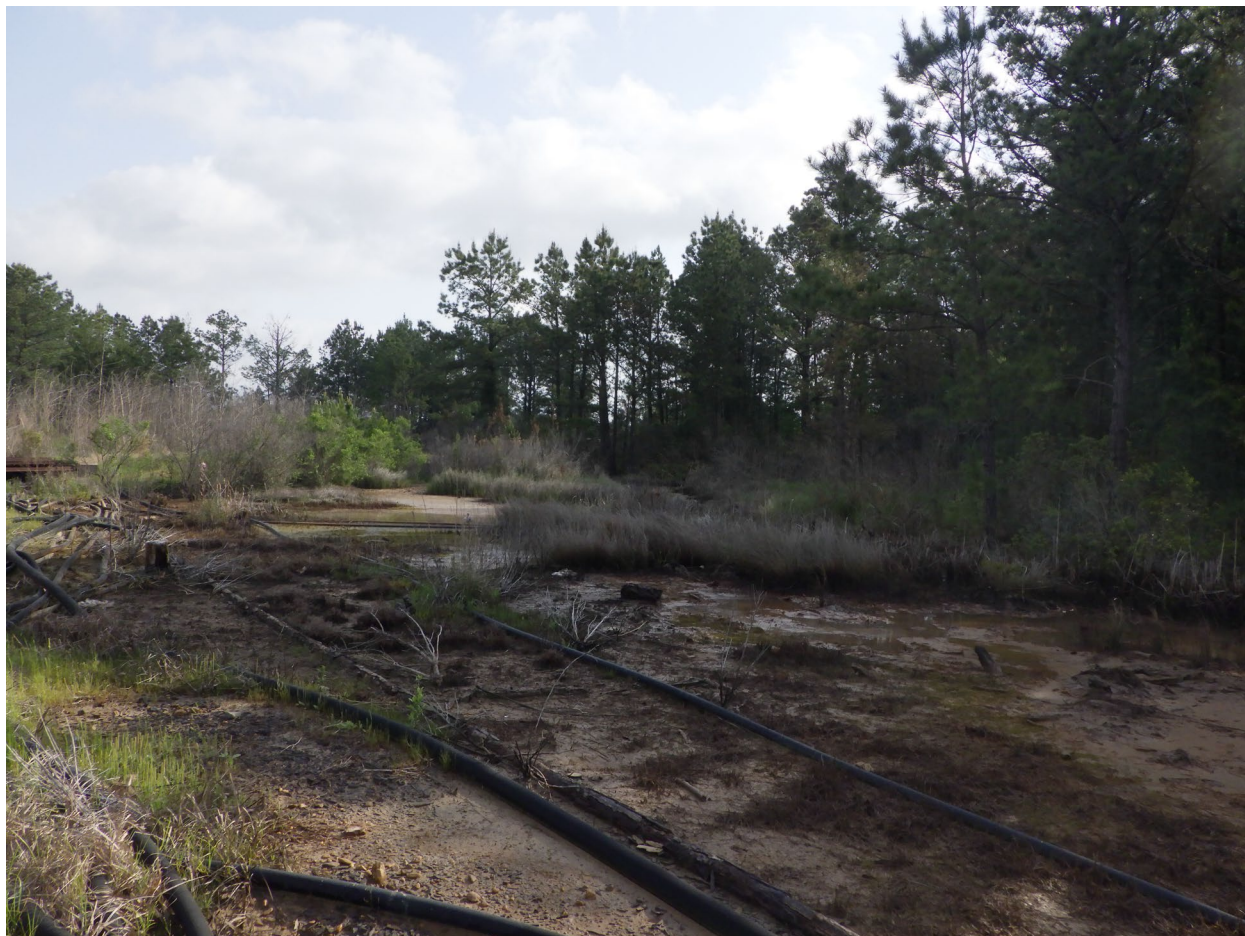
Photo No. 9

**Description:** Looking NNE, this photo shows an additional view of the flowlines and dead vegetation within a wetland adjacent to the distribution setup.

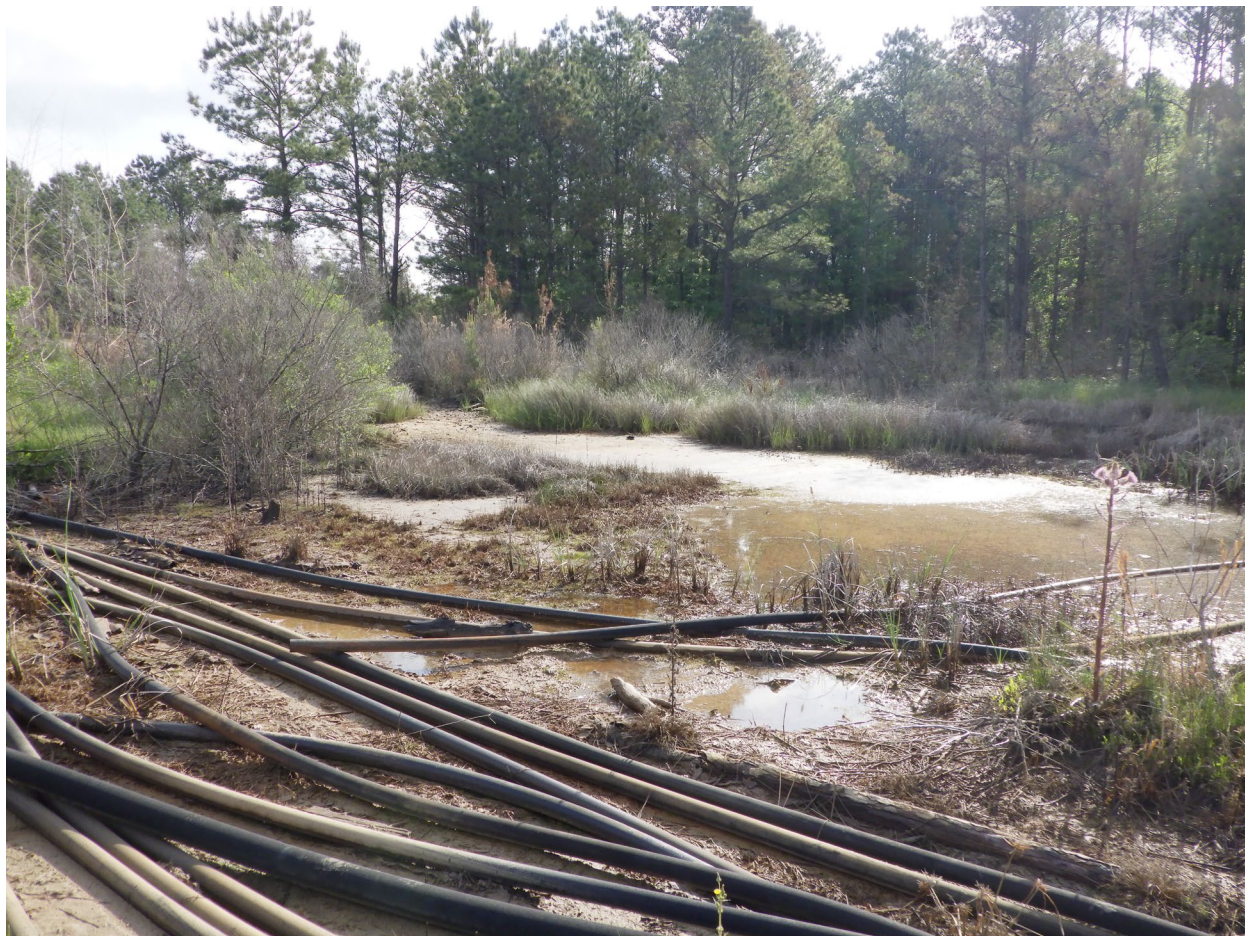
Photo No. 10

**Description:** Looking ENE, this photo shows an additional view of the wetland area from Photo No. 9.

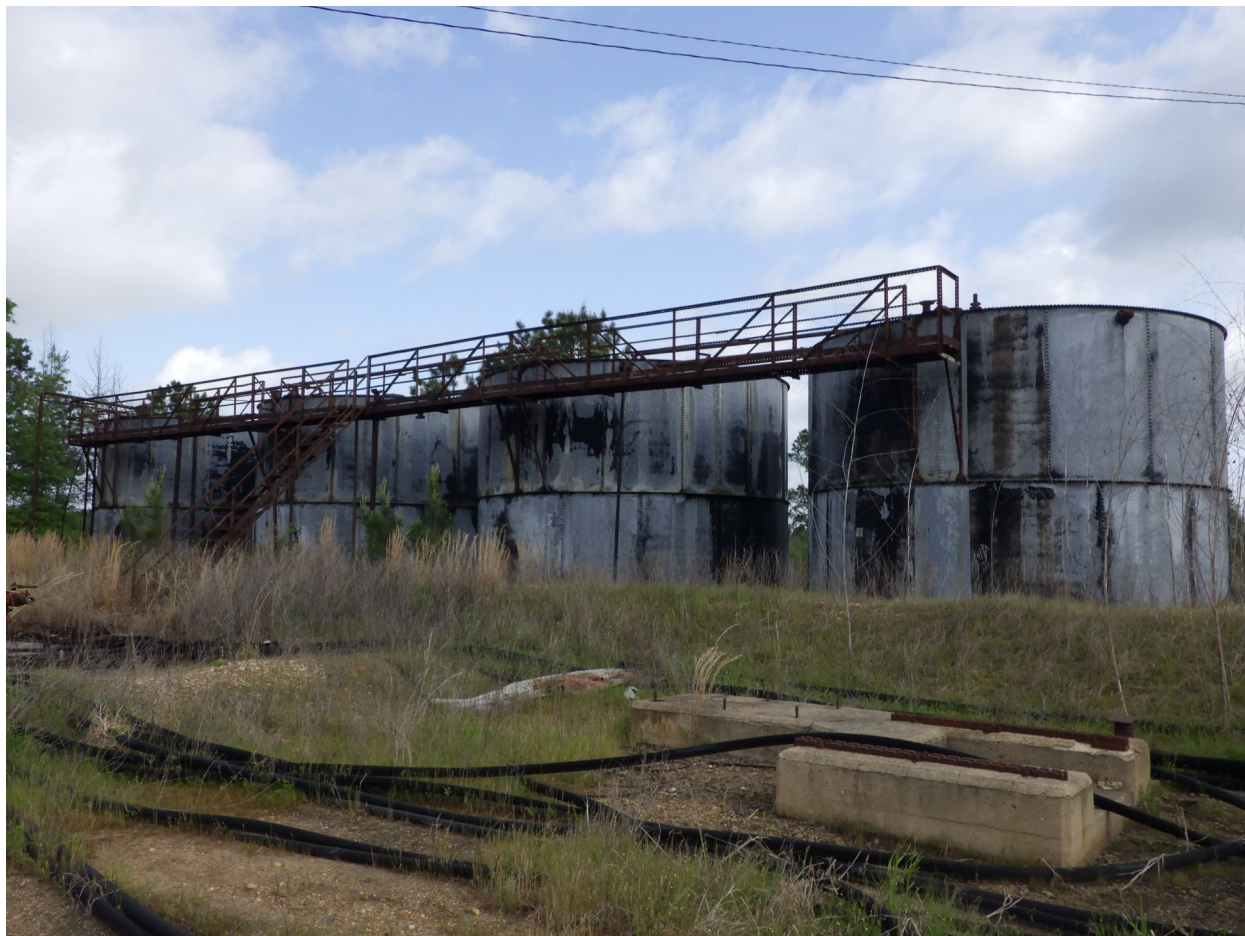
Photo No. 11

**Description:** Looking NW, this photo shows a tank battery with storage tanks that appeared to be out of service.

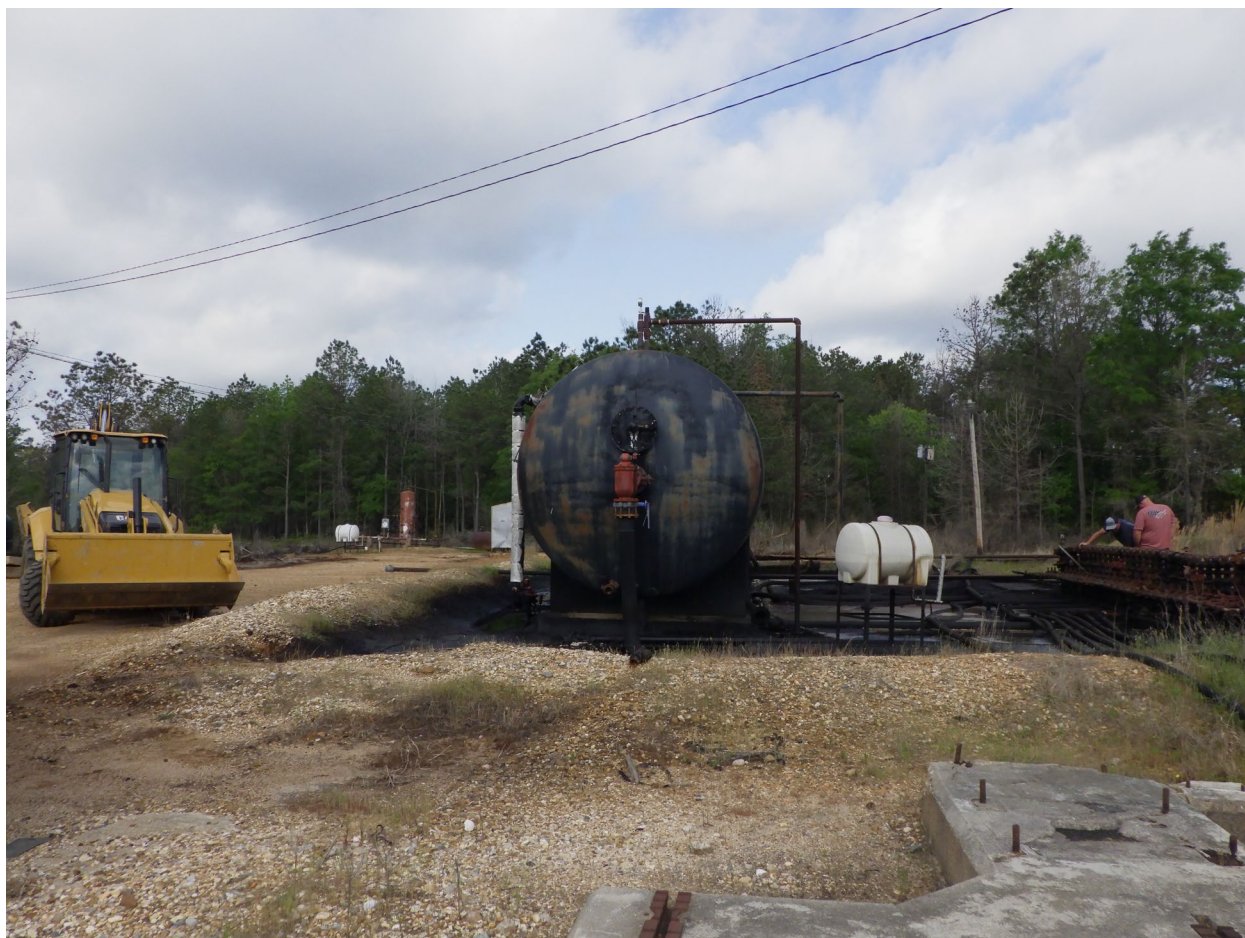
Photo No. 12

**Description:** Looking W, this photo shows a free water knock-out (FWKO) tank inside secondary containment with loose crude oil.

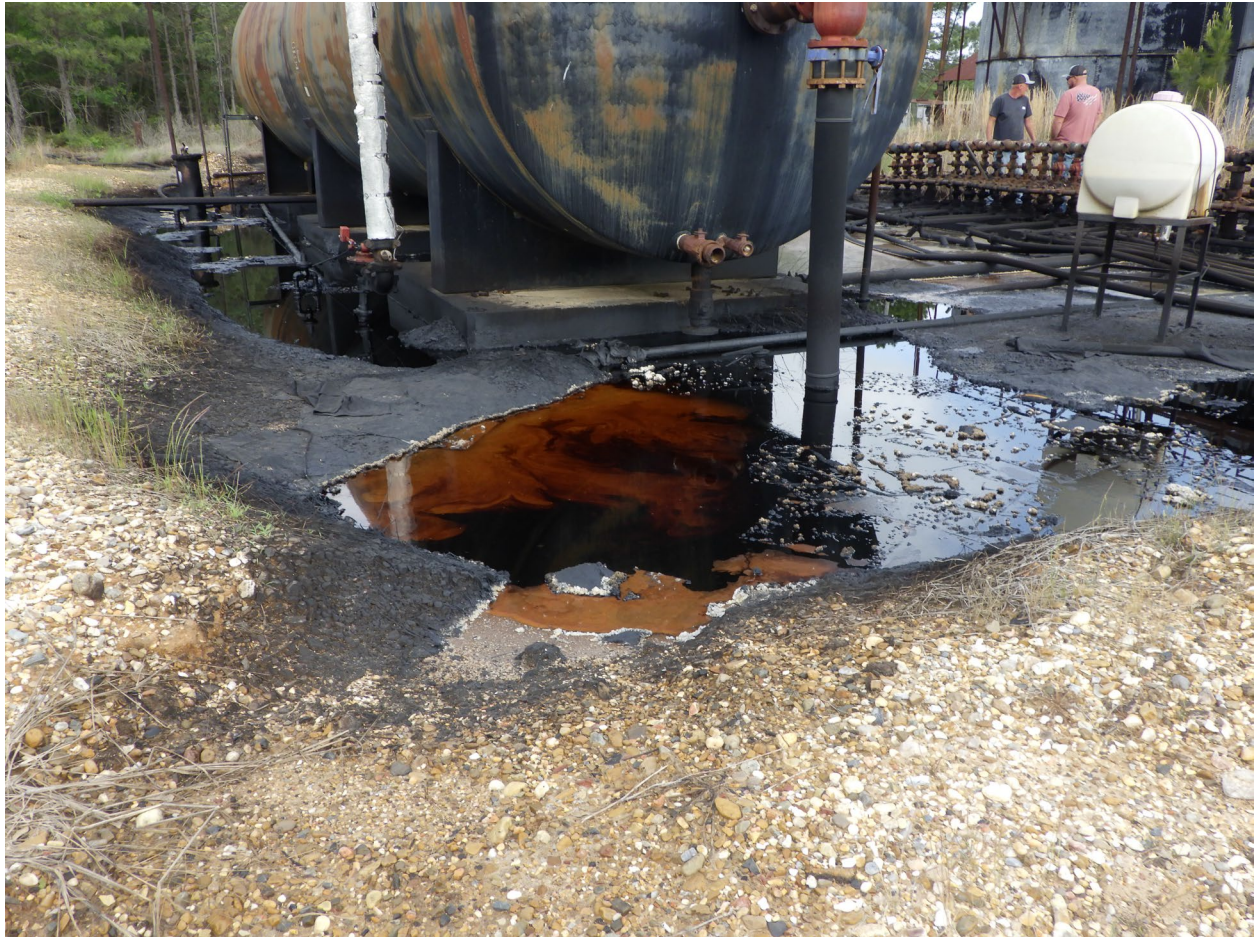
Photo No. 13

**Description:** Looking WNW, this photo shows loose crude oil and saltwater inside the secondary containment for the FWKO tank.

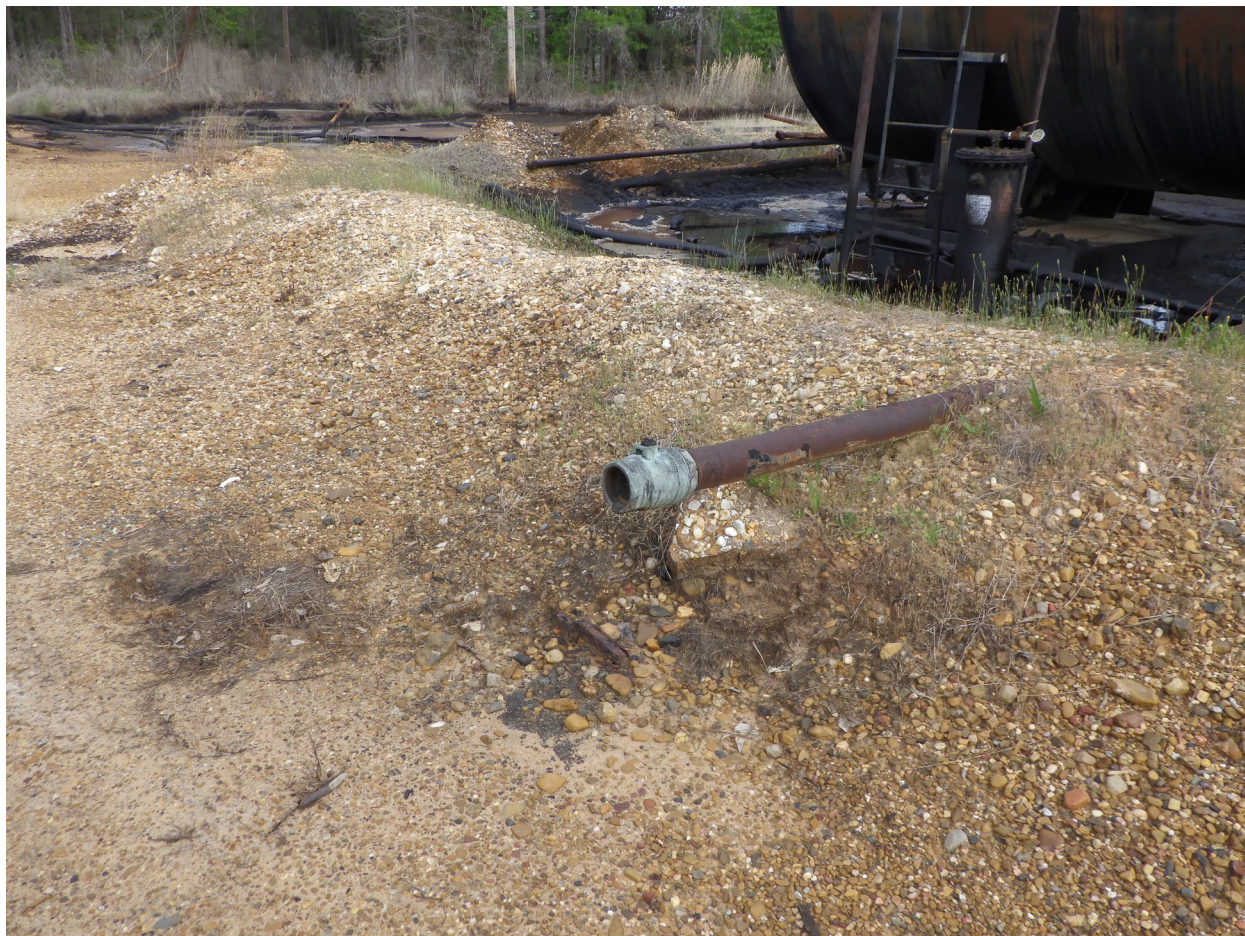
Photo No. 14

- The transfer line for the FWKO tank without a catchment bucket or control mechanism (Photo No. 14),
- An active leak from a flowline outside secondary containment (Photo No. 23),

**Description:** Looking NW, this photo shows a transfer pipe without a catchment bucket or cap at the FWKO tank battery.

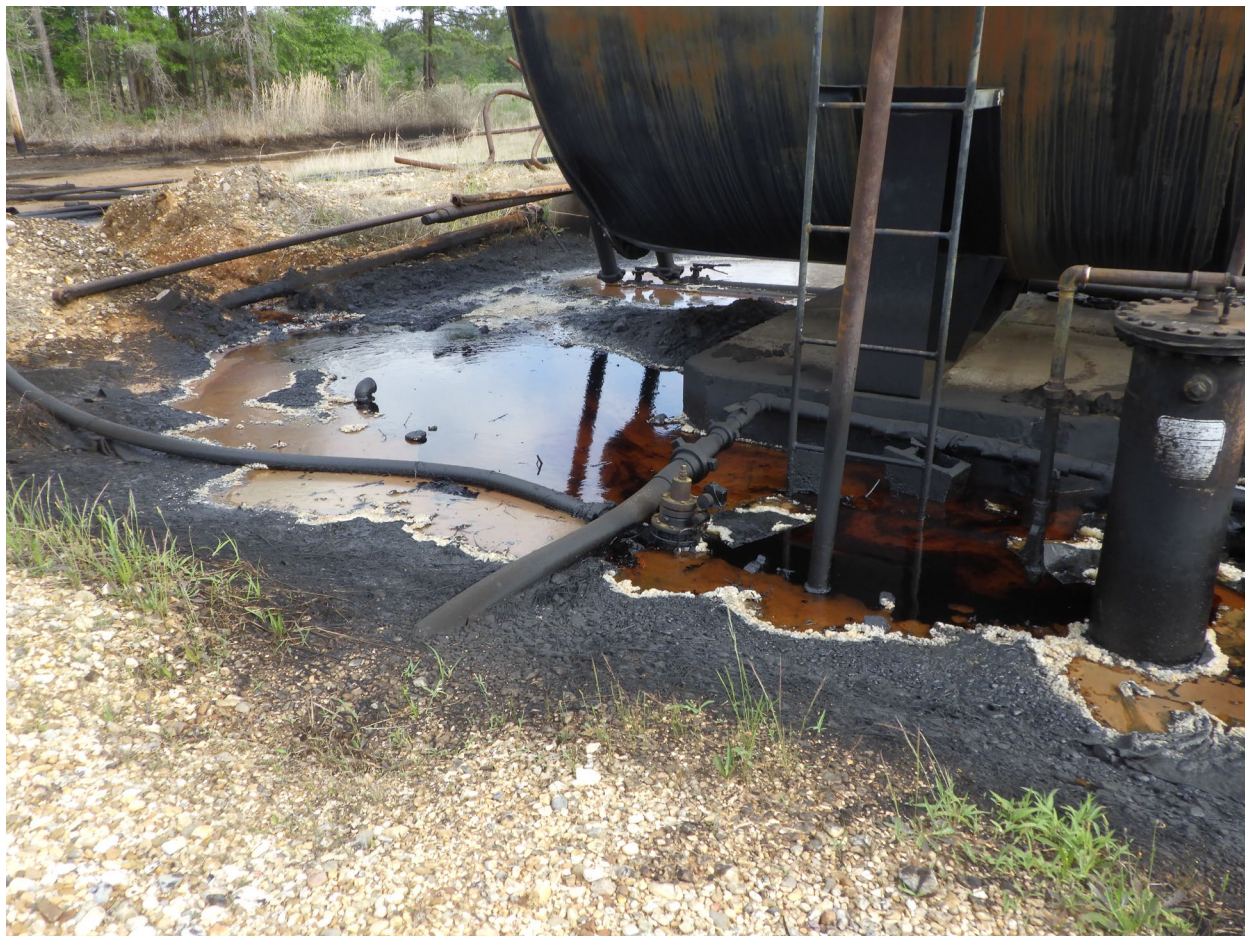
Photo No. 15

**Description:** Looking NNW, this photo shows an additional view of the inside of the FWKO tank battery with loose crude oil and saltwater.

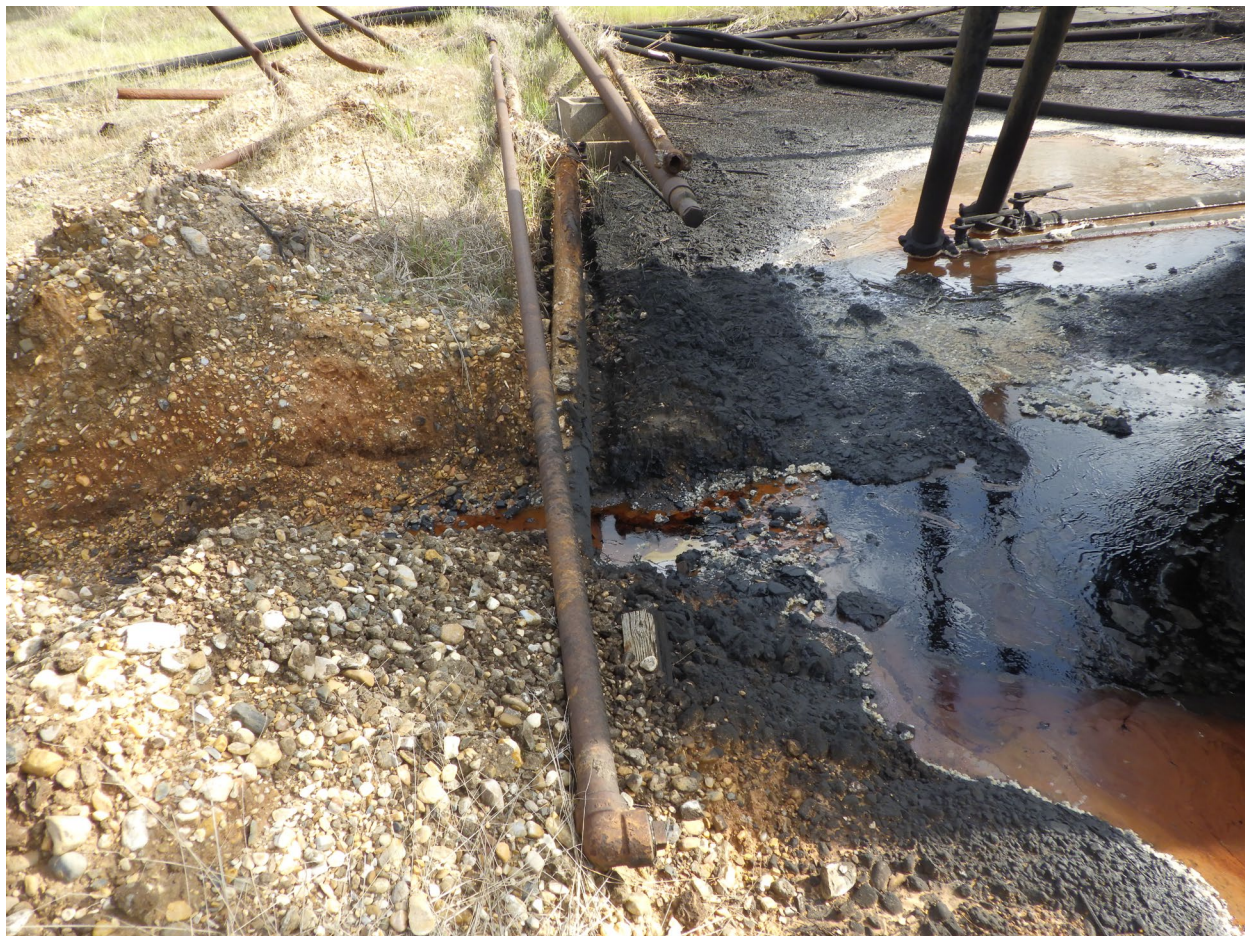
Photo No. 16

- A cut berm for the FWKO tank with loose crude oil and saltwater discharged onto the ground and into the surrounding area (Photos No. 12 through No. 19),

**Description:** Looking N, this photo shows a cut in the berm of the FWKO secondary containment with loose crude oil and saltwater actively flowing from the structure.

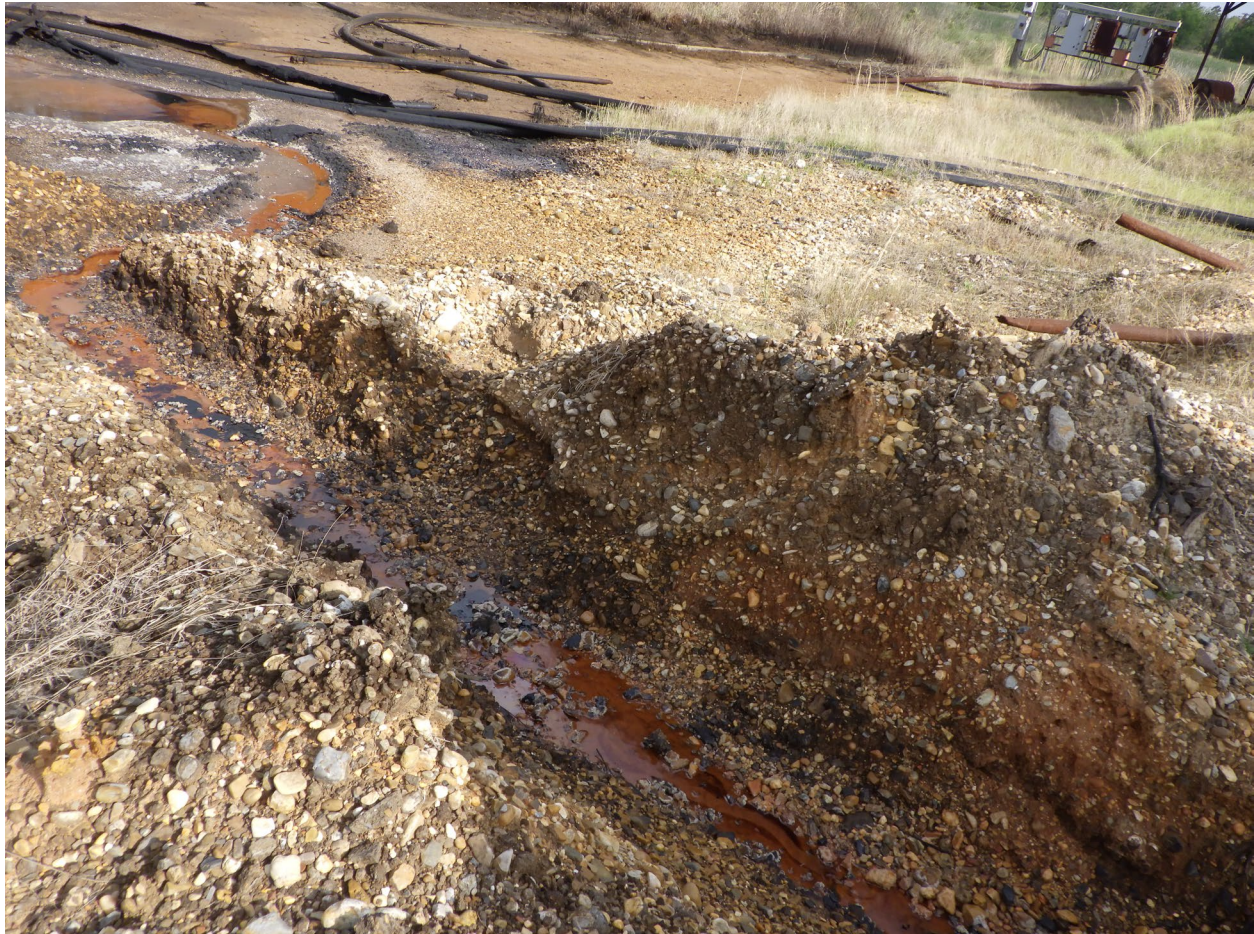
Photo No. 17

**Description:** Looking NW, this photo shows a closeup of the cut in the berm of the FWKO secondary containment from Photo No. 16.

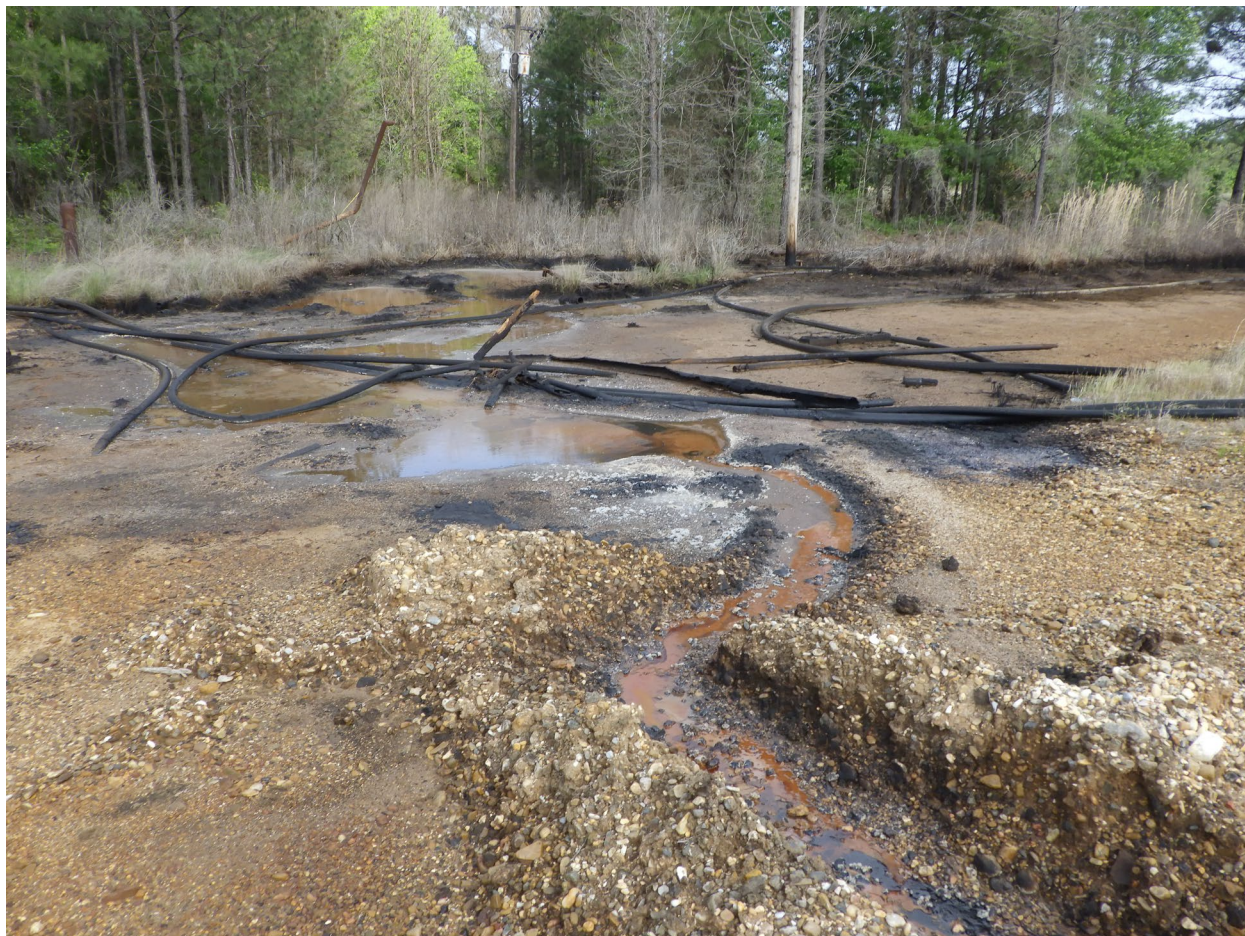
Photo No. 18

**Description:** Looking WNW, this photo shows an overview of the active release from the FWKO tank battery with loose crude oil and saltwater on the ground.

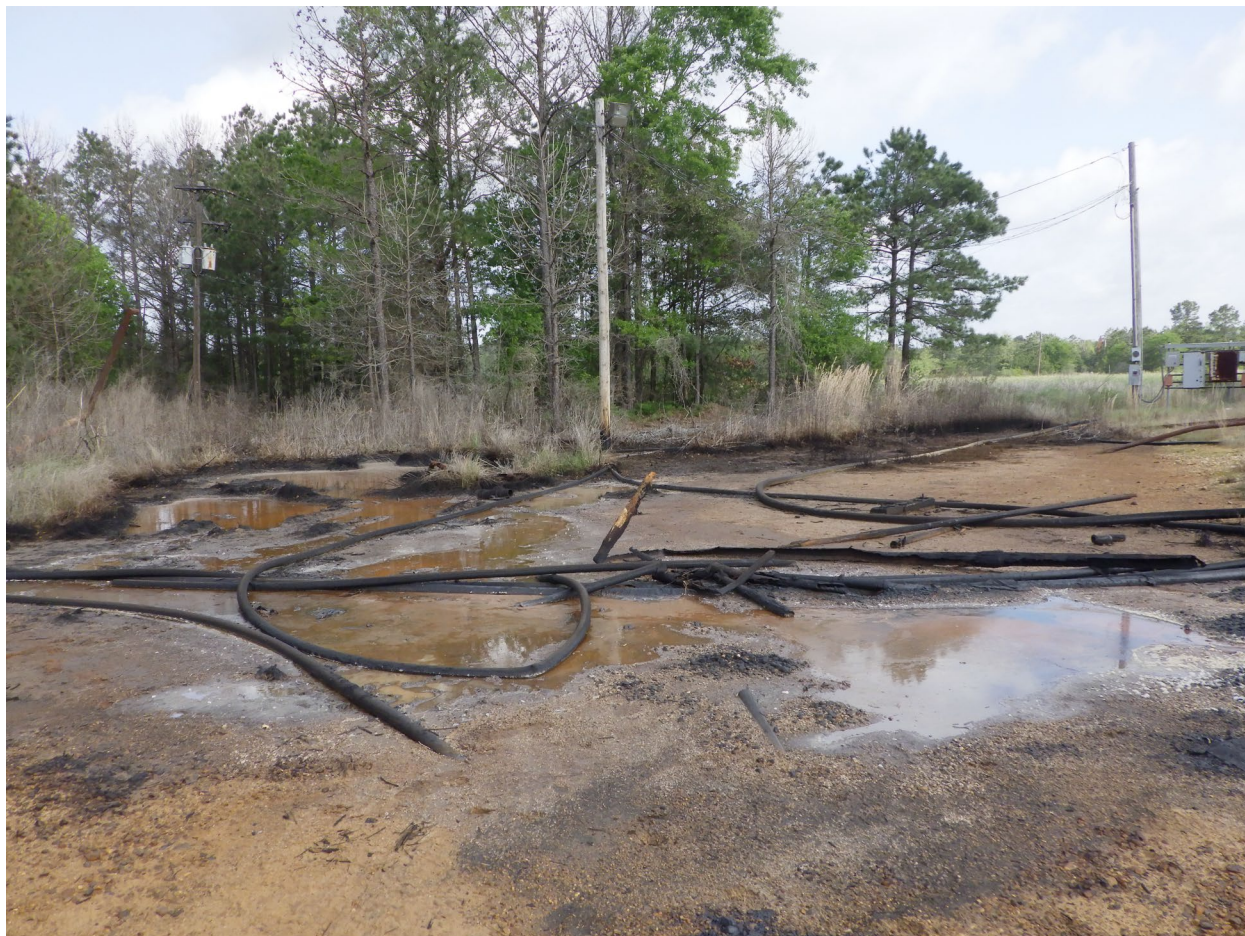
Photo No. 19

**Description:** Looking NW, this photo shows an additional view of the release of loose crude oil and saltwater from Photo No. 18.
