**Region 6 - Enforcement & Compliance Assurance Division**  
**INSPECTION REPORT**

| Inspection Date(s): | 04/17/2025 | |
| Company Name: | <b>C12: Arkansas Oil, LLC</b> | |
| Facility Name: | <b>Midway Smackover Unit Tract #3 Tank Battery</b> | |

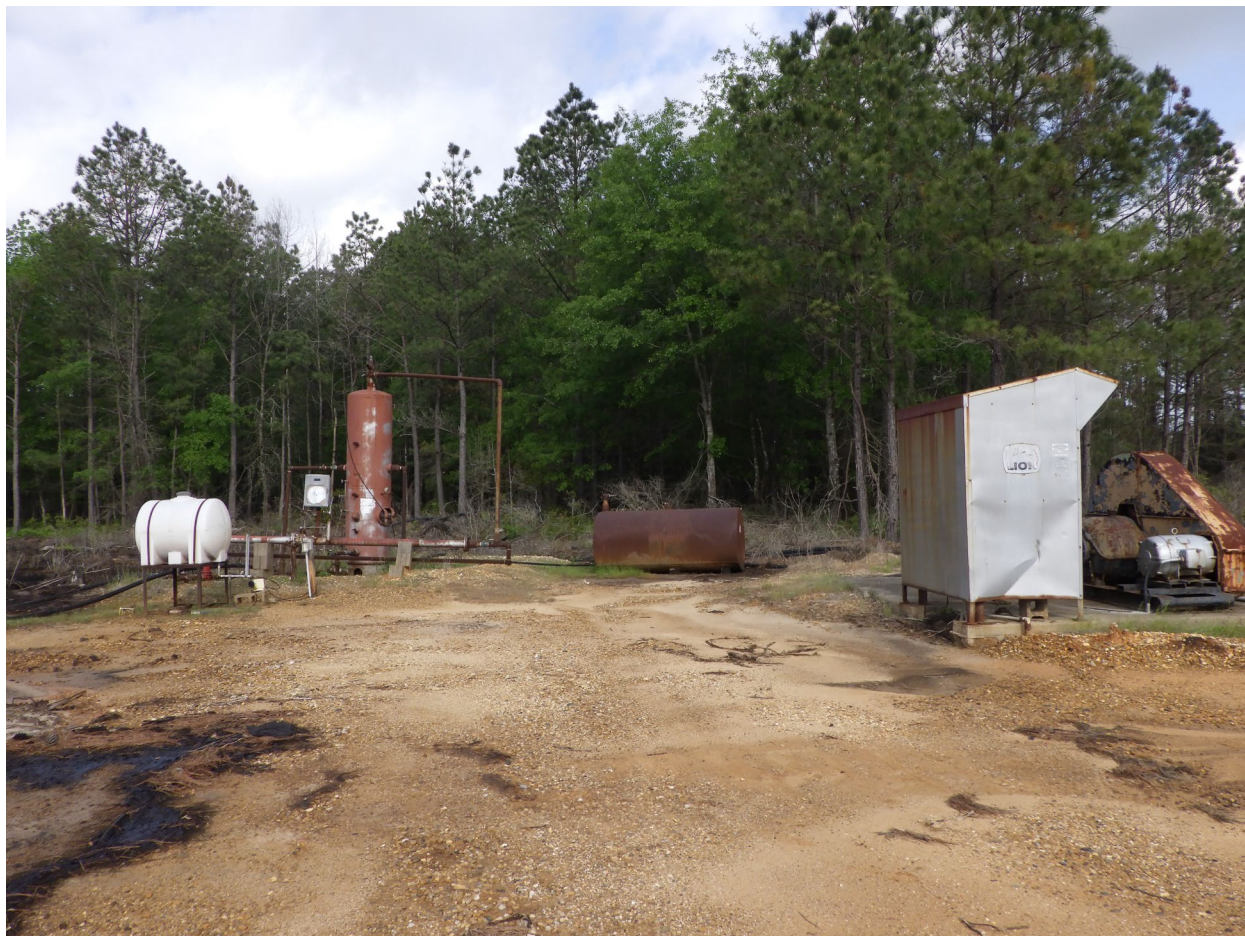
Photo No. 20

**Description:** Looking W, this photo shows an overview of some miscellaneous equipment outside secondary containment.

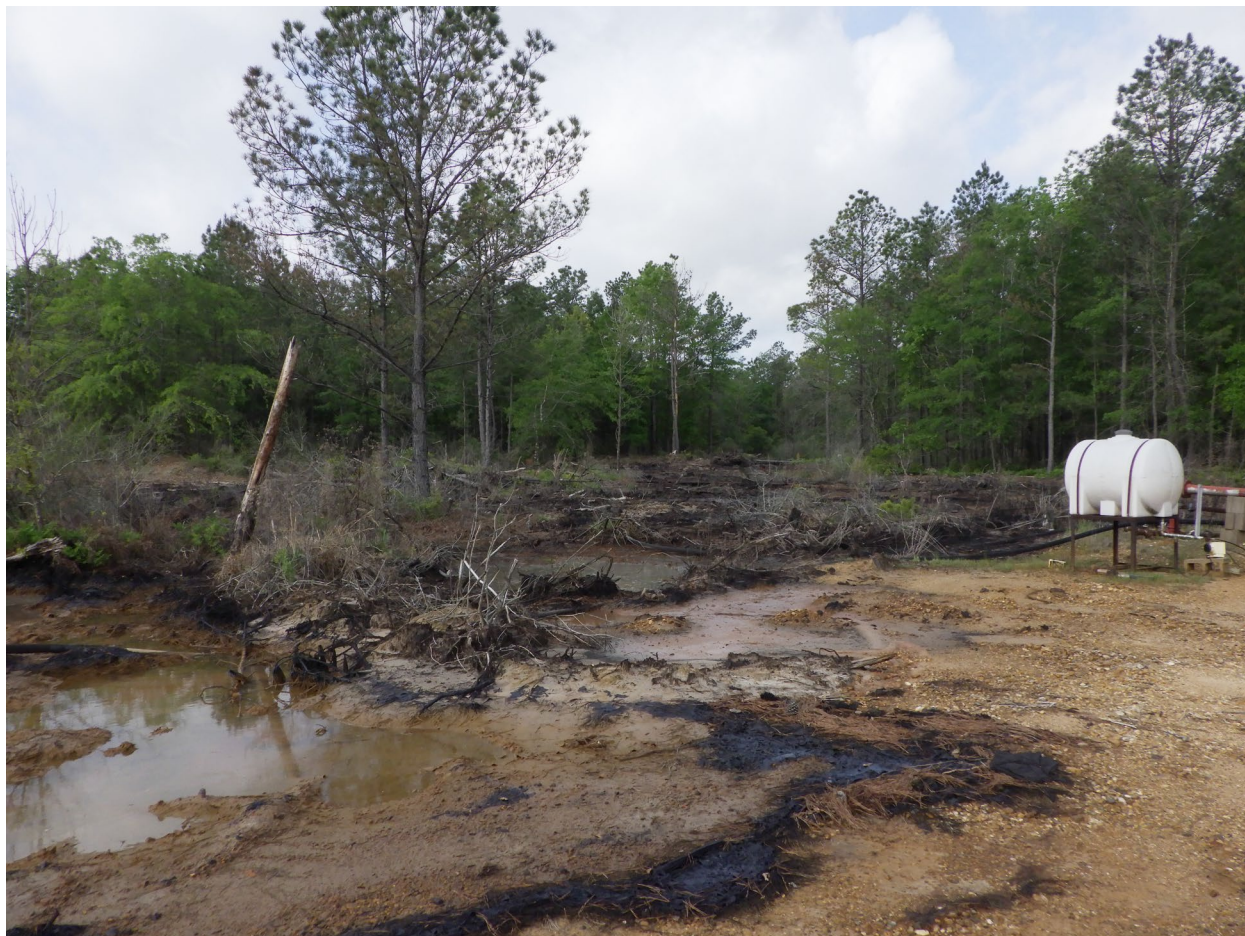
**Description:** Looking WSW, this photo shows an area adjacent to the facility that has been impacted by a release of loose crude oil and saltwater.

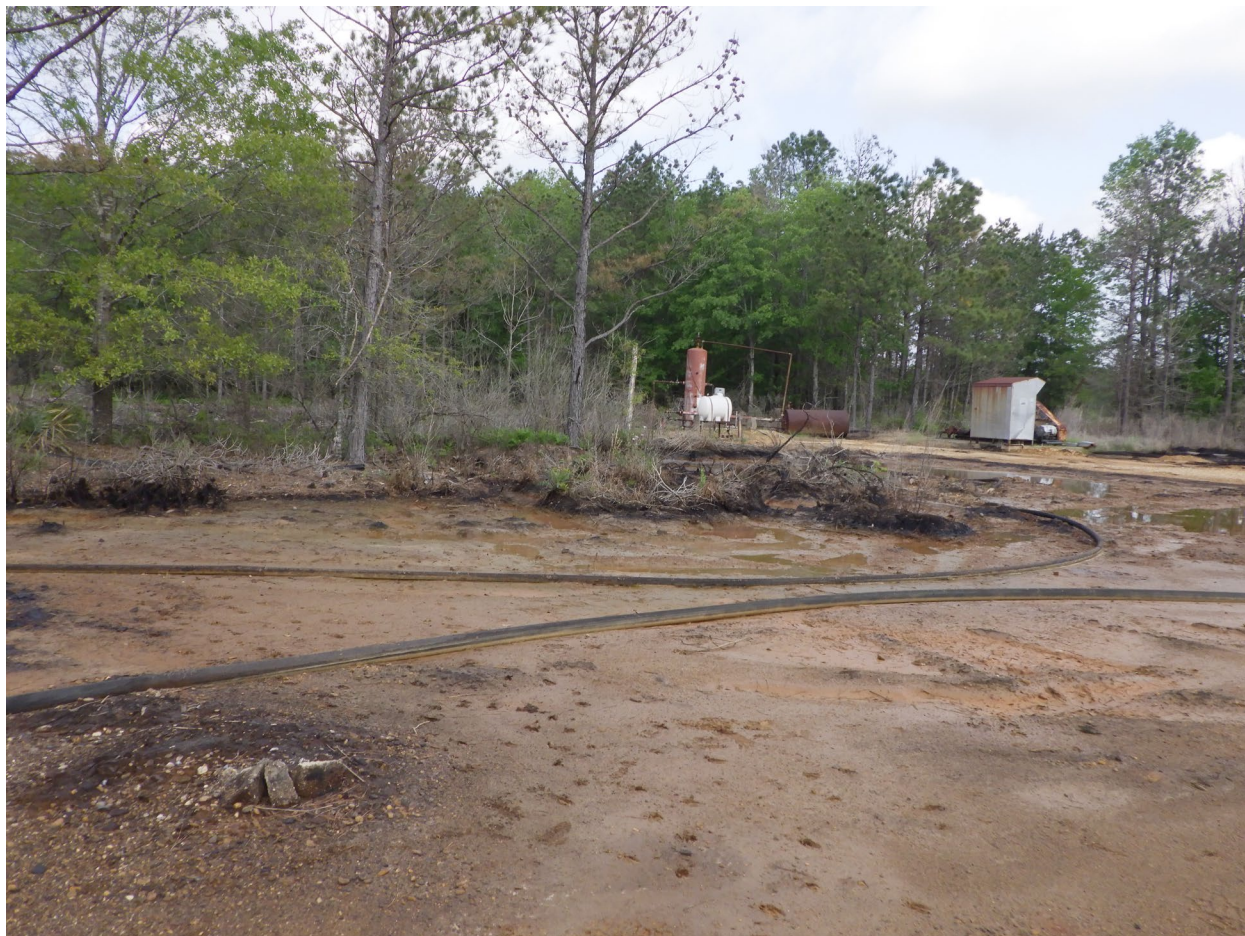
**Description:** Looking WNW, this photo shows the extent of a release of loose crude oil and saltwater adjacent to the facility.

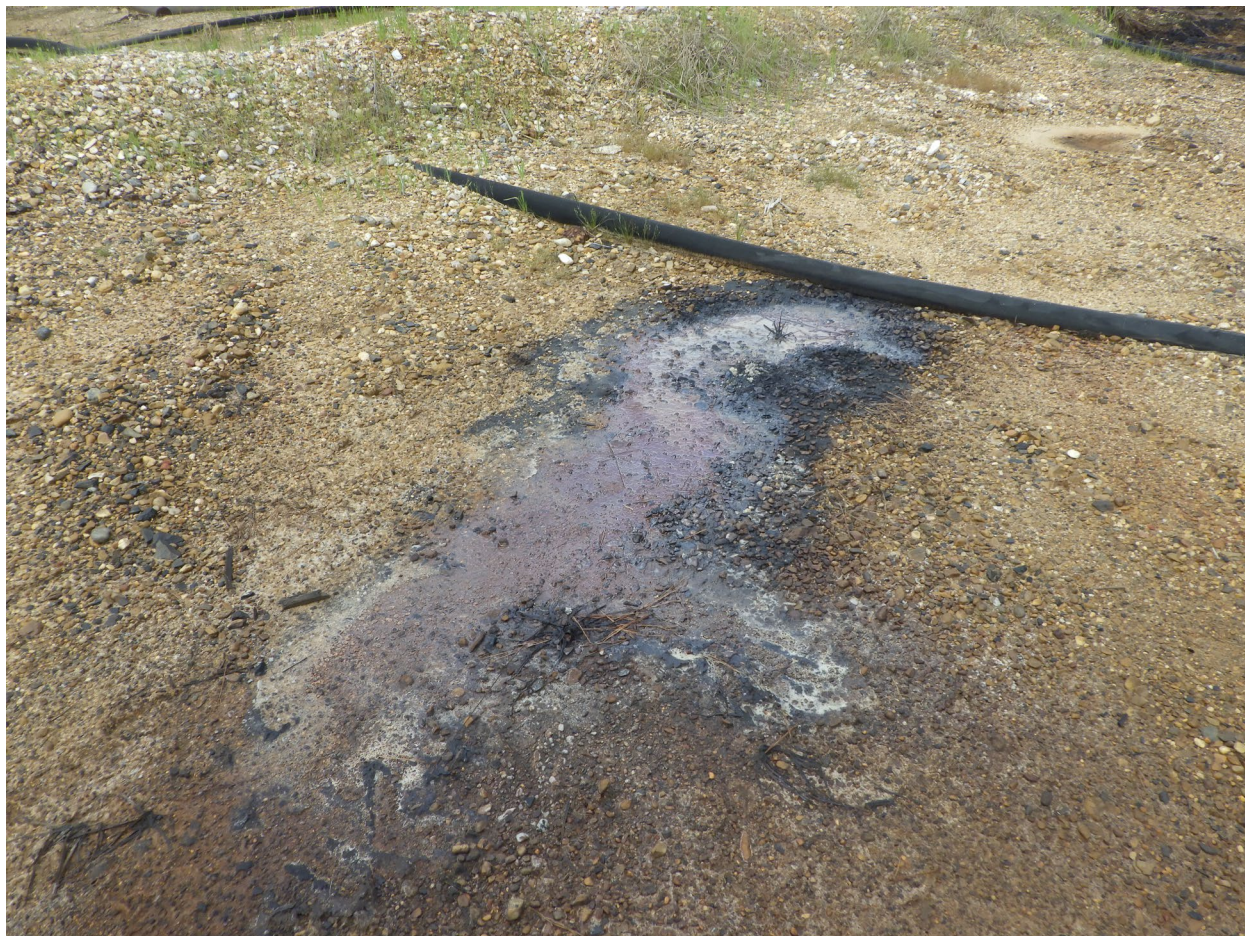
**Description:** Looking SW, this photo shows an active leak from a flowline for another tank battery at the facility.

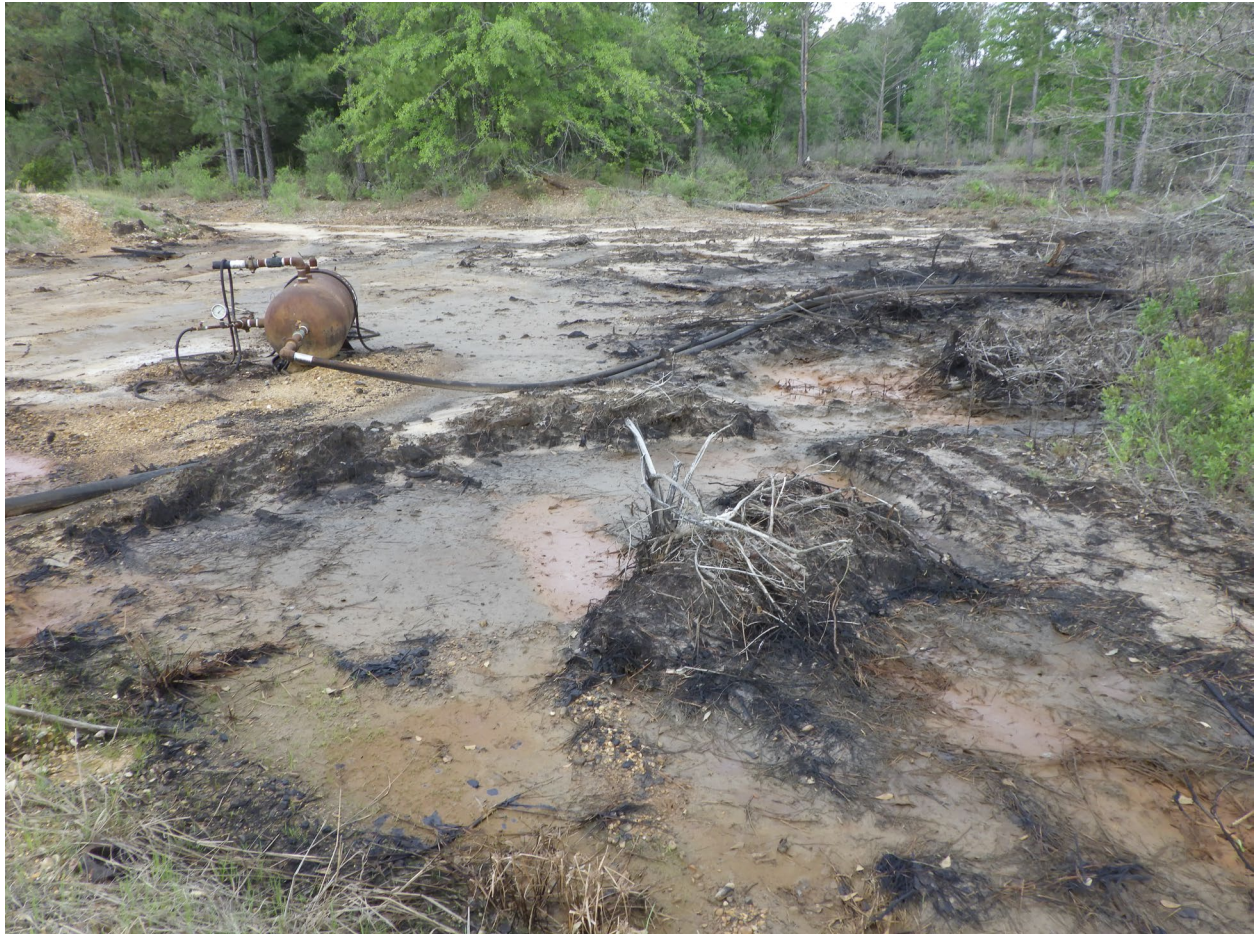
**Description:** Looking WSW, this photo shows an additional view of a release of loose crude oil and saltwater associated with the facility.

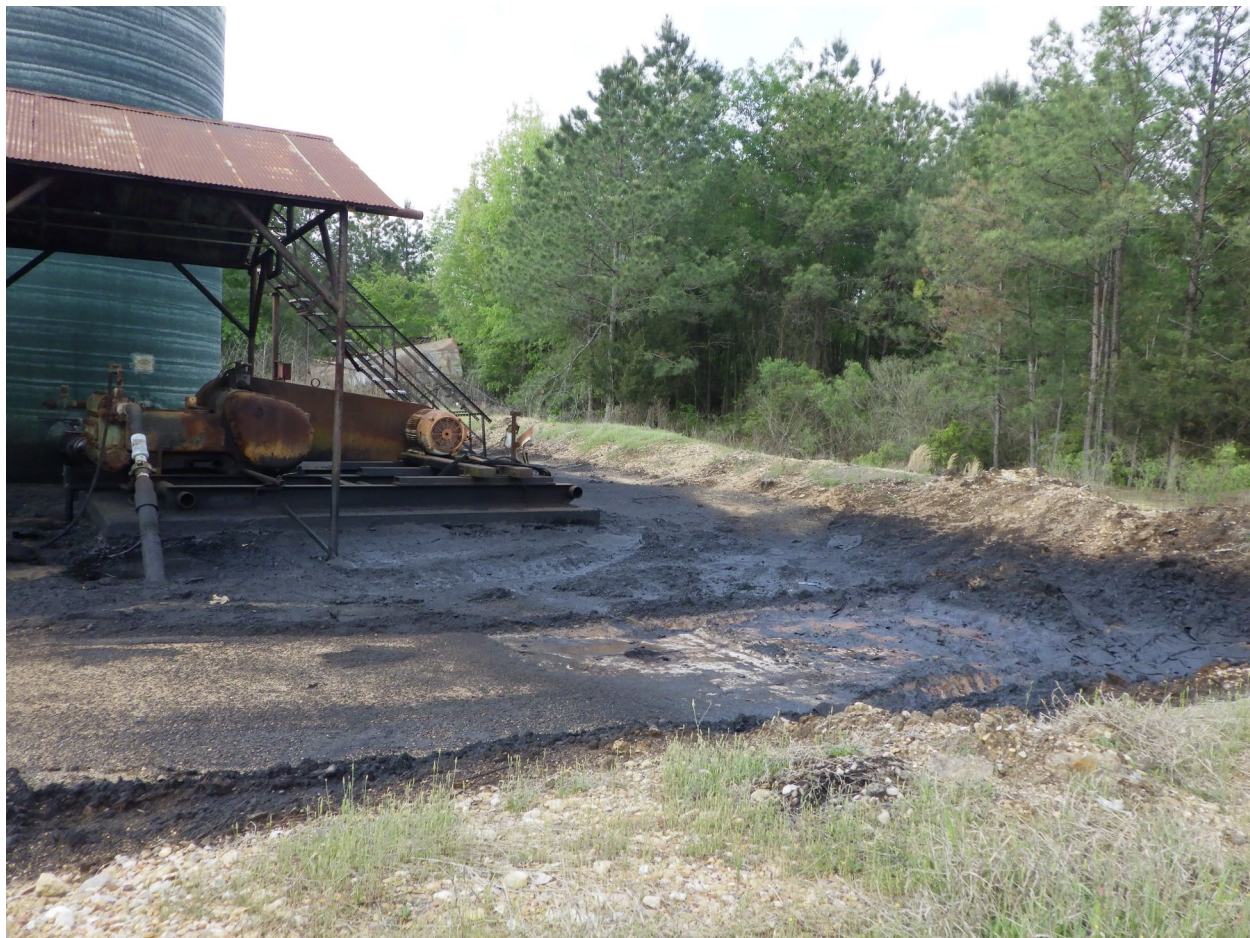
**Description:** Looking SW, this photo shows the inside of an additional tank battery located at the facility with loose crude oil.

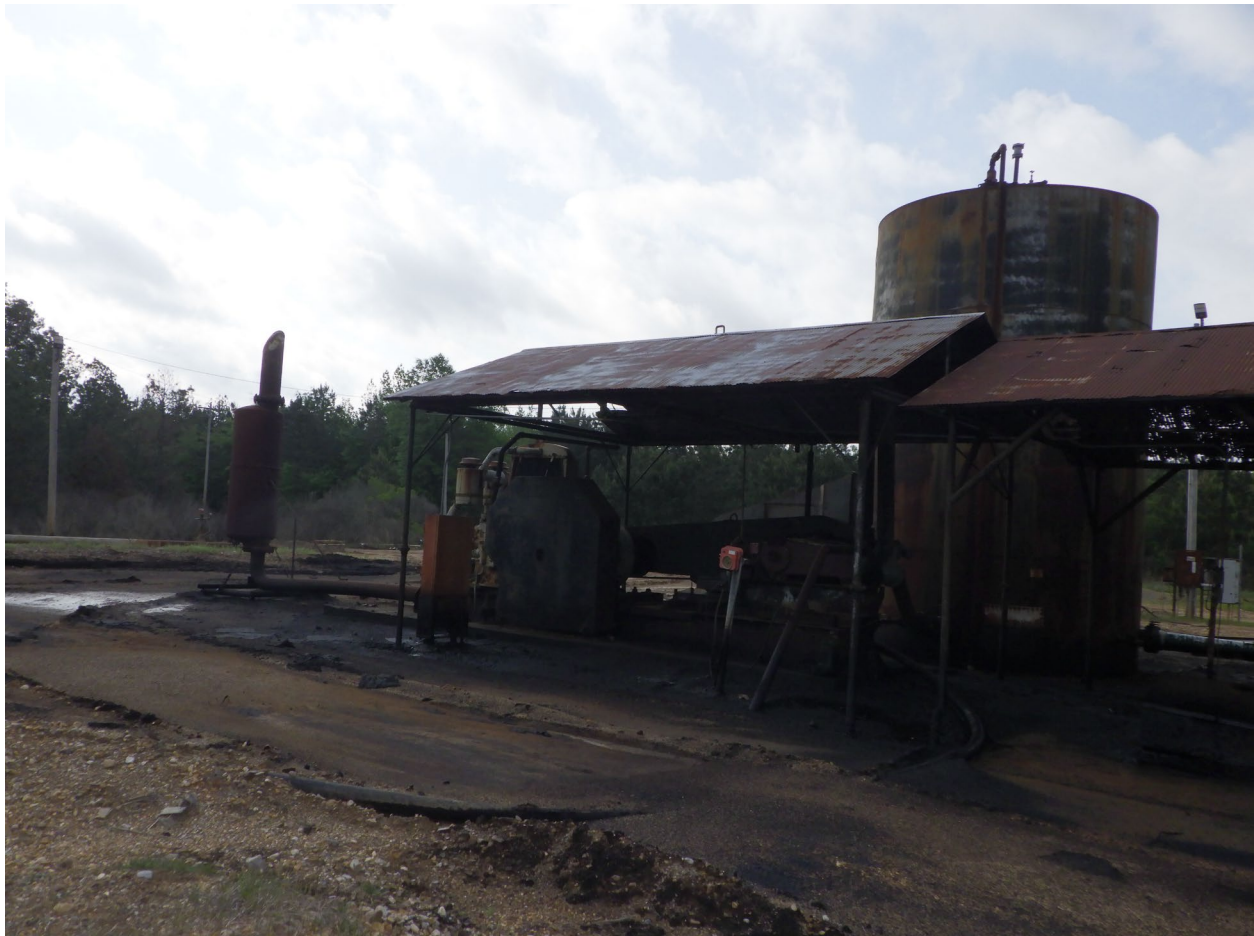
**Description:** Looking S, this photo shows the inside of the tank battery from Photo No. 25 that appeared to be scraped to remove loose crude oil.

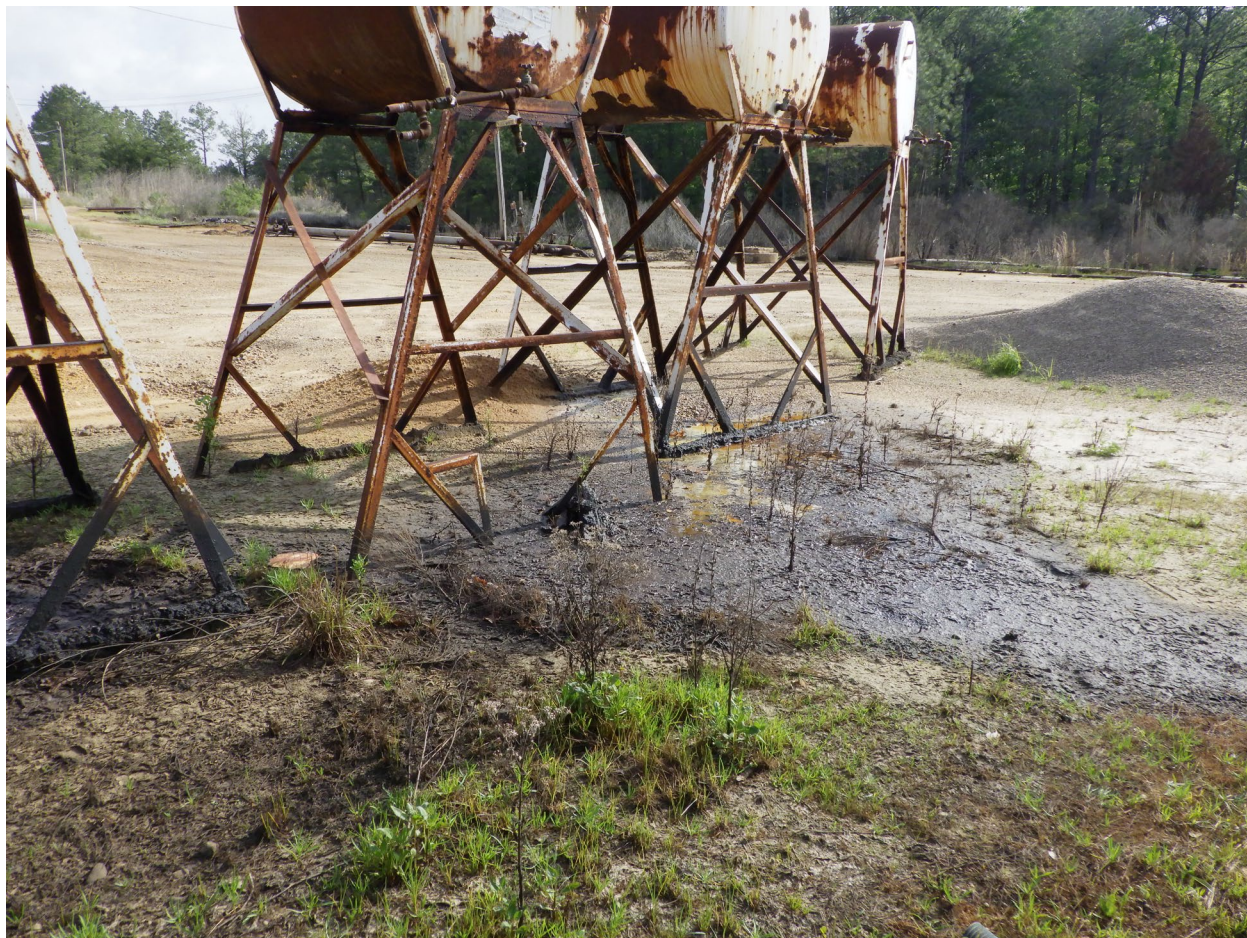
**Description:** Looking NE, this photo shows tanks for refined petroleum products outside secondary containment with loose product on the ground.
