**UNITED STATES ENVIRONMENTAL PROTECTION AGENCY**

**Subject:** Reconnaissance and Sampling Inspection Report  
Clean Water Act – National Pollutant Discharge Elimination System  
Town of Swampscott, MA

- A. Facility Name:* Town of Swampscott, MA
- B. Facility Location:* 22 Monument Avenue, Swampscott, MA 01907
- C. Facility Contact:* Gino A. Cresta, Jr., Director of Public Works  
(781)596-8860, gcresta@town.swampscott.ma.us
- D. NPDES Permit ID:* MAR041064 (MS4)

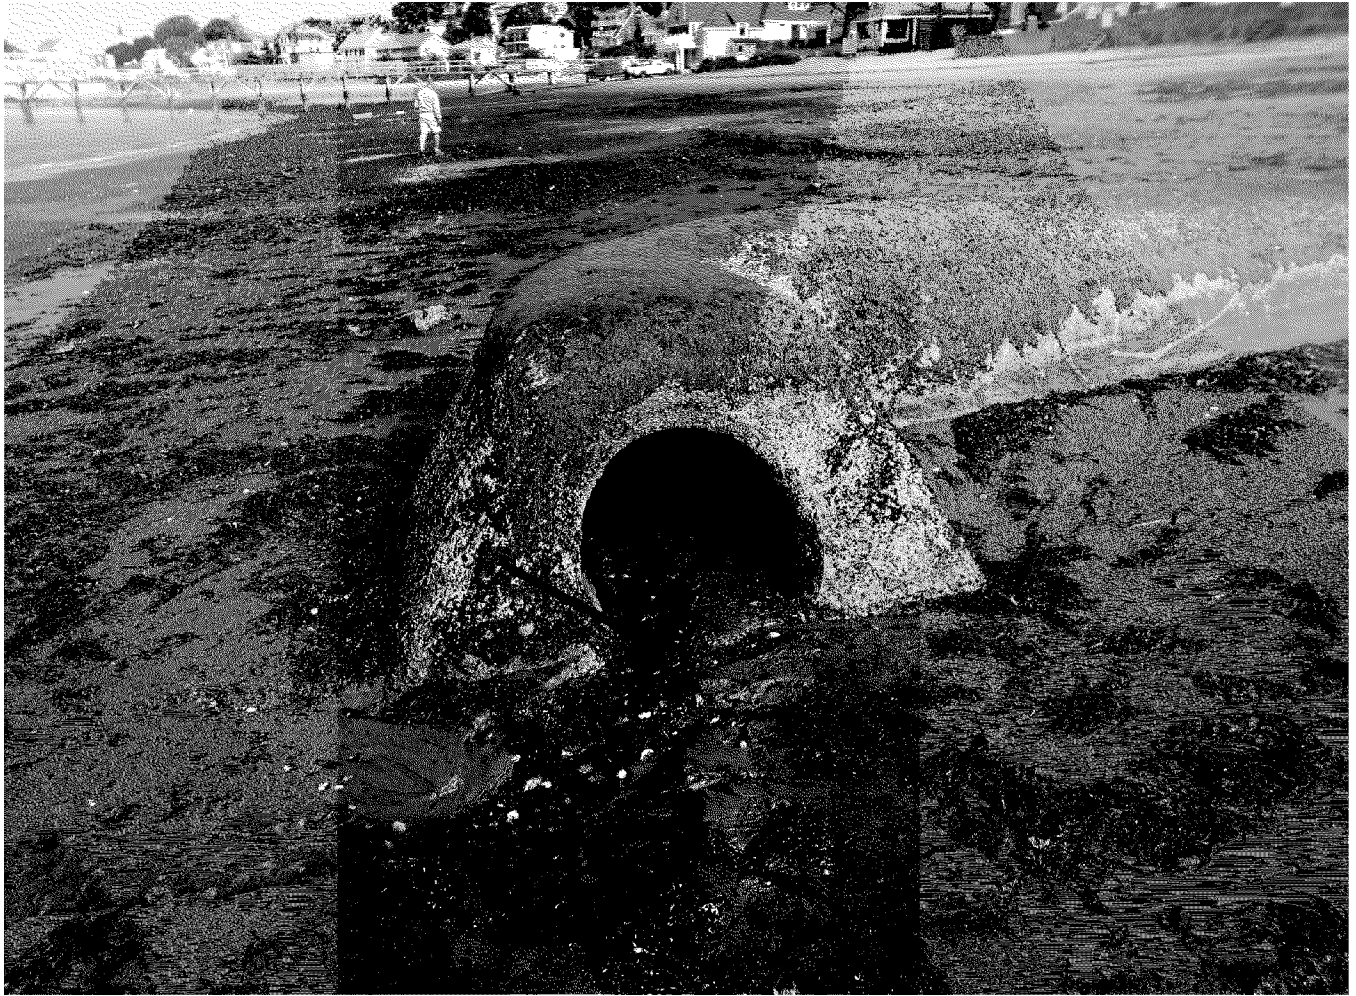
- **SWAMP11:** A single concrete pipe approximately 24 inches in diameter located on Fisherman's Beach. Discharge flow was approximately 15 gpm into Nahant Bay. No odor was detected and the discharge appeared clear and free of floatables. Sample was collected from the mouth of the outfall.

**SWAMP11 (photograph taken on 06/16/2021, camera recorded inaccurate time):** Outfall located on Fisherman's Beach discharging into Nahant Bay. Sample point is indicated by a red arrow.

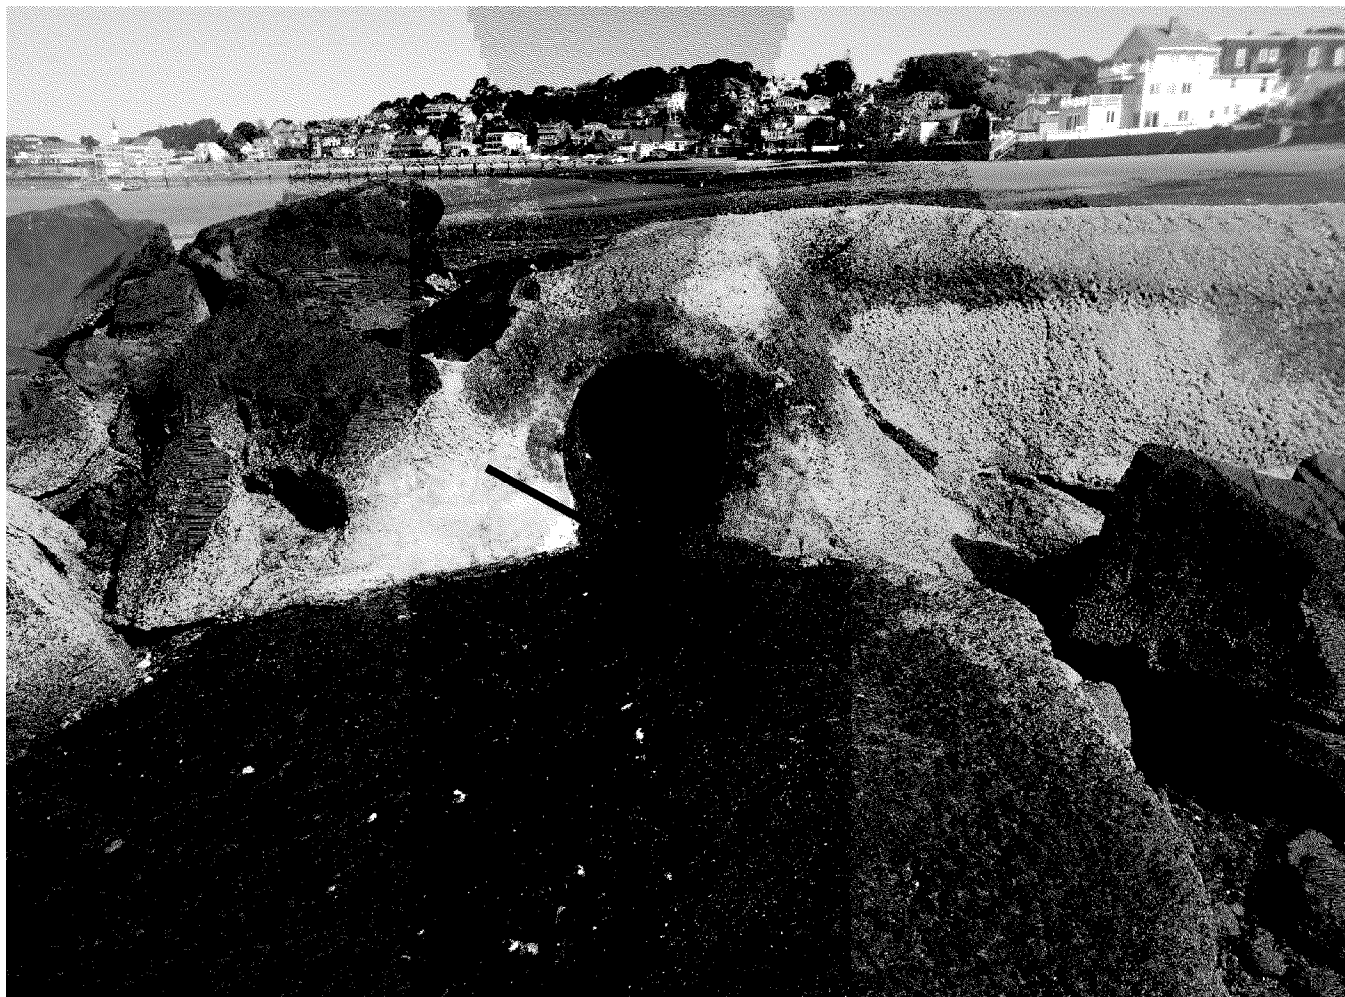
- **SWAMP13:** A single concrete pipe approximately 36 inches in diameter located on Fisherman's Beach. Discharge flow was approximately 10 gpm into Nahant Bay. White suds and a large amount of green algae were observed in the pipe and on the rocks

downstream. No odor was detected and the discharge appeared to be clear and free of floatables. Sample was collected at the mouth of the outfall.

**SWAMP13 (photograph taken on 06/16/2021, camera recorded inaccurate time):** Outfall located on Fisherman's Beach discharging into Nahant Bay. Note the green algae growth downstream of the outfall. Sample point is indicated by a red arrow.
