## RCRA Compliance Evaluation Inspection Report

United States Postal Service - Vehicle Maintenance Facility  
6707 Winton Blount Boulevard  
Montgomery, Alabama 36119-9351  
Montgomery County  
(334) 244-7533

**UNITED STATES POSTAL SERVICE – VEHICLE MAINTENANCE FACILITY**

**APRIL 20, 2021**

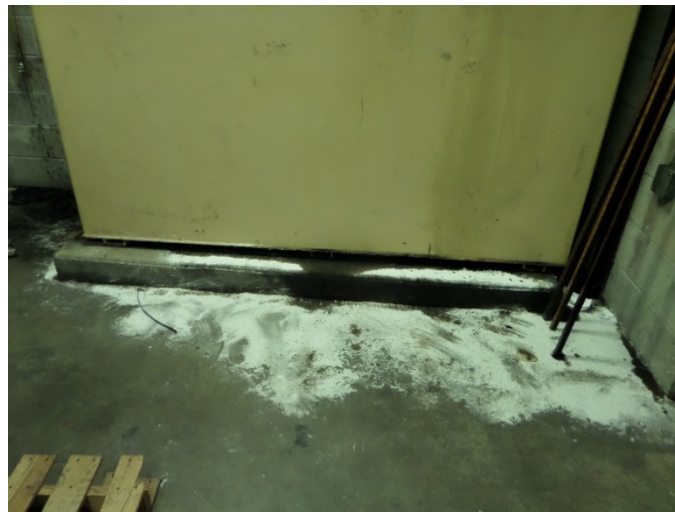
observed the 650-gallon used oil tank labeled as “Used Oil” and the tank containing new oil labeled as “Virgin Oil”. The inspectors observed oil stains in the floor covered by the shop absorbent- “Stardust” (Picture-6) near the base of the used oil tank. Mr. Clardy mentioned that there was an accidental spill during a routine pick up of used oil from the Lube Room last week. Mr. Clardy mentioned that spill was in the process of being cleaned up.

*Picture 6: Absorbent material covering the used oil spill*

The inspectors observed several closed and labeled 55- gallon drums containing products also stored in the Lube Room. There was no leaks and spills near the product drums. The inspectors also observed a spill kit in the Lube Room. The spill near the used oil tank was later cleaned up before the inspection was concluded. The inspectors later verified the cleanup in the Lube Room prior to concluding the inspection.
