Re: Inspection of Village of Piketon Wastewater Treatment Plant in Piketon, Ohio

INSPECTION REPORT

SECTION I – INTRODUCTION**Site Entry and Inspection Objectives**

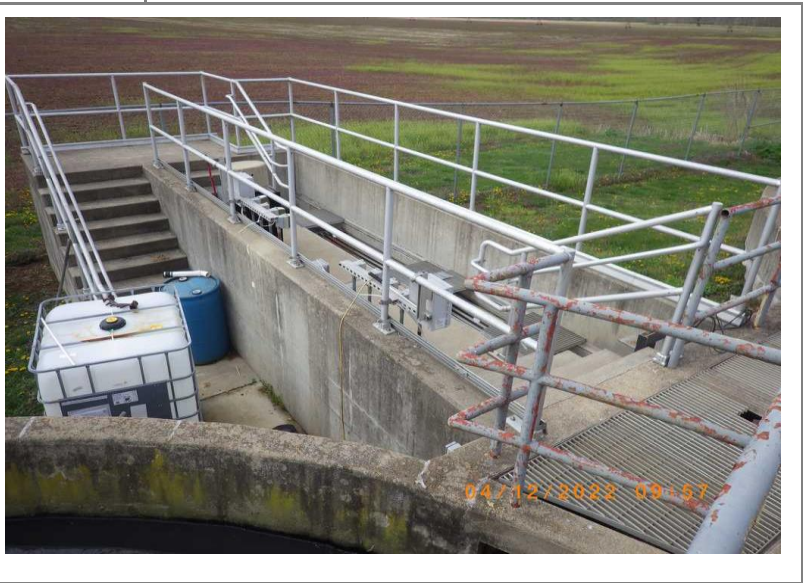
Discharge channel
RIMG2534.JPG
04/12/2022 12:16 PM (CT)
Andi Hodaj
Discharge channel
No CBI
No PII
The discharge channel located south of the secondary clarifiers. Effluent samples are taken here and PAA is added in this channel for disinfection. Camera looking south.

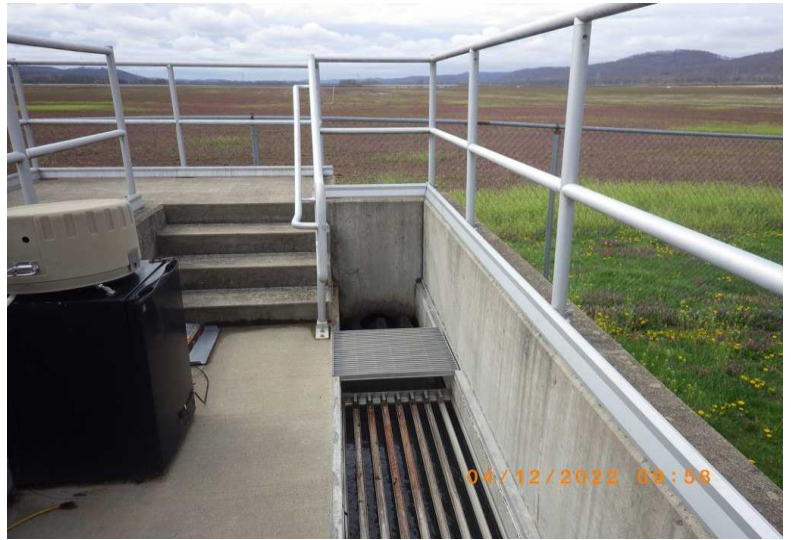
Discharge channel
 RIMG2536.JPG
 04/12/2022 12:16 PM (CT)
 Andi Hodaj
 Discharge channel
 No CBI
 No PII
 The discharge channel located south of the secondary clarifiers. Effluent samples are taken here and PAA is added in this channel for disinfection. Camera looking south.

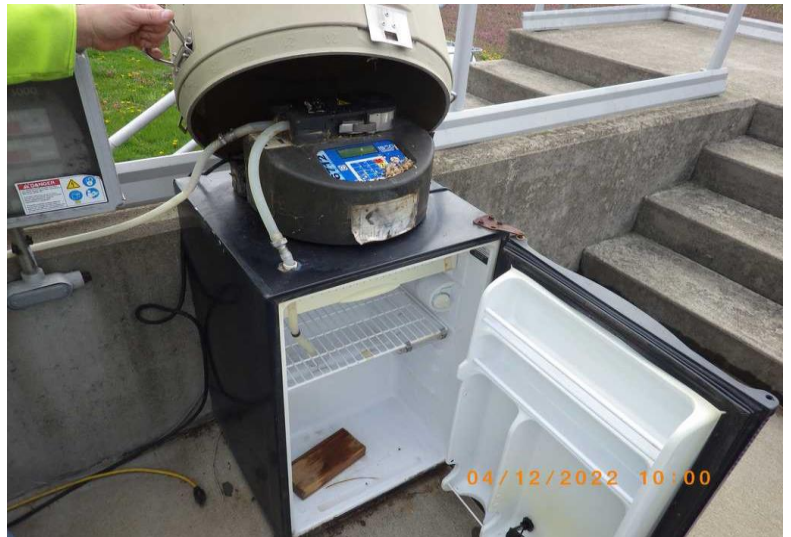
Unit: Discharge channel	Contains CBI: No
Observation #: AH2-OB-008	Date: 04/12/2022
EPA observed the discharge channel with an autosampler, depth measuring device and a tank of PAA next to it. The thermometer in the autosampler's refrigerator read 5 degrees Celsius at the time of the inspection. EPA observed flow in the discharge channel.	
Photos <ol style="list-style-type: none"> 1. RIMG2534.JPG 2. RIMG2536.JPG 3. RIMG2537.JPG 4. RIMG2535.JPG 	
Unit: Influent/Bar Screen	Contains CBI: No
Observation #: AH2-OB-003	Date: 04/12/2022
EPA observed two Peracetic Acid totes with no secondary containment next to and south of the bar screen. Facility representatives stated that the Peracetic Acid is used for disinfection at the discharge channel and that approximately three and half totes of Peracetic Acid are used between May and October of each year.	
Photo <ol style="list-style-type: none"> 1. RIMG2521.JPG

Autosampler
 RIMG2537.JPG
 04/12/2022 12:16 PM (CT)
 Andi Hodaj
 Discharge channel
 No CBI
 No PII
 The ISCO autosampler used for sampling of the effluent at the discharge channel. Camera looking southeast.

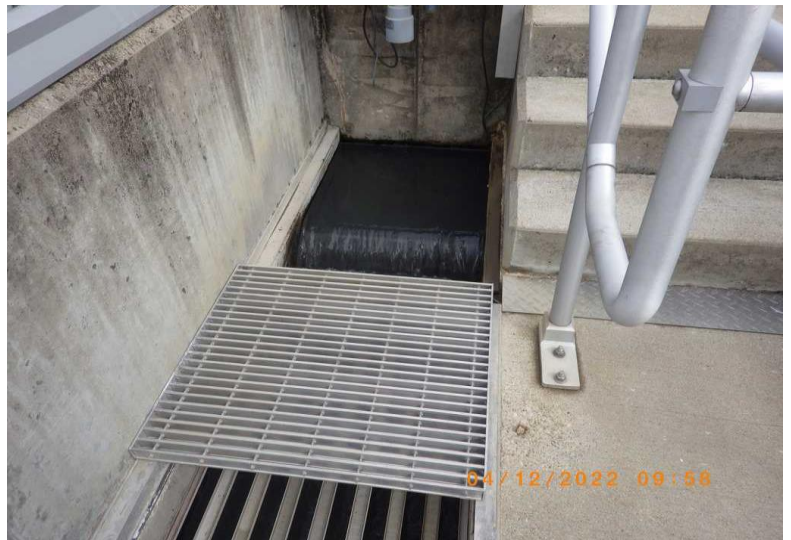
Discharge channel
 RIMG2535.JPG
 04/12/2022 12:16 PM (CT)
 Andi Hodaj
 Discharge channel
 No CBI
 No PII
 The discharge channel located south of the secondary clarifiers. Depth over the rectangular weir is measured with an ultrasonic sensor. Camera looking north.

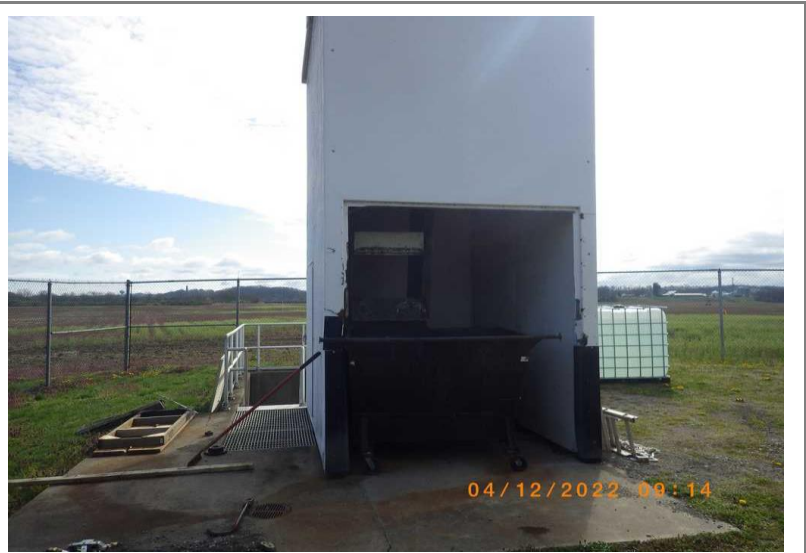
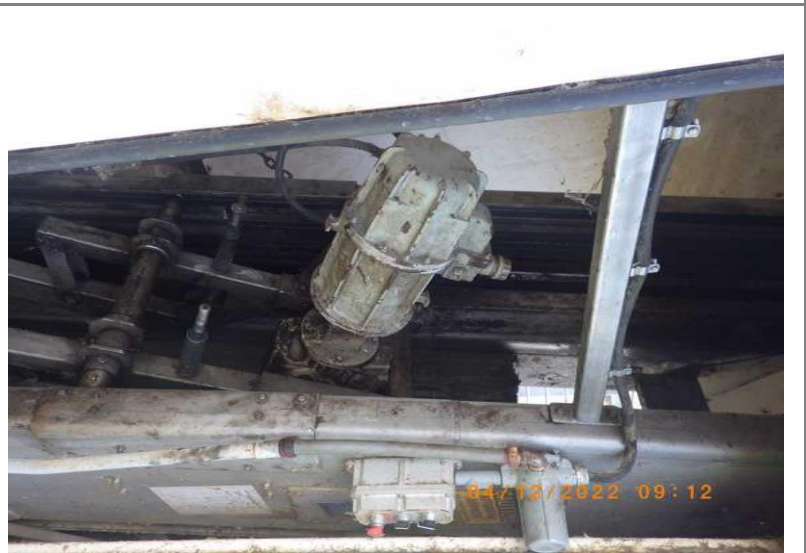
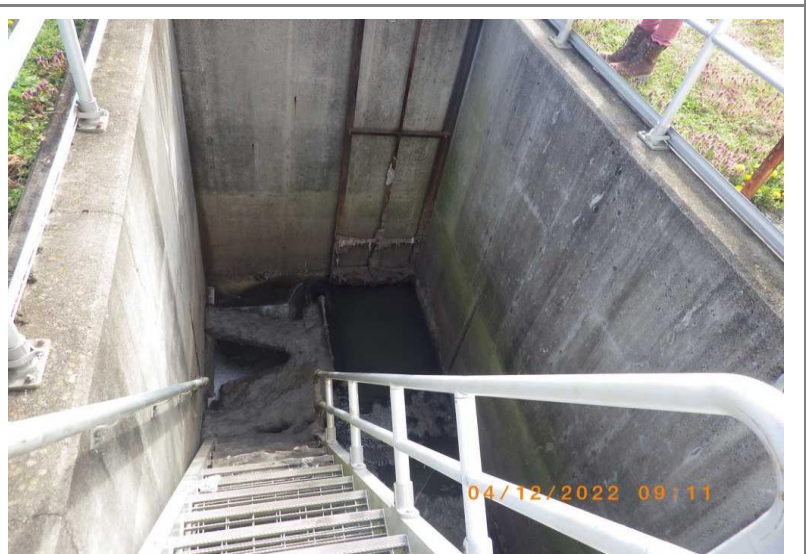
Unit: Influent/Bar Screen	Contains CBI: No
Observation #: AH2-OB-002	Date: 04/12/2022
EPA observed the bar screen located next to the influent channel. The bar screen was not working at the time of the inspection. According to facility representatives, the bar screen had not been working for the last three days. Facility representatives stated that repairs are performed by staff usually.	
Photos <ol style="list-style-type: none"> 1. RIMG2520.JPG 2. RIMG2519.JPG 	
Unit: Influent/Bar Screen	Contains CBI: No
Observation #: AH2-OB-001	Date: 04/12/2022
EPA observed the influent channel at the northeast corner of the property.

Unit:	Citation Reference
AH2-RR-001	NPDES Permit OH0027031
EPA observed 90 effluent limit exceedances for the period May 2017 - March 2022. The effluent limit exceedances were mainly for CBOD AND E. coli.	Part I,A.
Unit: Influent/Bar Screen	Citation Reference
AH2-OB-002	NPDES Permit OH0027031
A bar screen located next to the influent channel was not working at the time of the inspection. According to facility representatives, the bar	Part II,B.

screen had not been working for the last three days.	
AH2-OB-003	Citation Reference
EPA observed two Peracetic Acid totes with no secondary containment next to and south of the bar screen.	
Unit: Primary treatment system	Citation Reference
AH2-OB-004	NPDES Permit OH0027031
EPA observed trash, rags and debris in the primary clarifier.	Part II,B.
Unit: Outfall 001	Citation Reference
AH2-OB-010	NPDES Permit OH0027031
EPA observed the outfall signage on the banks of Scioto River. The signage displayed the incorrect outfall number and was facing away from the Scioto River.	Part II,S.

Screenings dumpster
RIMG2520.JPG
04/12/2022 12:14 PM (CT)
Andi Hodaj
Influent/Bar Screen
No CBI
No PII
Dumpster behind the bar screen that receives screening from the bar screen. Screenings are eventually hauled to a landfill. Camera looking east.
Bar Screen
RIMG2519.JPG
04/12/2022 12:14 PM (CT)
Andi Hodaj
Influent/Bar Screen
No CBI
No PII
The bar screen shown is next to the influent channel and it was not operating on the day of the inspection.
Influent channel
RIMG2518.JPG
04/12/2022 12:14 PM (CT)
Andi Hodaj
Influent/Bar Screen
No CBI
No PII
The influent channel was located at the northeast corner of the property. Camera looking east.

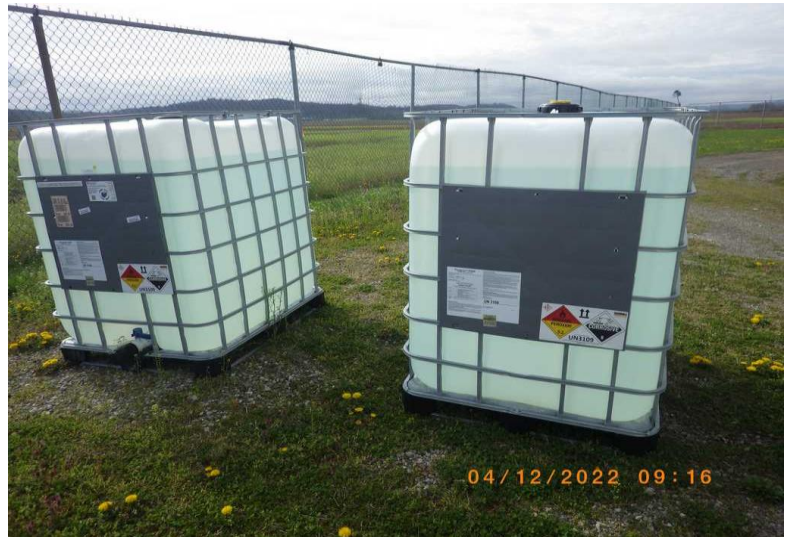
PAA tanks
RIMG2521.JPG
04/12/2022 12:14 PM (CT)
Andi Hodaj
Influent/Bar Screen
No CBI
No PII
Two PAA tanks next to the influent channel. Camera looking southeast.

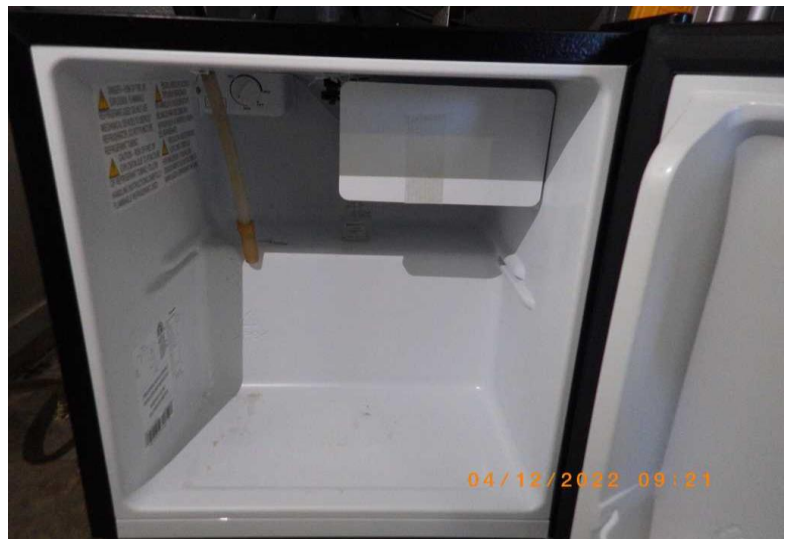
Photo	
1. RIMG2518.JPG	
Unit: Main building	Contains CBI: No
Observation #: AH2-OB-004	Date: 04/12/2022
<p>EPA observed an autosampler with a refrigerator in the Main Building that according to facility representatives, is used to take influent samples after the influent has gone through the bar screen. The thermometer in the autosampler's refrigerator read 40 degrees Fahrenheit at the time of the inspection. Flow-proportional samples of the influent are taken during a 24 hour period every Wednesday. The composite sample is then split and part of it goes to the Masi Environmental Labs in Dublin, Ohio for analyzing for the required parameters per the NPDES permit. The facility conducts its own analysis for Total Suspended Solids (TSS) and measures pH, Dissolved Oxygen and temperature from the samples.</p>	
Photos

ISCO autosampler's fridge
RIMG2523.JPG
04/12/2022 12:14 PM (CT)
Andi Hodaj
Main building
No CBI
No PII
The refrigerator of the autosampler along with the autosampler, is located in the main building and takes flow-proportionate samples of the influent to the WWTP.

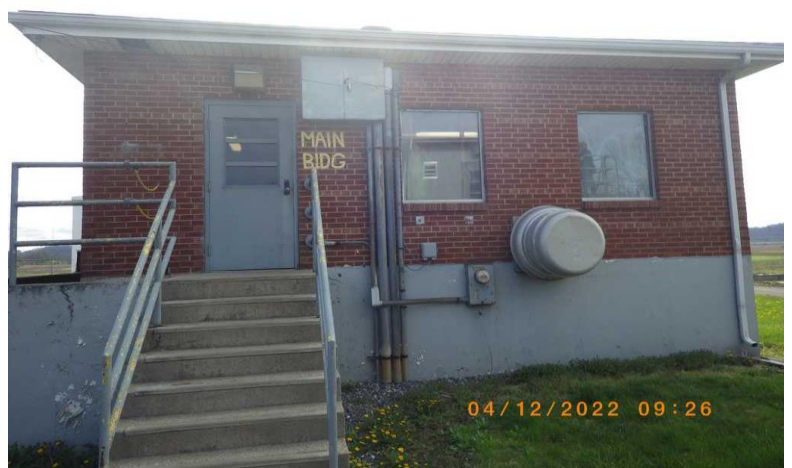
Main building
RIMG2524.JPG
04/12/2022 12:14 PM (CT)
Andi Hodaj
Main building
No CBI
No PII
The main building at the WWTP houses pumps, autosampler and an office for the operator. Camera looking east.

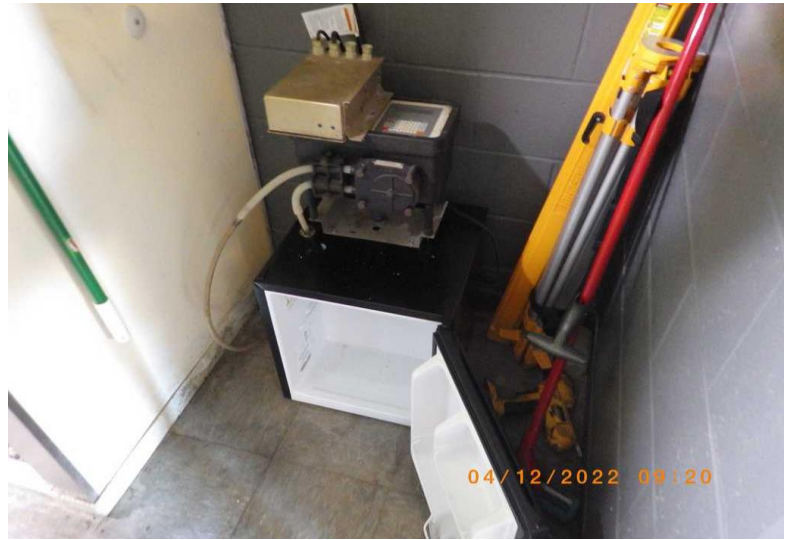
ISCO autosampler
 RIMG2522.JPG
 04/19/2022 12:15 PM (CT)
 Andi Hodaj
 Main building
 No CBI
 No PII
 The autosampler is located in the main building and takes flow-proportionate samples of the influent to the WWTP.

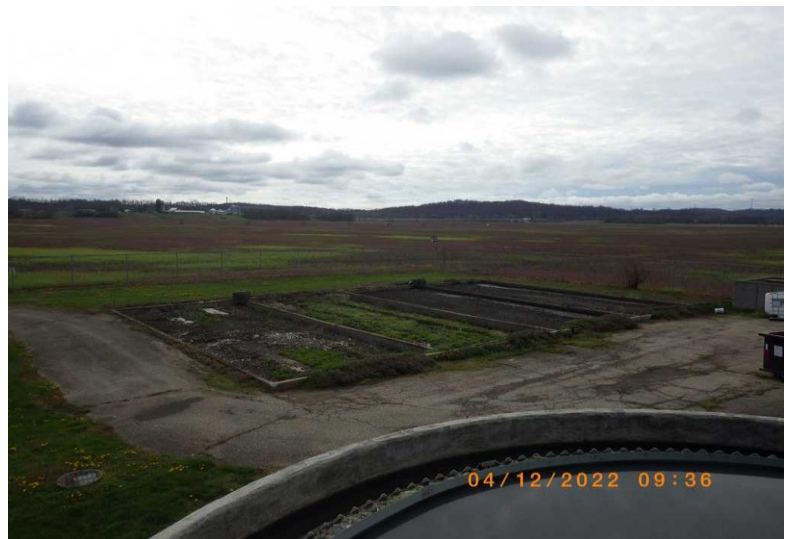
Digester and sludge drying beds	Facility operates an anaerobic digester with holding capacity of 116,500 gallons. Sludge is pumped out of the digester once per year and stored in four drying beds. Dry sludge is hauled from the drying beds by Rumpke Waste & Recycling.
--	---

Sludge drying beds
 RIMG2529.JPG
 04/12/2022 12:16 PM (CT)
 Andi Hodaj
 Main building
 No CBI
 No PII
 Four sludge drying beds at the southeast corner of the property. Camera looking southeast.

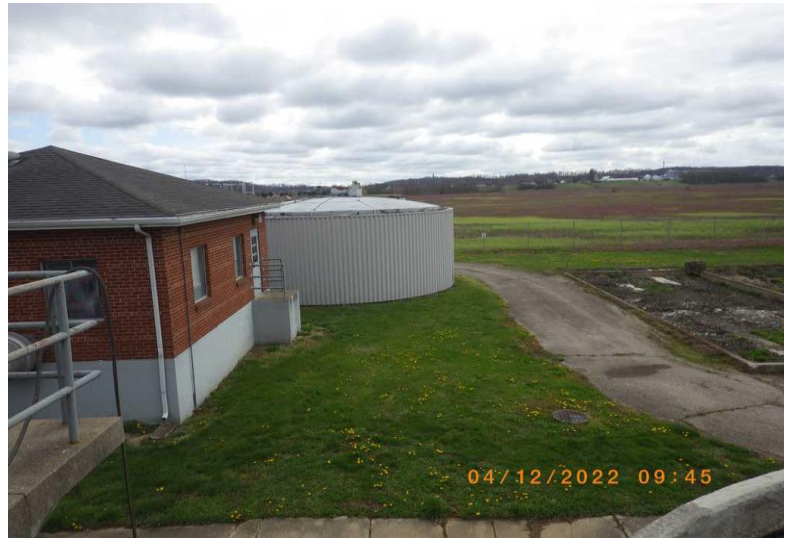
Digester
 RIMG2530.JPG
 04/12/2022 12:16 PM (CT)
 Andi Hodaj
 Main building
 No CBI
 No PII
 The digester, located east of the Main Building. Camera looking east.

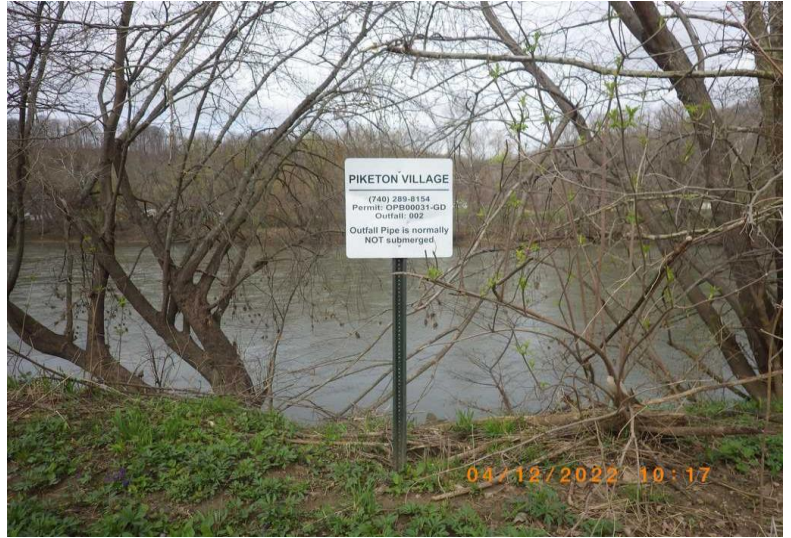
1. RIMG2533.JPG	
2. RIMG2540.JPG	
Unit: Secondary treatment	Contains CBI: No
Observation #: AH2-OB-010	Date: 04/12/2022
EPA observed the outfall signage on the banks of Scioto River. The signage displayed the incorrect outfall number and was facing away from the Scioto River.	
Photos

Outfall 001 signage
RIMG2538.JPG
04/19/2022 12:17 PM (CT)
Andi Hodaj
Outfall 001
No CBI
No PII
Outfall 001 signage on the banks of the Ohio River. The signage incorrectly says "002". Camera looking west.

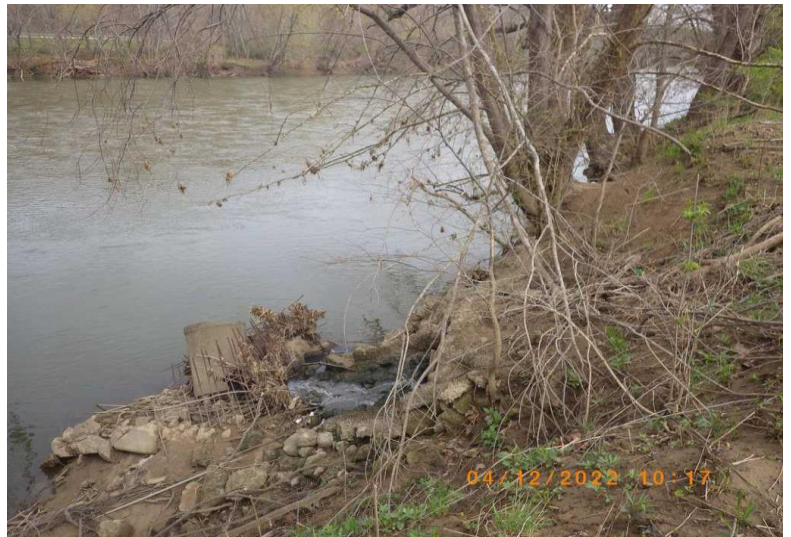
1. RIMG2523.JPG	
2. RIMG2524.JPG	
3. RIMG2522.JPG	
4. RIMG2529.JPG	
5. RIMG2530.JPG	
Unit: Outfall 001	Contains CBI: No
Observation #: AH2-OB-009	Date: 04/12/2022
<p>Flow from the discharge channel was routed through underground piping and about 3,000 feet into Outfall 001 on the banks of the Scioto River. EPA observed the outfall signage and the physical outfall that was discharging at the time of the inspection.</p>	
Photos

Outfall 001
RIMG2539.JPG
04/12/2022 12:17 PM (CT)
Andi Hodaj
Outfall 001
No CBI
No PII
Outfall 001 with final discharge in the Scioto River. Camera looking northwest.

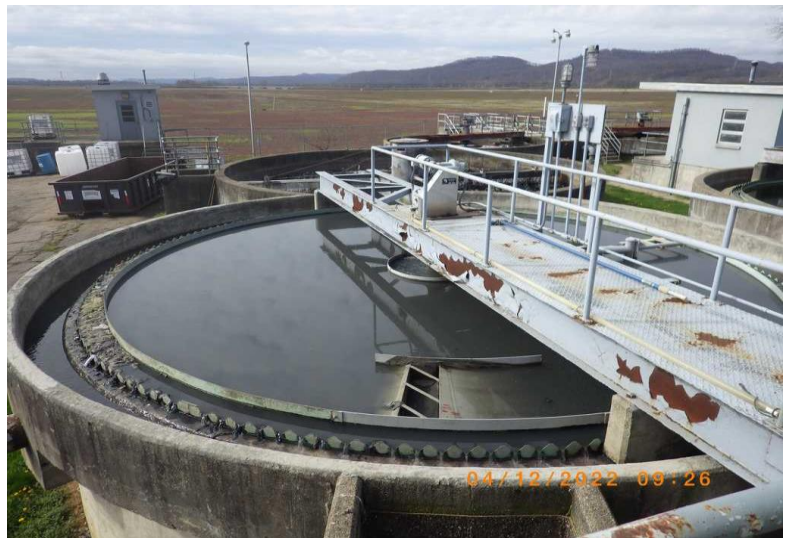
1. RIMG2538.JPG	
2. RIMG2539.JPG	
Unit: Primary treatment system	Contains CBI: No
Observation #: AH2-OB-005	Date: 04/12/2022
<p>EPA observed two primary clarifiers with only one of them in operation at the time of the inspection. The other clarifier was full at the time but not in operation. EPA observed trash, rags and debris in the primary clarifier. The facility representatives stated that it was due to the bar screen not operating in the last three days. Influent was pumped from the Main Building to the Primary Building and from there via two pumps into the primary clarifier.</p>	
Photos

Primary clarifier
RIMG2525.JPG
04/12/2022 12:14 PM (CT)
Andi Hodaj
Primary treatment system
No CBI
No PII
One of the two primary clarifiers at the WWTP. The clarifier was in operation at the time of the inspection. Camera looking south.

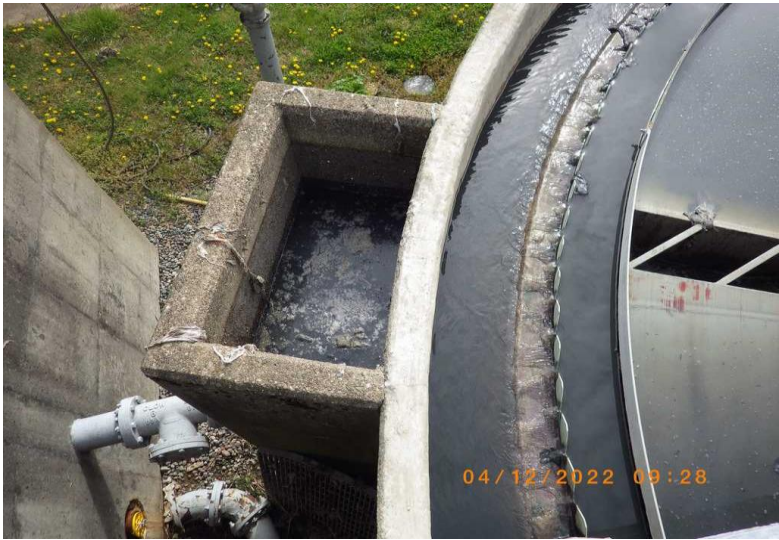
<p>Primary clarifier sludge pit</p> <p>RIMG2526.JPG</p> <p>04/12/2022 12:15 PM (CT)</p> <p>Andi Hodaj</p> <p>Primary treatment system</p> <p>No CBI</p> <p>No PII</p> <p>Sludge pit on the north side of the primary clarifier. Camera looking east.</p>

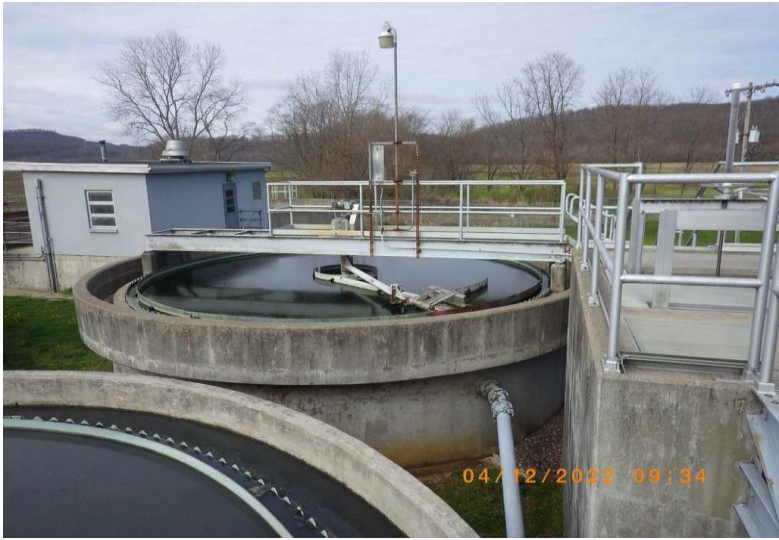
<p>Primary clarifier</p> <p>RIMG2528.JPG</p> <p>04/12/2022 12:16 PM (CT)</p> <p>Andi Hodaj</p> <p>Primary treatment system</p> <p>No CBI</p> <p>No PII</p> <p>The second primary clarifier at the WWTP. The clarifier was not operating at the time of the inspection. Camera looking west.</p>

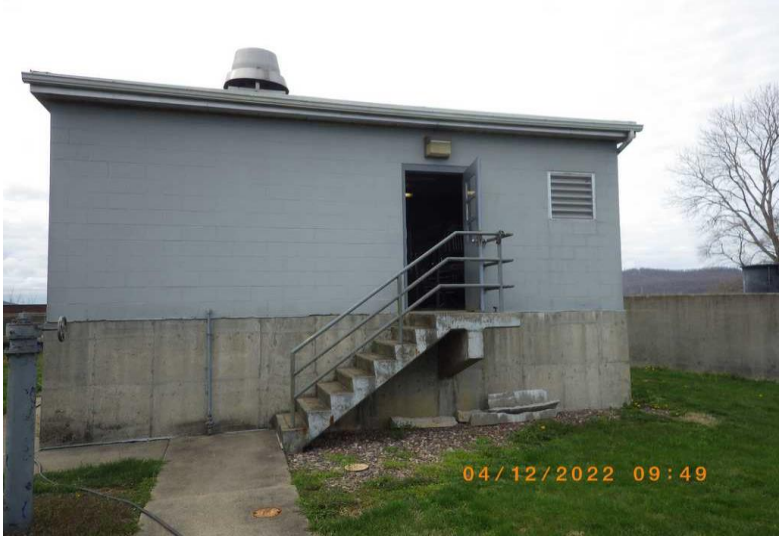
<p>Primary building</p> <p>RIMG2531.JPG</p> <p>04/12/2022 12:16 PM (CT)</p> <p>Andi Hodaj</p> <p>Primary treatment system</p> <p>No CBI</p> <p>No PII</p> <p>The primary building hosts the pumps to the primary clarifiers and a sludge pump to the digester. Camera looking south.</p>

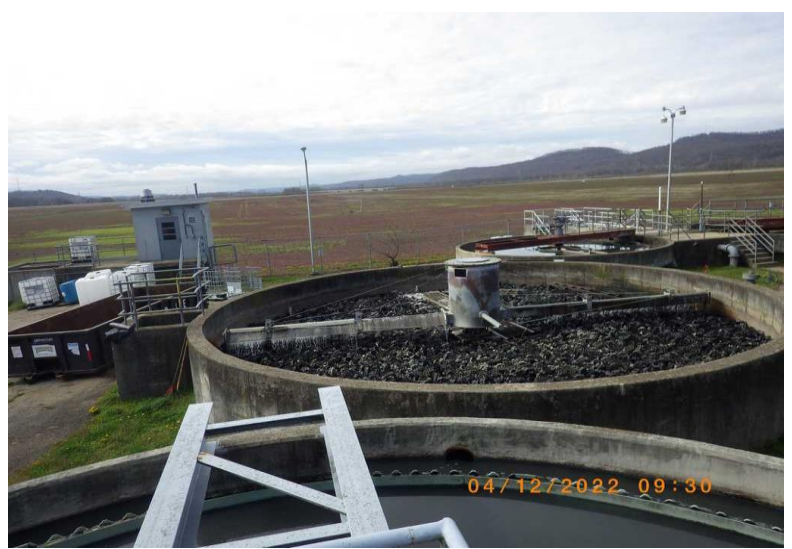
1. RIMG2538.JPG	
Unit: Secondary treatment	Contains CBI: No
Observation #: AH2-OB-006	Date: 04/12/2022
EPA observed the trickling filter biological reactors of which one was in operation at the time of the inspection while the other one was empty. The trickling filter bedding material consisted of black plastic discs. At the time of the inspection, there was not enough water in the basin to cover the bedding material.	
Photos

Trickling filter basin
 RIMG2527.JPG
 04/12/2022 12:14 PM (CT)
 Andi Hodaj
 Secondary treatment
 No CBI
 No PII
 The trickling filter basin was filled with plastic discs as the medium for microorganisms to grow on. Camera looking south.

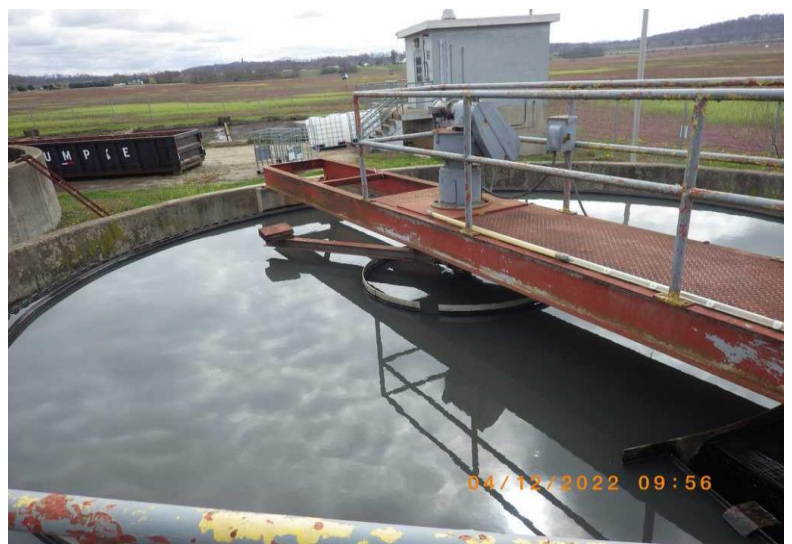
Unit: Secondary treatment	Contains CBI: No
Observation #: AH2-OB-007	Date: 04/12/2022
EPA observed one of the two secondary clarifiers was operating at the time of the inspection. According to the facility, the second clarifier is not typically used.	
Photos

Secondary clarifier
 RIMG2533.JPG
 04/12/2022 12:16 PM (CT)
 Andi Hodaj
 Secondary treatment
 No CBI
 No PII
 One of the two secondary clarifiers was in operation at the time of the inspection. Camera looking east.

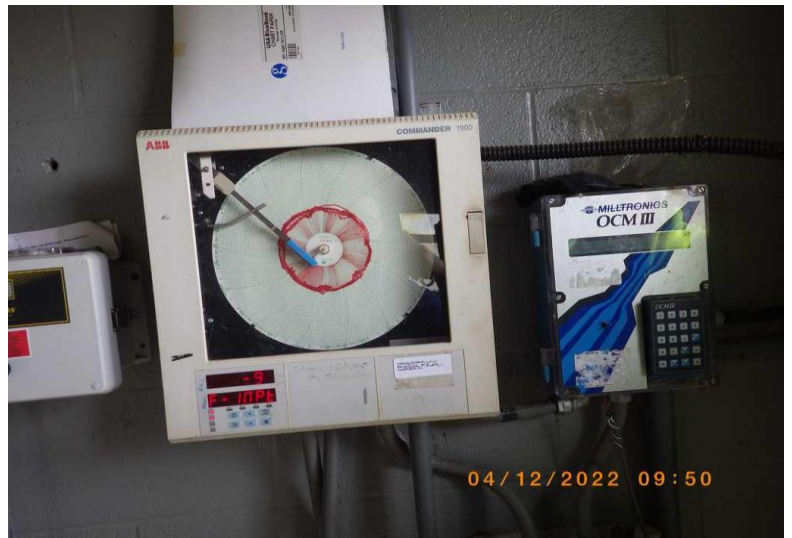
Flow meters
 RIMG2532.JPG
 04/12/2022 12:16 PM (CT)
 Andi Hodaj
 Secondary treatment
 No CBI
 No PII
 Flow meters housed in the Secondary building.
