## **RCRA Inspection Report**

PCS Nitrogen Fertilizer LP  
1460 Columbia Nitrogen Drive  
Augusta, Georgia 30901  
Richmond County

EPA ID# GAD057281958

October 19, 2023, 9:00 a.m.

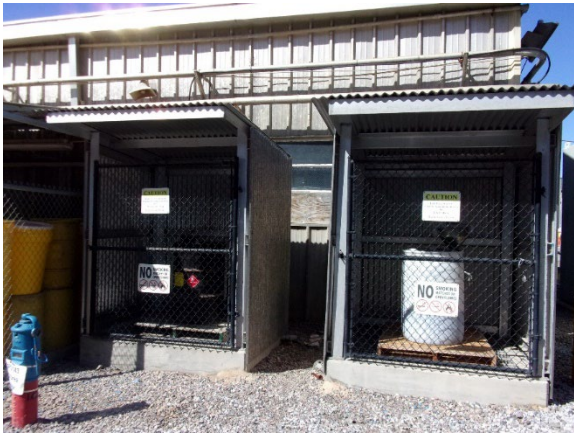
Photo 1 SAA R&P Shack #6 and Maintenance Shop #10

The SAA shed floor is comprised of a concrete pad, approximately 6 ft x 6 ft, which includes spill containment. The concrete pad is raised approximately one foot above the ground. The sides and the roof of the shed is comprised of corrugated metal walls with a chain link gate at the front. Each SAA is visible through the chain link gate. Each SAA is marked with a placard that states "Hazardous Waste" and identified with SAA number and the hazardous waste generator location (e.g., lab, control room). Please see Photo-1 in the photo log at the end of the document.

At the time of the inspection, the R&P SAA #6 had one SAA present, The SAA #6 was comprised of one 55-gallon closed drum on a wooden pallet. The SAA drum contained Lab Reagent Waste. The drum was labeled with the words “Hazardous Waste,” and an indication of hazards of the contents as “Flammable Liquid” and “Corrosive”.

Adjacent to the R&P SAA, the Maintenance Shop had one SAA comprised of one 55-gallon closed drum on a wooden pallet. The SAA drum contained waste aerosol cans and was labeled with the words “Hazardous Waste” and an indication of the hazards of the contents as “Flammable Gas”.

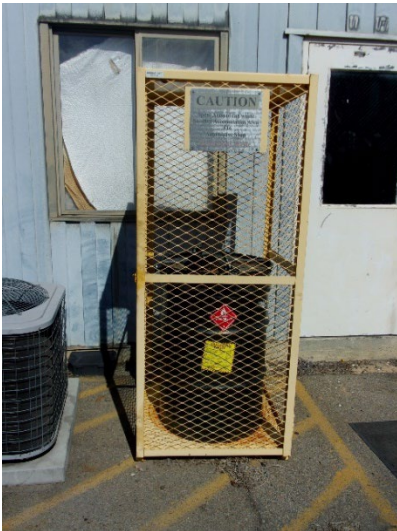
Photo-2 SAA Automotive Shop #16

At the time of the inspection, hazardous waste was not stored at the Pastille Plant. The following three SAAs #14, #15 and #16 were enclosed by a metal cage raised approximately two inches off the ground (Photo-2).

At the time of the inspection, the Automotive Shop had one SAA present. The SAA #16 was comprised of one 55-gallon closed drum. The SAA drum contained waste aerosol cans and was labeled with the words "Hazardous Waste" and an indication of the hazards of the contents as "Flammable Gas".

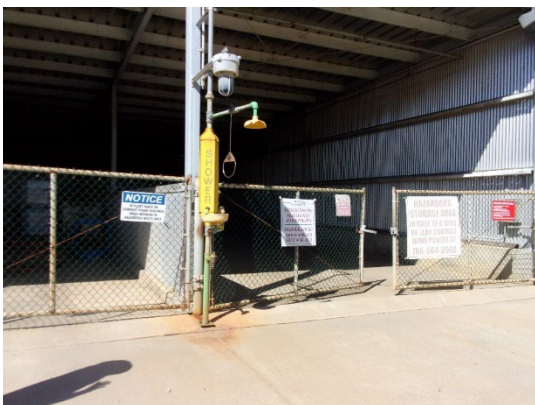
Photo-3 Central Accumulation Area (CAA) Exterior

The facility operates one CAA. This 90-day CAA is enclosed on the three sides by corrugated metal walls and a corrugated roof (Photo-3). It has a chain link locked gates at the front. The floor of the storage area is concrete with a raised concrete barrier around the edge that serves as a secondary containment. A corrugated metal barrier exists within the CAA creating two separate areas. At the time of the inspection, one side was labeled "Empty Container Storage Area". The

other side was labeled as “Hazardous Storage Area”. There was signage for “No Smoking”. The CAA was equipped with an eye wash station, safety shower and a fire extinguisher. There were 11 55-gallon plastic containers and one 275-gallon Intermediate Bulk Container (IBC) tote (Photo-4). All the containers including the IBC tote were observed to be closed, labeled with the words “Hazardous Waste,” an indication of the hazards of the contents, and with an accumulation start date (Photo-3 and Photo-4). There were no leaks and spills observed in the CAA.

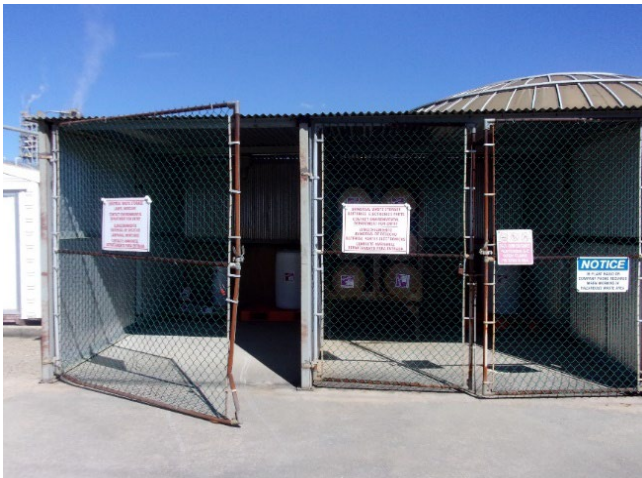
Photo-5 Universal Waste Storage Area

The facility generates universal waste lamps, batteries, and electronic waste during regular facility and equipment maintenance. Universal waste is stored in a shed which has a concrete floor surrounded on three sides by corrugated metal, a corrugated metal roof, and a chain link gate at the front (Photo-5). The universal waste storage was comprised of two separate areas labeled “Universal Waste Storage.”

All the containers were observed to be closed, labeled, and dated. Cleanlites Recycling South, LLC (EPA ID# SCR000767814) handles the facility’s universal waste recycling.

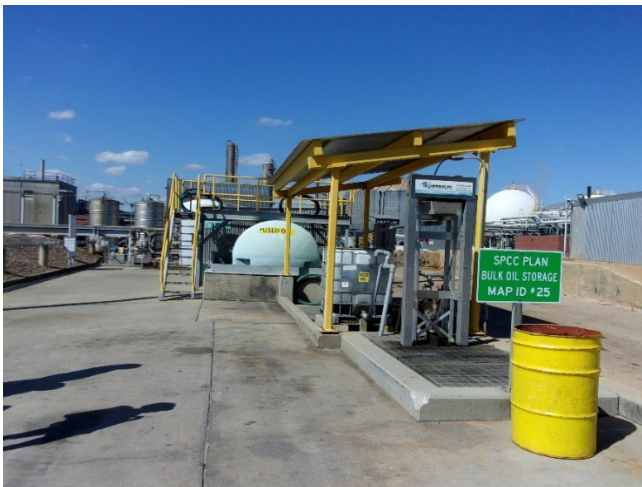
Photo-6 Used Oil Storage Area

Used oil Storage was observed adjacent to the CAA. There was one 3000-gallon tank and one 275-gallon plastic IBC tote (Photo-6). Both the tank and tote were closed and labeled as “Used Oil”. The 275-gallon tote is used for storage of recycled oil from the facility’s mobile equipment and the 3000-gallon used oil tank is used for collecting recycled oil from the facility’s pumps and compressors. The 275-gallon tote and the 3000-gallon used oil tank had a concrete secondary containment. The secondary containments were free of crack and gaps. The inspectors observed oily residue in the secondary containment of the 3000-gallon tank (Photo-7 and Photo-8). According to the facility personnel, the source of the leak was a leaking gasket from the used oil tank’s ancillary equipment. The facility personnel were monitoring the leak and that parts to fix the leak had been ordered for repairing it. The 275-gallon tote was observed to be intact and

nonleaking.

**Pursuant to Ga. Comp. R. and Regs. 391-3-11-.17(1) [40 C.F.R. § 279.22(c)(1)], containers and aboveground tanks used to store used oil at generator facilities must be labeled or marked clearly with the words “Used Oil.”**

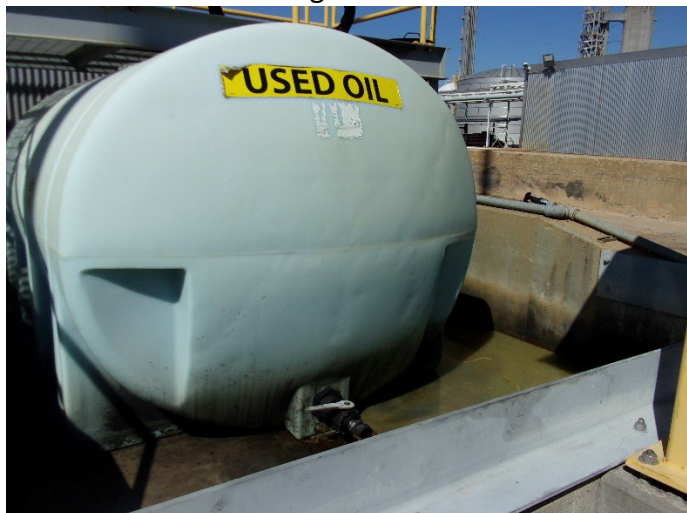
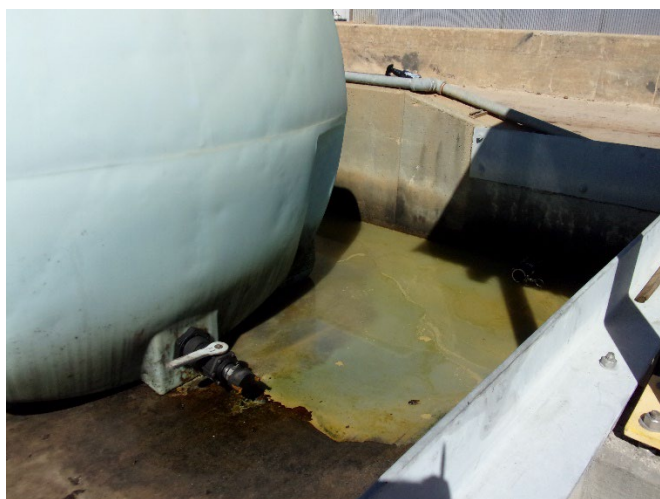
There were two roll-off dumpsters adjacent to the used oil storage. The dumpsters were used for storage of oily rags, booms, pads, and oil dry. Both dumpsters were covered with a tarp. The inspectors observed residual oil below the one of the dumpsters. The oily residue on the ground was cleaned up with oil dry the same day. The inspectors observed a 1000-gallon tank with secondary containment that was used to collect used oil from the Automotive maintenance shop #16 . The used oil storage tank and its secondary containment appeared to be in disrepair. There was a sign indicating “Used Oil” however, the sign was not clearly visible and faded. Safety-Kleen Systems, Inc. (EPA ID# SCD077995488) manages the facility’s used oil recycling program.

Photo-7 Oily Residue in Secondary Containment

Photo-8 Oily Residue in Secondary Containment

**Pursuant to Ga. Comp. R. and Regs. 391-3-11-.17(1) [40 C.F.R. § 279.22(d)], upon detection of a release of used oil to the environment, the facility must clean up and manage properly the released used oil and other materials.**
