**UNITED STATES ENVIRONMENTAL PROTECTION AGENCY**

**Subj:** Inspection Report  
Clean Water Act - National Pollutant Discharge Elimination  
System ("NPDES")  
Clean Harbors of Braintree

- A. *Date(s) of inspection:* August 25, 2022
- B. *Weather Conditions:* Low 80s and mostly sunny
- C. *US EPA Representative(s):*  
David Turin
- D. *State/Local Representative(s):*  
Gerald Podlisny, MassDEP
- E. *Federally Enforceable Requirements Covered During the Inspection:*  
NPDES Permit No. MA0031551, issued February 1, 2021  
Clean Water Act Sections 301(a) (33 U.S.C. § 1311(a)) and 311 (33 U.S.C §  
1321)

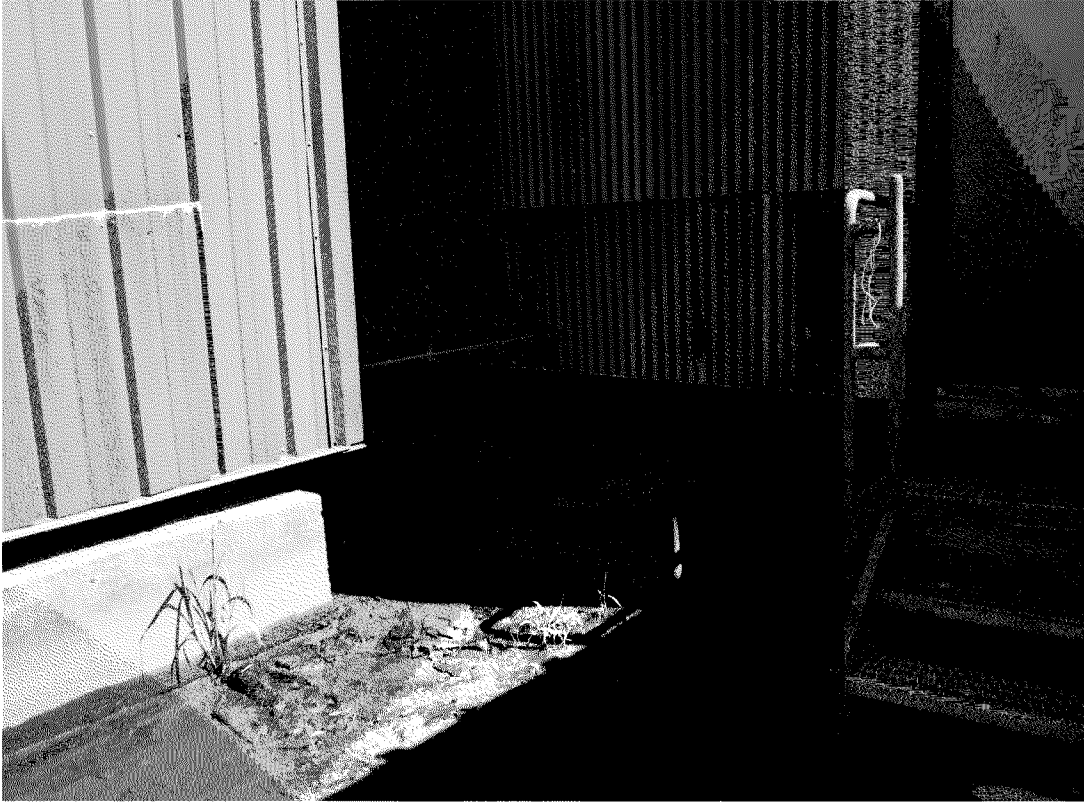
The facility tour began at the stormwater treatment system [see photos 1 and 2] and Mr. Medina described the treatment process. I checked the ISCO composite sampler refrigerated sample compartment but there is no bulb thermometer. Mr. Medina believed (and subsequently confirmed) that the ISCO sampler monitors and records the temperature in the sample compartment.

Photo 1: Intake to Stormwater Treatment System

1. The facility should confirm documentation of temperature control in the ISCO sampler refrigerator; I recommend adding a calibrated bulb thermometer to the unit for spot temperature checks.
2. I recommended that the dumpster(s) be covered when not in active use.
3. The pH probe should be stored in appropriate storage solution.
4. The facility should record and report when the DMR reflects discharges from tank farm secondary containment basin.
5. The facility should consider investigating elevated bacteria results reported in its DMRs.

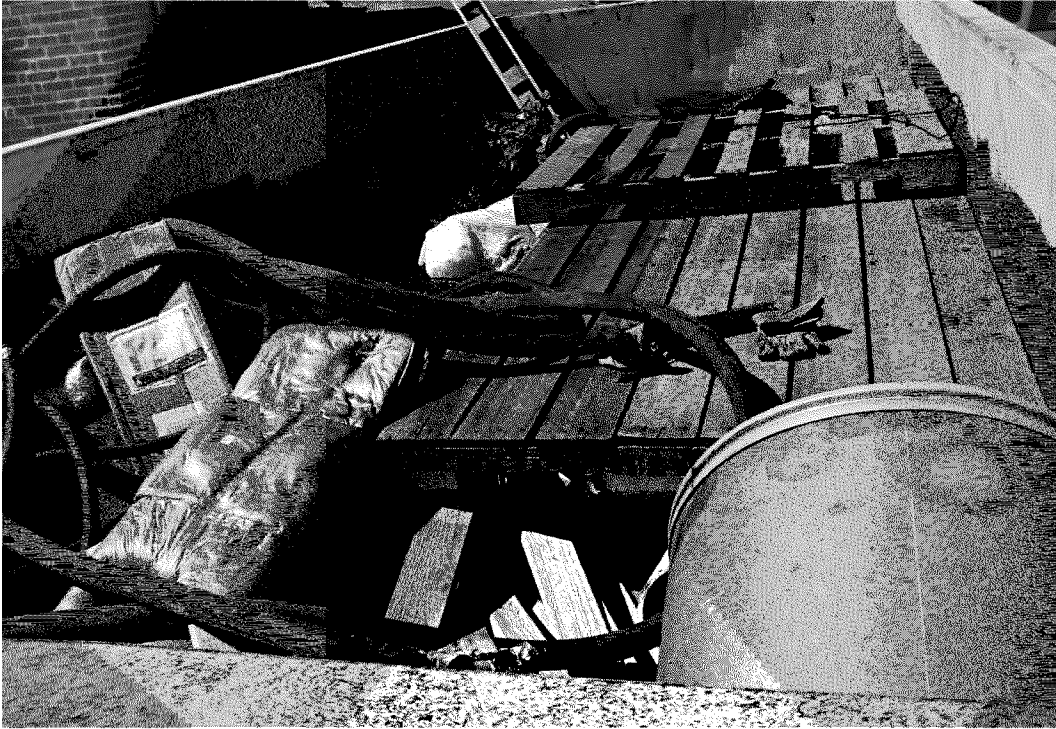
Leaving the treatment system, we walked by a conventional solid waste dumpster [photo 3]. I recommended that these types of containers be covered when not in active use as a general good housekeeping practice to prevent exposure to stormwater.

Photo 3: Uncovered Solid Waste Dumpster

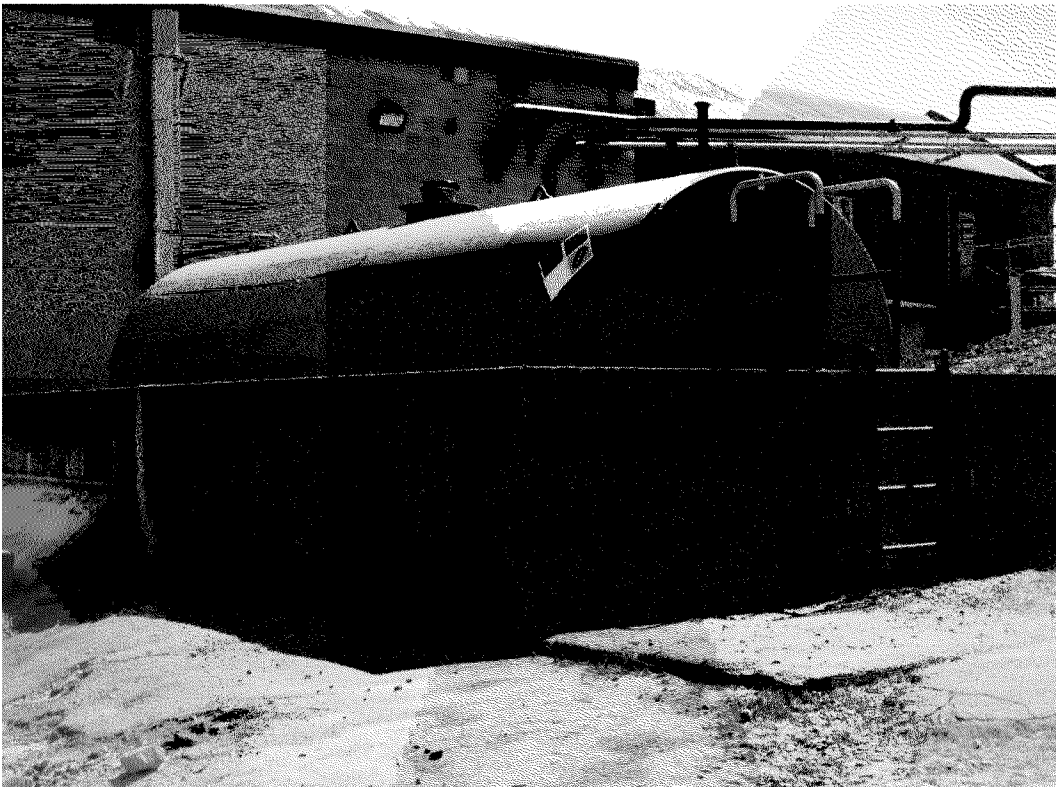
We inspected a #2 fuel oil tank with secondary containment outside building #5 [see photos 4 and 5]. No issues with either the tank or secondary containment were evident.

Photo 4: No. 2 Fuel Oil Tank Outside Building #5

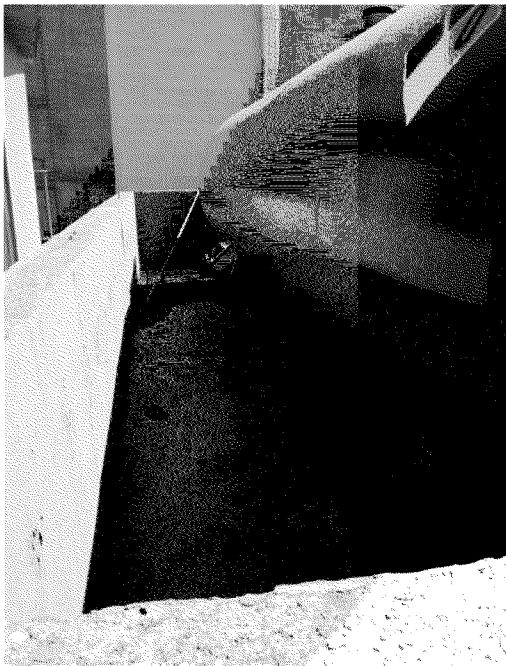
Photo 5: Oil Tank Outside Building #5

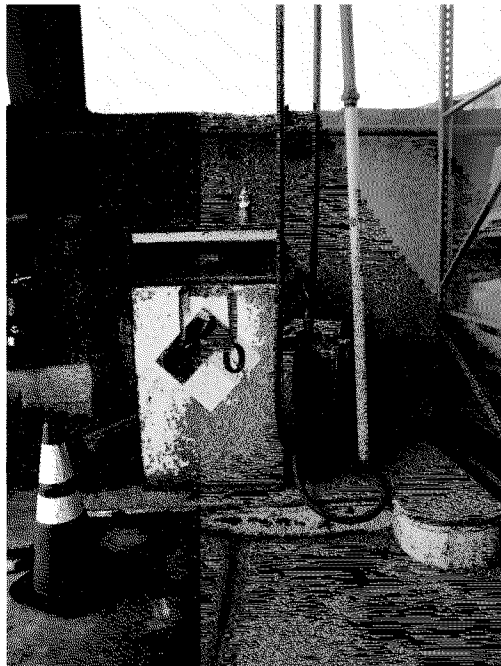
Under the roofed area tank farm, there are 9 waste storage tanks within secondary containment walls. Also under the roofed area, outside of the tank containment area, were approximately 10 tanker trucks, presumably offloading or unloading waste materials to or from the tanks. At the north side of the roofed area is an old fuel dispenser [see photo 6]. I was told that this dispenser and an associated tank, located within the tank secondary containment area, are no longer used and have been replaced by a new fuel tank and dispenser located just south of the tank farm. I was told that the old dispenser and tank are going to be removed.

Photo 6: Old Fuel Dispenser

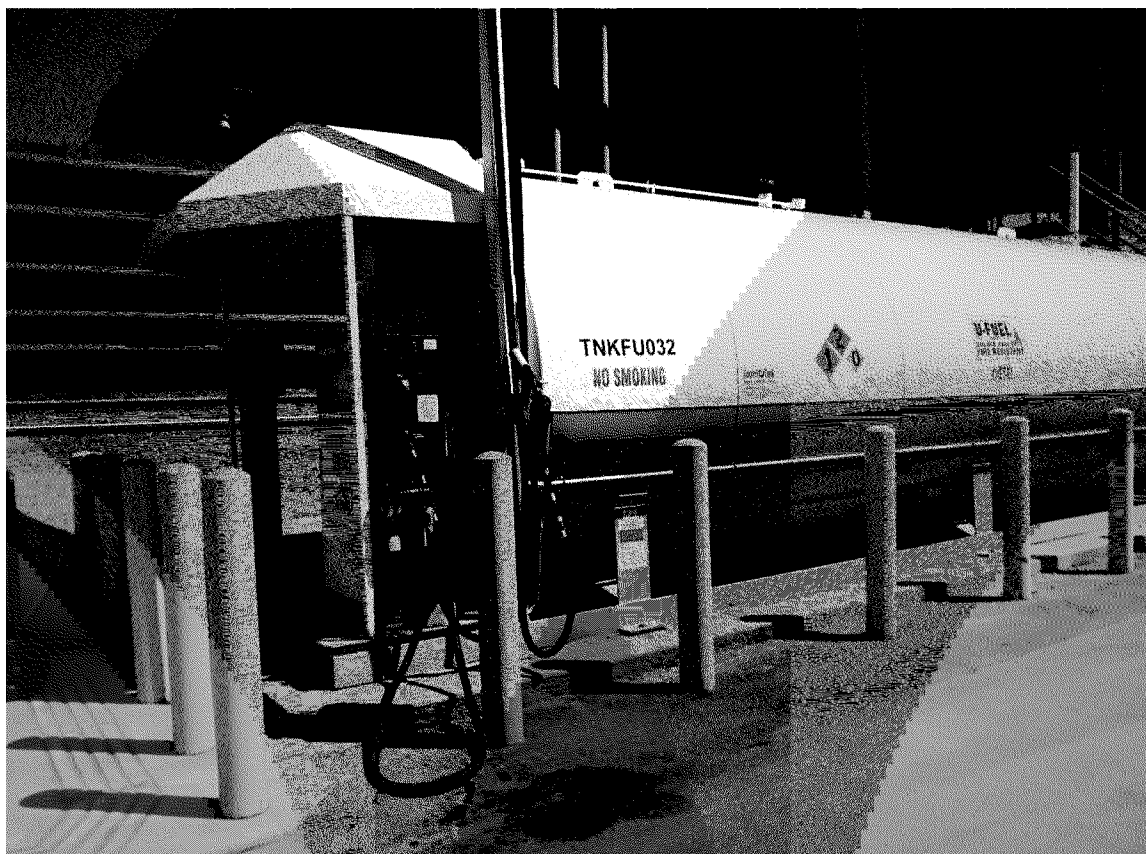
We proceeded to the fuel tank and dispenser located to the south of the tank farm. According to the SPCC Plan, this is a double-walled 12,000 gallon #2 fuel oil tank [see photo 7].

Photo 7: 12,000 gallon #2 Fuel Oil Tank
