**CWA NPDES COMPLIANCE EVALUATION INSPECTION REPORT**  
**U.S. ENVIRONMENTAL PROTECTION AGENCY, REGION 5**

**Inspection Type:** Compliance Evaluation Inspection

Hyponex Corporation  
3875 South Elyria Road  
Shreve, Ohio 44676

**NPDES Permit Number:** OH0107077 (effective March 1, 2017 and expires February 28, 2022)

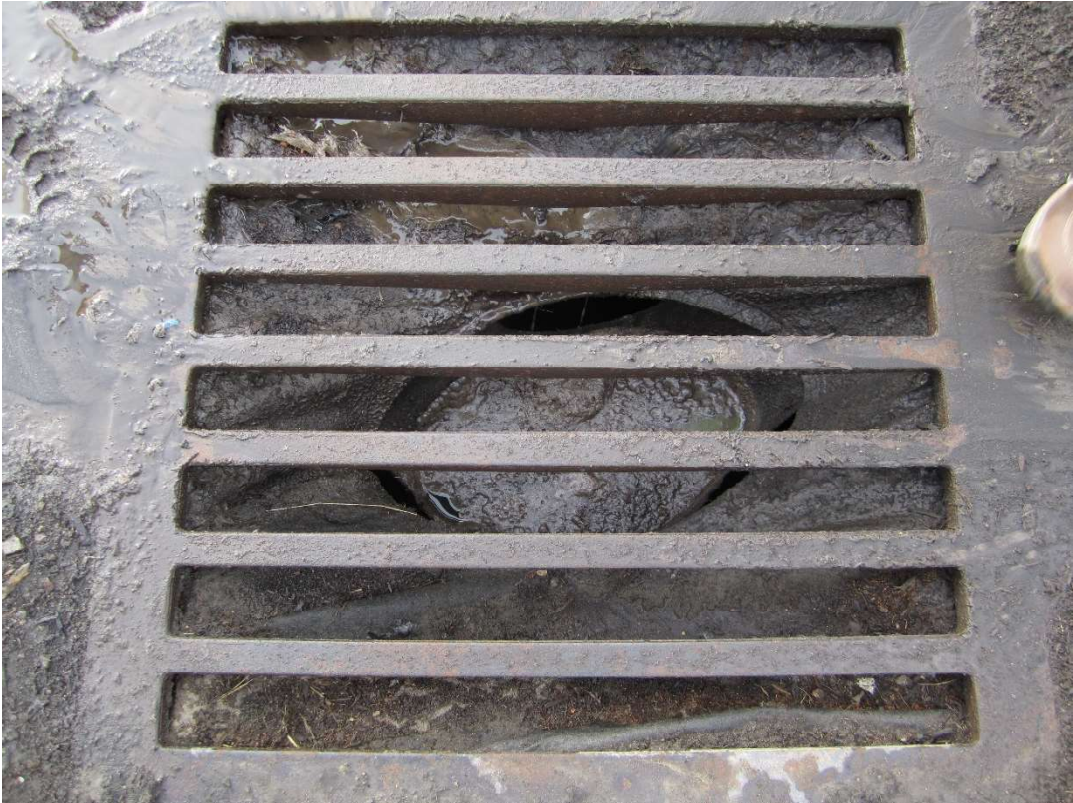
<b>Photo No.:</b> 3	<b>Time:</b> 9:23 AM		
<b>Direction Photo Taken:</b> down			
<b>Photo Description:</b> This is the catch basin insert in the storm drain shown in Photo No. 2. It is an Eagle Manufacturing Company Model No. T8702B.			
		<b>File:</b> Hyponex IMG_0368

3. At least three storm water catch basins are not shown in Figure 2 of the SWPPP. There is a catch basin in the truck loading dock and there are two catch basins between buildings (see Photo No. 13), which are not shown in the figure.
4. One of the BMPs included in the SWPPP is keeping areas adjacent to storm water catch basins clean of soil. According to Mr. Kendra, the facility has an outdoor sweeper and water truck for cleaning paved areas and suppressing dust. There was a moderate amount of mud and dust adjacent to some storm water catch basins (see Photo Nos. 2, 13 and 15). Catch basins are fitted with geotextile fabric inserts (Eagle StormNEST™ Model No. T8702B). According to Mr. Kendra, these are replaced or cleaned as needed. Since it was dry during the inspection, the effectiveness of the catch basin filters could not be evaluated.

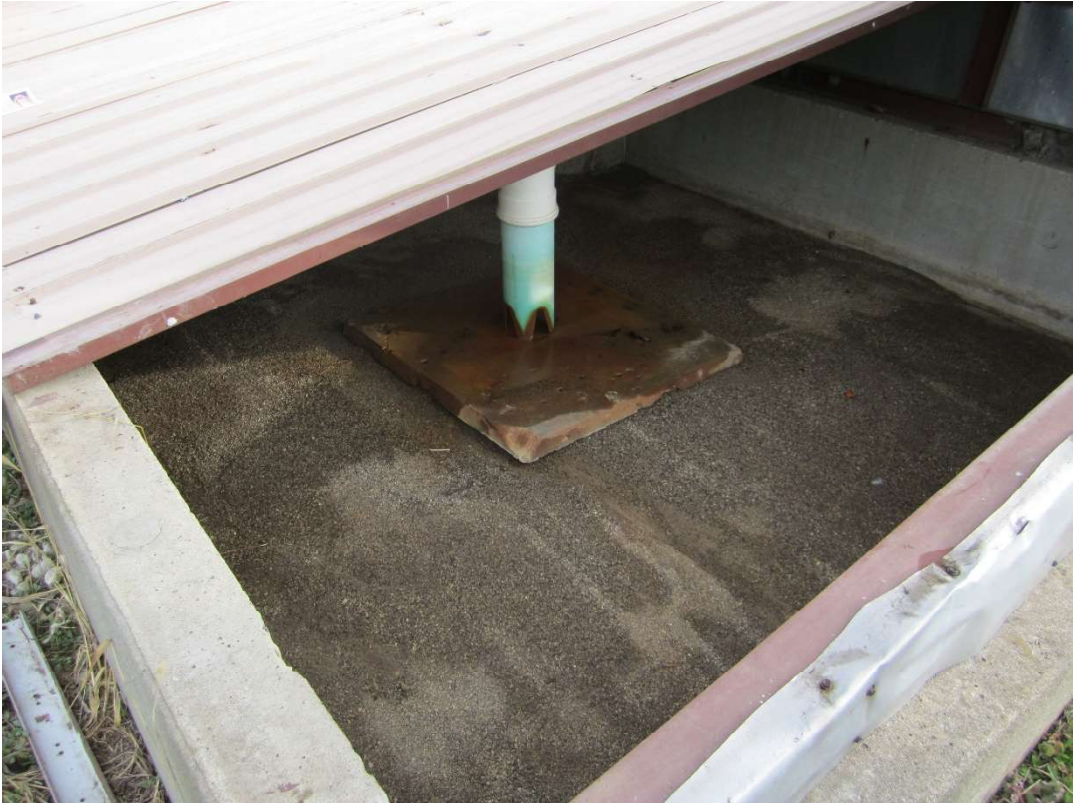
<b>Photo No.:</b> 4	<b>Time:</b> 9:27 AM		
<b>Direction Photo Taken:</b> northeast			
<b>Photo Description:</b> This is one of the two sand filter beds in the package wastewater treatment plant. This filter bed was not in use at the time of the inspection. One filter bed is used at a time, and they are alternated.		<b>File:</b> Hyponex IMG_0369

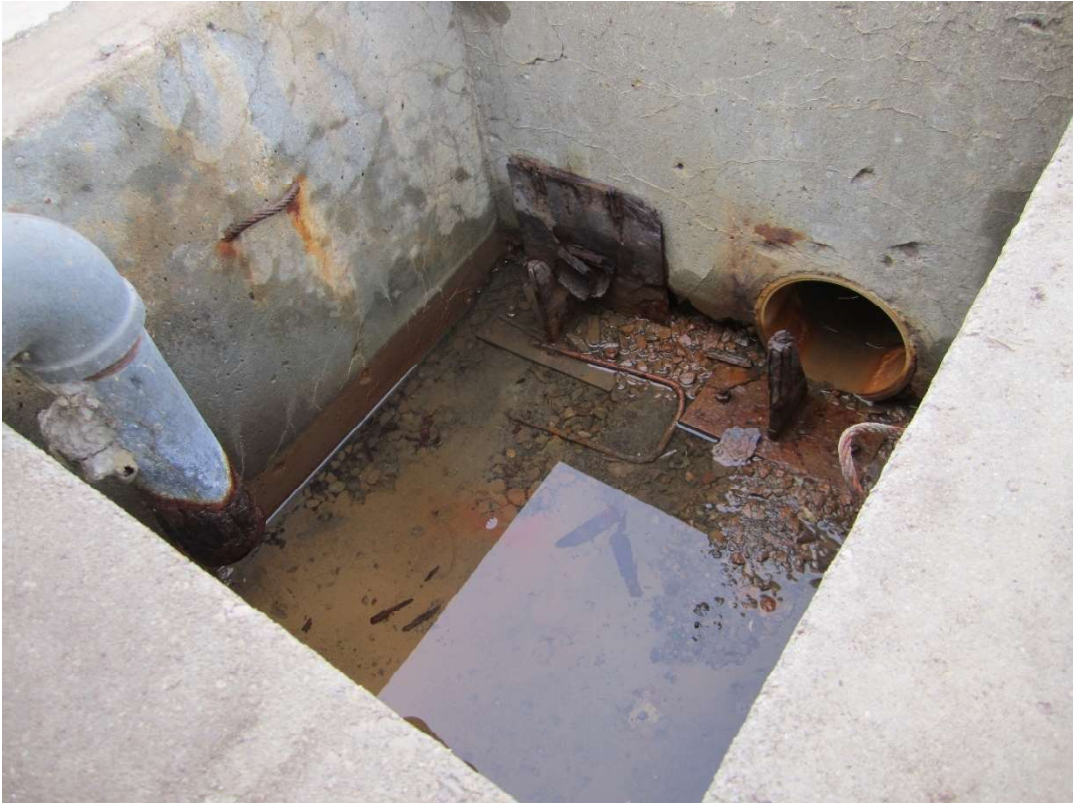
<b>Photo No.:</b> 5	<b>Time:</b> 9:39 AM		
<b>Direction Photo Taken:</b> Down			
<b>Photo Description:</b> This is the distribution box for the filter beds. Clarified water from the dosing tank is pumped to one sand filter by sealing a drainpipe in the distribution box.		<b>File:</b> Hyponex IMG_0370

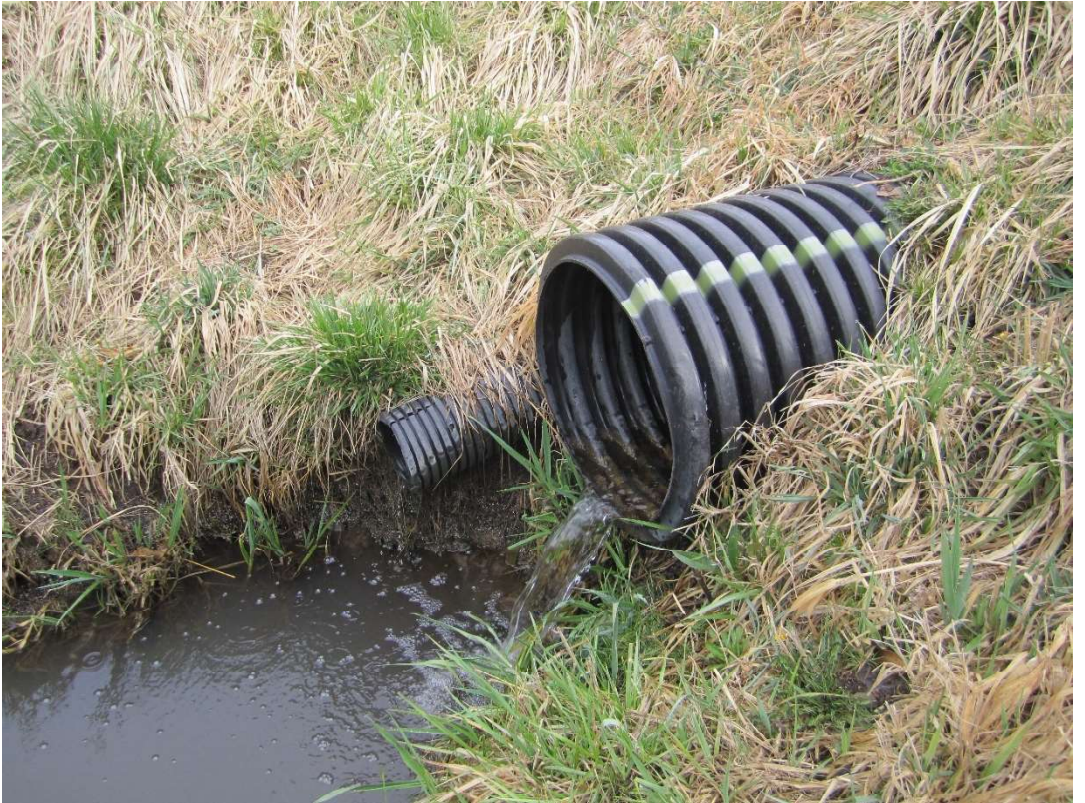
<b>Photo No.:</b> 6	<b>Time:</b> 9:49 AM		
<b>Direction Photo Taken:</b> north			
<b>Photo Description:</b> The smaller pipe is the discharge from the package wastewater treatment plant. The larger pipe discharges storm water and artesian well water. Samples for Outfall 002 are collected from the pool of water shown here.		<b>File:</b> Hyponex IMG_0371

1. The samples collected for Outfall 002 may not be representative of the combined sanitary, stormwater, and artesian well water under all sampling conditions. Two pipes (one for the package plant and one for storm water plus artesian well water) discharge to a ditch that ultimately enters Kiser Ditch. Samples are collected from a pool just below the end of the two pipes (see Photo No. 6). There may not always be adequate mixing in this area to represent the combined flow.

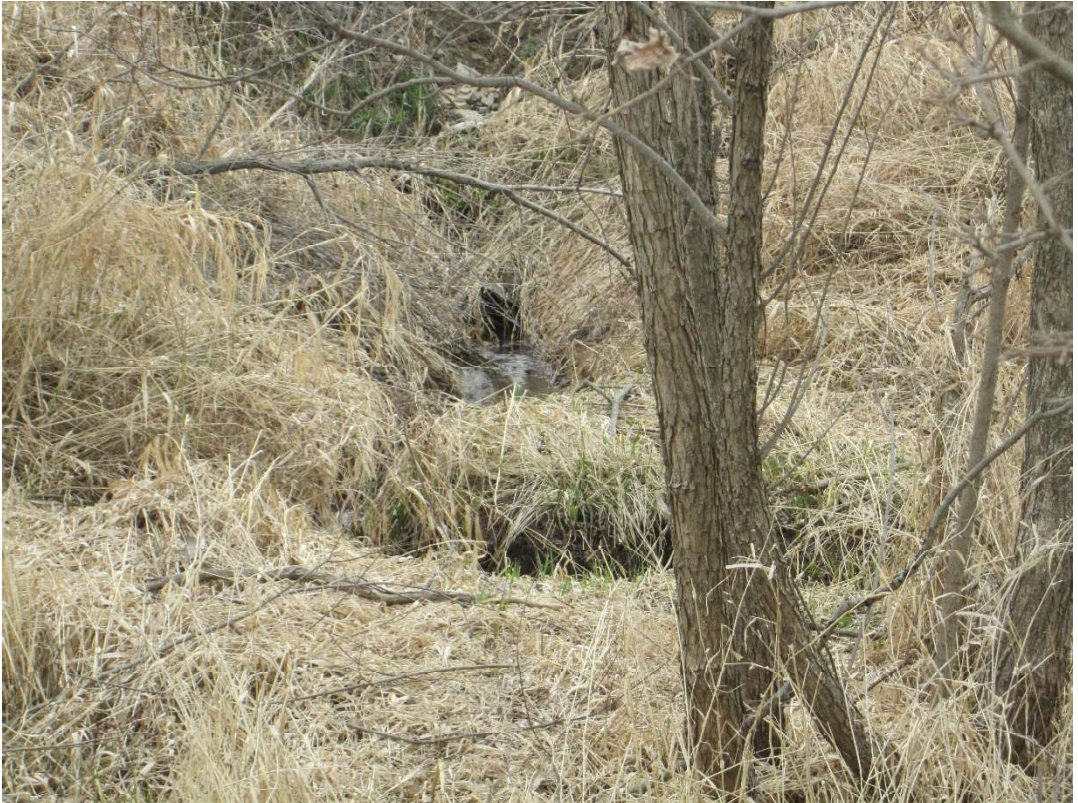
<b>Photo No.:</b> 7	<b>Time:</b> 9:57 AM		
<b>Direction Photo Taken:</b> East			
<b>Photo Description:</b> In the middle of this photo is an artesian spring that flows into a storm water ditch along the far western edge of the bulk material storage area.		<b>File:</b> Hyponex IMG_0372

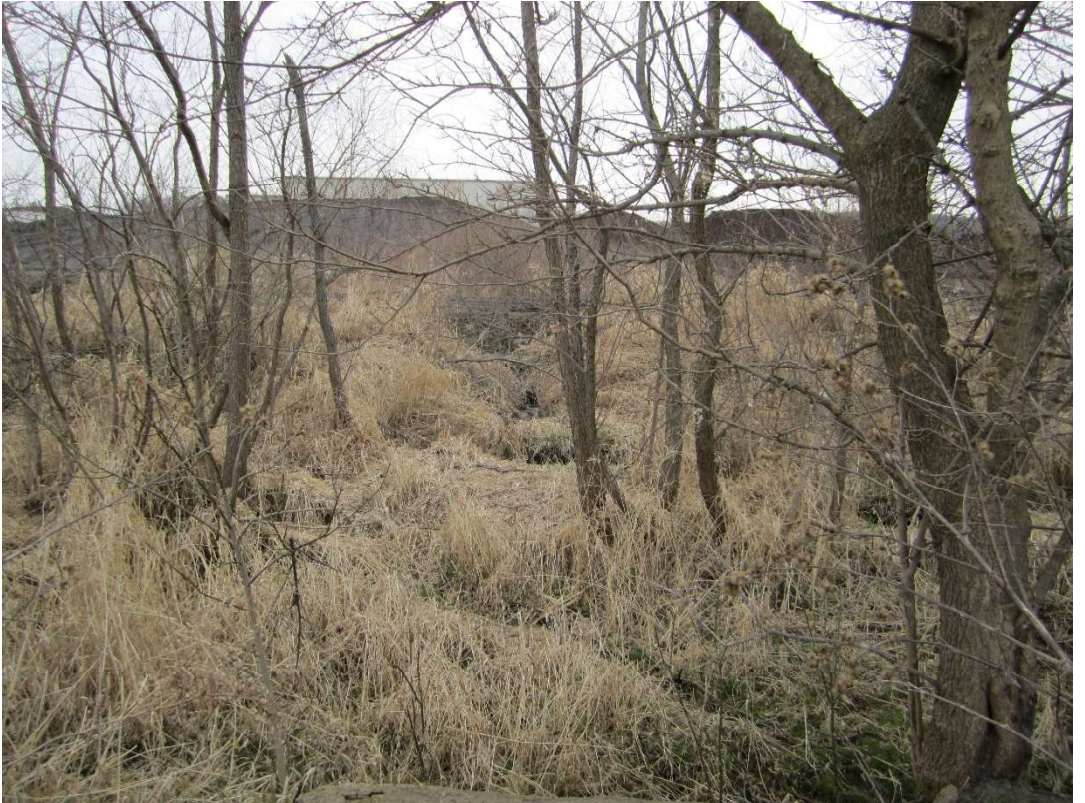
<b>Photo No.:</b> 8	<b>Time:</b> 9:57 AM		
<b>Direction Photo Taken:</b> East			
<b>Photo Description:</b> In the middle of this photo is an artesian spring that flows into a storm water ditch along the far western edge of the bulk material storage area. Bulk material storage piles and the bagging plant are in the background.		<b>File:</b> Hyponex IMG_0373

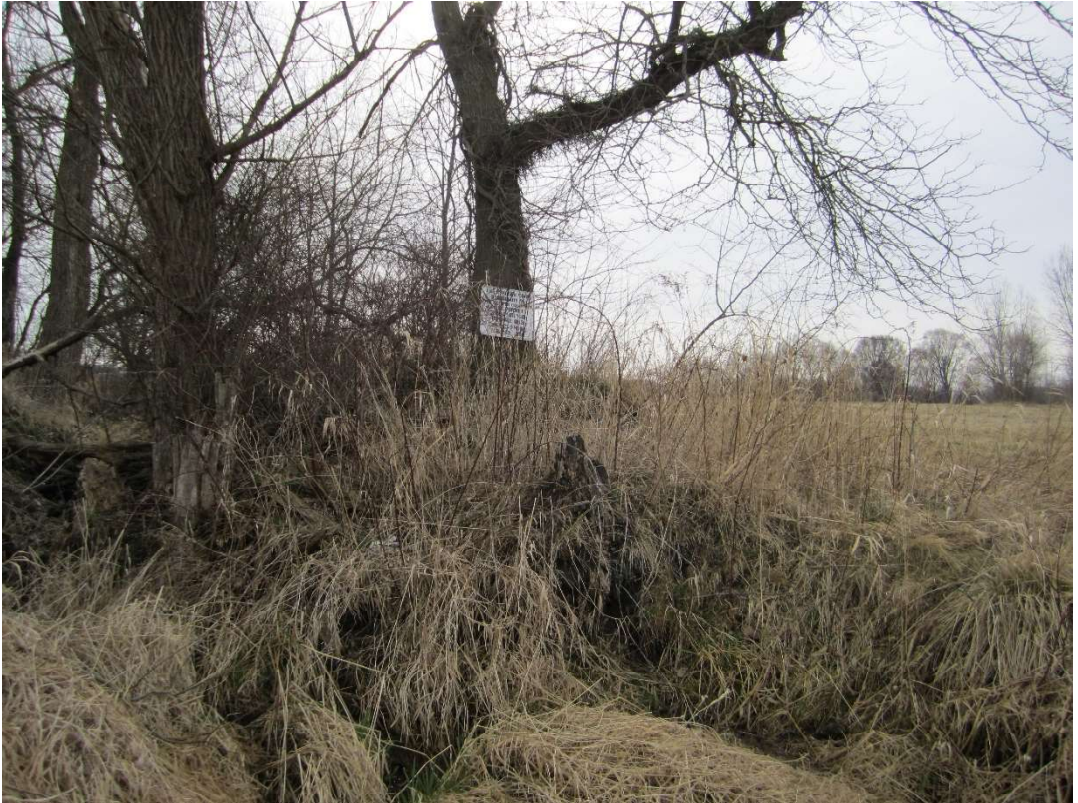
<b>Photo No.:</b> 9	<b>Time:</b> 10:00 AM		
<b>Direction Photo Taken:</b>			
<b>Photo Description:</b> The sign for Outfall 003 is on the tree in the center of the photo. The photo was taken from the approximate location where storm water visual assessments are usually made. There is another storm ditch that combines with this storm water downstream of this location.		<b>File:</b> Hyponex IMG_0374

5. Part II.I of the NPDES permit requires the permittee to maintain a permanent marker on the stream bank at each outfall. Hyponex has permanent markers at the sample locations for Outfalls 002 and 003. The markers are near their property line; they are not at the receiving stream's bank.

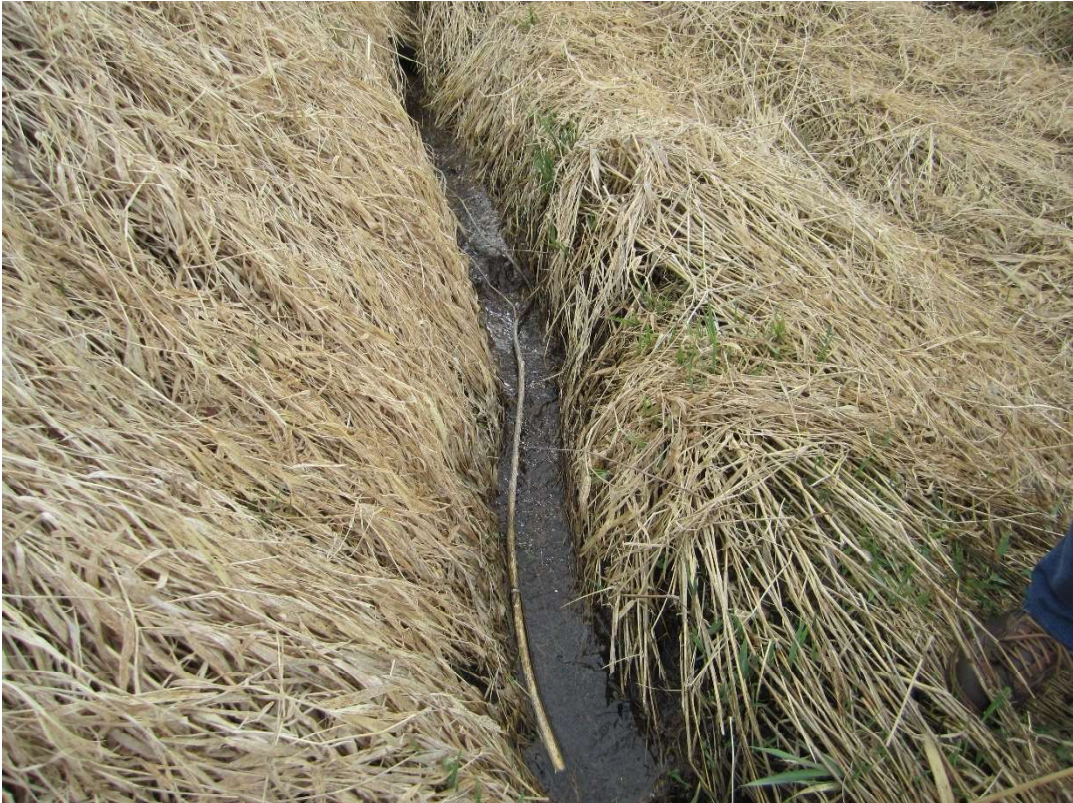
<b>Photo No.:</b> 10	<b>Time:</b> 10:00 AM		
<b>Direction Photo Taken:</b> east			
<b>Photo Description:</b> This is storm water runoff near Outfall 003. It includes storm water from several facility storm drains and a storm water swale. It does not include storm water from the ditch that runs parallel to the far western edge of the bulk material storage area.		<b>File:</b> Hyponex IMG_0375

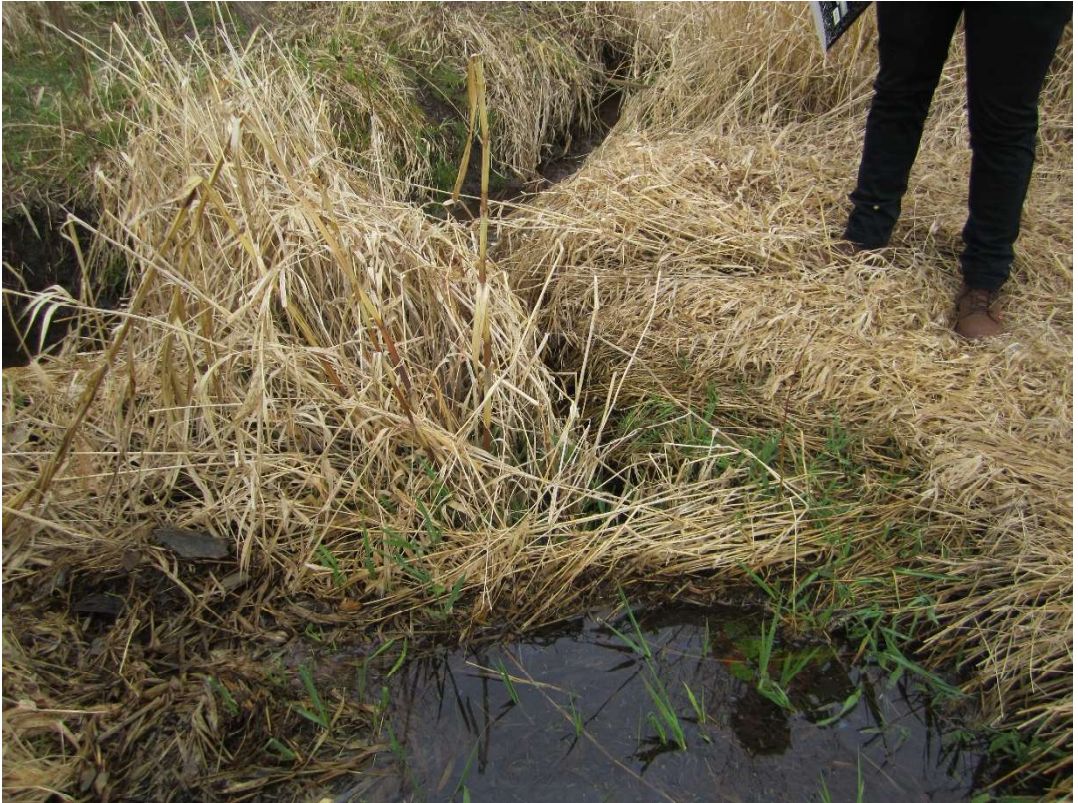
<b>Photo No.:</b> 11	<b>Time:</b> 10:01 AM		
<b>Direction Photo Taken:</b> west			
<b>Photo Description:</b> This is where the storm water shown in Photo No. 10 and storm water from the ditch that runs parallel to the far western edge of the bulk material storage area combine.		<b>File:</b> Hyponex IMG_0376

<sup>1</sup> The location of Outfall 003 identified in the permit seems to be at a point downstream of where two storm water discharges combine, which would be representative of storm water from the southern half of the production area. The company has an outfall marker before the point where the two storm water discharges combine, so not all storm water is represented at that location. Figure 2 in Hyponex’s storm water pollution prevention plan shows the location of Outfall 003 as being downstream of where the two storm water ditches combine.

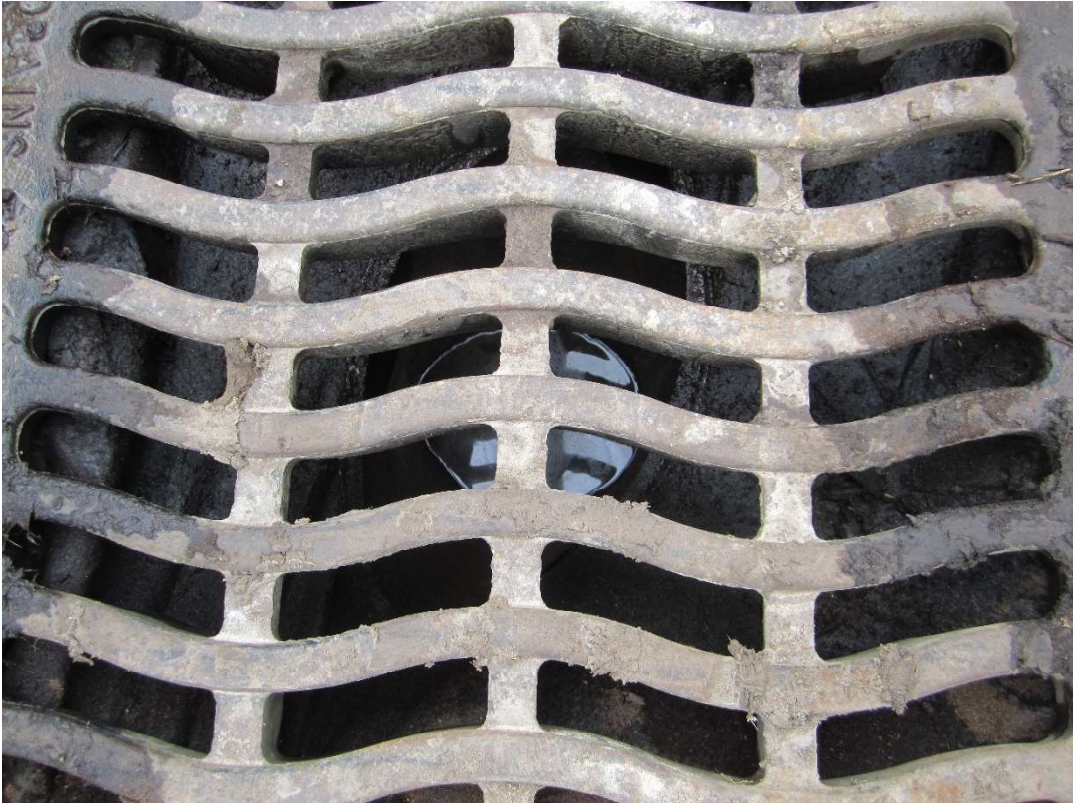
<b>Photo No.:</b> 14	<b>Time:</b> 10:32 AM		
<b>Direction Photo Taken:</b>			
<b>Photo Description:</b> This is a storm water catch basin close to the north side of the bagging plant.			
		<b>File:</b> Hyponex IMG_0379

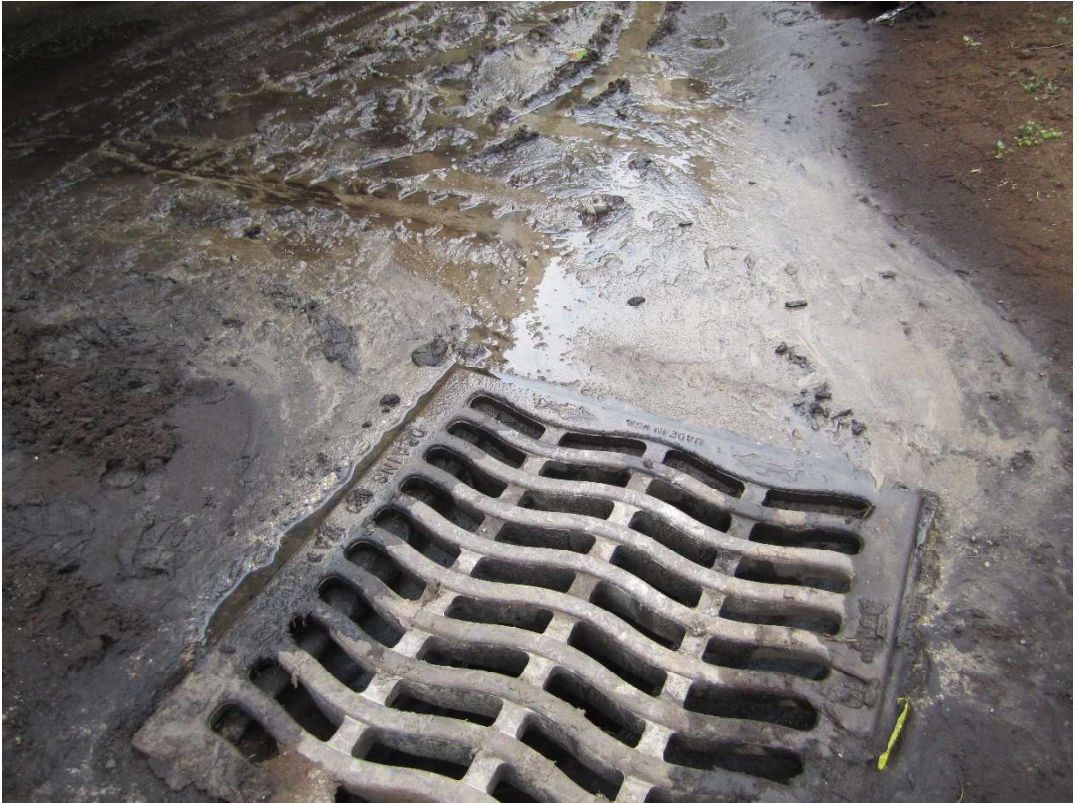
<b>Photo No.:</b> 15	<b>Time:</b> 10:32 AM		
<b>Direction Photo Taken:</b>			
<b>Photo Description:</b> This is the area around the storm water catch basin shown in Photo No. 15. The catch basin was fitted with a filter insert.		<b>File:</b> Hyponex IMG_0380
