**Region 6 - Enforcement & Compliance Assurance Division**  
**INSPECTION REPORT**

| Company Name: | <b>W.H.B. Cattle, LP</b> | |
| Facility Name: | <b>Braum's Dairy</b> | |
| Identification/Permit Number: | OKG010029 | |

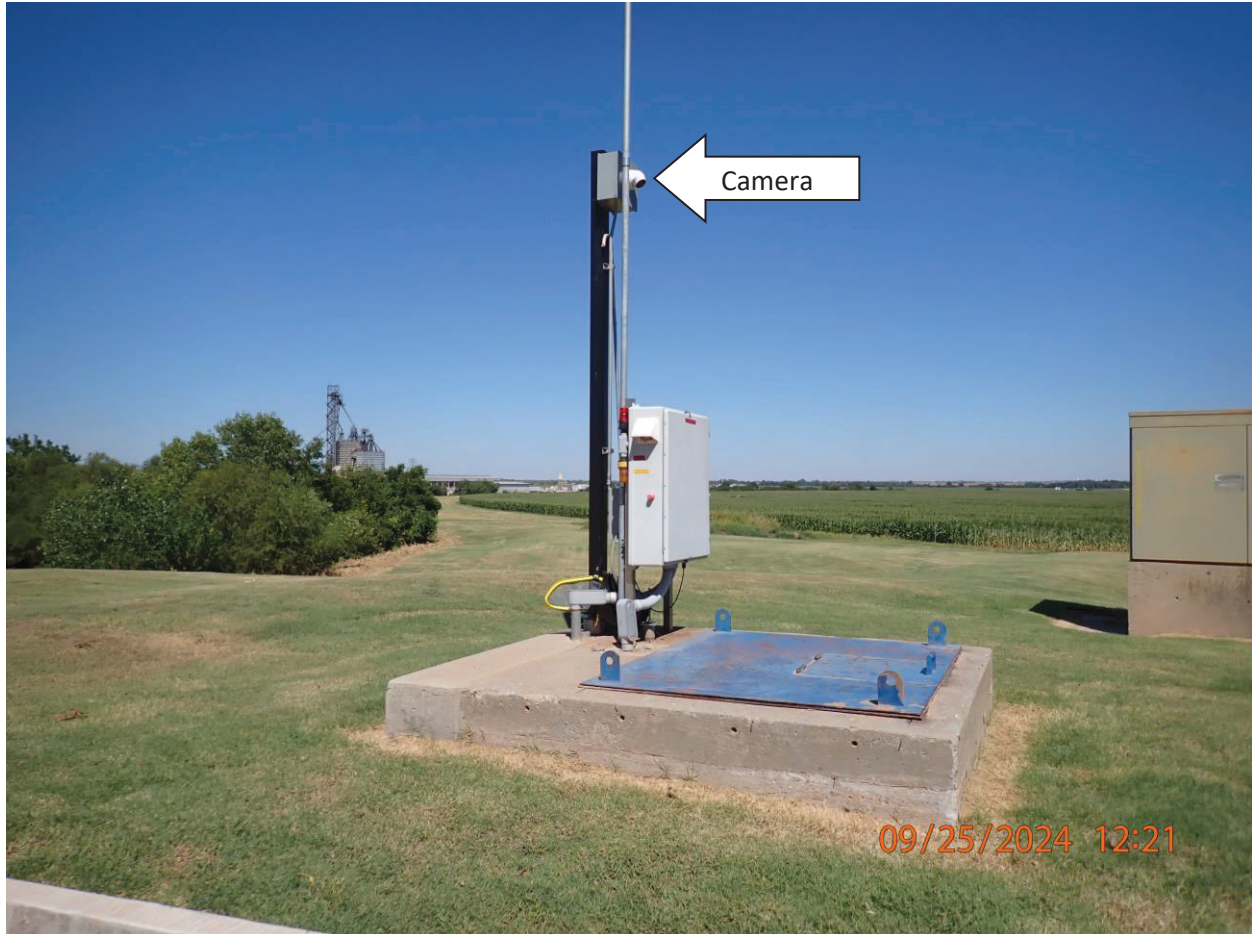
Photo No. 1

Description: This is the lift station for all water leaving the bakery and ice cream plants. This lift station transfers the water to another lift station approximately 900-feet to the west. View is to the northwest.

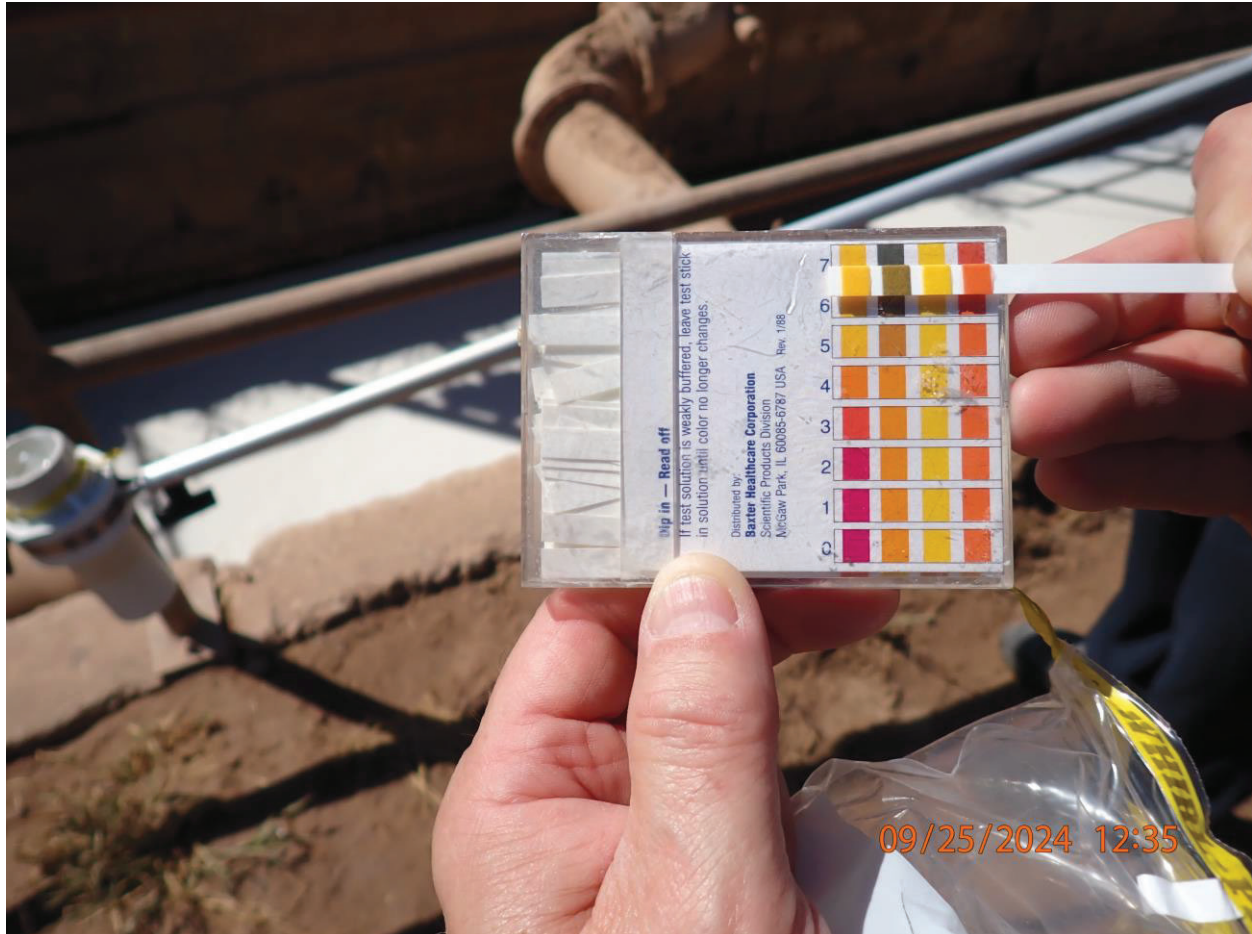
Photo No. 2

Description: A grab sample was collected from the inflow pipe to evaluate the pH of the water from the two plants. The pH value determined from the colorimetric strip indicated a value of 6. View is to the southwest.

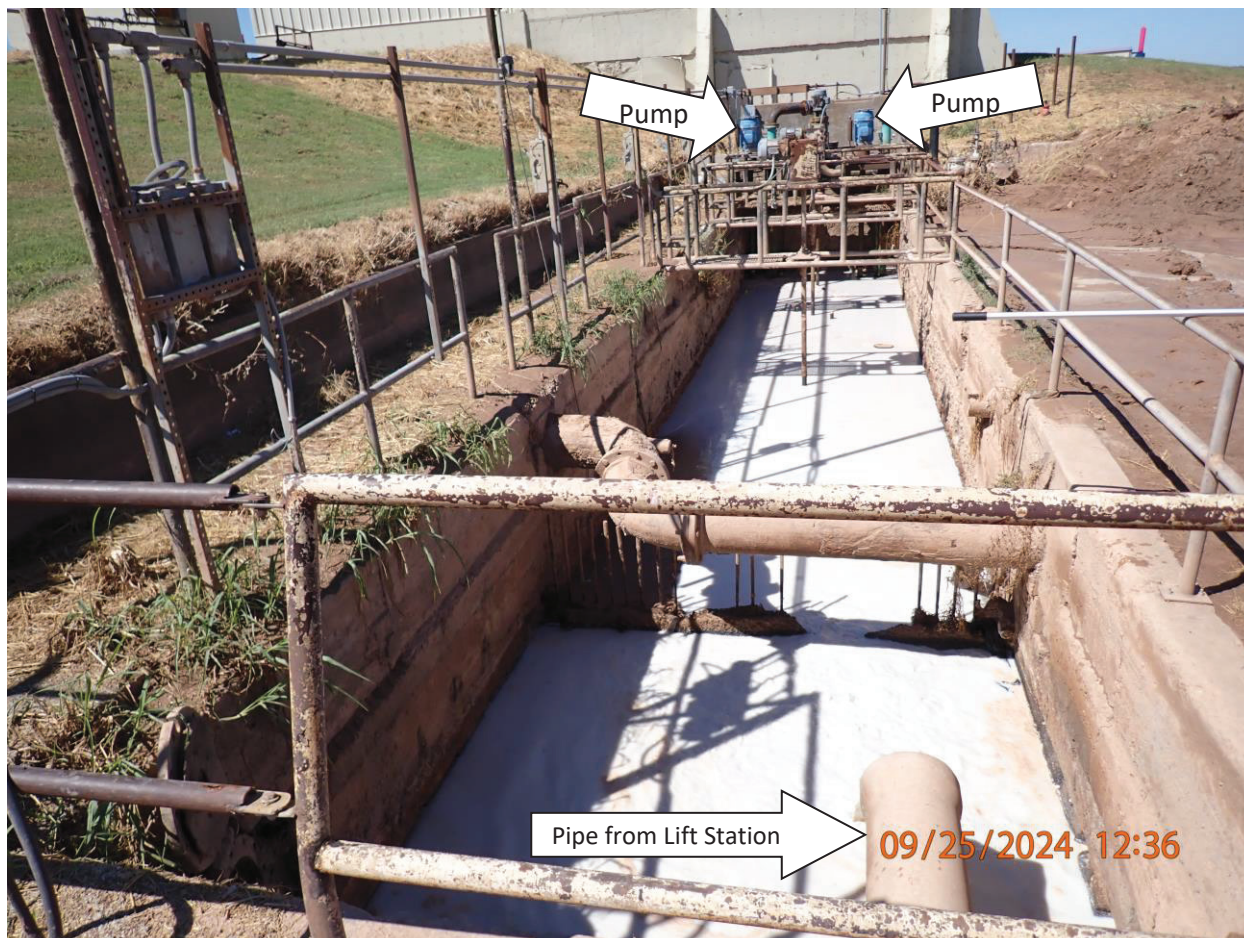
Photo No. 3

Description: Large trough approximately 900-feet west from first lift station. This trough has two pumps at the west end to pump the water to three screens and then flows via gravity into the lagoon. Mounted above the pumps is a camera, which allows all with access to view the water level in the trough if the high-level alarm is tripped. Additionally, to the right (north) of the trough is a concrete emergency containment area with stem walls on three sides to contain any overflow. View is to the west-northwest.

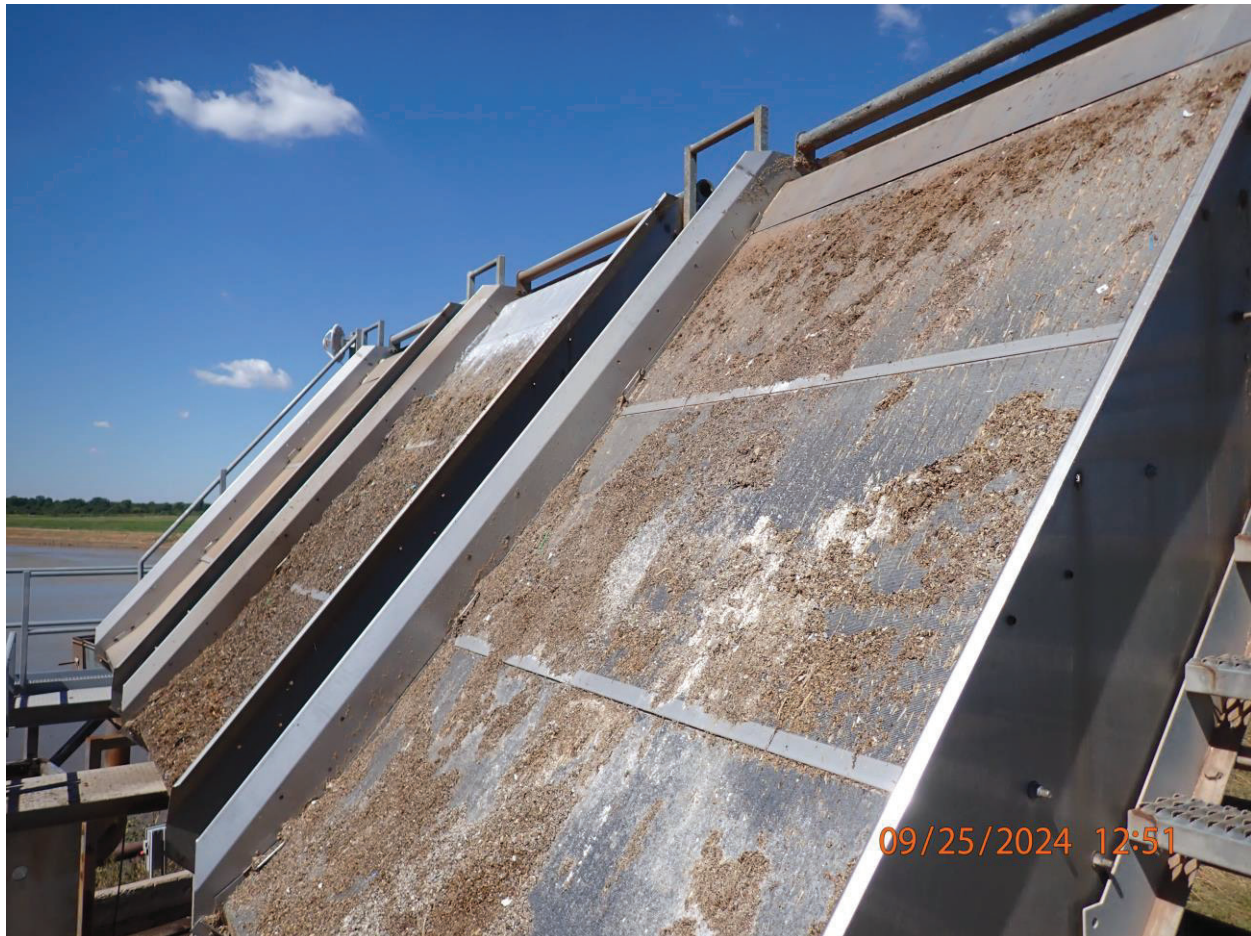
Photo No. 4

Description: Three screens are used to remove any solids prior to flowing into the lagoon. Only one screen is used at a time. View is to the west-northwest.

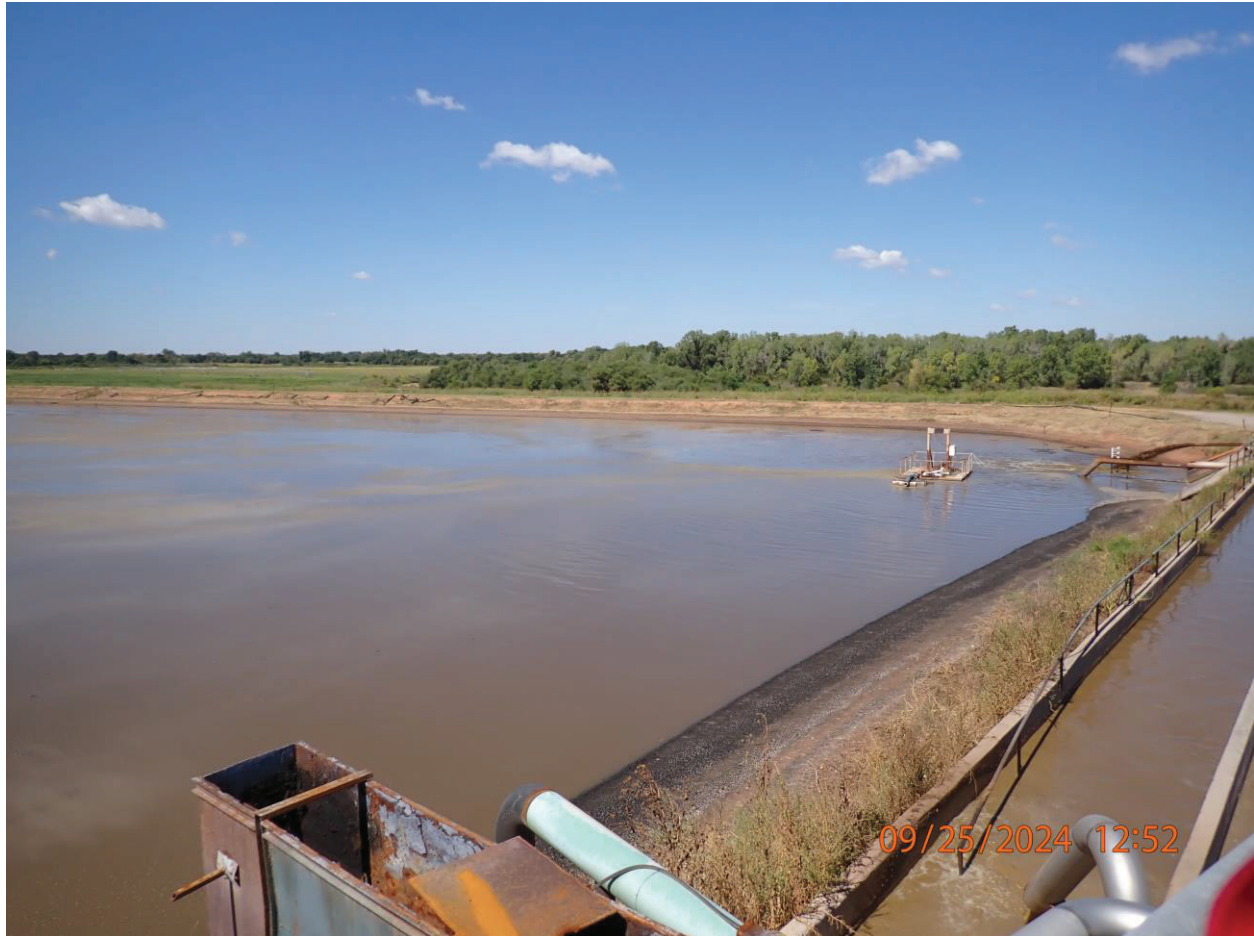
Photo No. 5

Description: Pictured is the inflow from the plants and the dairy along with the northern levee of the lagoon. The inflow comes in via the concrete channel on the right. The view is to the northwest.

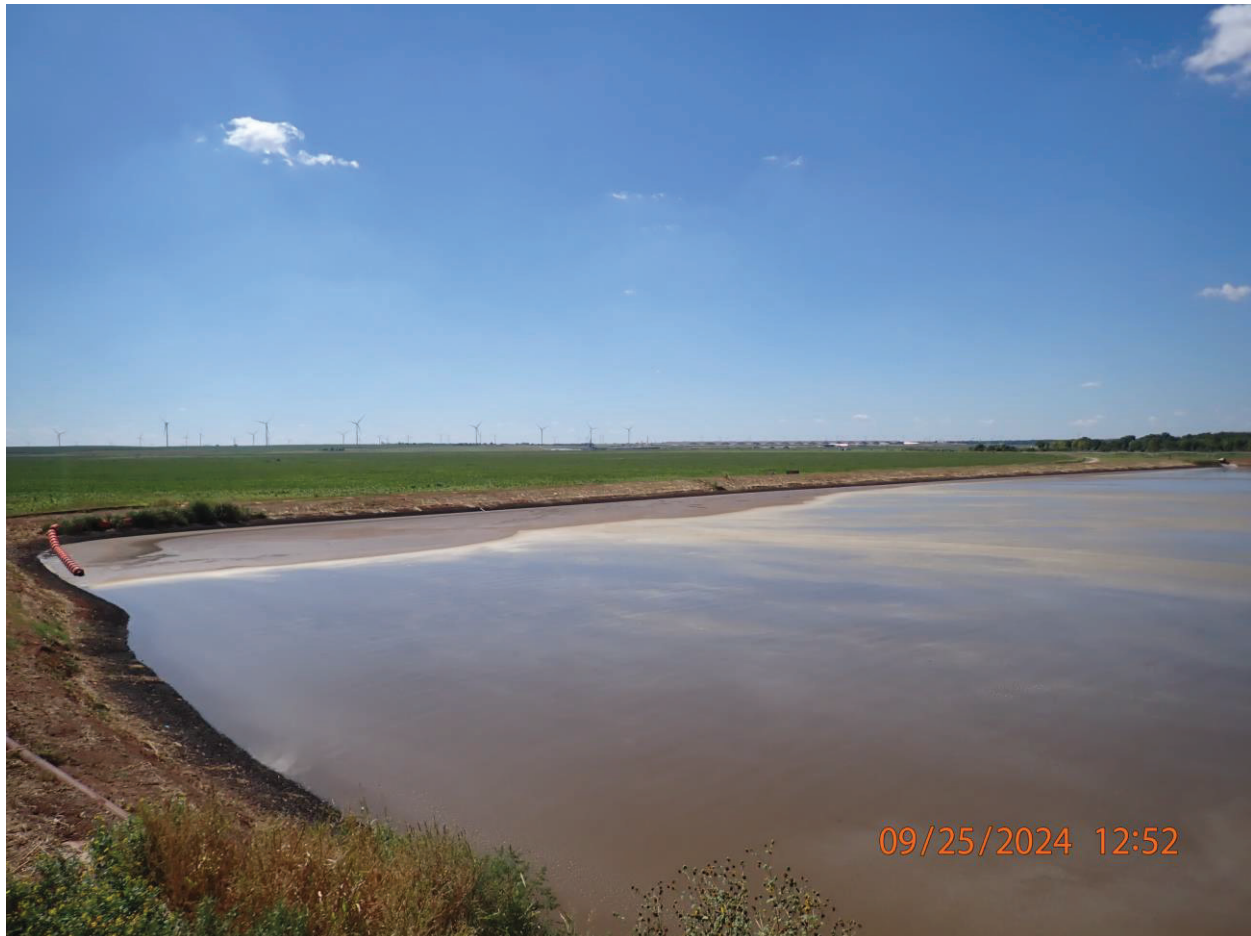
Photo No. 6

Description: Pictured is the southern levee of the lagoon showing adequate freeboard. The view is to the southwest.

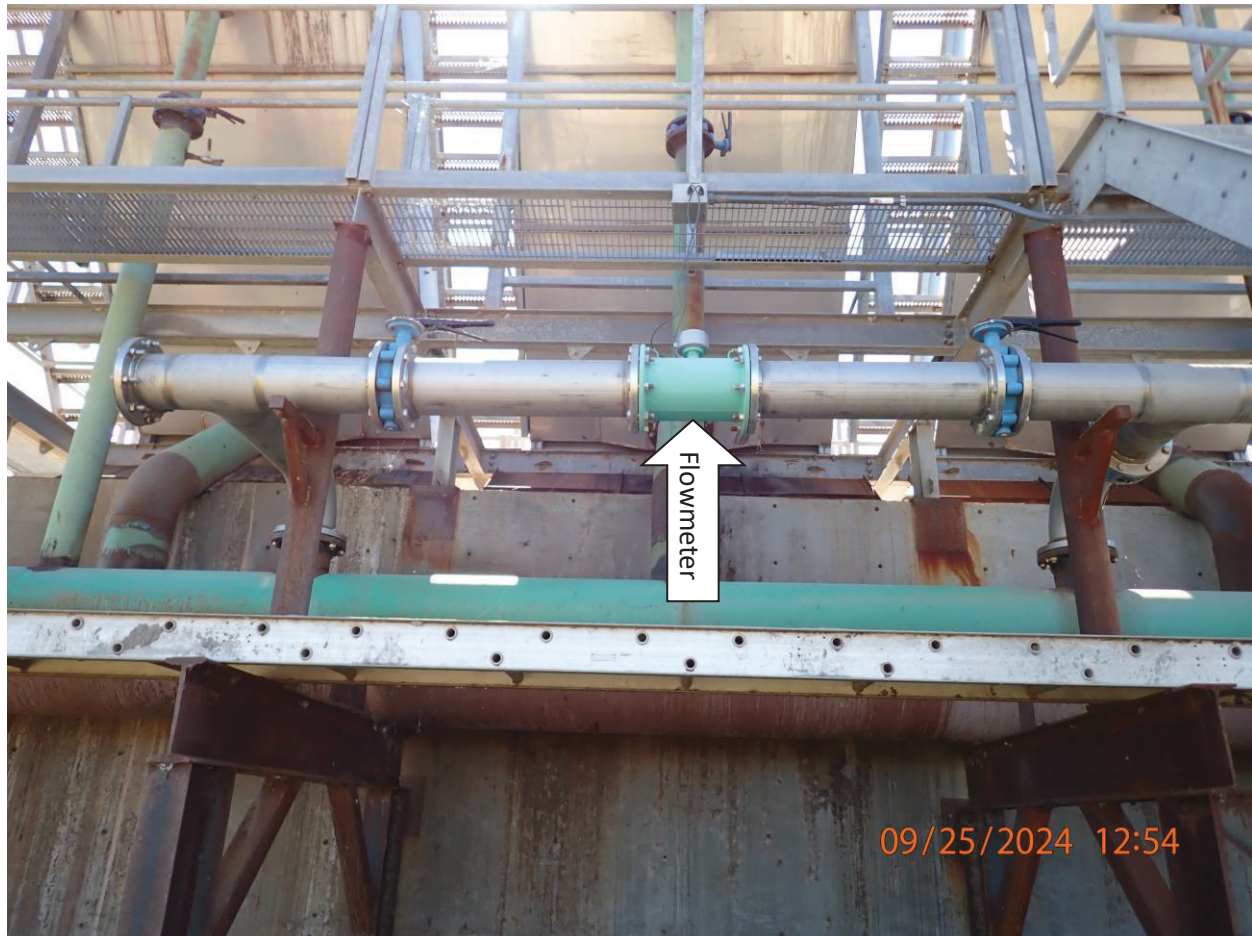
Photo No. 7

Description: Pictured is the flowmeter located prior to the diverter for the three screens see Photograph 4. The view is to the south.

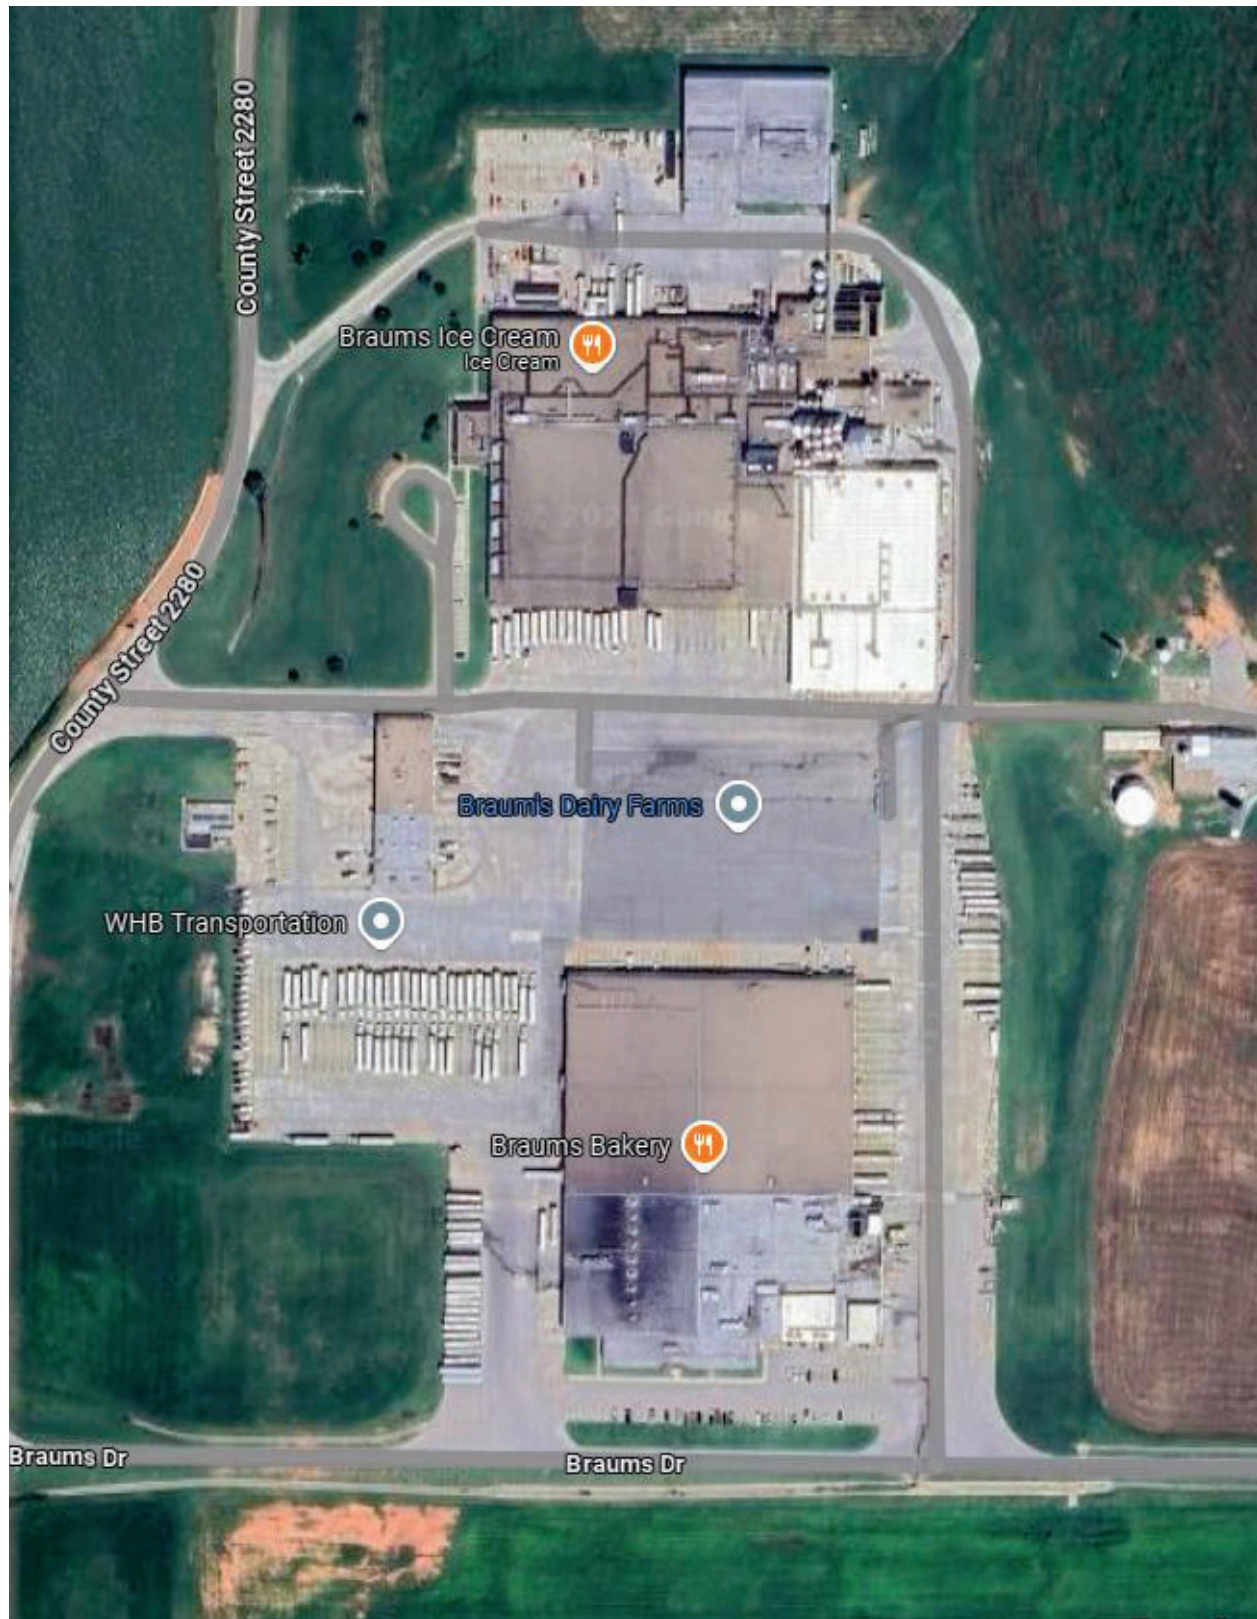
Appendix 3  
Aerial Photograph  
Bakery and Dairy Food Plants

The Ice Cream Plant was constructed on the Braum's property in Tuttle, OK and started operations in 1987. In 2008, Braum's moved their bakery from Oklahoma City to the Tuttle property and started operations. The bakery is located adjacent to the milk plant (see Appendix 3). The industrial wastewater generated from cleaning and washing of the bakery and creamery equipment is piped to their CAFO lagoon and later land applied.
