## **RCRA Inspection Report**

University of Louisville - ESPC  
1810 Arthur Street  
Louisville, Kentucky 40208

June 04, 2024, at 8:30 A.M.

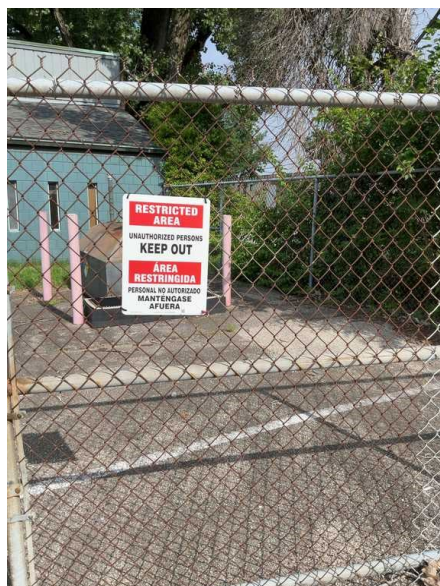
| Photo 1 | IMG-2024060409584158416218661.jpg |

| Outside, signage along perimeter fence. | 38.22124275, -85.75287269 |

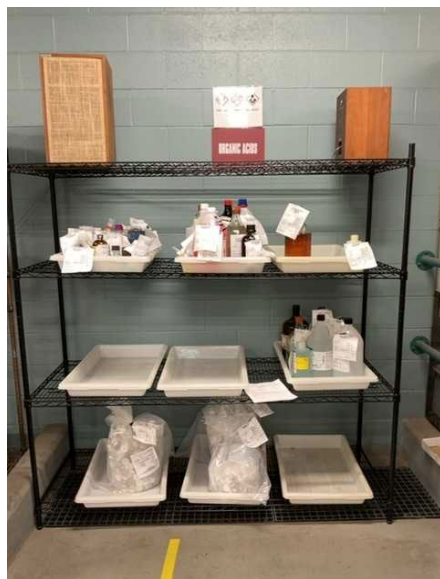
| Photo 2 | IMG-2024060409043443481263.jpg |

| Room 108, organic acids section. | 38.22069271, -85.75231105 |

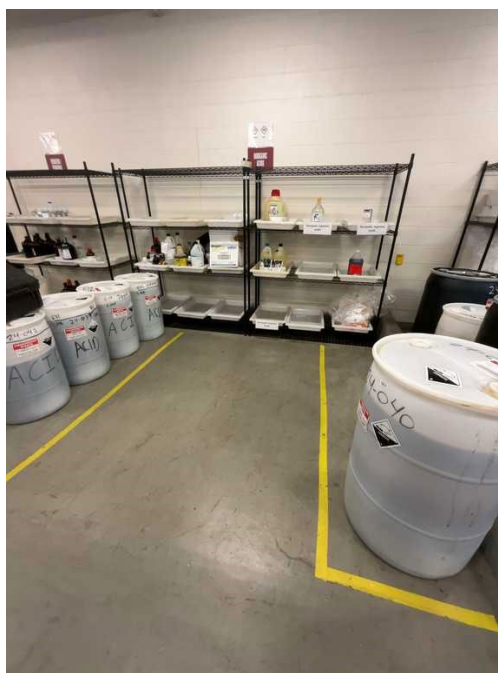
| Photo 3 | IMG-2024060409182418241705603.jpg |

| Room 108, inorganic acids section. | 38.22056701, -85.75217558 |

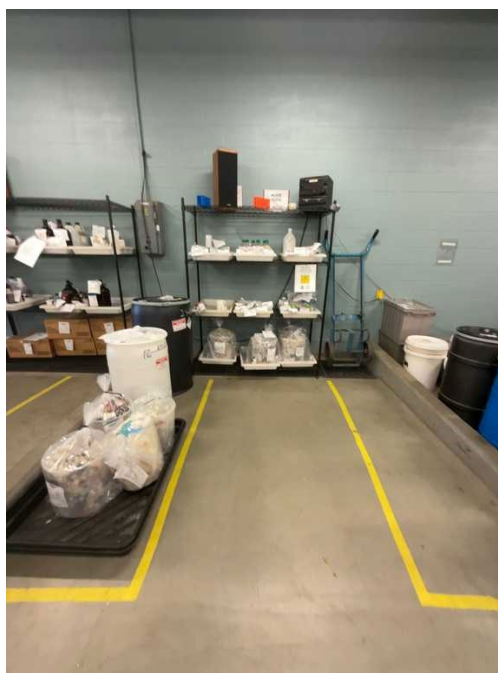
| Photo 4 | IMG-2024060409231823181593812.jpg |

All hazardous waste containers (except for two in the Acute Toxics section) were closed, labeled hazardous waste, marked with an indication of the hazards and were labeled with an accumulation start date. The oldest date observed was 08/28/2023. In the Acute Toxics section, the inspectors observed one 30-gallon container and one 55-gallon container of hazardous waste that were not labeled with an indication of the hazard of the contents. Both containers did have a hazardous waste label, an accumulation start date, and were closed.

**Pursuant to 401 KAR 39:080, Section 1(1) [40 C.F.R. § 262.17(a)(5)(i)(B)], a large quantity generator must mark or label its containers with the following: (B) An indication of the hazards of the contents (examples include, but are not limited to, the applicable hazardous waste characteristic(s) (i.e., ignitable, corrosive, reactive, toxic); hazard communication consistent with the Department of Transportation requirements at 49 CFR part 172 subpart E (labeling) or subpart F (placarding); a hazard statement or pictogram consistent with the Occupational Safety and Health Administration Hazard Communication Standard at 29 CFR 1910.1200; or a chemical hazard label consistent with the National Fire Protection Association code 704).**

| Room 108, acute toxics section. | 38.22056276, -85.75217213 |

The facility representatives immediately marked the containers with an indication of the hazard for toxicity.

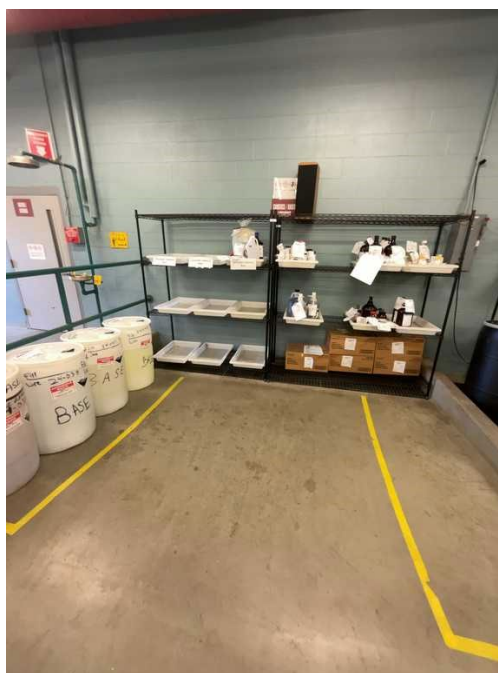
| Photo 05 | IMG-2024060409334333431697276.jpg |

| Room 108, caustics and bases section. | 38.22056205, -85.75217076 |

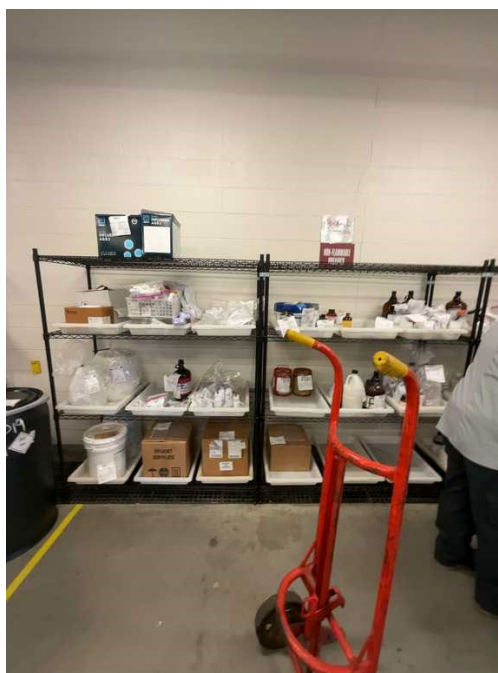
| Photo 06 | IMG-2024060409361536151804067.jpg |

| Room 108, non-flammable organics section. | 38.22055019, -85.75216035 |

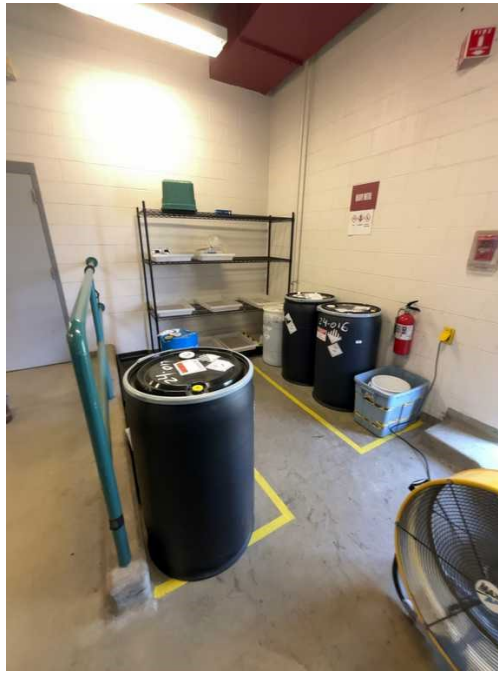
| Photo 07 | IMG-2024060409391739171515029.jpg |

| Room 108 heavy metals section. | 38.22063451, -85.7522507 |

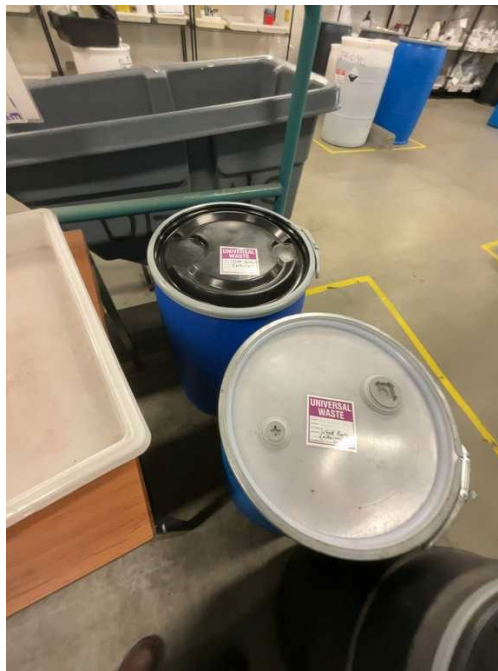
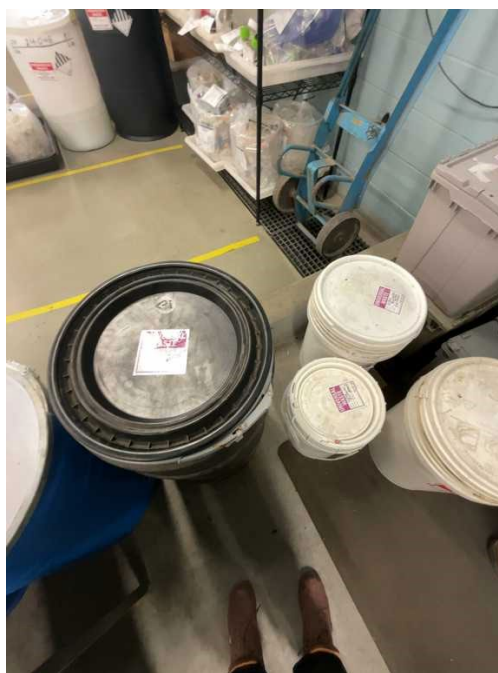
| Photo 08 | IMG-202406040910041041687416.jpg |

There was also a separate section for universal waste storage (Photos 8-9). All containers of universal waste were labeled “Universal Waste”, closed, and marked with an accumulation start date. The oldest date observed was 12/15/2023.

| Room 108, universal waste section. | 38.22069108, -85.75231095 |

| Room 108, universal waste section. | 38.22069235, -85.75231103 |

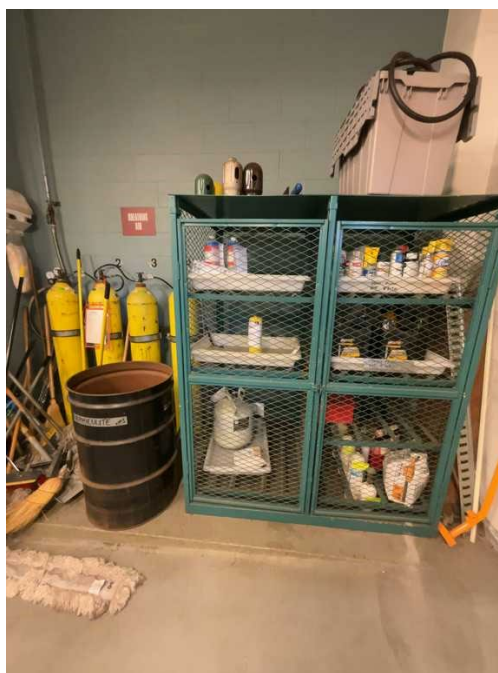
| Photo 10 | IMG-2024060409533253322032840.jpg |

Compressed gases that are waste are also located within Room 108 next to the loading dock inside a cage. The inspectors observed one small 1-liter container labeled “Hazardous Waste”, closed, dated 03/18/2024, and marked with an indication of the hazard of the contents (Photos 10).

| Compressed gases storage. | 38.22059208, -85.75220258 |

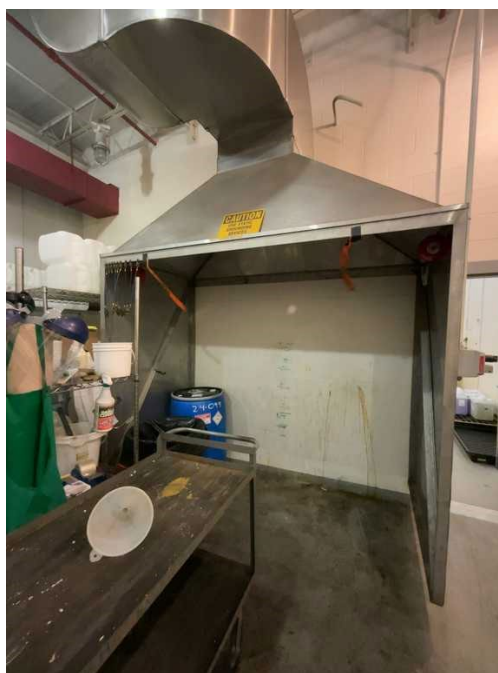
| Photo 11 | IMG-202406040946054651709519.jpg |

This room is used for waste bulking, blending, and consolidation activities. This room is equipped with fire control equipment and spill control equipment. The inspectors observed one 55-gallon container of formalin debris. The container was closed, labeled “Hazardous Waste”, marked with an indication of the hazard of the contents, and labeled with an accumulation start date of 05/24/2024 (Photo 11).

| Room 111, bulking and blending. | 38.22057276, -85.75218247 |

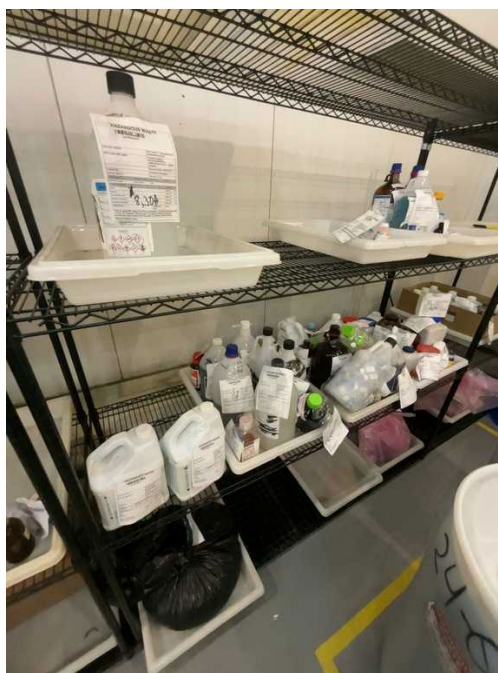
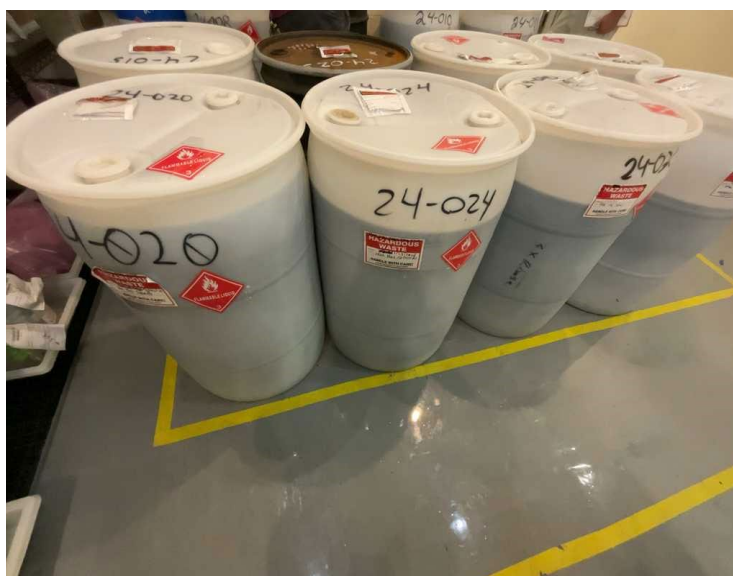
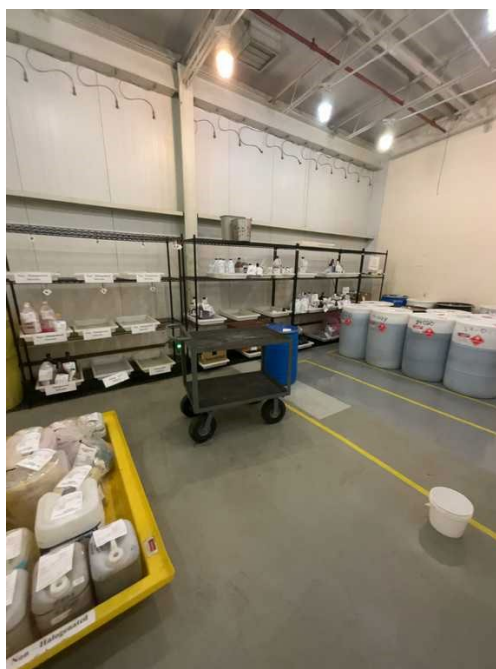
| Photo 12 | IMG-202406040949004902121942.jpg |

Flammable waste is stored in this room which is equipped with fire control equipment and spill control equipment. Waste stored in smaller containers such as quart-size containers to 5-gallon containers are consolidated into 55-gallon drums. Waste stored on shelves in smaller containers are placed in secondary containment trays (Photos 12-14). All hazardous waste in this room was observed to be closed, labeled with the words “Hazardous Waste”, marked with an indication of the hazard of the contents, and were labeled with an accumulation start date. The oldest date observed was 12/13/2023.

| Room 112, flammable storage. | 38.22058928, -85.75219344 |

| Room 112, flammable storage. | 38.2205813, -85.75219134 |

| Room 112, flammable storage. | 38.22057778, -85.75218154 |

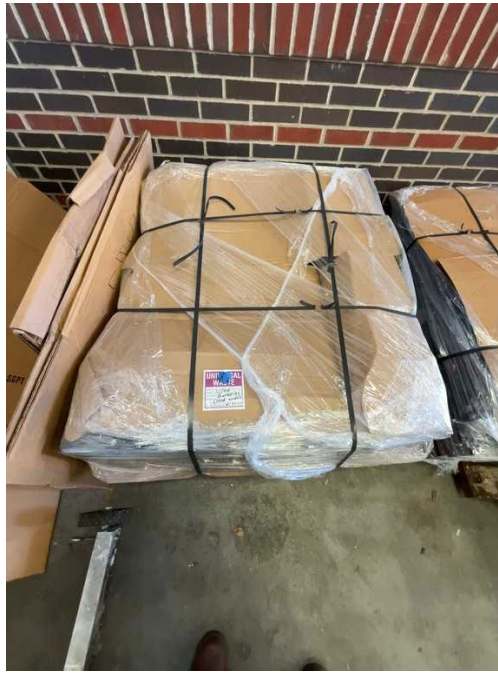
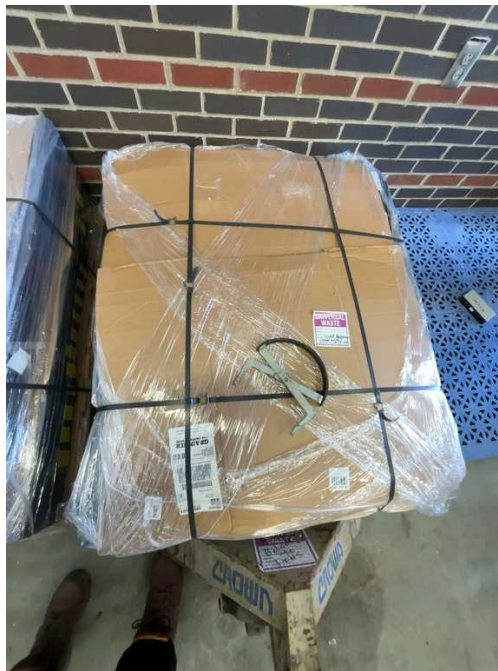
| Photo 15 | IMG-2024060409564556452430891.jpg |

The inspectors observed two pallets of shrink-wrapped lead acid batteries on the loading dock (Photos 15-16). Both pallets had one “Universal Waste” label on the shrink wrap and were labeled with accumulation start dates of 01/25/2024 and 04/12/2024. It did not appear that each lead acid battery was individually labeled with “Universal Waste”. Shrink-wrapped pallets do not constitute as a container. Therefore, each lead acid battery should have a universal waste label or, the lead acid batteries must be placed in a structurally sound container which should have a universal waste label placed on the container. No hazardous waste was observed in this area.

Pursuant to 401 KAR 39:080, Section 3(1) [40 C.F.R. § 273.34(a)], universal waste batteries (i.e., each battery), or a container or tank in which the batteries are contained, must be labeled or

marked clearly with any one of the following phrases: “Universal Waste—Battery(ies),” or “Waste Battery(ies),” or “Used Battery(ies);”

| Loading dock. | 38.22068884, -85.75231118 |

| Loading dock. | 38.22068853, -85.75231085 |

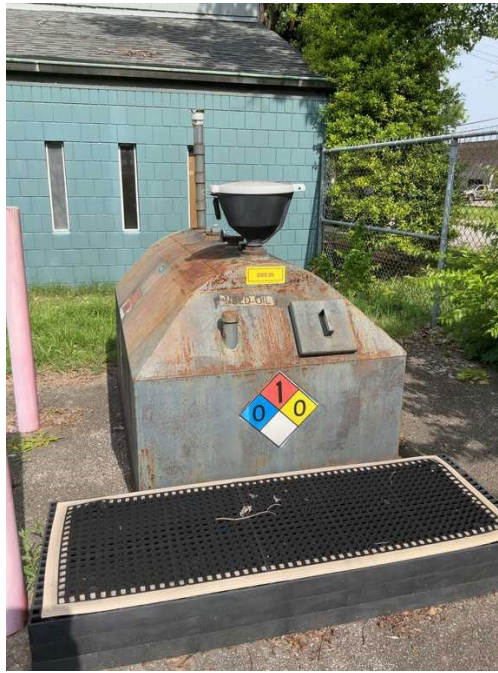
| Photo 17 | IMG-2024060409585058504577398.jpg |

Outside on the northwest side of the property was a double-walled 200-gallon above-ground storage tank that used to be used to collect used oil (Photo 17). The tank is empty and is not in-service.

| Above ground storage tank for used oil, no longer in service. | 38.22123969, -85.75287044 |

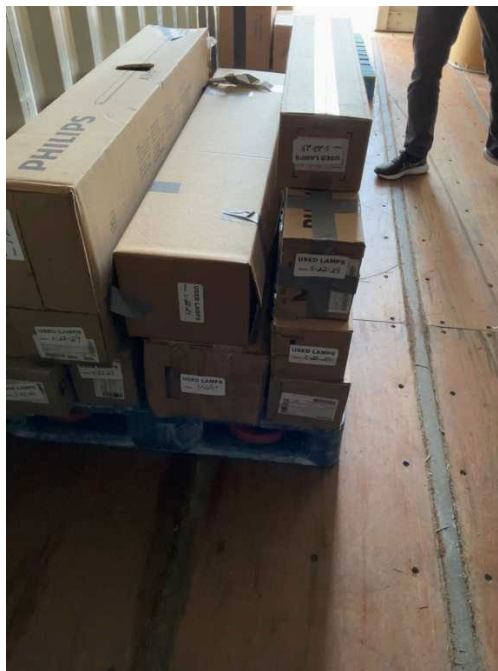
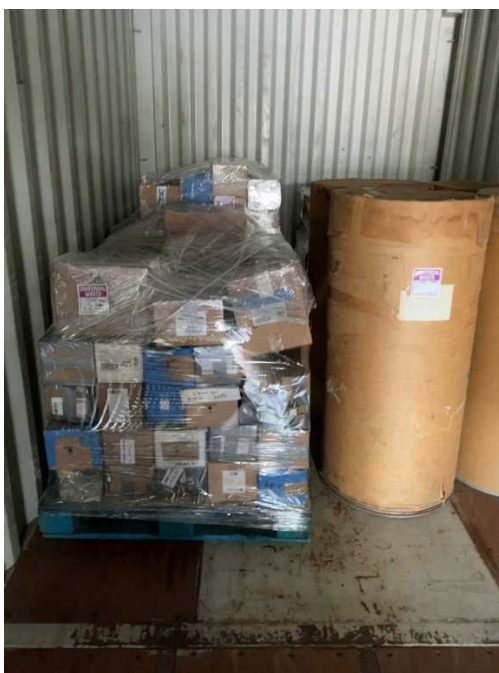
| Photo 18 | IMG-202406041001221222217065.jpg |

On the southwest side of the property there is a trailer that is used to store universal waste lamps (Photos 18-19). All the containers were closed, labeled “Universal Waste—Used Lamps”, and were labeled with an accumulation start state. No container was observed to be stored longer than one year.

| Trailer for universal waste lamps. | 38.22054894, -85.75230444 |

| Trailer for universal waste lamps. | 38.22085018, -85.75250553 |
