Compliance Evaluation Inspection Report  
USPS Western Nassau Process & Distribution Facility &  
Vehicle Maintenance Facility  
830 Stewart Avenue  
Garden City, NY  
March 5, 2024

## COMPLIANCE EVALUATION INSPECTION REPORT

Facility Name: USPS Western Nassau Vehicle Maintenance Facility (VMF)  
Facility Address: 830-A Stewart Ave, Garden City, NY 11599-0001  
Latitude & Longitude: 40.733582, -73.603274

Date of Inspection: March 5, 2024  
Inspector: Ron Lockwood  
Inspector-in-Training: Kevin Dyer

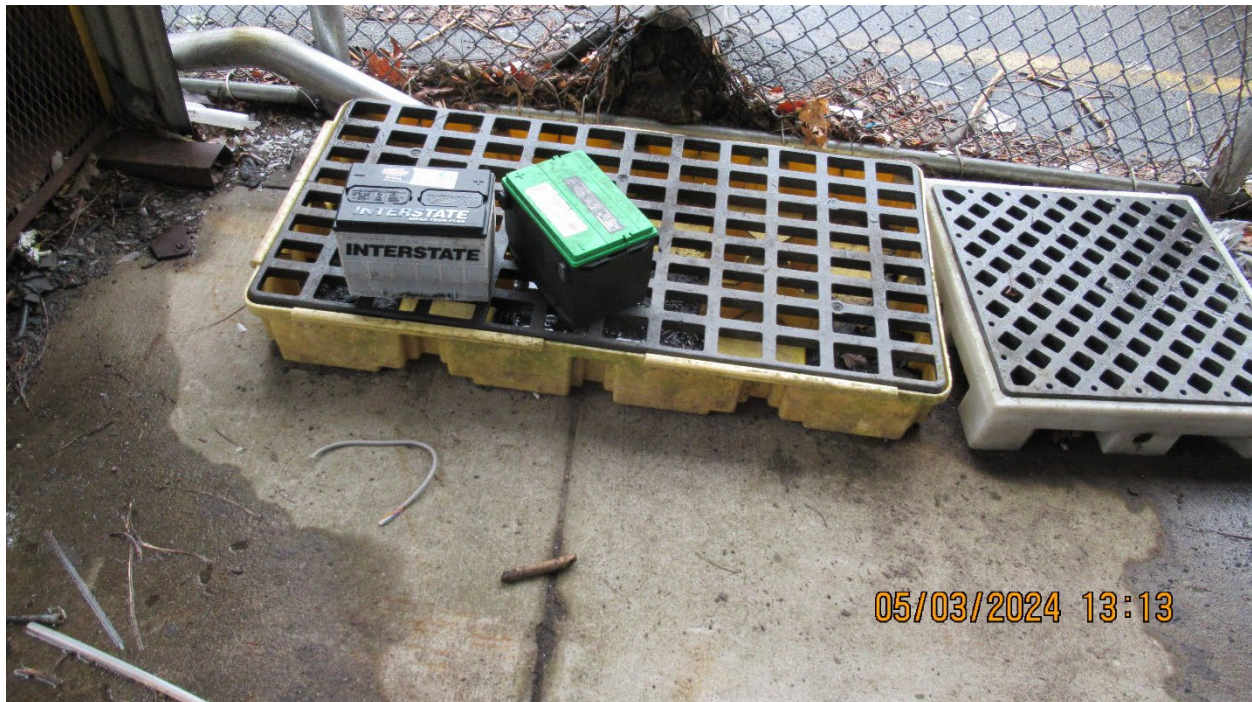
Photo 4

Vehicle Batteries – These batteries are stored outside in a gated shed (i.e., no walls) with a steel roof. The batteries are stored on plastic secondary containment pallets (See, Photo 4). No signage identifying the area as a universal waste storage area was observed. The two universal waste batteries being stored on the pallets were also not labeled as universal waste.

| REGULATORY, STATUTORY OR PERMIT REFERENCE | FIELD OBSERVATION |
|---|---|
| 6 NYCRR 374-3.2 (e)(1) - Universal waste batteries (i.e., each battery), or a container in which the batteries are contained, must be labeled, or marked clearly with any one of the following phrases: "universal waste - battery(ies)," or "waste battery(ies)," or "used battery(ies)." | The two universal waste vehicle batteries being stored on the pallets in the gated shed were not labeled as universal waste – batteries or waste batteries or used batteries. Also, no signage identifying the shed being used to store universal waste vehicle batteries as a universal waste storage area was observed. |

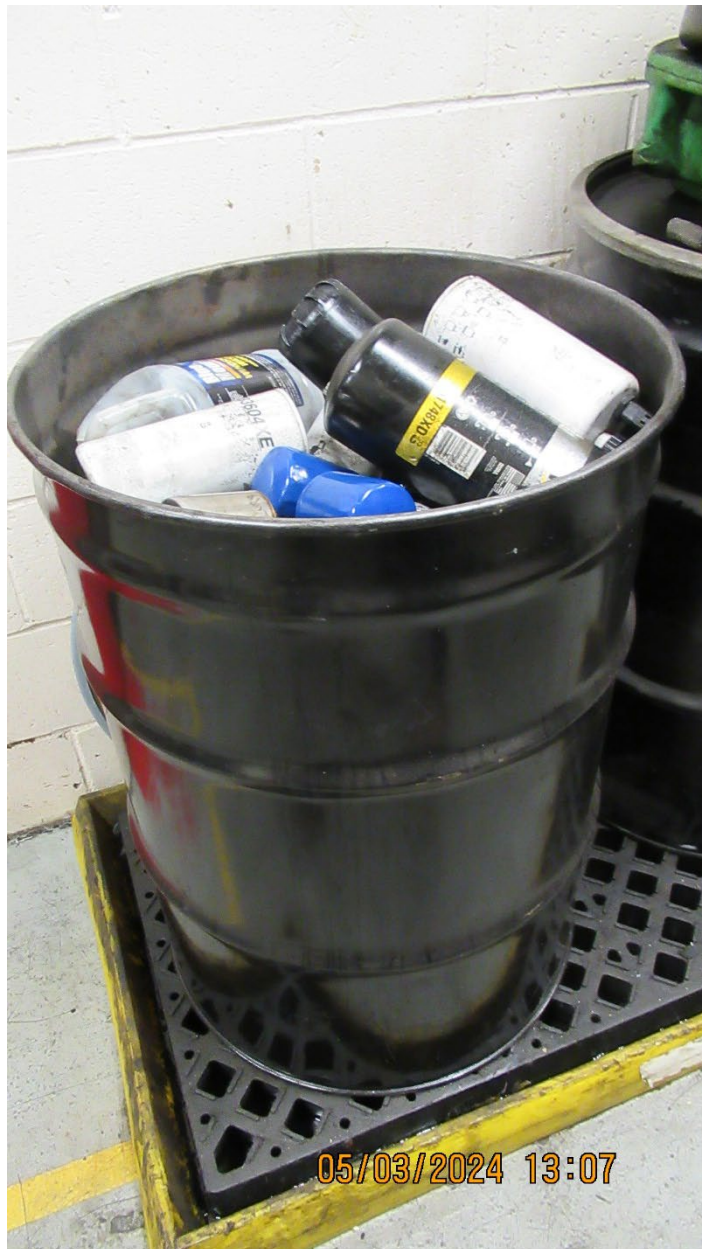
Photo 5

Used oil collected from empty containers and spent filters are collected in two 55-gallon steel drums (See, Photos 5 & 6). The drums are stored on top of secondary containment plastic pallets. There was no visible signage identifying that the area is used for storing used oil. Once the containers and spent filters are drained into the 55-gallon drums, they are then transferred to a 450-gallon steel above ground storage tank (AST), which was clearly labeled “Used Oil” (See, Photo 7). The 55-gallon drums used to store used oil drained from the filters and containers were not labeled “Used Oil.”

| REGULATORY, STATUTORY OR PERMIT REFERENCE | FIELD OBSERVATION |
|---|---|
| 6 CRR-NY 374-2.3 (c)(4)(i) - Every container and aboveground used oil tank used to store used oil at a generator facility must be clearly labeled or marked with the words "Used Oil". In addition, every aboveground tank used to store oil at a generator facility must be labeled with the design capacity and working capacity of the tank. | The 55-gallon drums used to store used oil drained from the filters and containers were not labeled "Used Oil" |

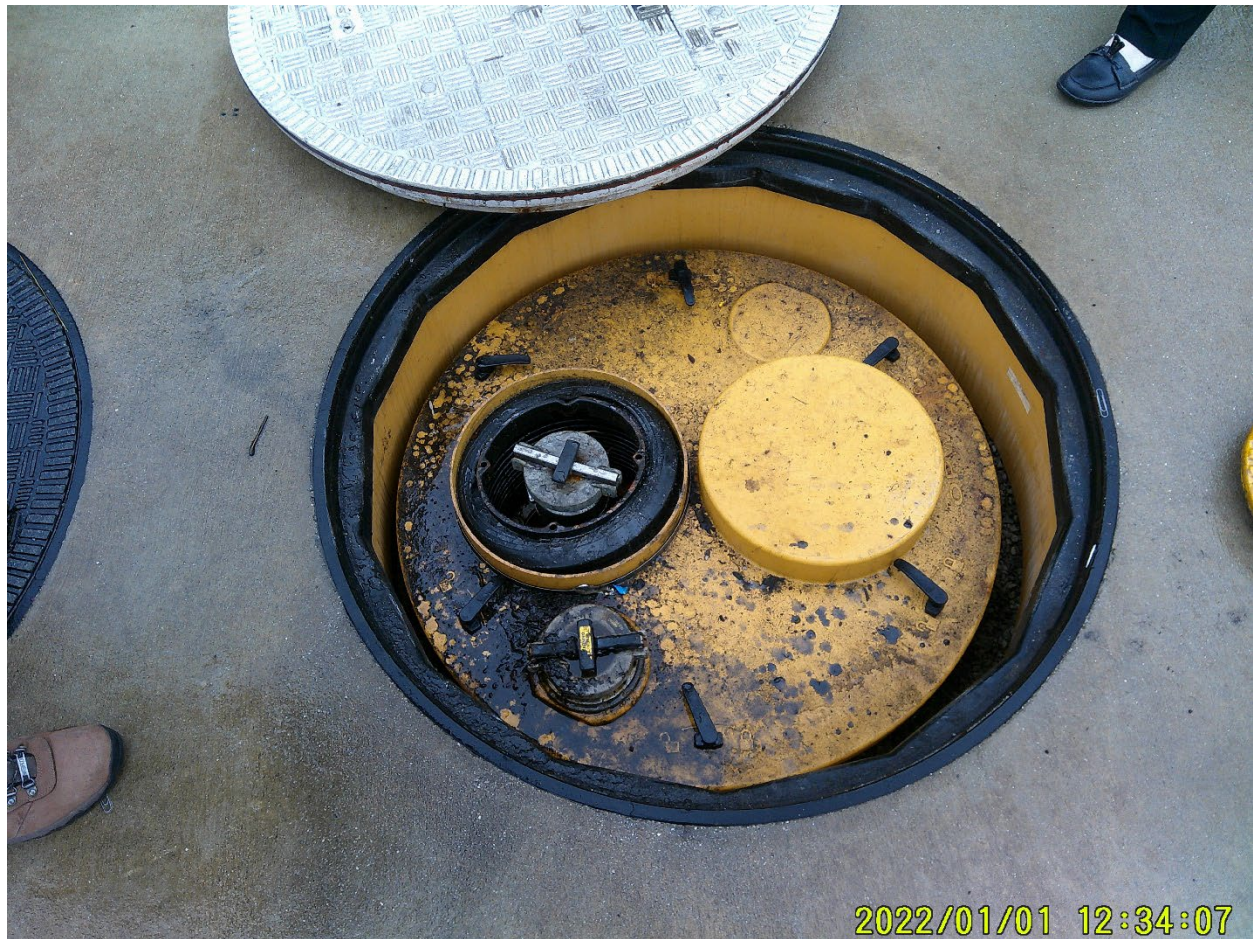
Photo 11

Fill Pipe – The fill port for the UST is located just outside the eastern facing side of the building, within a bollard-protected area of the large surface lot. The fill port utilizes double-walled containment and a coaxial stage-1 vapor recovery system (See, Photo 10). Other overfill prevention devices includes an auditory overfill alarm (See, Photo 11) and an automatic shutoff device/flapper valve (See, Photo 12).
