INSPECTION REPORT

| Type of Inspection | CEI - Compliance Evaluation Inspection | |
| Permittee Name | Camino Real Regional Utility Authority (CRRUA) | |
| Facility or Site Name | North Wastewater Treatment Plant | |

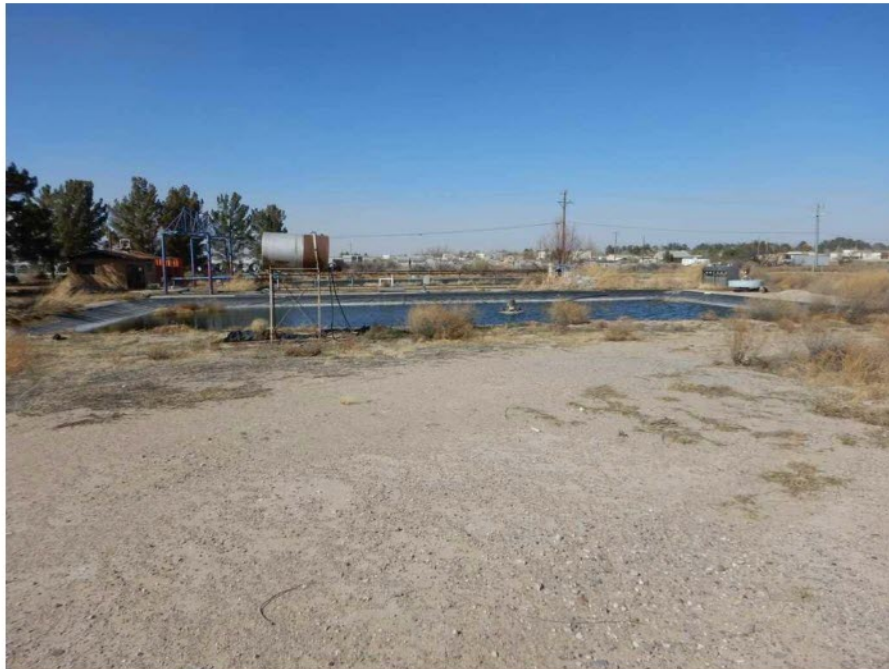
| Photo 1 | DSCN1767.JPG | |

| <p>A lagoon and clarifier that are still present from the previous Santa Teresa WWTP (which was located adjacent to the current North WWTP) are currently being used as overflow capacity for the North WWTP. Overflow wastewater is sent to the lagoon and clarifier directly from the Viewpoint lift station. The lagoon and clarifier are not hard-piped to the North WWTP, CRRUA hires Rain-for-Rent to bring equipment and lay temporary lines to pump stored wastewater to the North WWTP sump, which then pumps all water collected back to the headworks.</p> <p>There have been major air-line repairs to the blower pipes under the wastewater surface - replacing PVC with stainless steel.</p> | | |

| View of lagoon left over from the old Santa Teresa WWTP that is currently used for holding excess flow prior to being pumped to the headworks of the North WWTP. | | |

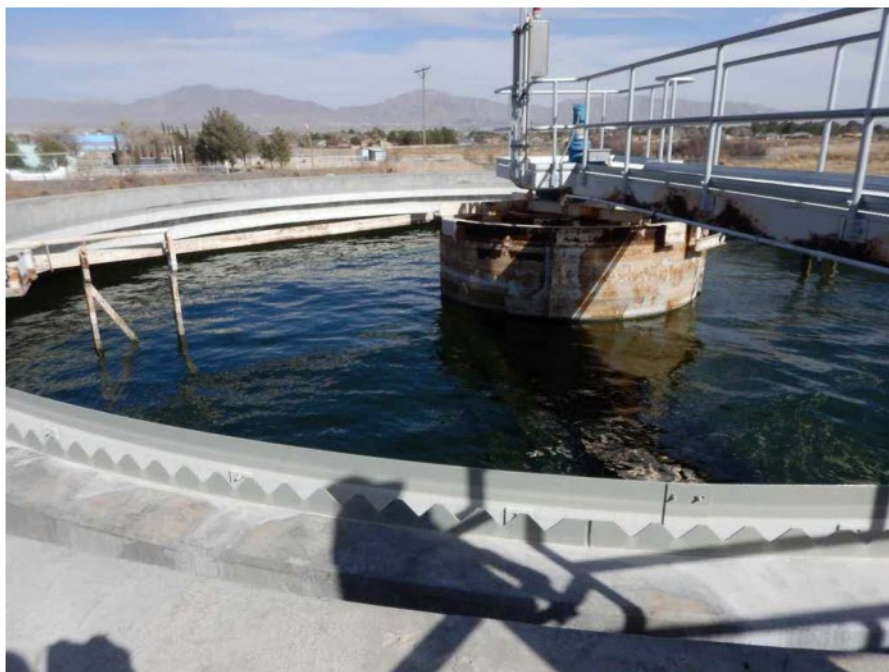
| Photo 2 | DSCN1768.JPG | |

| View of clarifier left over from the old Santa Teresa WWTP that is currently used for holding excess flow prior to being pumped to the headworks of the North WWTP. | | |

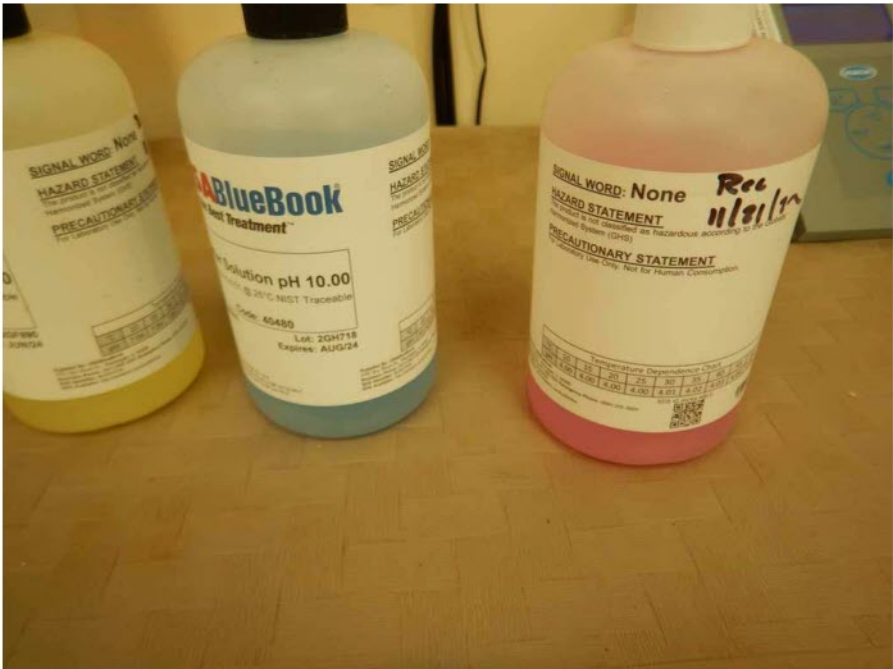
| Photo 4 | DSCN1784.JPG | |

| Location: 5 - Sampling & Laboratory | | |
|---|---|---|
| <p>BOD and TSS are sampled every Wednesday from 10am to 3pm via autosampler. Both autosamplers were cold with thermometers present. Facility personnel stated that they do not flow weight the samples, and there is no documentation was provided showing the times the portions were collected.</p> <p>pH buffers are missing opened-on date and revised expiration date based on the opened date, which may have indicated that buffers were expired. It was therefore impossible to confirm proper calibration of the pH instrument.</p> | | |

| pH buffers missing opened-on and revised expiration dates | | |

| <b>AOC:</b><br>pH buffers are missing opened-on date and revised expiration date based on the opened date, which may have indicated that buffers were expired. It was therefore impossible to confirm proper calibration of the pH instrument. | |

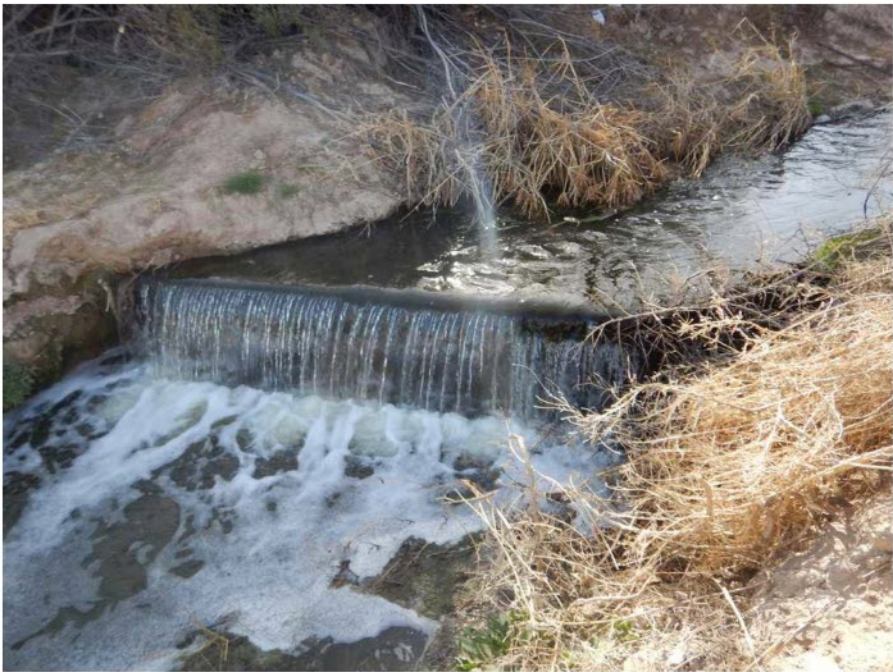
| Photo 5 | DSCN1787.JPG | |

| Location: 3 - Disinfection, Flow Meters & Outfall | | |
|---|---|---|
| <p>The UV system was installed in 2018, but facility personnel report that the system has been a "nightmare" since then. High water has been damaging the UV ballasts. Recently the whole UV system was raised up out of the effluent water level approximately 8-inches, which they hope will solve the problem.</p> | | |

| View of Outfall 001. | | |
