INSPECTION REPORT

Inspection Date:	08/25/2022	Announced: Yes
Time:	Entry: 08:35 AM (ET)	Exit: 02:24 PM (ET)
Media:	Water	
Statute(s)/Program(s):	Clean Water Act, NPDES, WWTP	
Type of inspection:	CEI - Compliance Evaluation Inspection	
Access:	Granted	
Permittee Name: SAGINAW CHIPPEWA INDIAN TRIBE OF MICHIGAN		
Facility or Site Name: SAGANING WWTP		
Facility/Site Physical Address: 2500 EAST WORTH ROAD		
(City, state, zip code) STANDISH, MI 48658		
County/Parish: ARENAC		
Facility GPS Coordinates: 43.92504, -83.90606		
Facility/Site Identifier: 110039409985		
Permit Number: MI0058582

SECTION I – INTRODUCTION**Site Entry and Inspection Objectives**

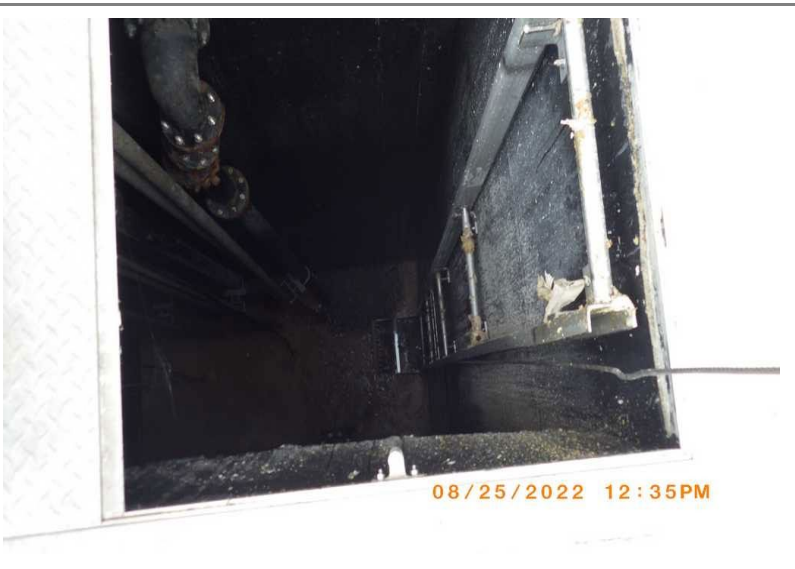
<p>Influent wet well</p>	 
<p>SAGA0100.JPG</p>	
<p>08/25/2022 12:35 PM (ET)</p>	
<p>Dean Maraldo</p>	
<p>Physical Inspection/Headworks</p>	
<p>No CBI</p>	
<p>No PII</p>	
<p>Influent wet well</p>

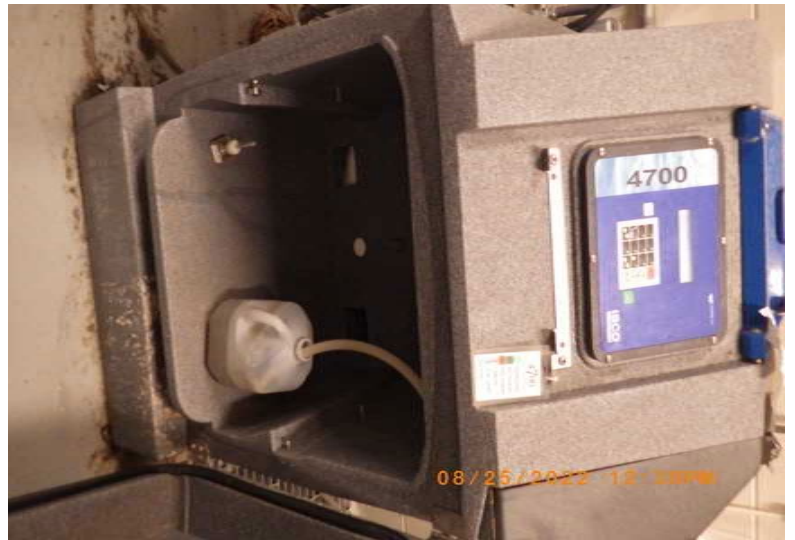
Influent Autosampler (ISCO)
SAGA0103.JPG
08/25/2022 12:39 PM (ET)
Dean Maraldo
Physical Inspection/Headworks
No CBI
No PII
Note, thermometer located inside unit.

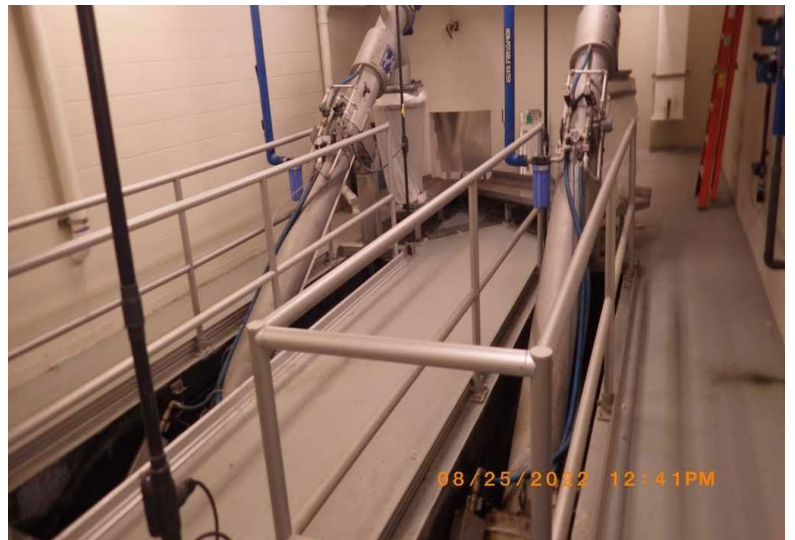
Document(s):	
<ul style="list-style-type: none"> Saganing Inspection_Records Received_Lab SOPs_EquipList_Methods.pdf 	
Unit: Physical Inspection/Headworks	Contains CBI: No
Observation #: DM1-OB-008	Date: 08/25/2022
<p>The Manager led the tour of the wastewater plant, along with Cody Berk. We started at the influent wet well (see Photo Log image SAGA0100). The influent wet well has a basket/rag screen at the bottom of the rail (see Photo Log image SAGA0101). The Manager pointed out where the sludge decant flows returned to the influent wet well and noted that they estimate the amount of return flows and subtract from influent flow totals to avoid double counting of flows. We then entered the treatment plant building and stopped in the influent room to observe the influent flow meter (see Photo Log image SAGA0102) and ISCO influent composite sampler. I noted a thermometer in the ISCO sampler (see Photo Log image SAGA0103).</p> <p>Next we entered the fine screen room and observed the twin fine screen units (see Photo Log image SAGA0104). The Manager said the fine screens are working well.</p>

Twin fine screens
SAGA0104.JPG
08/25/2022 12:45 PM (ET)
Dean Maraldo
Physical Inspection/Headworks
No CBI
No PII

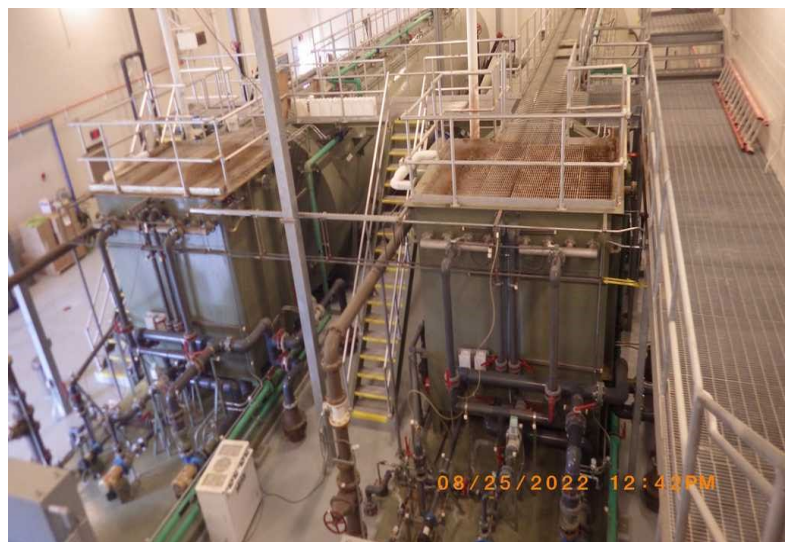
View of MBR units
SAGA0105.JPG
08/25/2022 12:42 PM (ET)
Dean Maraldo
Physical Inspection/MBR
No CBI
No PII

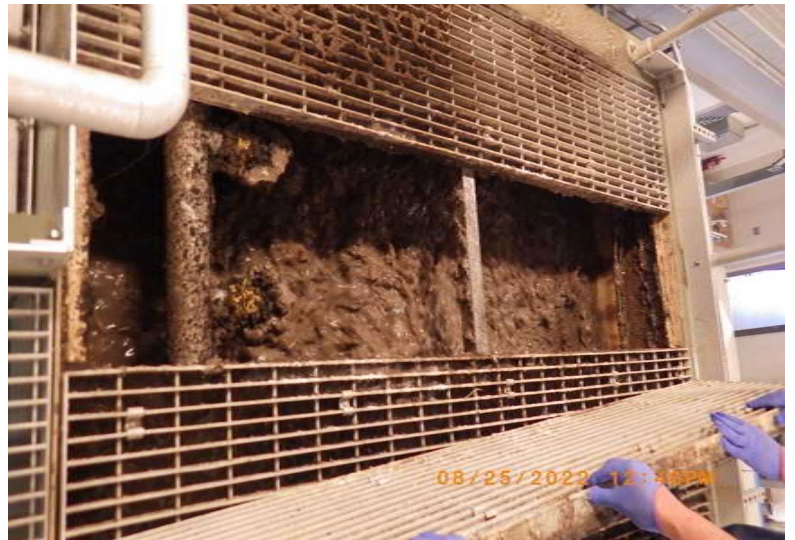
View of MBR Tank
SAGA0106.JPG
08/25/2022 12:48 PM (ET)
Dean Maraldo
Physical Inspection/MBR
No CBI
No PII

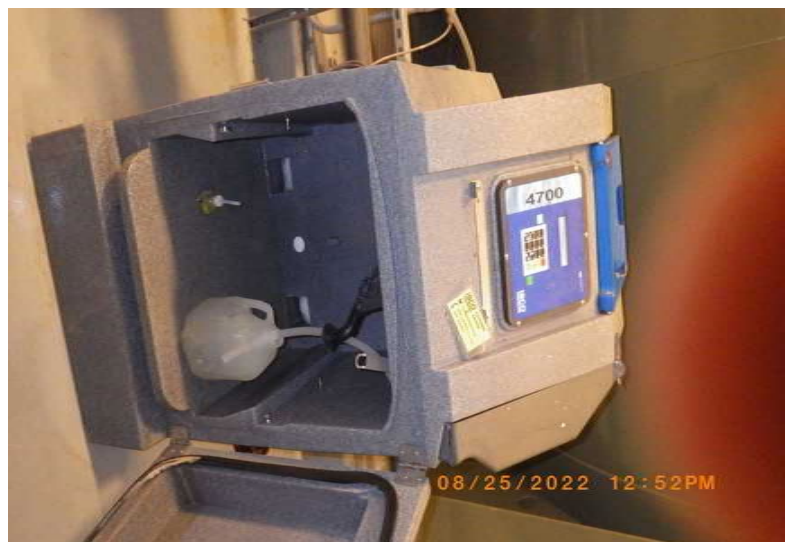
Are the correct effluent sample types (grab or composite) taken? *Not currently, they cannot collect composite samples from MBR #2.*

Effluent Autosampler
SAGA0108.JPG
08/25/2022 12:52 PM (ET)
Dean Maraldo
Physical Inspection/MBR
No CBI
No PII

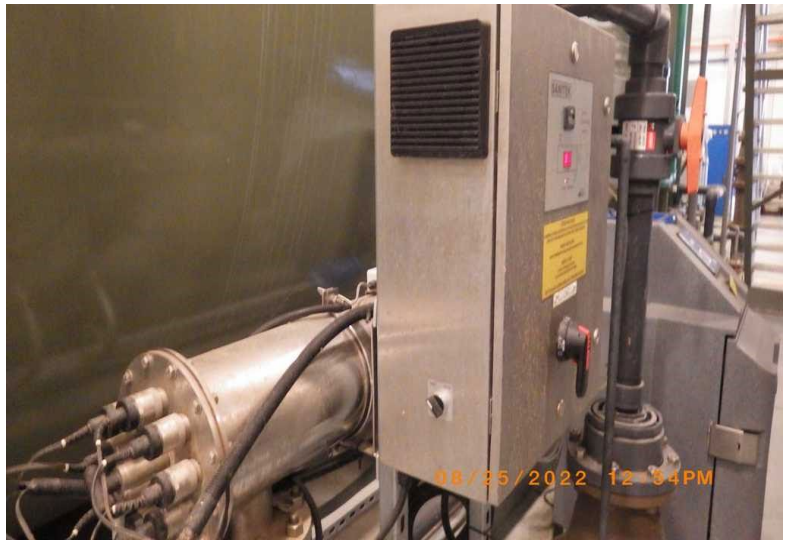
MBR#1 UV system
SAGA0109.JPG
08/25/2022 12:54 PM (ET)
Dean Maraldo
Physical Inspection/UV
No CBI
No PII

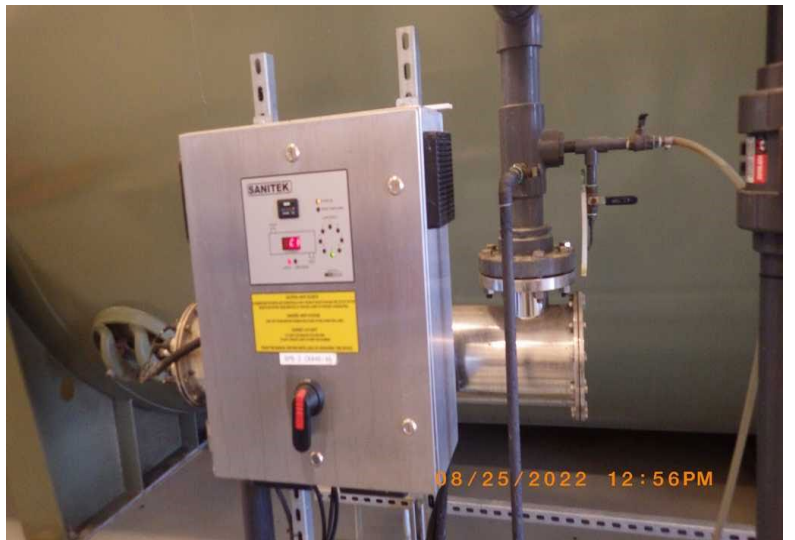
MBR#2 UV system
SAGA0110.JPG
08/25/2022 12:56 PM (ET)
Dean Maraldo
Physical Inspection/UV
No CBI
No PII

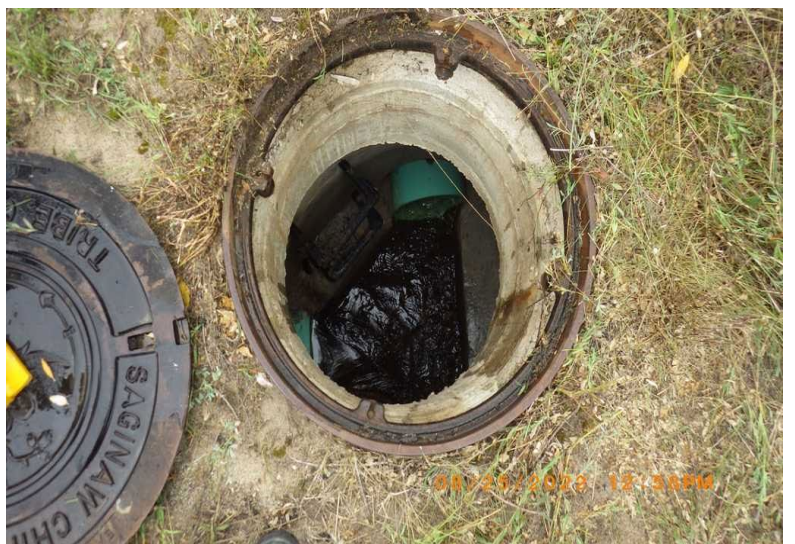
Manhole with access to pond/outfall flow controls
SAGA0111.JPG
08/25/2022 12:58 PM (ET)
Dean Maraldo
Physical Inspection/Outfall
No CBI
No PII

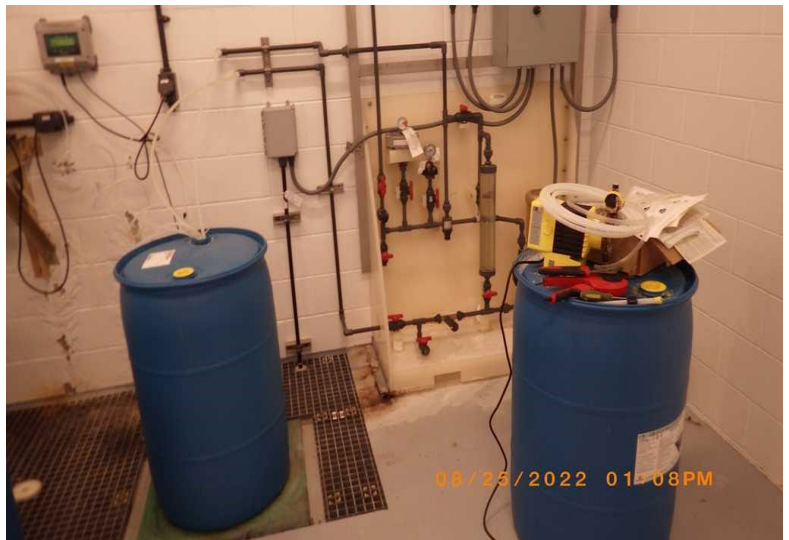
We returned to the treatment building and viewed the Chemical Room. I observed the areas where MBR cleaning chemical are stored, including the sodium hypochlorite area (see Photo Log image SAGA0113), and 50% citric acid area (see Photo Log image SAGA0114). I also observed the aluminum sulfate storage area (see Photo Log image SAGA0115). Aluminum sulfate is used for phosphorus removal.

Sodium hypochlorite area
SAGA0113.JPG
08/25/2022 1:08 PM (ET)
Dean Maraldo
Physical Inspection/Chemical Room
No CBI
No PII

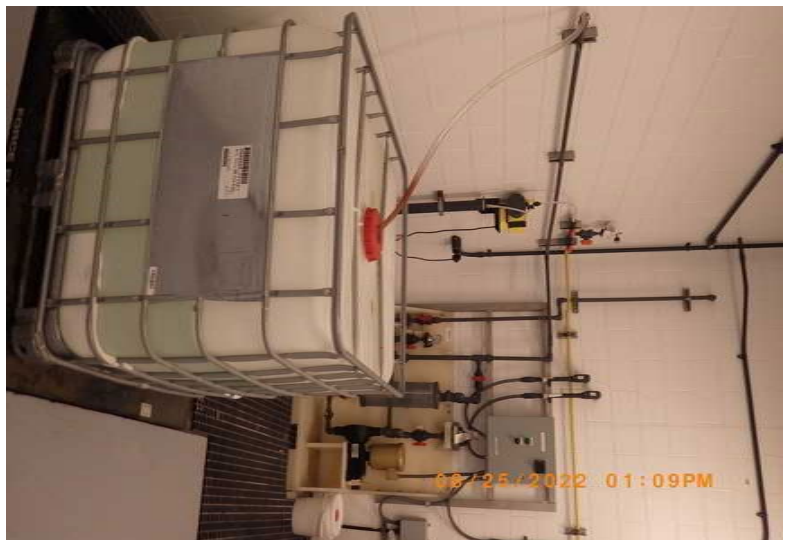
50% citric acid area
SAGA0114.JPG
08/25/2022 1:09 PM (ET)
Dean Maraldo
Physical Inspection/Chemical Room
No CBI
No PII

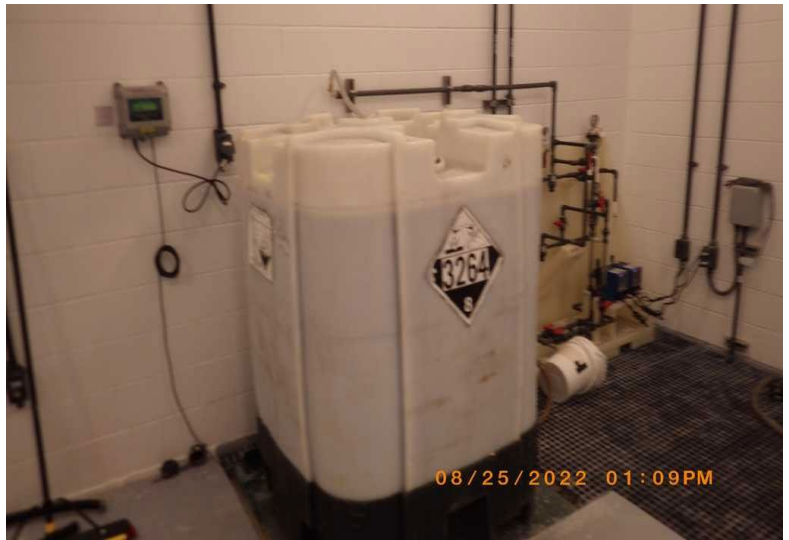
Aluminum sulfate storage area
SAGA0115.JPG
08/25/2022 1:09 PM (ET)
Dean Maraldo
Physical Inspection/Chemical Room
No CBI
No PII

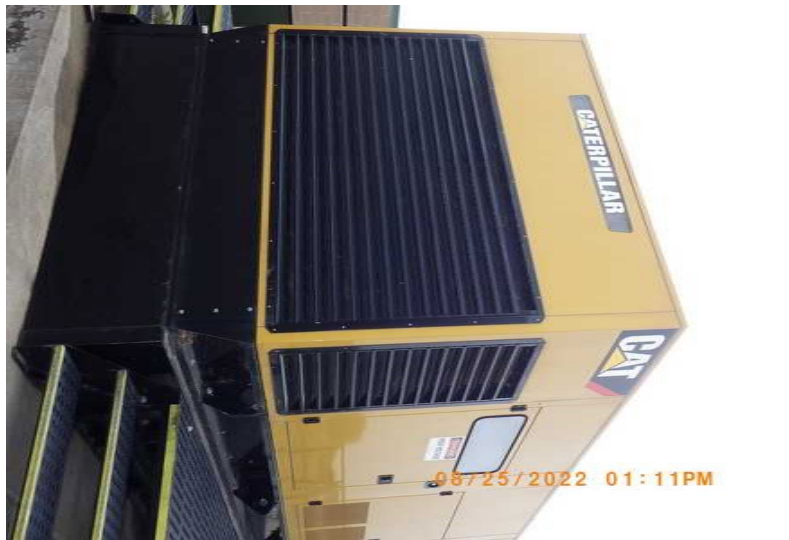
I observed the diesel Caterpillar generator which provides backup power for the Facility (see Photo Log image SAGA0116).

Facility backup generator (Diesel)
SAGA0116.JPG
08/25/2022 1:11 PM (ET)
Dean Maraldo
Physical Inspection/Generator
No CBI
No PII

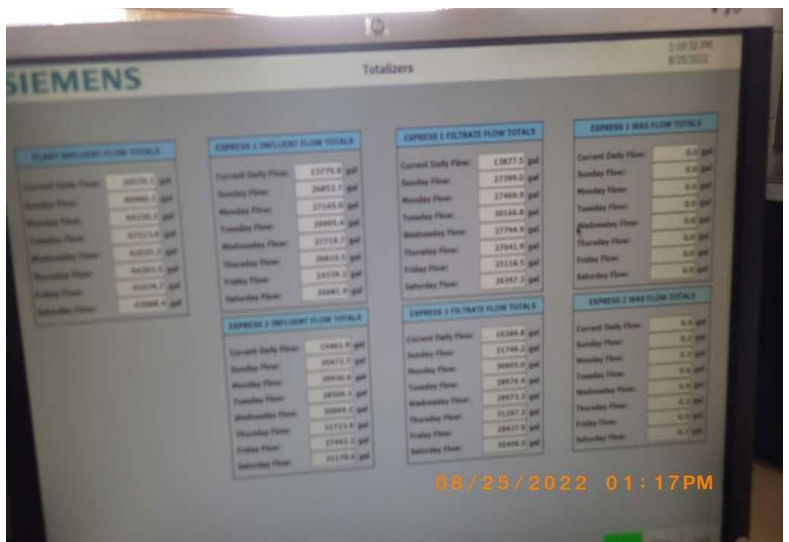
WWTP SCADA Totalizer Screen
SAGA0117.JPG
08/25/2022 1:17 PM (ET)
Dean Maraldo
Physical Inspection/SCADA
No CBI
No PII

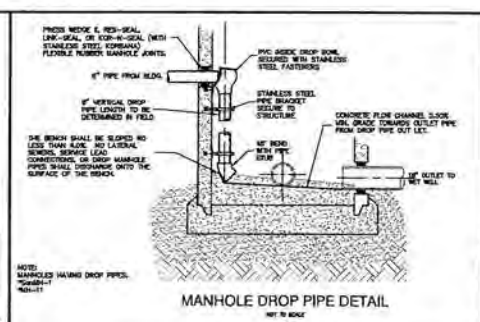
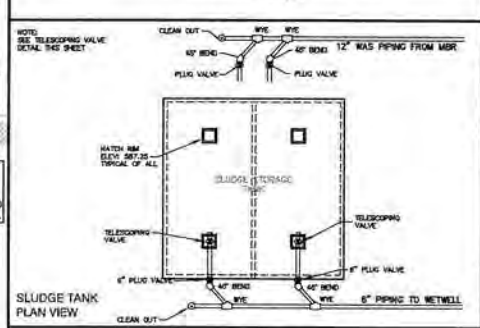
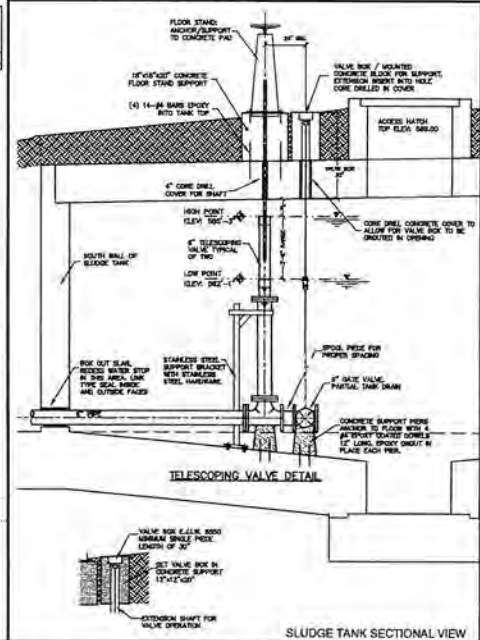
SHEET NUMBER
C-2

SCIT - SAGANING
WATER TREATMENT FACILITIES
WATER AND WASTE WATER LAYOUT
YARD PIPING PLAN
