## **RCRA Inspection Report**

Dupont Specialty Product USA LLC  
4250 Campground Road  
Louisville, KY 40216  
Richmond County

EPA ID# KYR000065805  
NAICS# 325120 - Industrial Gas Manufacturing

**Attachment A**  
**Photographs of DuPont Specialty Products USA LLC**  
**EPA ID# KYR000065805**  
**By: Callie Hite, KDEP**

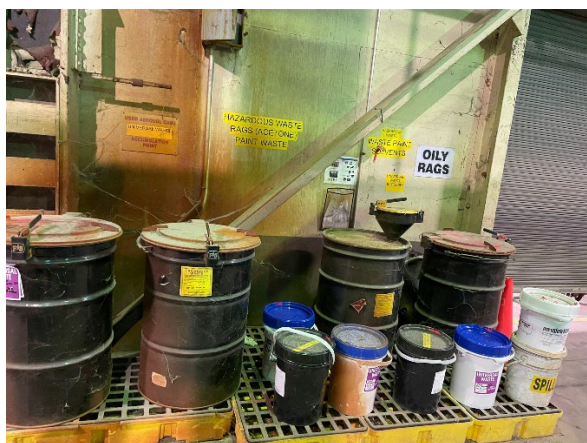
The SAA comprised of several drums and poly container on spill pallets. The SAA was used to store hazardous waste comprising of solvent contaminated waste rags and waste paint solvents. In the same area, universal waste was also stored (Photo-1). Both the SAA containers were observed to be closed and labeled with the words "Hazardous Waste". One SAA container with a latched funnel labeled as containing "waste paint and solvents" had a hazard indication label as "Flammable Liquid" (Photo-2). The other SAA container with a hinged lid labeled as "Rags with Acetone and Paint Waste" was not marked with a hazard indication label (Photo-3).

In the same area, the inspectors observed universal waste also being stored (Photo-1). The universal waste comprised of spent aerosol cans and spent batteries. All the containers were observed to be closed and labeled as "Universal Waste". The oldest accumulation start date was observed to be 04/06/2023. The containers were observed to be intact and nonleaking.

Photo-1 SAA and Universal Waste (Maintenance Shop)

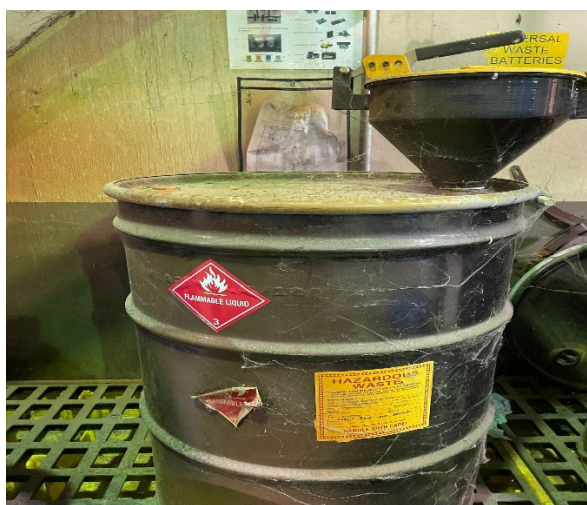
Photo-2 SAA Container (Maintenance Shop)

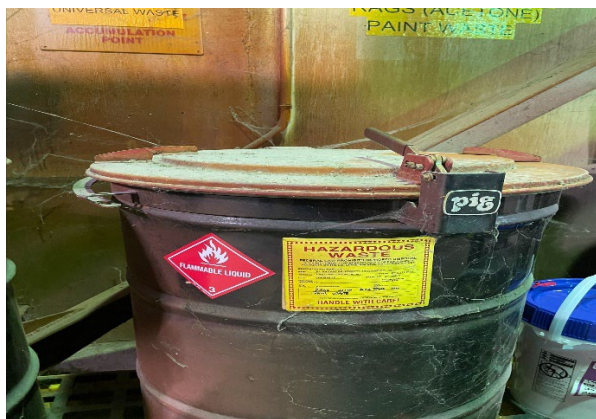
**Pursuant to 401 KAR 39:080 Section 1(1) [40 C.F.R. § 262.15(a)(5)], which is a condition of the SAA Permit Exemption, a generator is required to mark or label its containers with an indication of the hazards of the contents.**

Photo-3 SAA Container (Maintenance Shop)

The containers holding the waste were observed to be in good condition. There were no leaks or spills observed near the SAA containers. The SAA container was later marked with appropriate hazard indication label during the inspection (Photo-3).

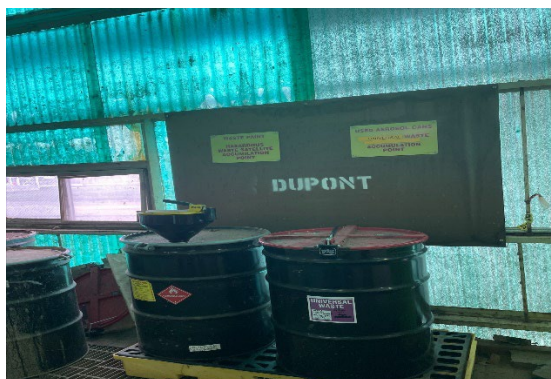
The inspectors observed two 55-gallon containers on the spill pallets (Photo-4). One 55-gallon SAA container with a latched funnel contained waste paint. The container was observed to be closed, labeled with the words “Hazardous Waste” and had a hazard indication label as “Flammable Liquid”. The other 55-gallon container with a latch was also closed, labeled with the words “Universal Waste” contained spent aerosol cans. The container was dated 01/17/2024. Both the containers were observed to be intact and nonleaking. Adjacent to the SAA containing waste paint, there was another SAA on a spill pallet comprising of one 55-gallon container and a spill kit (Photo-5). The SAA container was observed to be closed, labeled with the words “Hazardous Waste” and had a hazard indication label.

Photo-4 SAA (C&D Refrigeration Building)

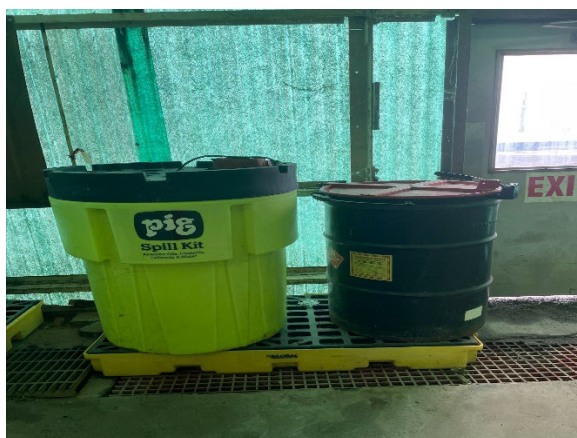
Photo-5 SAA (C&D Refrigeration Building)

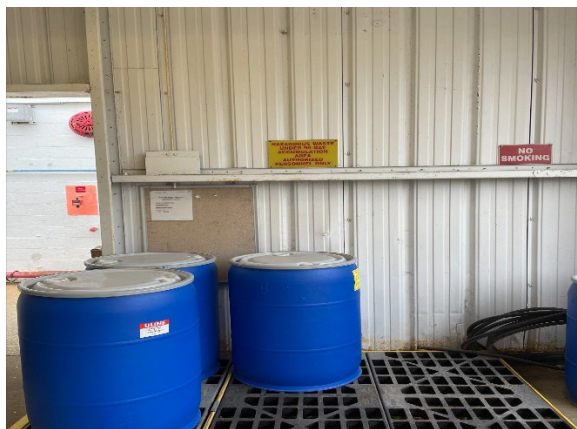
There were three 55-gallon plastic containers on the spill pallets (Photo-6) in the CAA. All the containers were observed to be closed, labeled with the words “Hazardous Waste” and with accumulation start dates. The oldest accumulation start date was observed to be 12/13/2023. There were no hazard indication labels on the containers to reflect the specific hazard associated with the waste.

**Pursuant to 401 KAR 39:080 Section 1(1) [40 C.F.R. § 262.17(a)(5)(i)(B)], which is a condition of the LQG Permit Exemption, a generator must mark or label its containers with an indication of the hazards of the contents.**

There were no leaks or spills in the accumulation area. The containers were observed to be in good condition. The storage area was equipped with a “No Smoking” sign and a spill kit.

Photo-6 Central Accumulation Area

The containers were later marked with appropriate hazard indication labels during the inspection. There was universal waste and used oil container in the storage area. There was one container containing 4-foot used lamps. The container was closed, labeled, and dated; one 55-gallon used oil container was also closed and labeled as “Used Oil”.
