**Region 6 - Enforcement & Compliance Assurance Division**  
**INSPECTION REPORT**

| Company Name: | <b>Neilco (4063) 3G Energy</b> | |
| Facility Name: | <b>Frost F1 SWD</b> | |

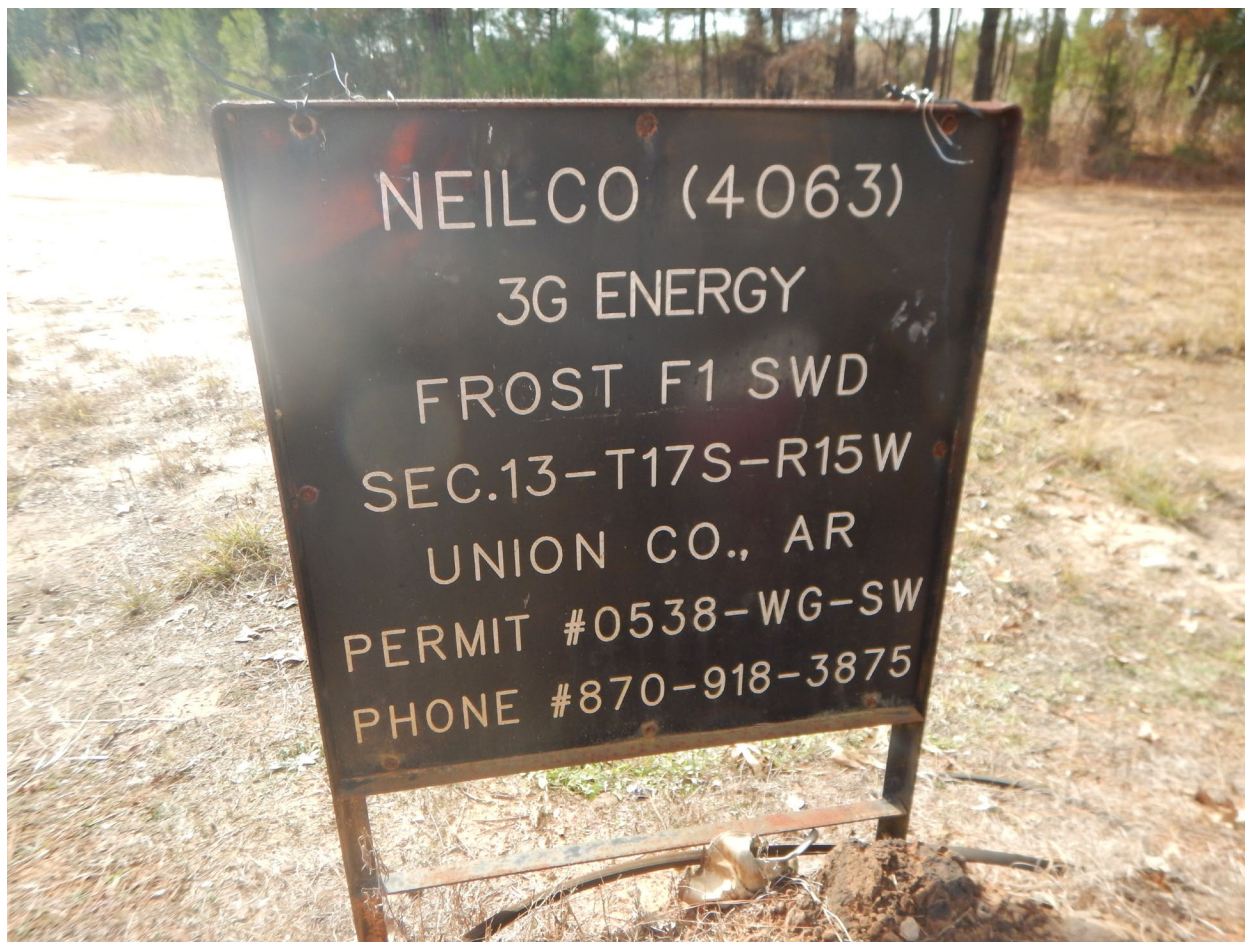
Photo No. 1

**Description:** This photo was taken looking SW at the facility showing the facility sign.

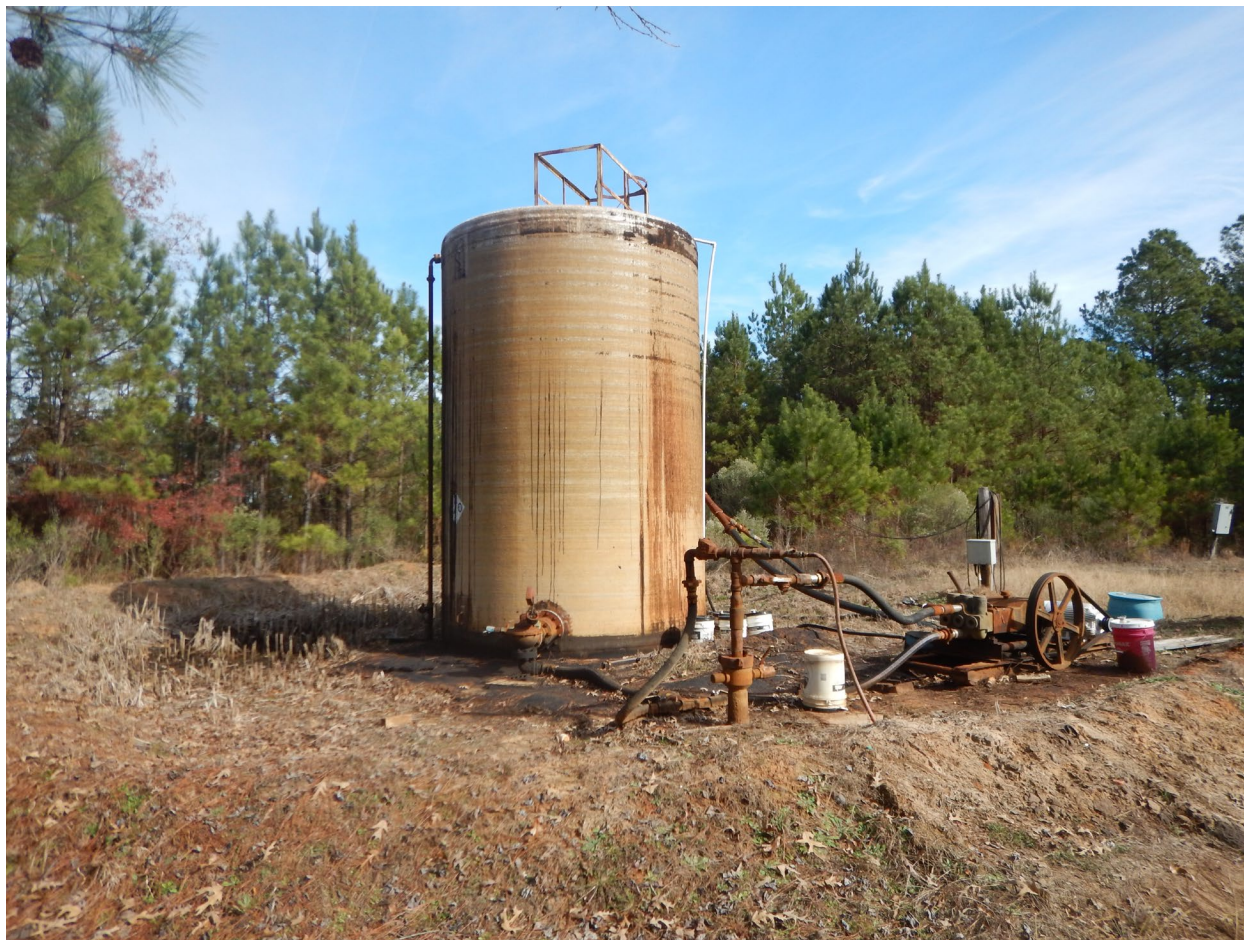
Photo No. 2

No closing conference was held due to no Neilco (4063) 3G Energy staff being present during the inspection. Areas of concern at the time of the inspection include: 1) secondary containment berm was low and should be built back up; 2) three pipes did not have caps on them; 3) loose oil within secondary containment; and 4) the plate on the tank was covered in oil and could not read the gallon amount.

**Description:** This photo was taken looking N at the facility showing overall facility overview.

Inspector will conduct follow-up phone calls with the company representatives over the coming weeks and months to ensure areas of concern are properly addressed.
