## **RCRA Inspection Report**

Clariant Corporation  
Mount Holly West Plant  
625 East Catawba Avenue  
Mount Holly, North Carolina 28120

January 16, 2025, 9:55 AM

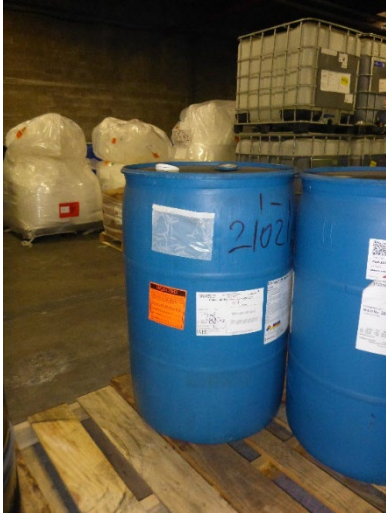
In the Warehouse #3 area designated for storing products and raw materials, the inspectors observed three 55-gallon containers with "rejected" stickers. One of these 55-gallon containers was identified with a potassium hydroxide product label and dated May 13, 2024 (Photo 1); one container was identified with a potassium hydroxide product label and dated October 17, 2024 (Photo 2); and one container was identified with a phosphoric acid product label and dated August 6, 2024 (Photo 3). In an email dated February 17, 2025, Lisa King stated that following the CEI, Clariant personnel determined that each container contained water and the contents were placed into the on-site wastewater treatment plant system.

**Photo 1:** One of three 55-gallon containers with a “rejected” sticker in Warehouse #3. The container is identified with a potassium hydroxide product label and dated May 13, 2024.

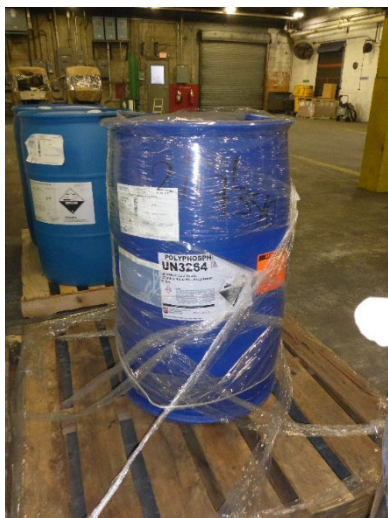
**Photo 2:** One of three 55-gallon containers with a “rejected” sticker in Warehouse #3. The container is identified with a potassium hydroxide product label and dated October 17, 2024.

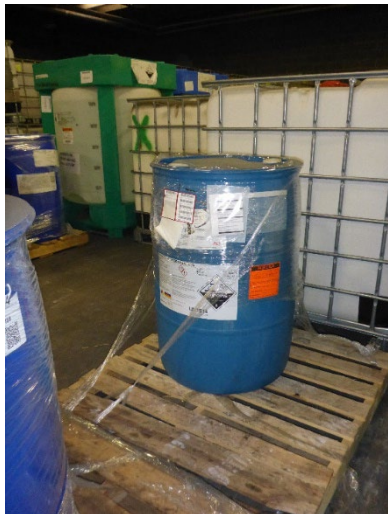
**Photo 3:** One of three 55-gallon containers with a “rejected” sticker in Warehouse #3. The container is identified with a phosphoric acid product label and dated August 6, 2024.

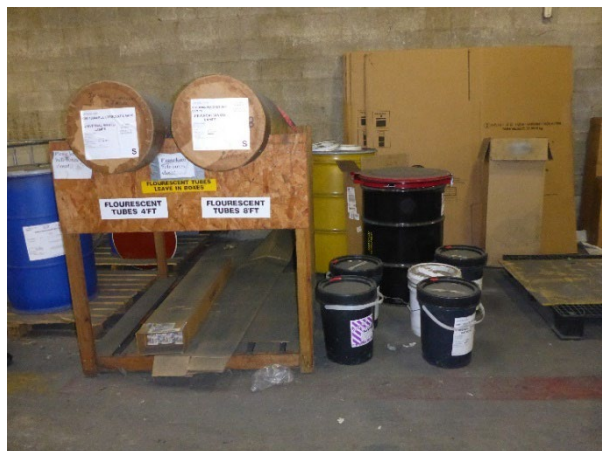
In this CAA, the inspectors observed (Photo 4): one 4-foot-long cardboard cylinder, labeled 4' universal waste lamps and dated November 22, 2024; one 8-foot-long cardboard cylinder, labeled 8' universal waste lamps and dated August 16, 2024; one 5-gallon container, labeled universal waste lithium batteries and dated July 19, 2023; one 5-gallon container, labeled universal waste batteries and dated February 28, 2024; one 5-gallon container, labeled universal waste NiCad batteries and dated August 30, 2023; one 5-gallon container, labeled used ballast; one 5-gallon container, labeled used HID lamps; one 55-gallon container, labeled universal waste aerosols and dated November 29, 2023; and one cubic yard box, labeled universal waste e-waste and dated November 18, 2024. Three of the containers of universal waste were marked with an accumulation start date greater than one year old (July 19, 2023, August 30, 2023, and November 29, 2023).

**Photo 4:** Containers of universal waste stored in the Warehouse #3 CAA.

**Pursuant to 15A NCAC 13A .0199(b) [40 C.F.R. § 273.13(d)(1)], a SQHUW must contain any lamp in containers or packages that are structurally sound, adequate to prevent breakage, and compatible with the contents of the lamps. Such containers and packages must remain closed and must lack evidence of leakage, spillage or damage that could cause leakage under reasonably foreseeable conditions.**

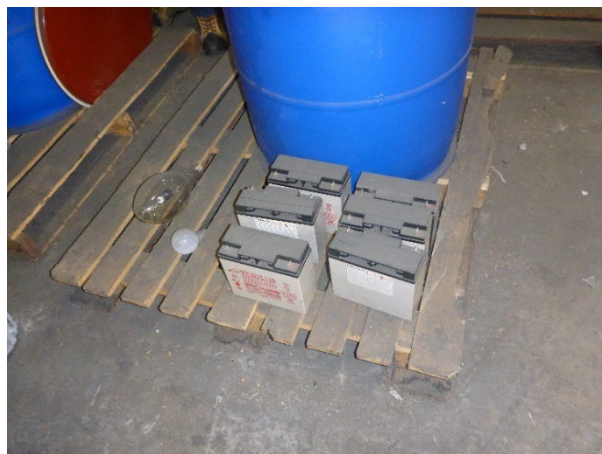
**Photo 5:** Six lead-acid batteries and one HID lamp on a wooden pallet at the Warehouse #3 CAA.

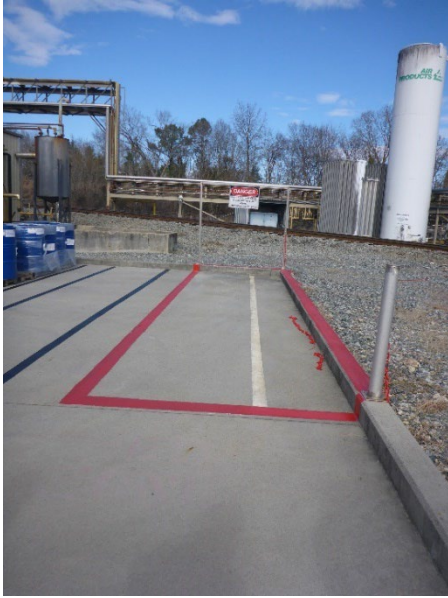
Plant 3, Plant 4, and Plant 5 are each equipped with a designated “Red Zone” for staging containers of wastes generated in their respective production areas. While staged in the Red Zone, each container of waste is marked with the name of the process generating the waste and with the date of generation. Each container is also labeled as hazardous waste pending analysis, non-hazardous waste pending analysis, hazardous waste, or non-hazardous waste. When ESHA Department personnel have performed the final waste characterization determination, personnel verify that the containers in the Red Zone are properly marked, labeled, dated, compatible with the waste, and inventoried before they are transferred to the appropriate storage area. Containers can only be staged in the Red Zone for up to 72 hours. The inspectors did not observe any waste containers in the Plant 4 Red Zone at the time of the inspection (Photo 6).

**Photo 6:** The Plant 4 Red Zone.

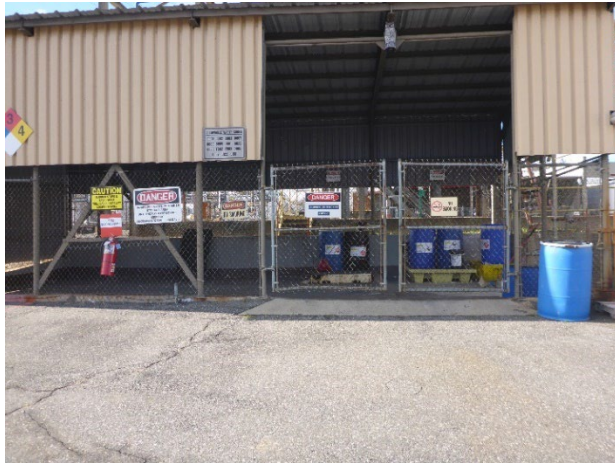
The hazardous waste Permitted Container Storage Area (Photo 7) is located on a bermed storage pad, which is approximately 35 feet by 16 feet, is subdivided by a masonry curb, enclosed by a chain link fence, and covered by a lean-to roof. According to the RCRA Permit, up to 64 55-gallon drums (or 16 totes) of ignitable and ignitable-compatible waste can be stored on the larger, left side of the masonry curb, and up to 24 55-gallon drums (or 6 totes) of corrosive and corrosive-compatible waste can be stored on the smaller, right side. The area is identified with a “no smoking” sign, and it is equipped with a fire extinguisher, an emergency shower and eyewash station, and spill response equipment.

**Photo 7:** The Permitted Container Storage Area.

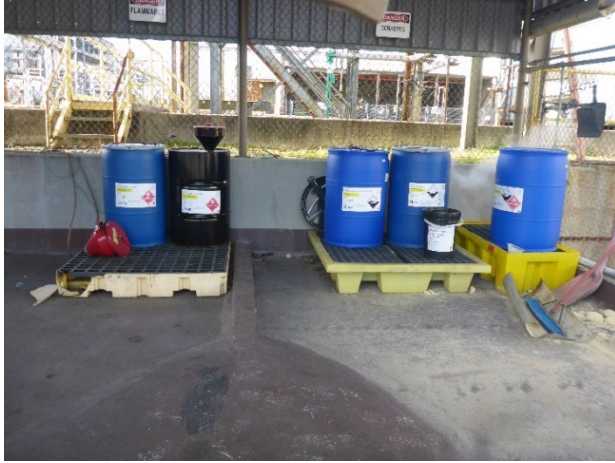
Because the area was secured with a padlock, the inspection participants did not enter the Permitted Container Storage Area. However, the inspectors observed the contents of the permitted area through the chain link fence (Photo 8). On the larger, left side of the masonry curb, the inspectors observed two 55-gallon containers on a secondary containment pallet. One container was labeled as hazardous waste spent lab vials and the other was labeled as hazardous waste mixed solvents. Each container was identified with a DOT flammable liquid hazard sticker. On the smaller, right side of the masonry curb, the inspectors observed two 55-gallon containers and one 5-gallon container on one secondary containment pallet, and two 55-gallon containers on another secondary containment pallet. On the first pallet, one 55-gallon container was labeled as hazardous waste sodium hydroxide solution and identified with a DOT corrosive hazard sticker; the other 55-gallon container was labeled hazardous waste COD vials and identified with DOT corrosive and toxic hazard stickers; and the 5-gallon container was labeled as non-regulated sharps. On the second pallet, each of the two 55-gallon containers was labeled hazardous waste glacial acetic acid and marked with DOT corrosive and flammable hazard stickers.

As noted above, one 55-gallon container of hazardous waste sodium hydroxide solution and one 55-gallon container of hazardous waste COD vials were observed on the same secondary containment pallet within the Permitted Container Storage Area. According to Clariant’s waste profile records, hazardous waste COD vials contain sulfuric acid and mercury sulfate. The

**Photo 8:** Containers of hazardous waste stored in the Permitted Container Storage Area.

**Pursuant to Permit No. NCD085074821-R3, Part III – Storage/Treatment in Containers, H3 Special Requirements for Incompatible Waste, the Permittee shall not store a container of hazardous waste that is incompatible with any waste or material stored nearby in other containers, piles, open tanks or surface impoundments unless the container is separated from the other materials by a dike, berm, wall, or other device.**

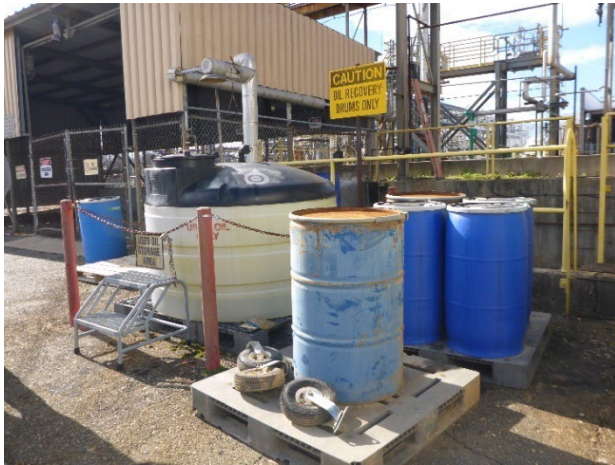
The inspectors also observed two 55-gallon steel containers and three 55-gallon plastic containers on wooden pallets next to the used oil tank (Photo 9). The steel containers held small used tires that appeared to have been removed from golf-carts used on-site. The plastic containers held gravel that Mr. Grieneisen stated was generated from the cleanout of on-site storm sewer lines to improve the capacity and effectiveness of the on-site stormwater management system.

**Photo 9:** Two 55-gallon steel containers and three 55-gallon plastic containers on wooden pallets next to the used oil tank.

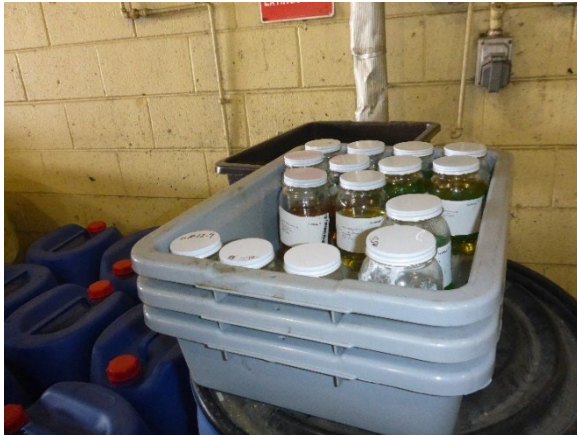
The inspectors observed three 55-gallon containers one bin of fifteen <½-gallon containers (Photo 10) in the Plant 1 SAA. One 55-gallon container was labeled as non-hazardous / non-regulated waste; another 55-gallon container was labeled as loosepacked lab retains D001 hazardous waste flammable liquid (solvent naphtha 1,2,4-trimethylbenzene) and dated December 30, 2024 (Photo 11); the last 55-gallon container, which was empty, was labeled as solvent paste loosepack D001, D035 hazardous waste, identified with a DOT flammable liquid hazard sticker, marked as toxic for RCRA only, and dated October 11, 2024 (Photo 12). Each <½-gallon container was labeled with information related to the sample retain material inside the container, and four were marked to indicate that the pH of the material was >11. None of the waste sample retain containers were labeled with the words “Hazardous Waste” or marked with an indication of the hazards of its contents.

**Photo 10:** Fifteen  $< \frac{1}{2}$ -gallon containers of retain samples in the Plant 1 SAA.

**Pursuant to 15A NCAC 13A .0107(a) [40 C.F.R. § 262.15(a)(5)], which is a condition of the SAA Permit Exemption, a generator is required to mark or label its containers (i) with the words “Hazardous Waste” and (ii) with an indication of the hazards of the contents.**

While the SAA Permit Exemption does not prohibit a facility from managing more than one container in the same SAA, it does limit the total volume of waste in a SAA to be no more than 55 gallons. At the time of the inspection, the total capacity of the hazardous waste containers observed in the Plant 1 SAA exceeded the SAA Permit Exemption limit, but the total volume of hazardous waste observed in these containers was less than 55-gallons. Please note that, if Clariant were to accumulate hazardous waste in excess of 55 gallons at any SAA, 15A NCAC 13A .0107(a) [40 C.F.R. § 262.15(a)(6)] requires the facility to either comply with 15A NCAC 13A .0107(a) [40 C.F.R. § 262.17(a)] with respect to that amount of excess waste or to remove the excess waste from the SAA within three consecutive calendar days.

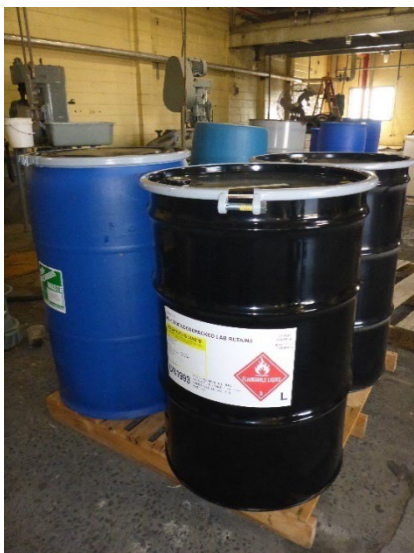
**Photo 11:** One 55-gallon container in the Plant 1 SAA. The container was labeled as loosepacked lab retains D001 hazardous waste flammable liquid (solvent naphtha 1,2,4-trimethylbenzene) and dated December 30, 2024.

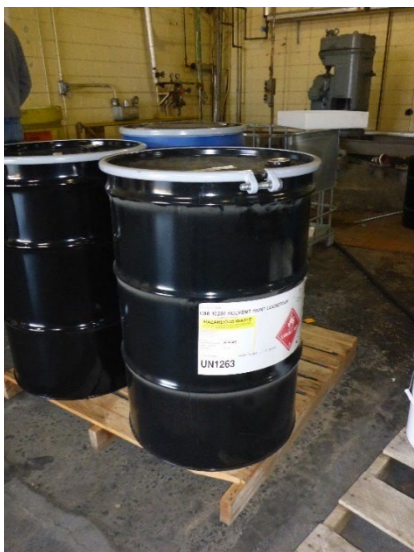
**Photo 12:** Empty 55-gallon container in the Plant 1 SAA. The container was labeled as solvent paste loosepack D001, D035 hazardous waste, identified with a DOT flammable liquid hazard sticker, marked as toxic for RCRA only, and dated October 11, 2024.

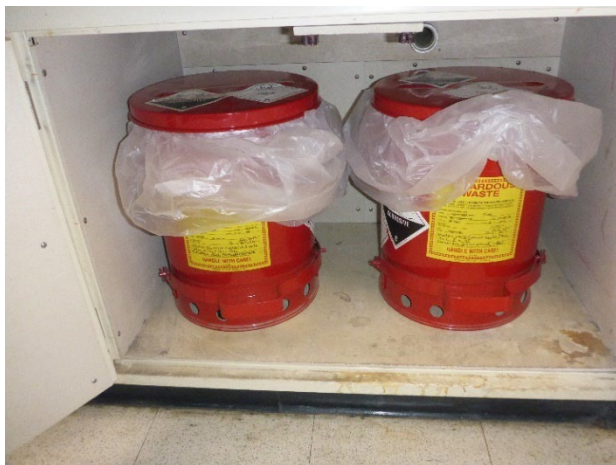
Clariant manages a SAA in the Wastewater Treatment Laboratory for accumulating waste COD vials and waste reagent vials. The inspectors observed two 5-gallon containers in this SAA (Photo 13). One container, labeled D002, D007, D011 hazardous waste corrosive liquid, toxic (sulfuric acid, potassium dichromate, silver), was in use at the time of the inspection. The other container, labeled D002, D007, D009, D011 hazardous waste corrosive and toxic liquid (sulfuric acid, mercuric, sulfuric), was identified as a backup accumulation container.

**Photo 13:** Two 5-gallon containers in the Wastewater Treatment Laboratory SAA.

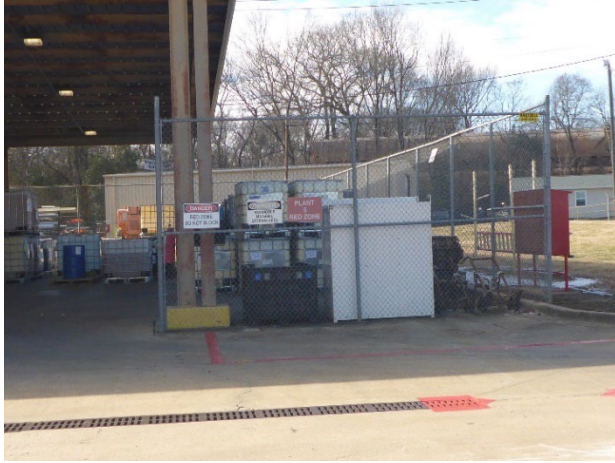
**Photo 14:** The Plant 5 Red Zone.

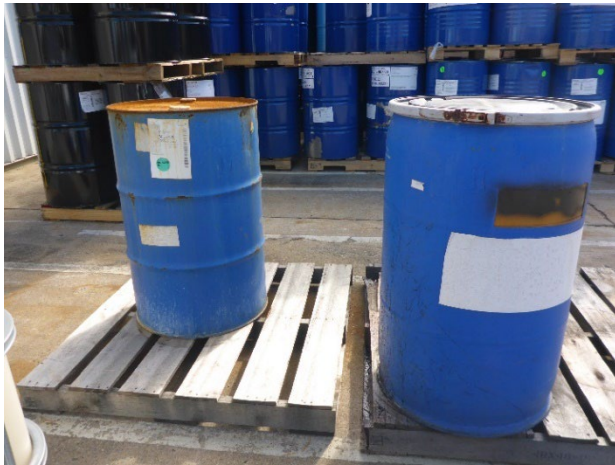
The inspectors also observed one 55-gallon container identified as “kitty litter” and one 55-gallon container identified with a Clariant Hostacoris product label in the product storage area next to the CAA (Photo 15). The Hostacoris container was rusting, and was marked with the words, “do not inventory.” In an email dated February 17, 2025, Lisa King stated that the Hostacor is a raw material used in one of Clariant’s products, and that the container is being stored as a product.

**Photo 15:** One 55-gallon container identified as “kitty litter” and one 55-gallon container identified with a Clariant Hostacoris product label in the product storage area next to the Plant 5 CAA.
