### INSPECTION REPORT

| Regulatory Program(s) | Water (CWA) Brine Program (Oil & Gas inspection) | |
| Company Name: | <b>Arkansas Production Services, LLC</b> | |
| Facility Name: | <b>Joyce-Farris Tank Battery</b> | |

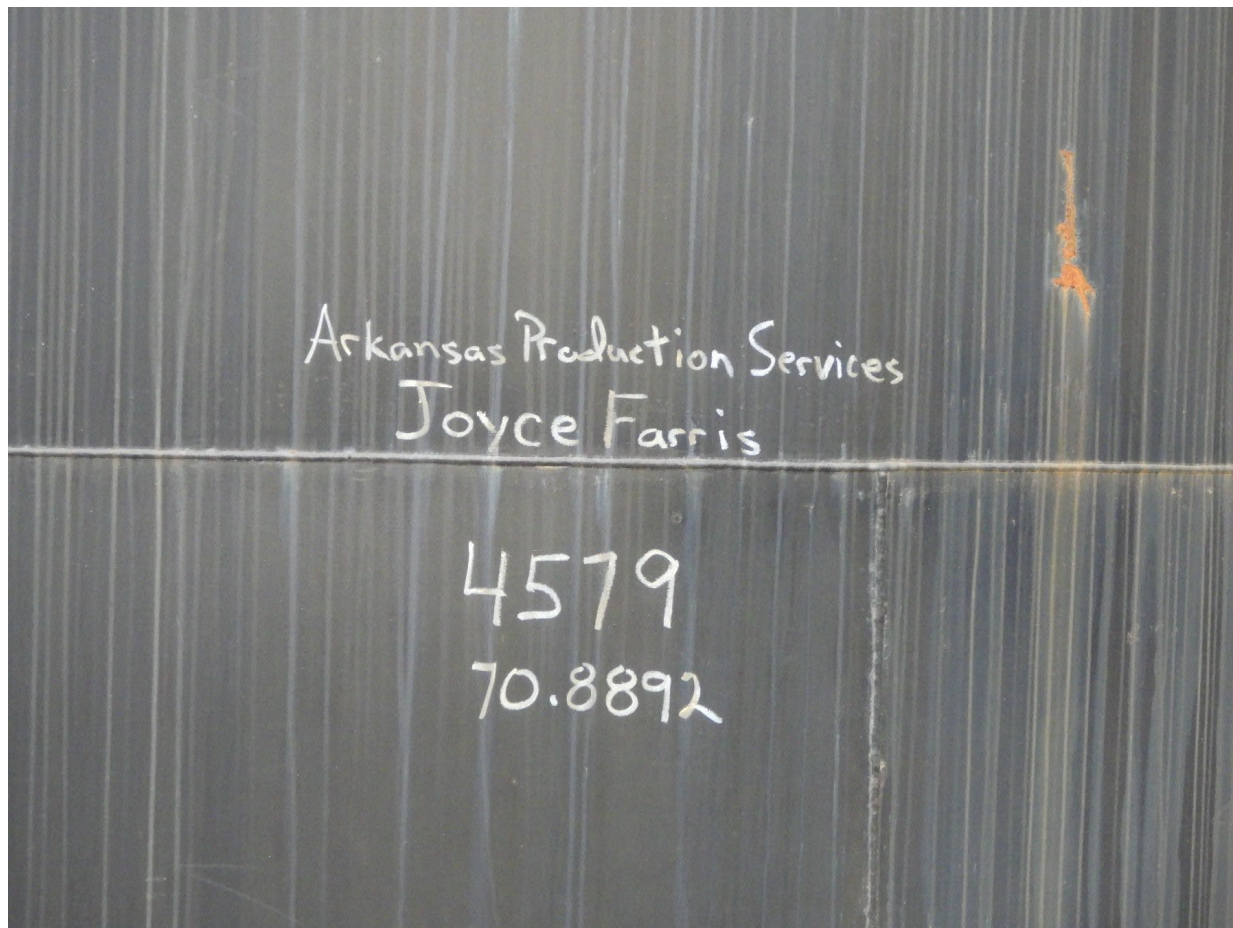
Photo No. 1

I observed the facility signage and an overview of the facility; see Appendix 1 (Photograph Log), Photos No. 1 and No. 2. For additional GPS location and photo metadata, see Appendix 1.

| Description: | Looking N, this photo shows tank labeling that identifies the company and lease names. | | |

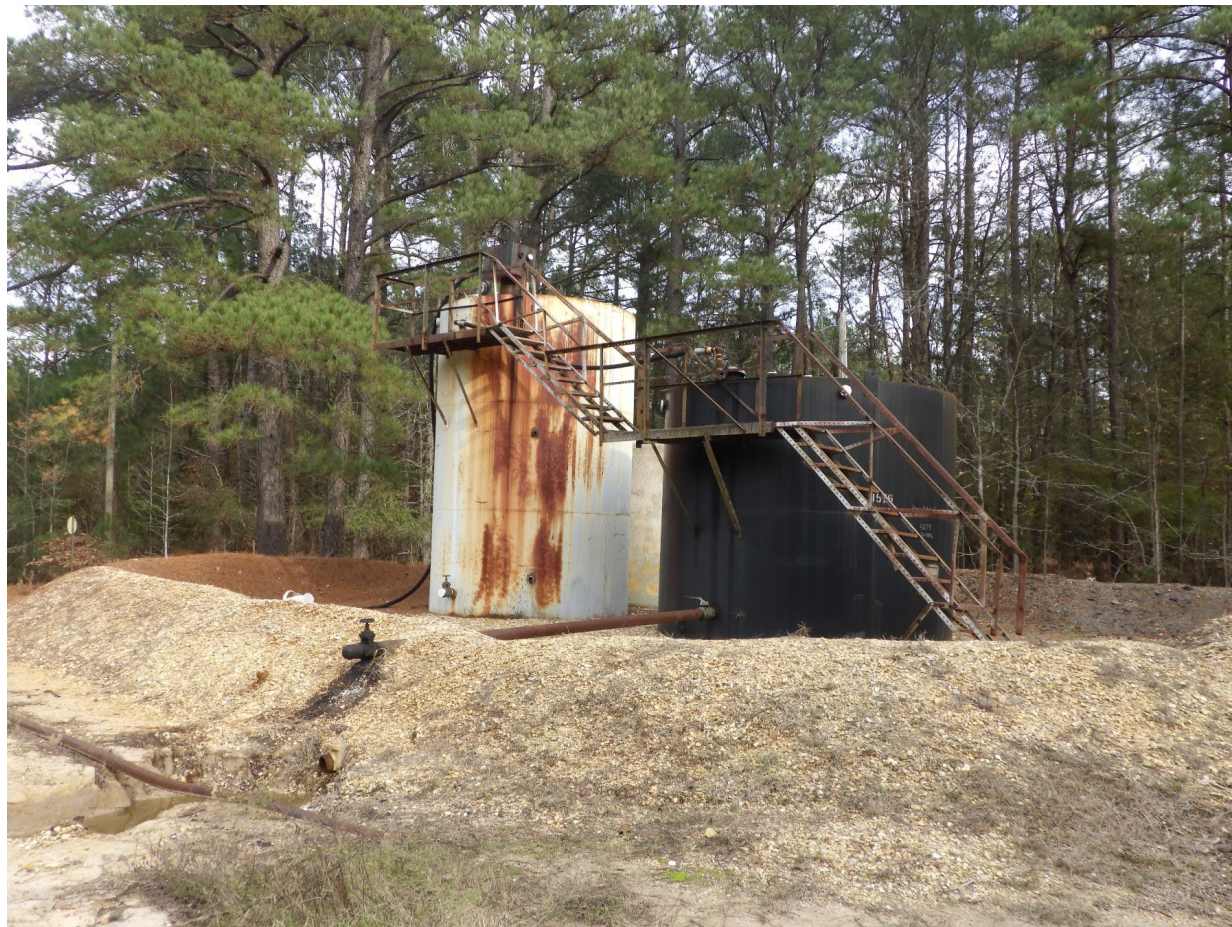
Photo No. 2

| Description: | Looking NE, this photo shows an overview of the facility. | | |

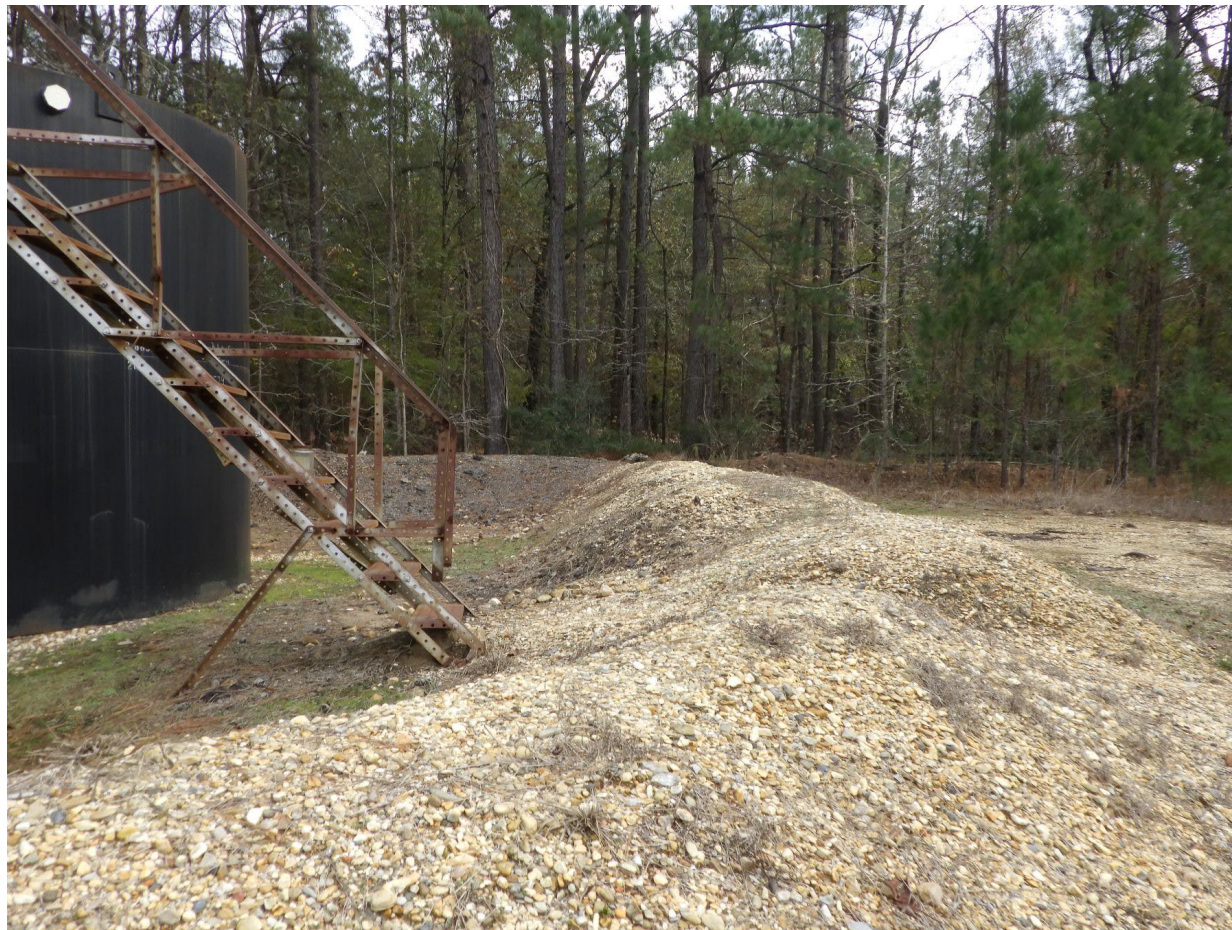
Photo No. 3

I observed the right side of the tank battery, see Photo No. 3.

| Description: | Looking E, this photo shows the right-side view of the containment structure. | | |

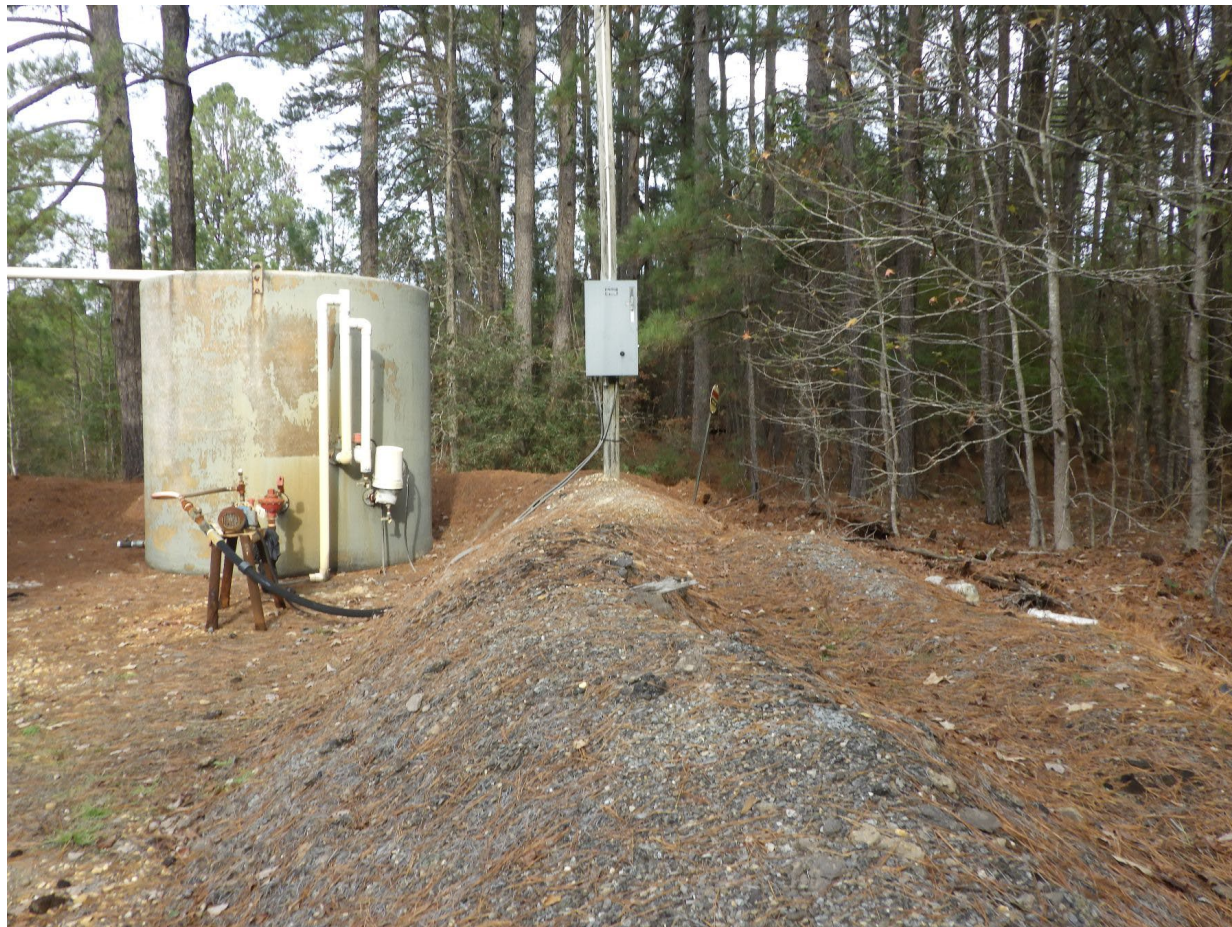
Photo No. 4

I observed the backside of the tank battery, see Photo No. 4.

| Description: | Looking NNE, this photo shows the backside view of the containment structure. | | |

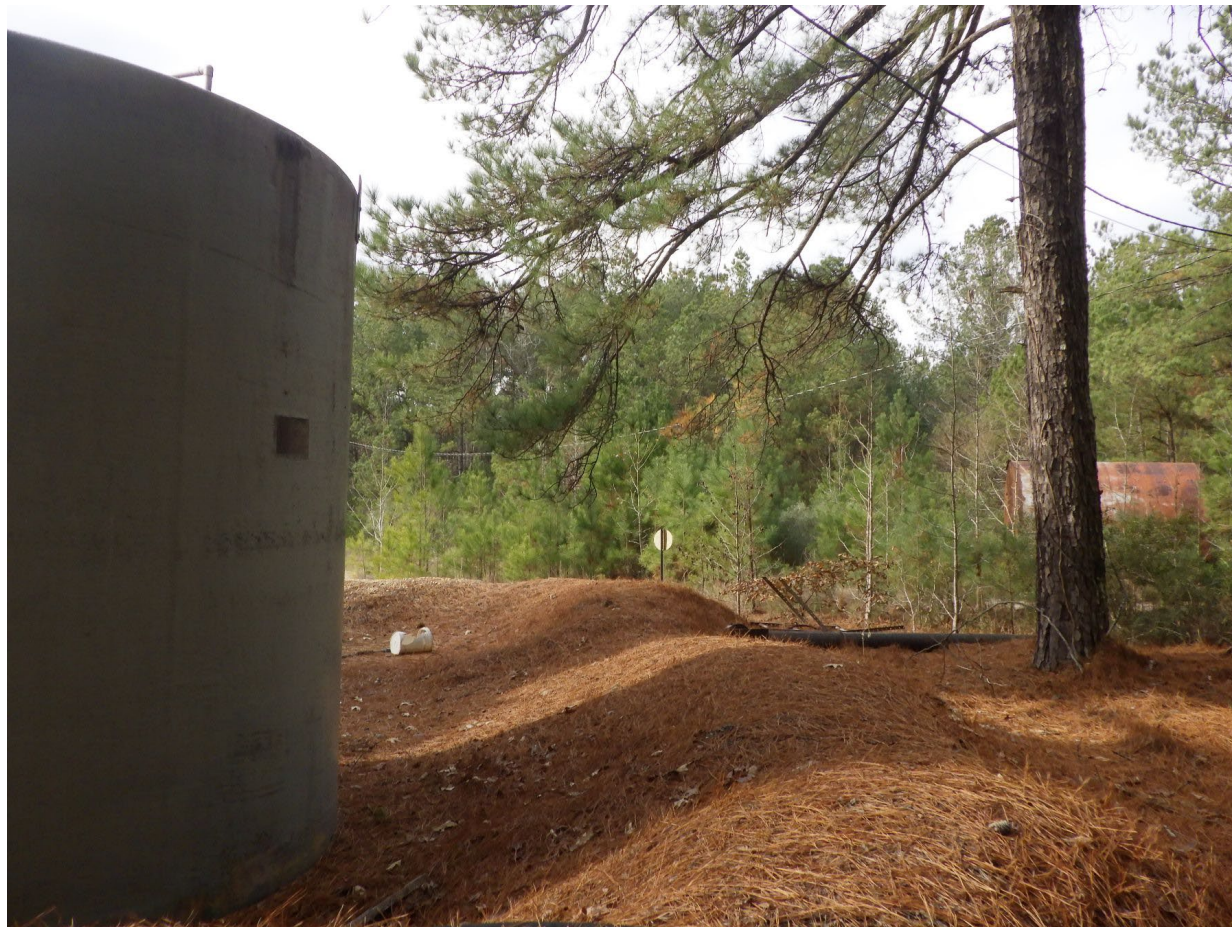
Photo No. 5

I observed the left side of the tank battery, see Photo No. 5.

| Description: | Looking NW, this photo shows the left-side view of the containment structure. | | |

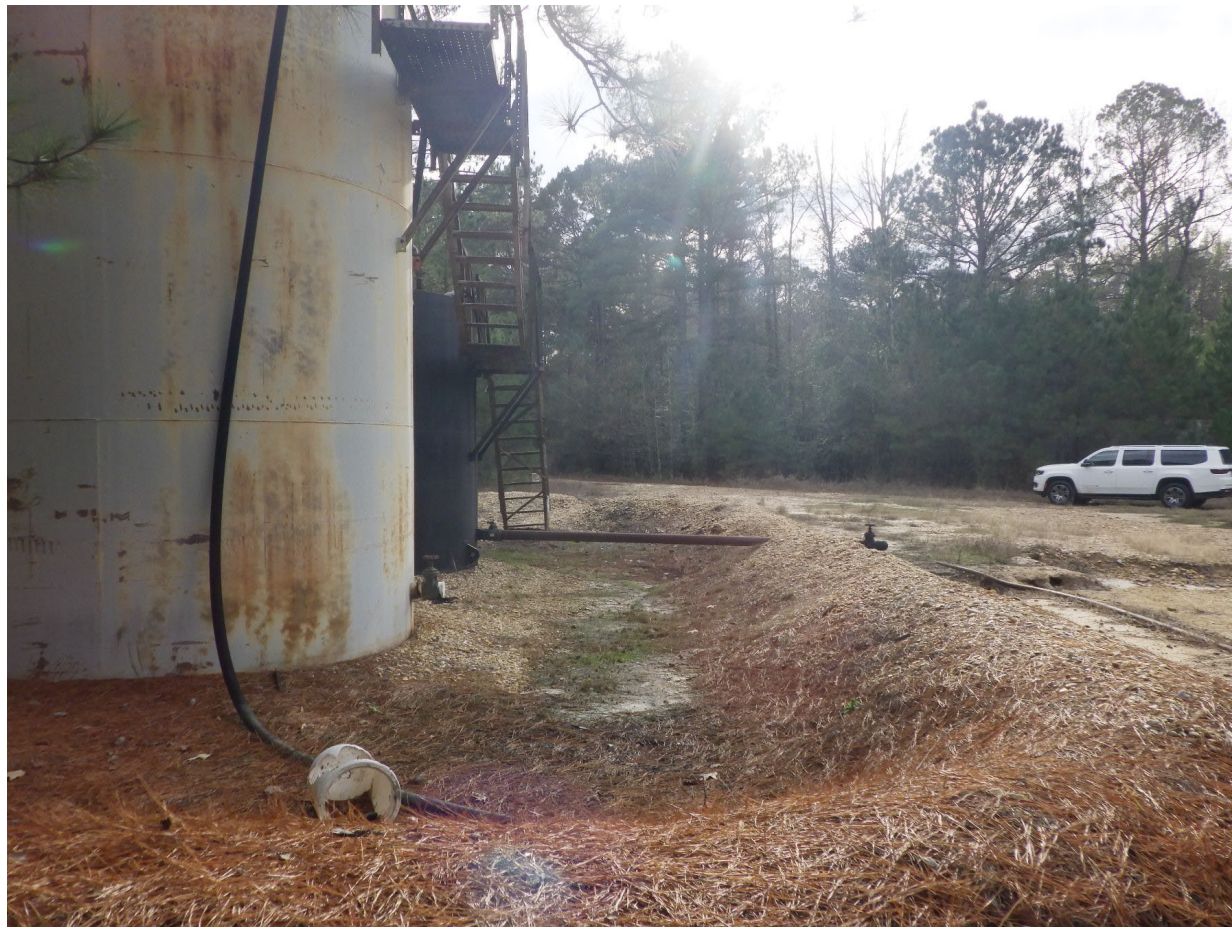
Photo No. 6

I observed the front side of the tank battery, see Photo No. 6.

| Description: | Looking WSW, this photo shows the front view of the containment structure. | | |

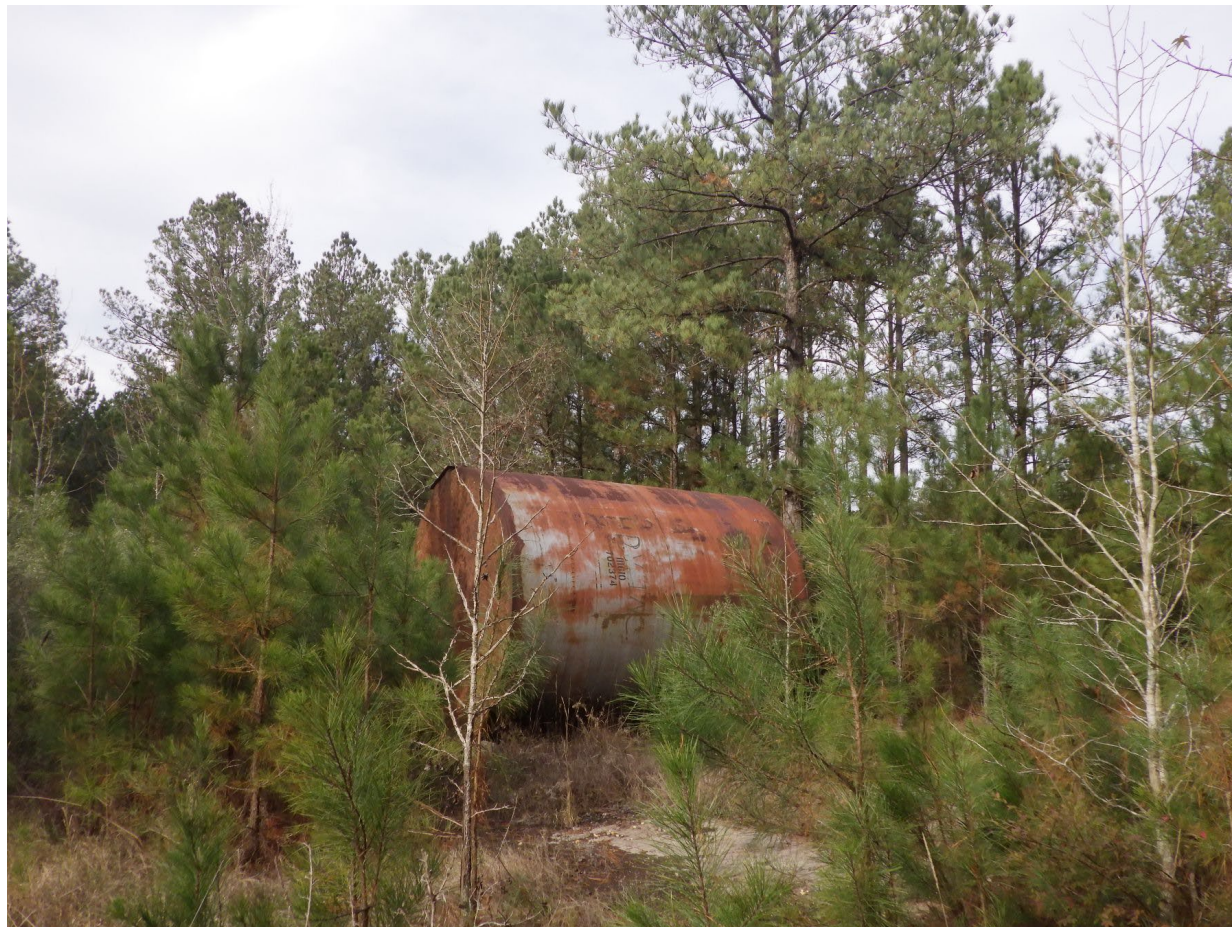
Photo No. 7

I observed two (2) tanks outside secondary containment that appeared to be out of service and not properly marked as “out of service,” see Photos No. 7 and No. 12.

- No catchment bucket and loose crude oil outside containment at the transfer/production line (Photo No. 8),
- No cap on the drainpipe for secondary containment, (Photos No. 9 and No. 10), and
- Two (2) tanks outside secondary containment not properly marked as “out of service” (Photos No. 7 and No. 12).

| Description: | Looking NNW, this photo shows a tank outside containment that was not in use. The tank was not marked, as required, indicating "out of service." | | |

Inspector will conduct follow-up phone calls with the company representative(s) over the coming weeks and months to ensure areas of concern are properly addressed.

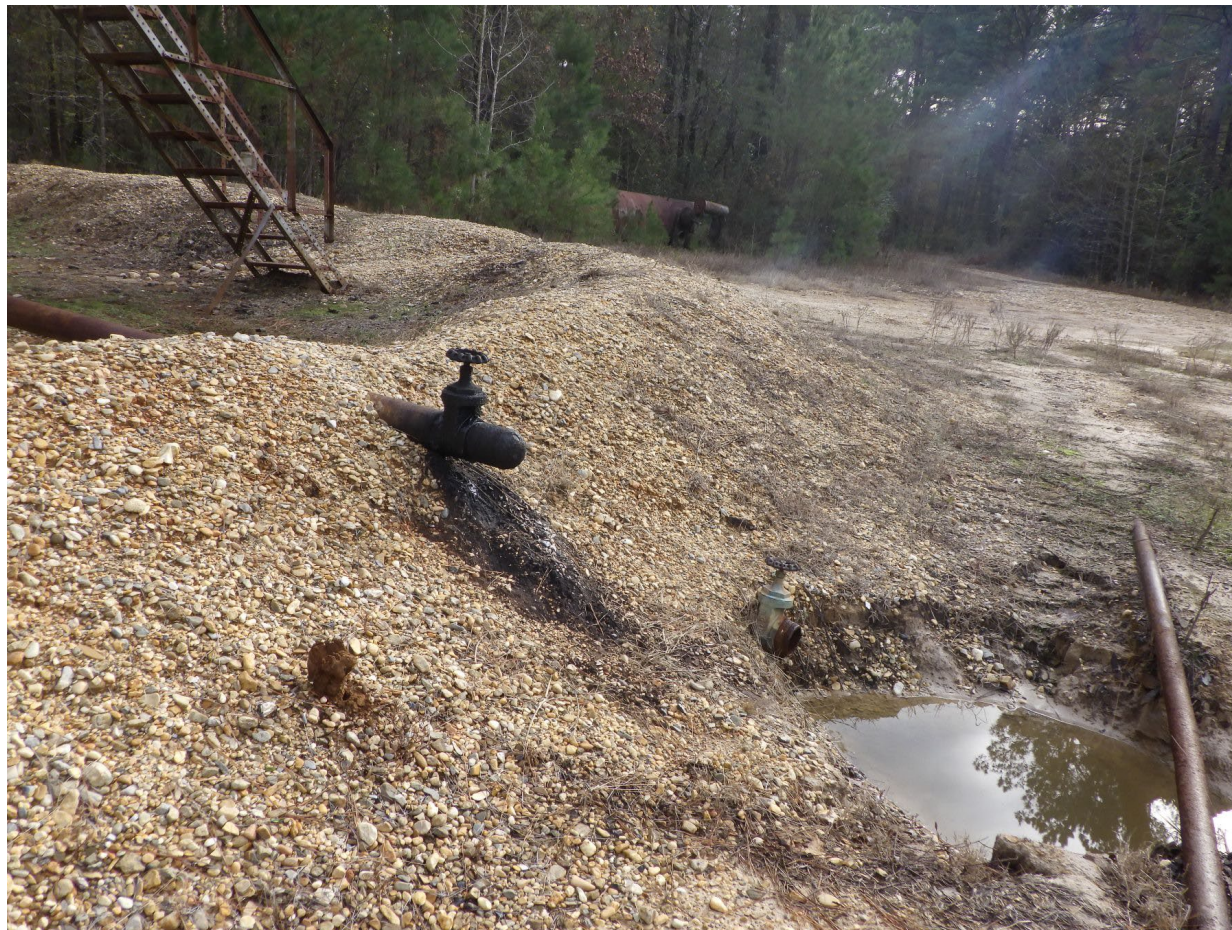
Photo No. 8

I observed the transfer/production line for crude oil without a catchment bucket, see Photo No. 8.

| Description: | Looking W, this photo shows a transfer/production line for crude oil without a catchment bucket and loose oil around the valve. | | |

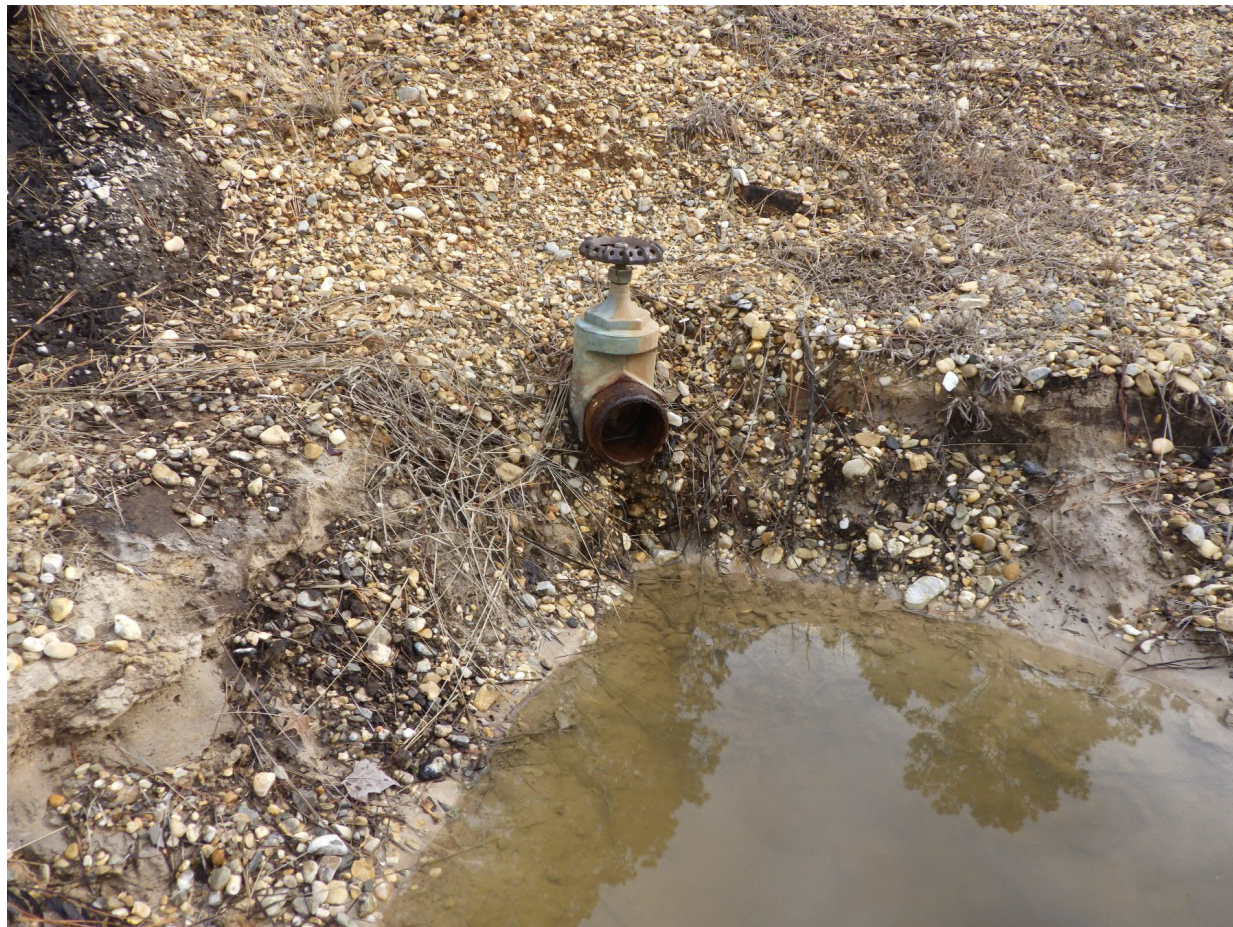
Photo No. 9

I observed the drainpipe for secondary containment without a cap, see Photos No. 9 and No. 10.

| Description: | Looking NNW, this photo shows the drainpipe for the containment structure without a cap. | | |

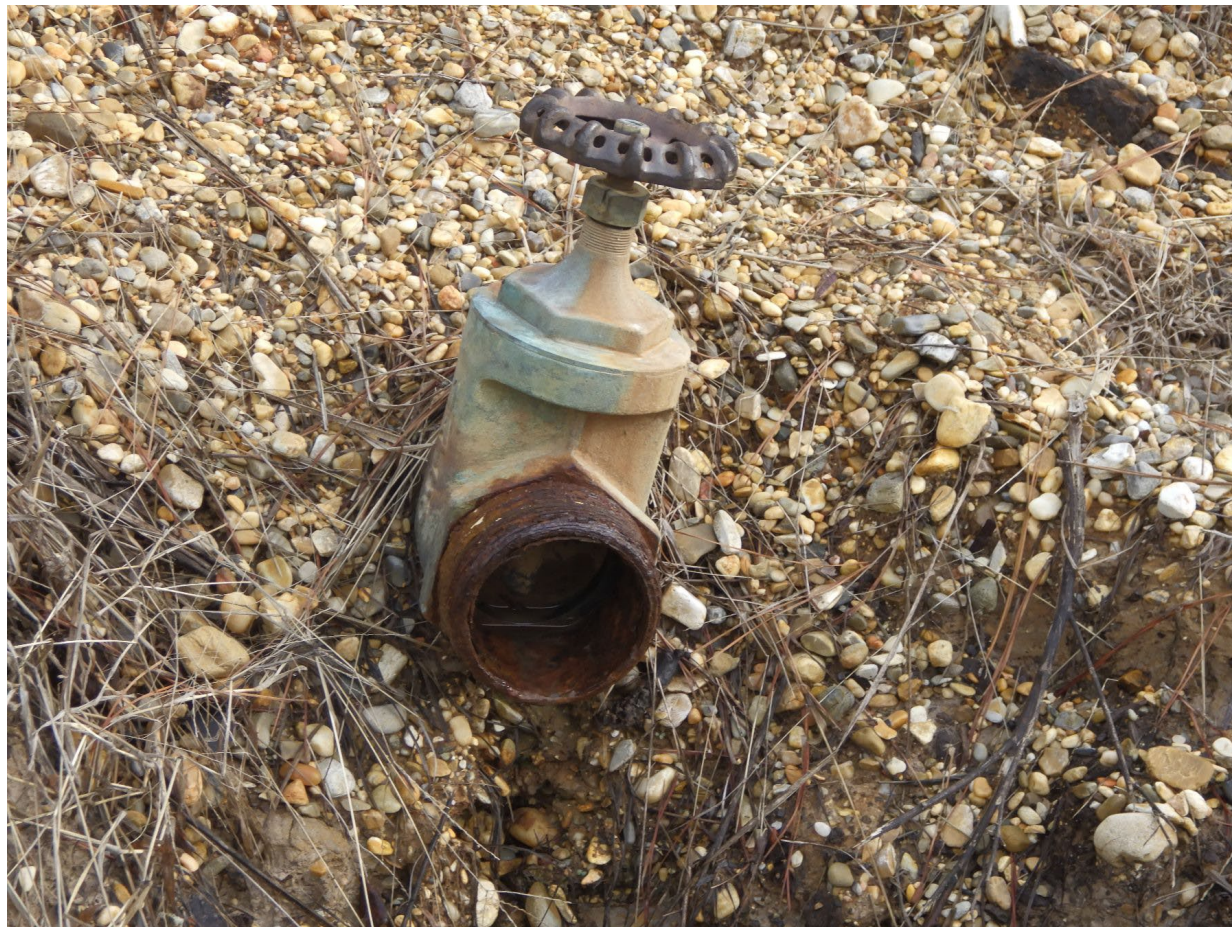
Photo No. 10

| Description: | Looking NNE, this photo shows a closeup of the drainpipe without a cap from Photo #9. | | |

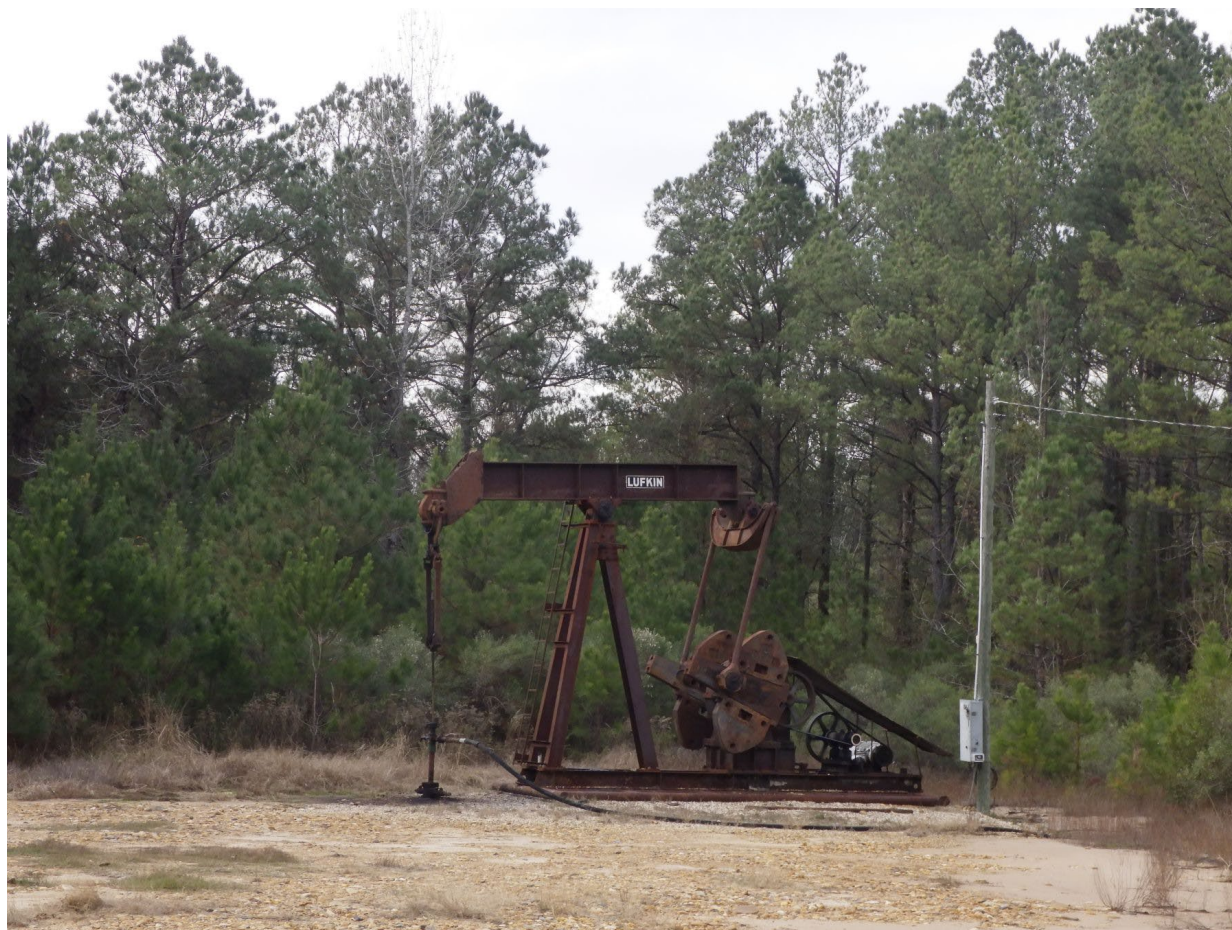
Photo No. 11

I observed an active production well onsite, see Photo No. 11.

| Description: | Looking NW. this photo shows an oil production well (active) adjacent to the facility. | | |

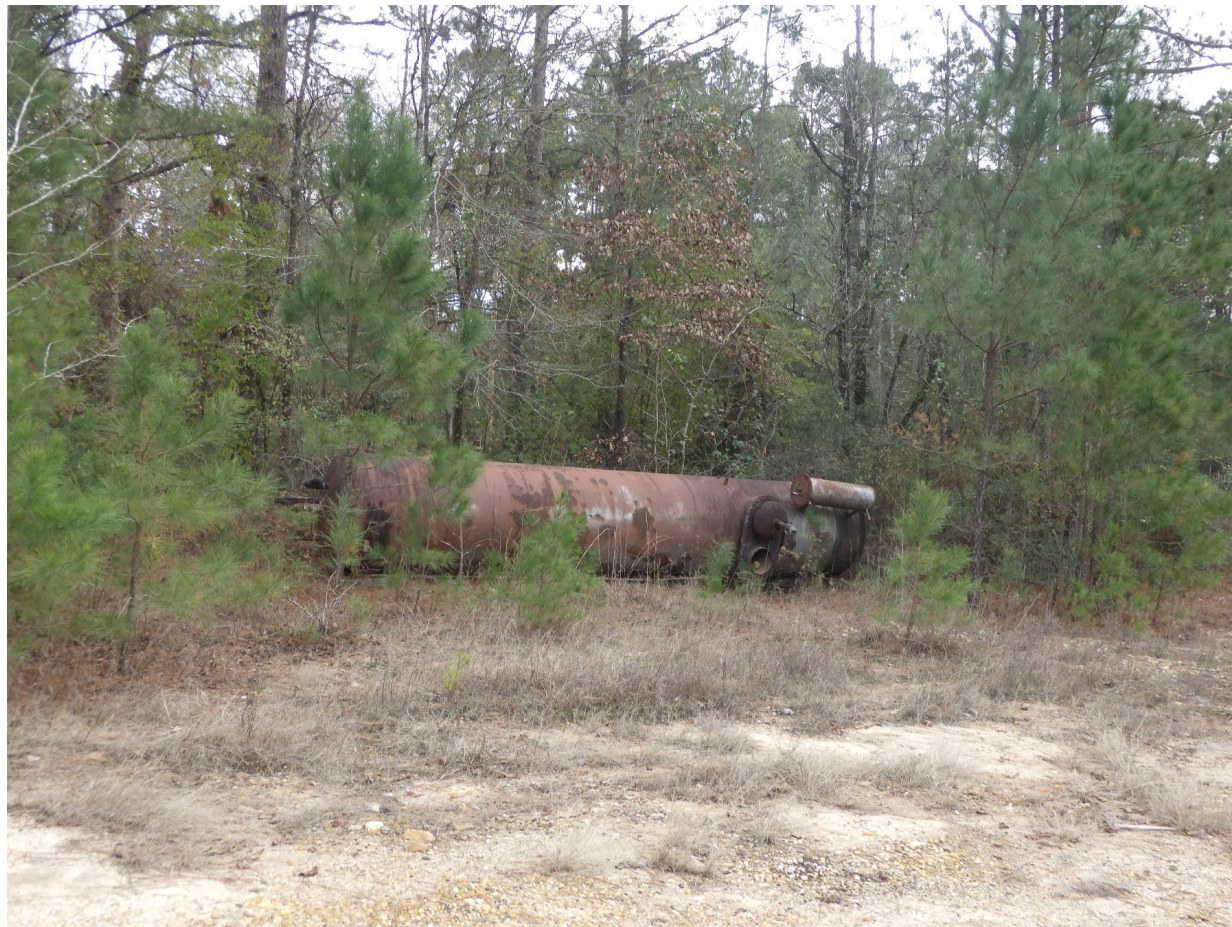
Photo No. 12

| Description: | Looking SW, this photo shows a tank outside containment that was not in use. The tank was not marked, as required, indicating "out of service." | | |
